STAFF REPORT: 8/9/2023 REGULAR MEETING

APPLICATION NUMBER: #23-8478

ADDRESS: 2325 W BOSTON

SCOPE: DEMOLISH GARAGE, REBUILD FRONT PORCH AND OTHER EXTERIOR REHABILITATION
(WORK STARTED WITHOUT APPROVAL)

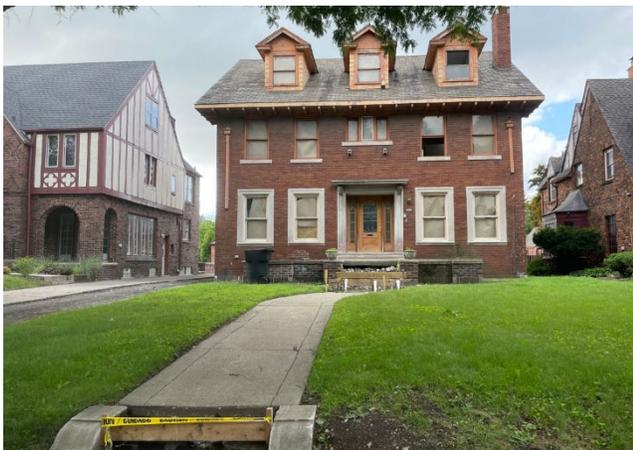
Site Photo 1, by Staff July 18, 2023: (North) front elevation.

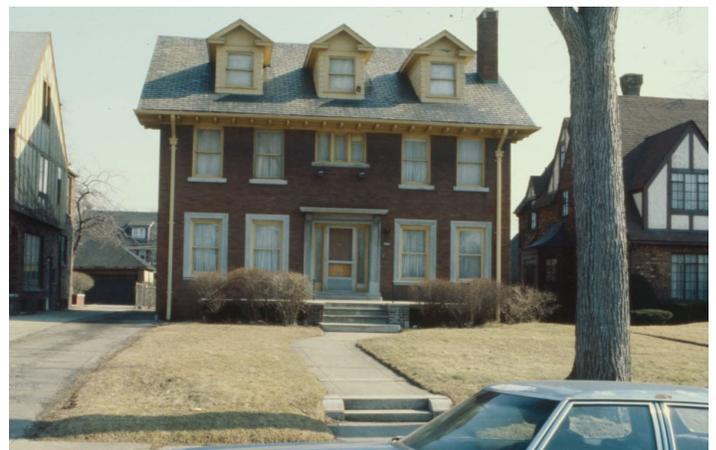
Designation Image, 1980: (North) front elevation.

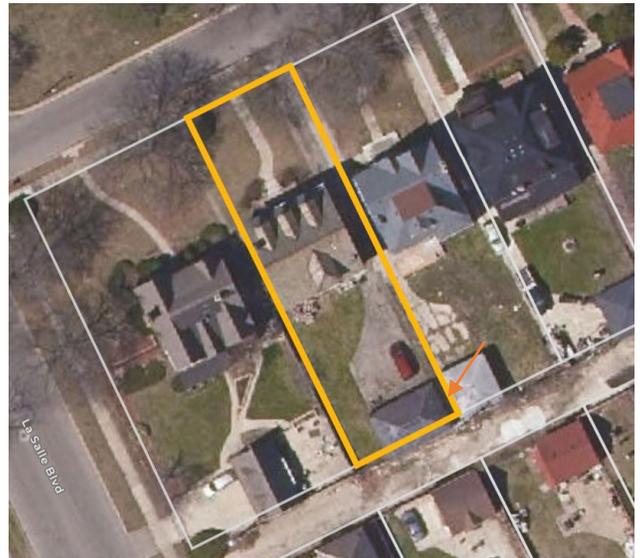
Aerial 1 of Parcel # 10002767 by Detroit Parcel Viewer, showing the former garage location (arrow).

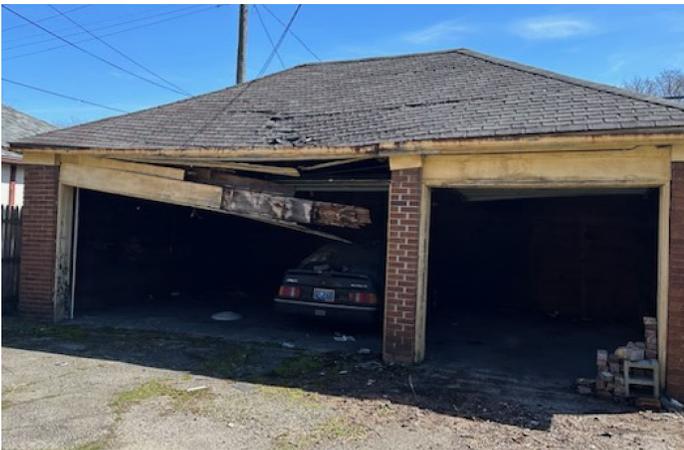
Site Photo 2, by applicant May 2023: (facing south) north elevation of garage, showing roof collapse and wood framing failure.

- Staff observes from these and the applicant's images that the building appears to be wood frame with brick cladding construction, and while a utilitarian product of its time, does not share character-defining architectural features with the primary structure (ie., the house).

- As shown by the applicant's photos, the roof appears to have a severe damage and beyond feasible repair, showing signs of subsidence failure in the center (see site photos 2 and 3), and the exterior walls in a state of collapse.

- All work in this application was completed or started without Historic District Commission (HDC) approval.
- It is the staff's opinion that the garage's structure was severely compromised, and the building had lost its historic integrity. Given these conditions, the staff finds it reasonable to approve demolition.

It is the staff's opinion that the demolition of the garage and the remaining rehabilitation work are appropriate. Staff therefore recommend the Commission issue a Certificate of Appropriateness for the work as proposed and completed because it meets the Secretary of the Interior Standards for Rehabilitation and the West Village Historic District Elements of Design.

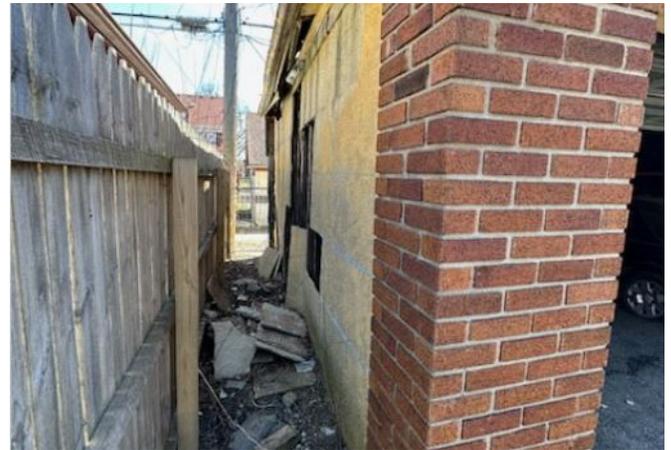
Site Photo 3, by applicant May 2023: (facing south) north elevation of garage, showing missing siding and framing failure.

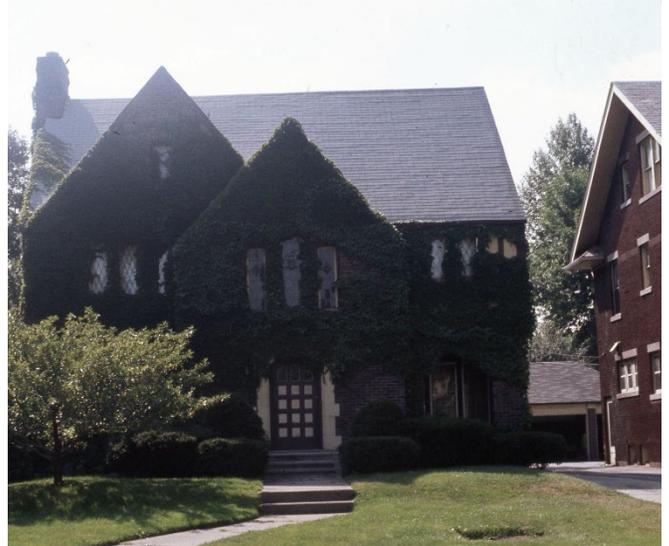
- The 1974 designation image of the adjacent property at 2135 W Boston shows the presence of a one-story wood frame garage at the northeast property corner (See site photo 4). It is staff's opinion that this is the same garage that was standing up until the recent demolition.

Site photo 4, 2135 Boston designation Image, 1974: (North) front elevation showing the 2325 Boston garage at rear.

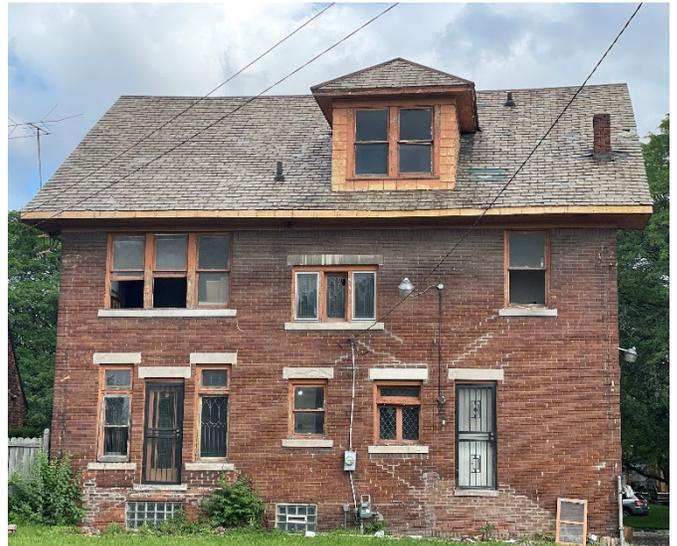
- Staff observed that the rear house has no steps or deck that reaches the rear doors. Staff received confirmation from the applicant that this work is not included in the application.

Site photo 5, by Staff, July 2023: (South) rear elevation showing missing rear steps.
