**STAFF REPORT: 8/09/2023 REGULAR MEETING**

**ADDRESS: 104 EDMUND PLACE, AKA LUCIEN MOORE HOUSE**

**APPLICATION NO: #23-8480**

**SCOPE: ALTER FRONT PORCH (WORK COMPLETED WITHOUT APPROVAL)**

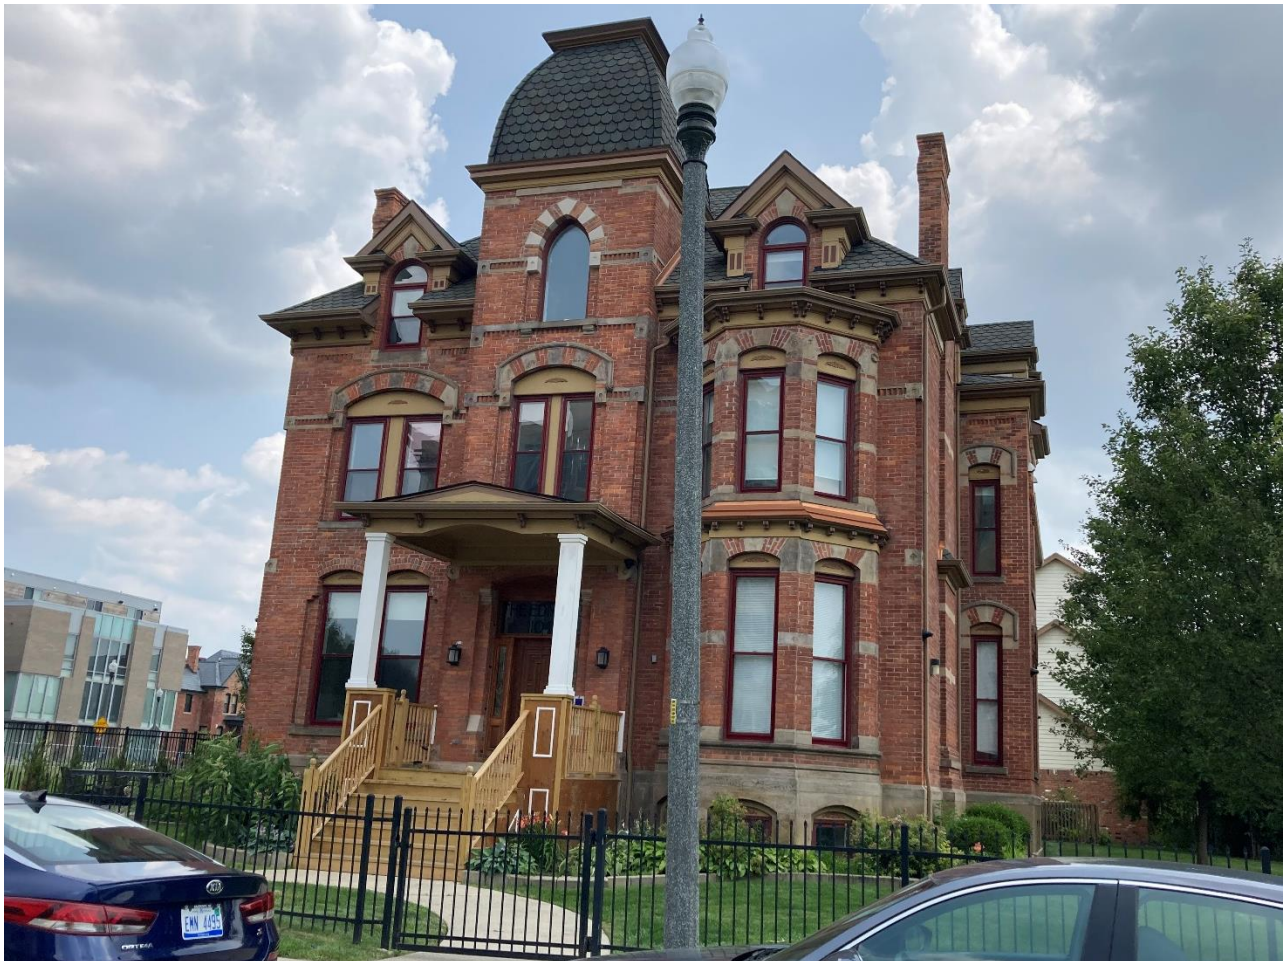
Erected ca. 1885, the building located at 104 Edmund Place is known as the Lucien Moore House. The building features a hipped-roof central/main mass with a lower hipped-roof addition at the rear. Gabled dormers and prominent brick chimneys top the roof. A projecting, three-story wing which is capped with a bell cast roof and a flat-roof, two-story, projecting bay is located at the front elevation. Exterior walls are red brick with stone at window sills and lintels. Rusticated stone is also present at the building's raised basement. The building underwent an extensive rehabilitation ca. 2010 which included the installation of 1/1, double-hung, aluminum windows with wood trim/brickmould. The current wood roof at the building's front elevation porch was also added during the ca. 2010 rehabilitation effort. However, the porch's wood newel posts, railing, steps, deck, and columns were added ca. 2023.

**104 Edmund Place, current appearance. Staff photo taken on 7/18/2023**

The porch that was erected without HDC approval/the current porch does is incompatible with the building's historic character as the new/current bright white, bulky, square porch columns, the current newel posts, deck skirting, and stringers present an awkward incongruent appearance better suited for a modern home versus this carefully-detailed, late 19<sup>th</sup> century, Victorian/Ruskinian Gothic style dwelling. Staff therefore recommends that the Commission issue a Denial for the current proposal because the work does not conform to the district's Elements of Design and does not meet the Secretary of the Interior's Standards for Rehabilitation. In particular, SOI Standard #9, which states the following:

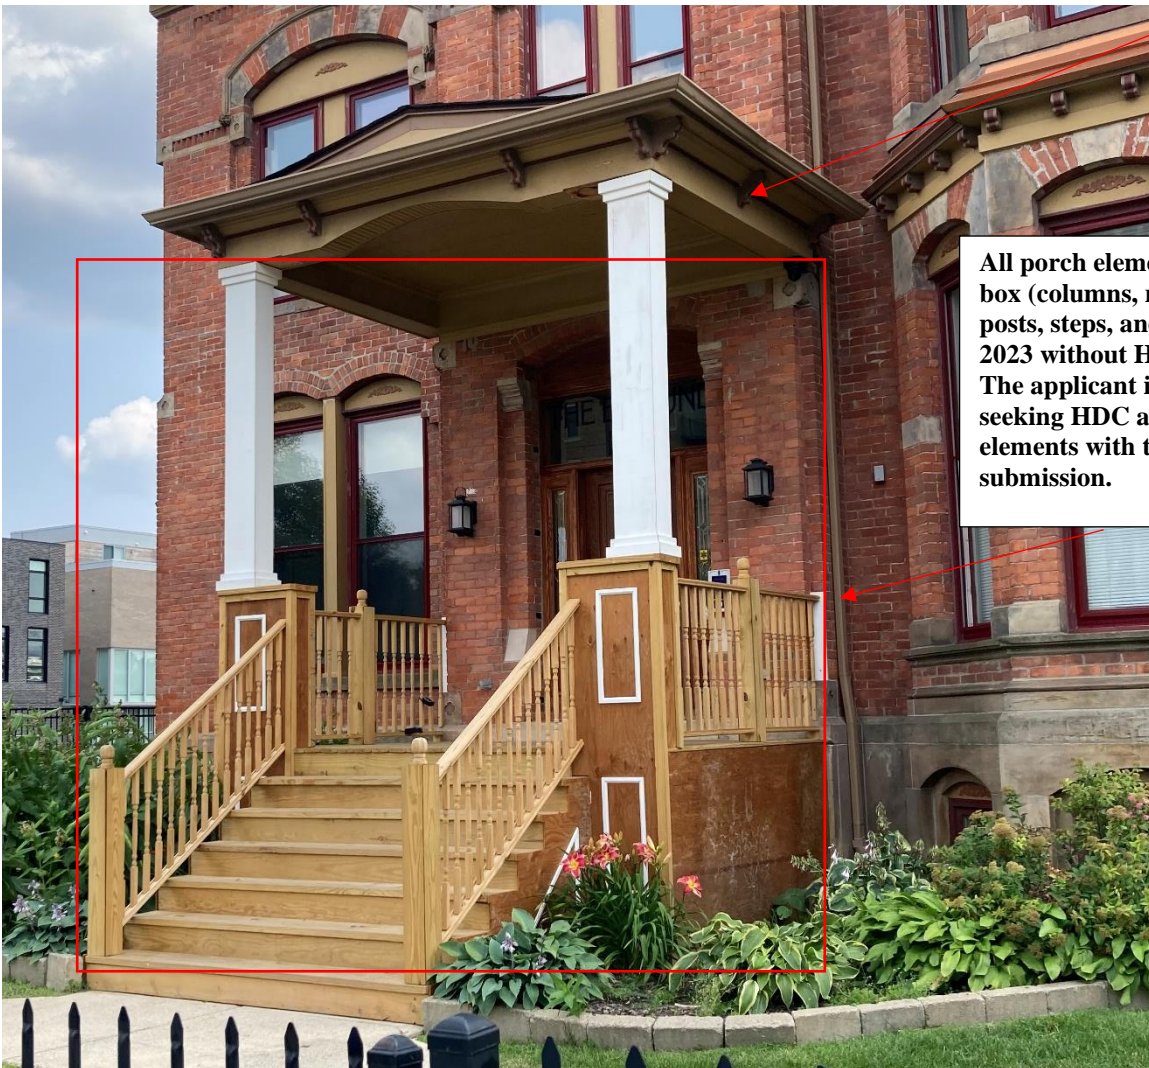
Per the current submittal, the applicant is seeking the Commission's approval of the current newels posts, railing, deck, steps, and columns at the front porch. These elements were installed in 2023 without HDC review and approval (see the below photo). Note that the newels posts, railing, deck, and steps are unpainted. The applicant has stated that they will paint these elements (colors not specified) once the wood has seasoned.

Current appearance. Staff photo taken on 7/18/2023

- As the original porch had been removed by the 1970s, the Standards do not require that a new porch match the original. Rather, the porch must be compatible with the property's historic character. It is staff's opinion that the new/current bright white, bulky, square porch columns are visually incompatible with the building's late Victorian/Ruskinian Gothic stylistic detailing/historic character. Also, staff does note that it appears the current newel posts, deck skirting, and stringers are made of plywood with applied details meant to approximate the appearance of the more substantial beadboard deck skirting and paneled stringer and new posts which were removed as a result of the current unapproved work (see the photos of the former porch included with the 2019 application). It is staff's opinion that the white columns in addition to the current newel posts, deck skirting, and stringers present a plastic, awkward incongruent appearance and might be better suited for a modern home versus this carefully-detailed, late 19<sup>th</sup> century dwelling. Staff recommends that the current unapproved columns be replaced with columns which display a more slender/refined appearance and that the current plywood newel posts, deck skirting, and stringers be replaced with wood elements of a quality and design that is more compatible with the building's historic character.

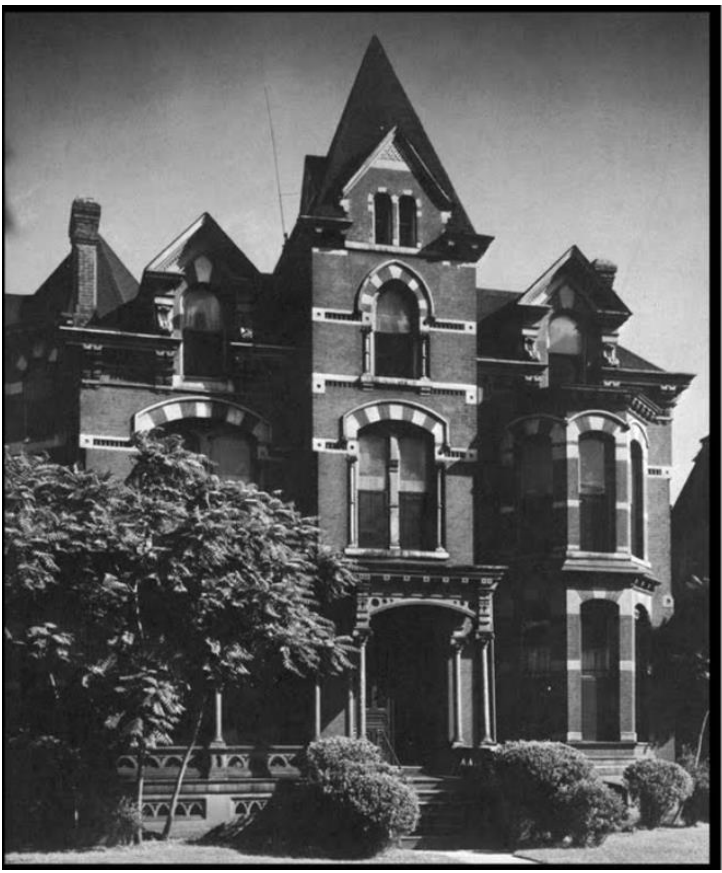
104 Edmund place, early 20<sup>th</sup> century, photos showing original porch

- The Detroit Historic Designation Advisory Board designation report for the district, which dates to 1980, describes the building as a “ruin” at that time. Per the above photos, the original porch had been removed by the 1970s. By 1980, a front porch was no longer extant at the property.

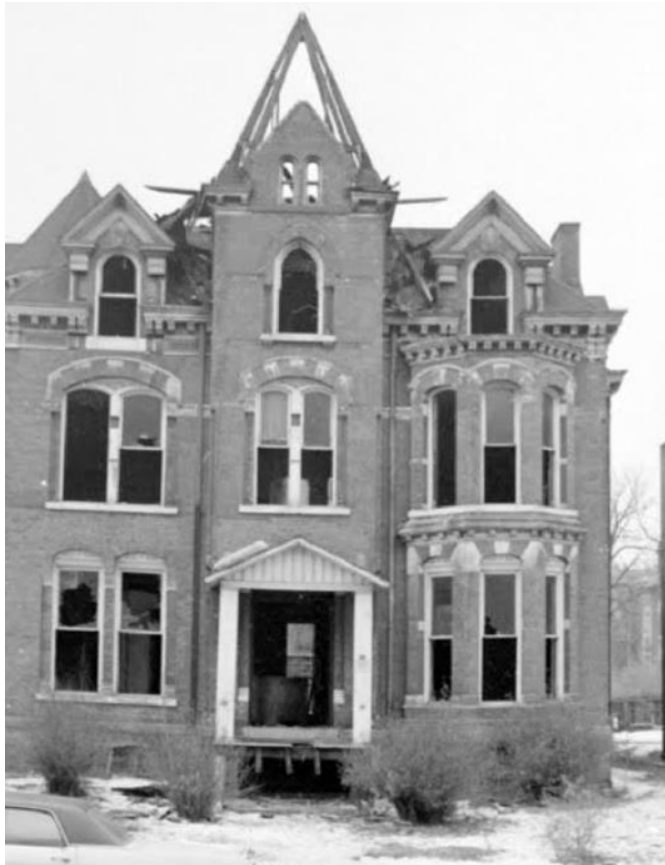
104 Edmund Place, appearance ca. 1980

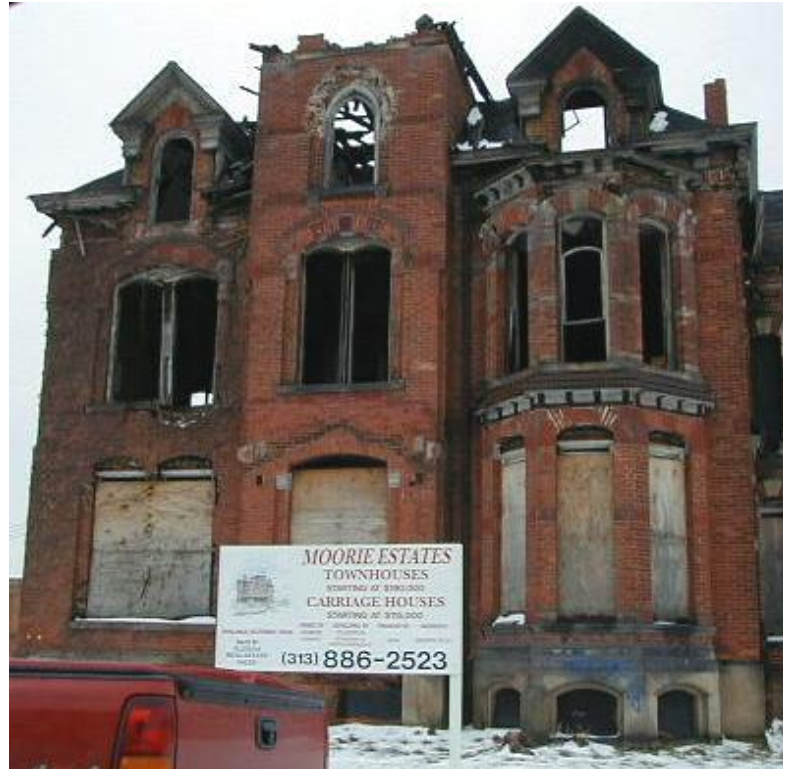
104 Edmund Place, appearance in 2004 (from HDC staff report/application for building rehabilitation

- An application was submitted to the Commission in 2004 for the rehabilitation of the building, which included the erection of a new porch at the front elevation. See the attached 2004 staff report for the conditions of the building at that time. Per the 2004 report, HDC staff recommended that the design of the new front porch be “...simplified in design and detail since the porch cannot be duplicated to match the original.” The Commission approved the proposed 2004 rehabilitation scope. The porch was subsequently erected per the appearance depicted in the above 2022 Google Streetview images. It is staff’s opinion that the porch that was erected as a result of the 2004 rehabilitation (2022 Google Streetview images) was compatible with the building’s historic appearance.

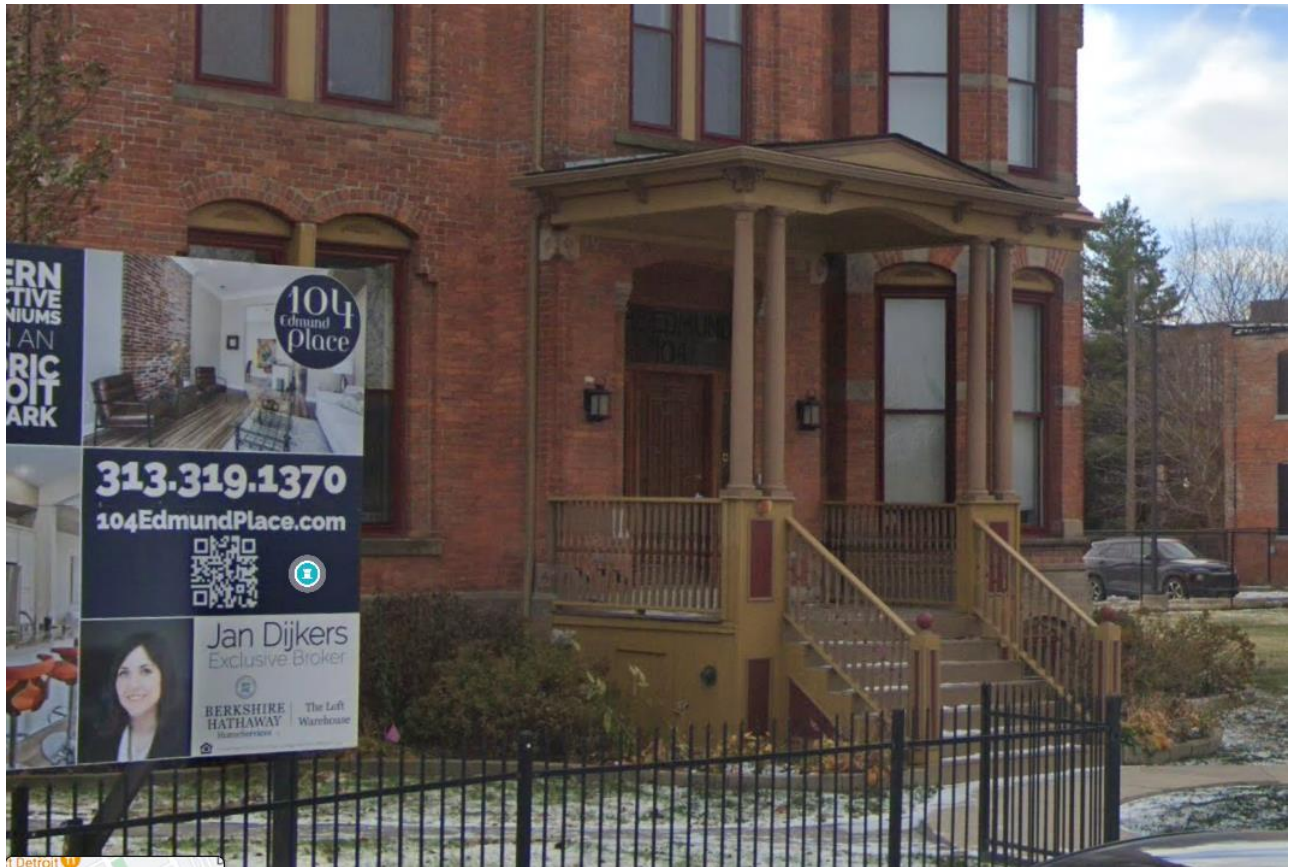
Google Streetview images from 2022 showing porch that was installed during ca. 2010 rehabilitation. The newel columns, posts, railings, deck, and steps were removed without HDC approval. In 2023

- As previously noted, the front porch that was removed and replaced without HDC approval was not historic age/was erected ca. 2010. Also, as an application for a repair had been submitted to staff in 2019, only nine years after the porch was installed, it is likely that the porch was of poor construction. However, the porch was esthetically compatible with the building’s historic character, in staff’s opinion.

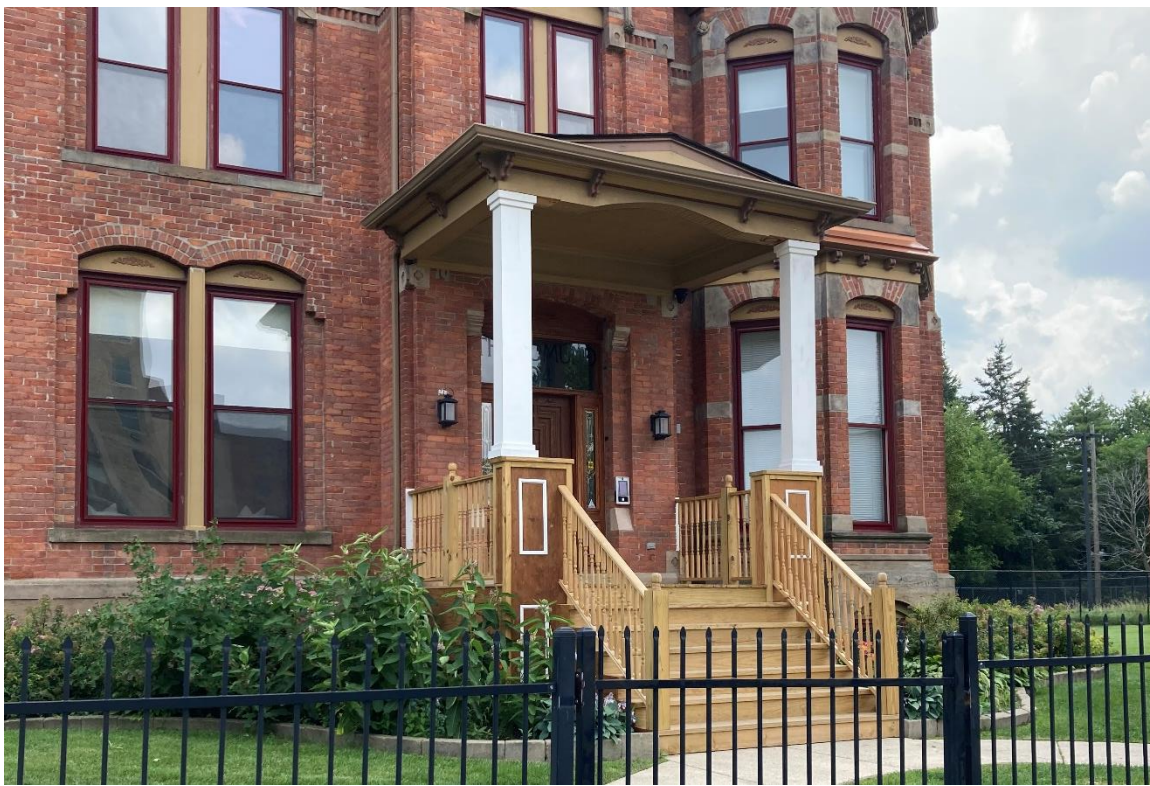
**104 Edmund Place, current appearance. Staff photo taken on 7/18/2023**
