STAFF REPORT: OCTOBER 11, 2023 REGULAR MEETING

APPLICATION NUMBER: HDC2023-00035

ADDRESS: 1471 HUBBARD

SCOPE: ERECT GARAGE

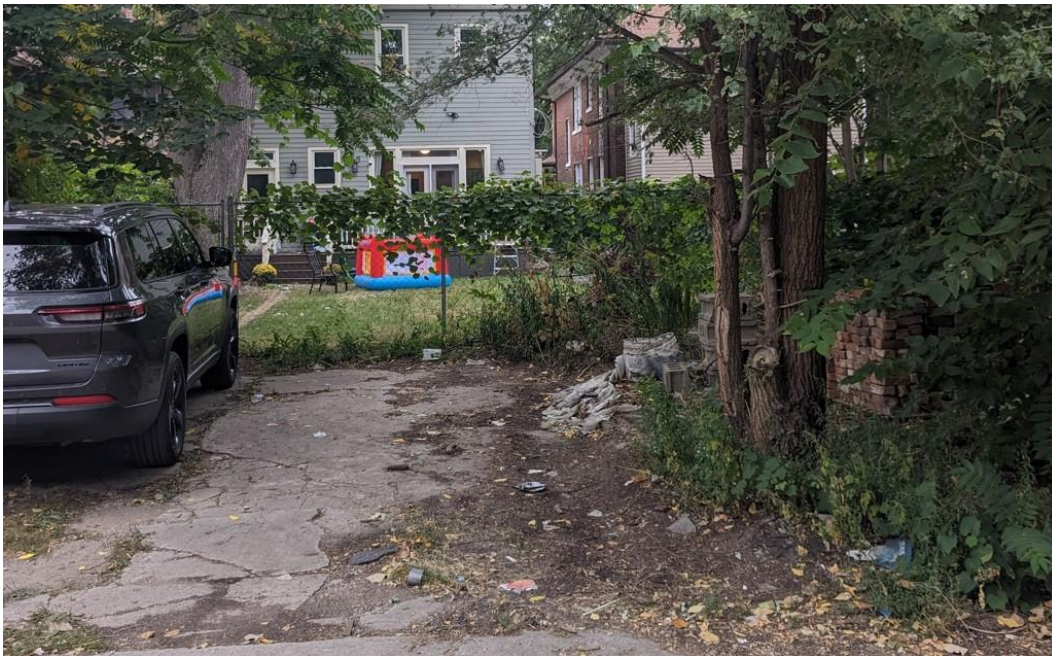
Footprint of demolished garage, facing west onto the alley. September 2023 photo by staff.

An alley-facing garage was built in 1920. According to the applicant, it collapsed in 2016. The Historic District Commission issued a Notice to Proceed for its demolition in 2018. A broken, concrete slab remains.

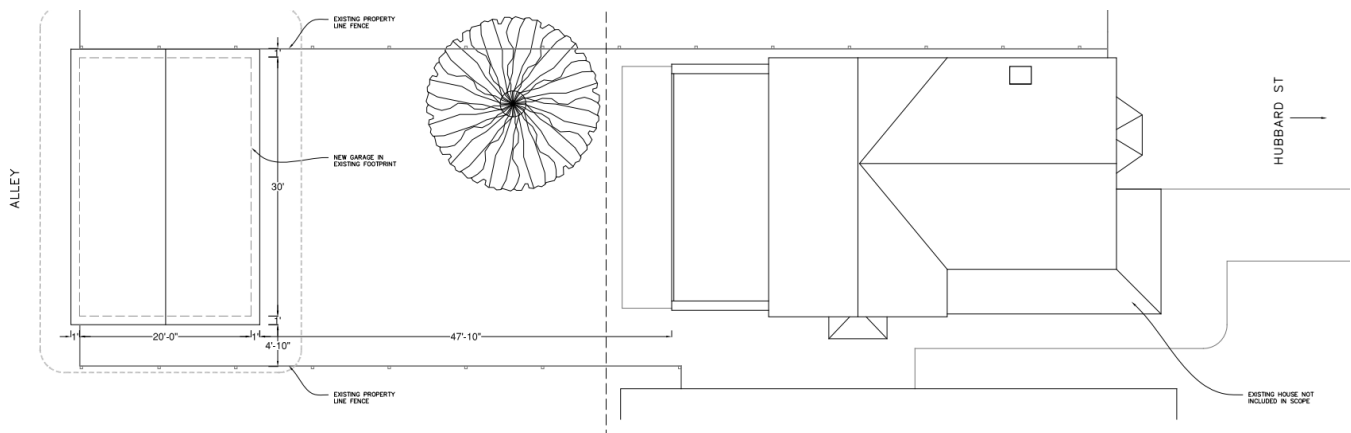
Site plan showing relationship of garage to house. Image from application documents.

- The proposed garage is appropriately located on the footprint of the demolished garage.
- The proposed fiber-cement siding is an appropriate substitute material for a secondary building such as a garage, as it closely resembles the appearance of historic wood siding.
- The proposed shingles, siding, and paint colors were previously approved for the house at 1471 Hubbard with a Certificate of Appropriateness issued in connection with application 18-5544. It is appropriate for the garage to match the house in color, texture, and materials.

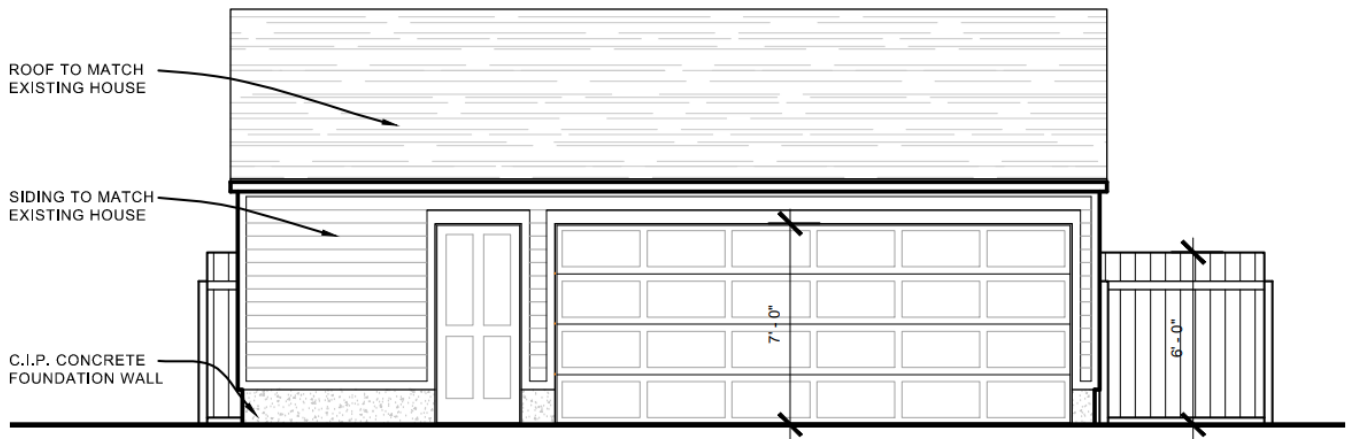
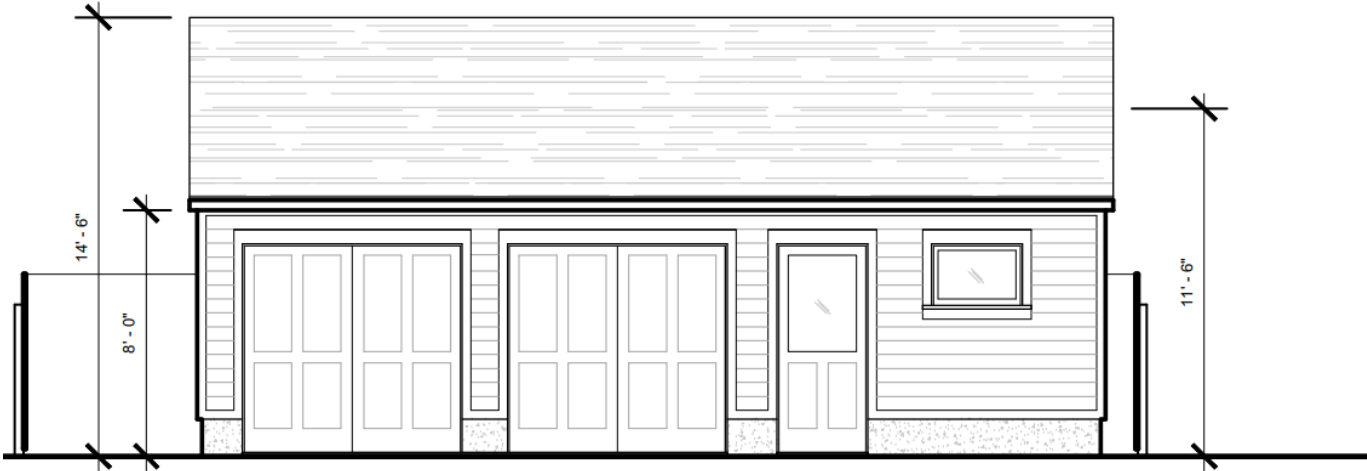
Top: West (alley-facing) elevation. Above: East (house-facing) elevation. Images from application drawings.

The application documents note that cementitious siding is proposed. Sectional steel garage doors and a pedestrian door with recessed panel designs and a white finish are shown in the application documents.

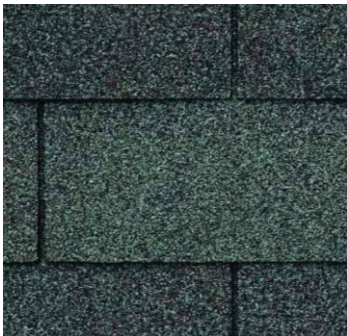
CertainTeed X25 asphalt shingles in slate grey. Image from product website.

Remove and replace existing concrete slab on current footprint. Build new 2-car garage per plans attached. Install new cement board siding to match existing house. Install new roof with asphalt shingles to match existing house in a color similar to CertainTeed XT 25 Slate Gray. Paint siding in a color similar to C1: Colonial Revival Grey to match existing house. Paint trim in a color similar to C4: Classical White to match existing house. Install new garage doors and man doors per plan.

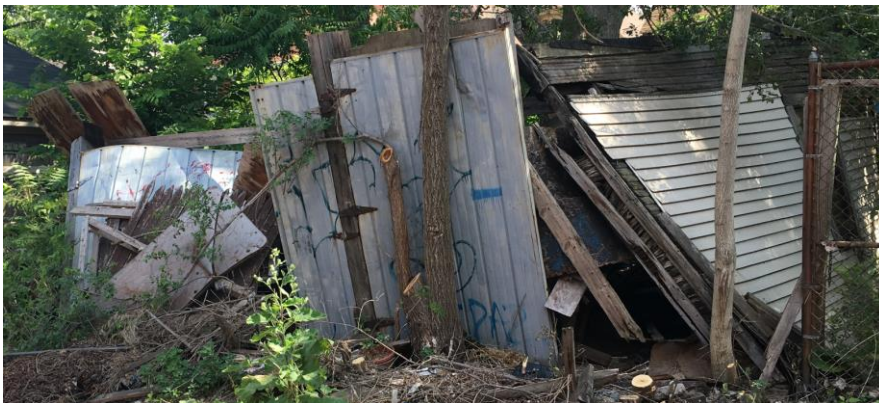
2018 photo provided by applicant.

- One bay of the demolished garage, as shown in the 2018 photos, had an east-facing pedestrian door and small window. The garage also had narrow, clapboard siding. No other defining features of the demolished garage are visible in the 2018 photos, as most of the building had collapsed by that time.

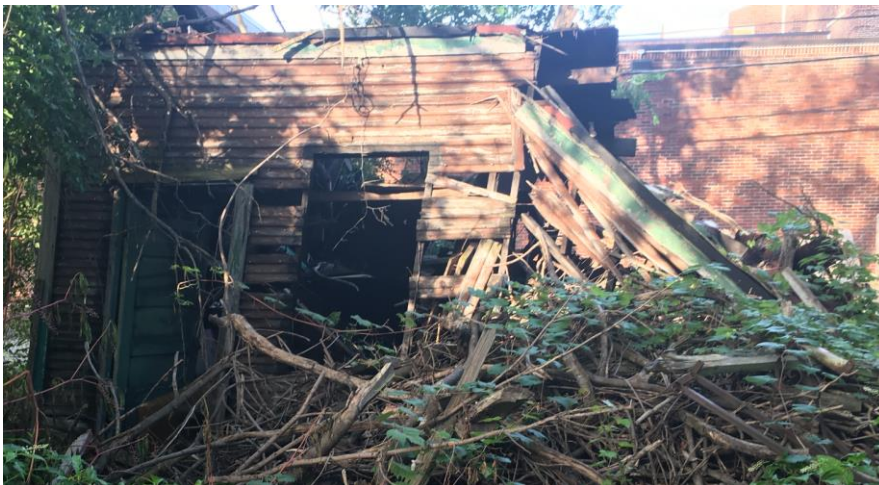
2018 photo of the collapsed garage, provided by the applicant.
