**STAFF REPORT: NOVEMBER 8, 2023 MEETING**

**APPLICATION NUMBER: HDC2023-00097**

**ADDRESS: 2905 GARLAND (AKA THE OSSIAN SWEET HOUSE)**

**SCOPE: ERECT SECOND FLOOR AND FIRST FLOOR PORCH PERIMETER RAILING AND PORCH STAIRS**

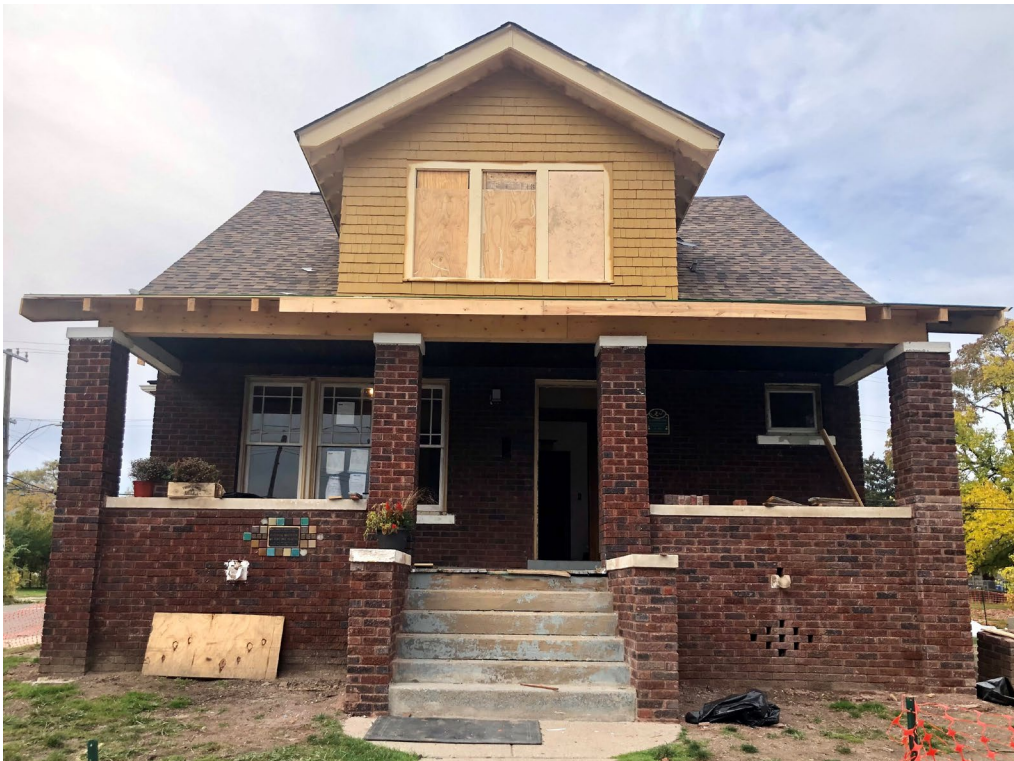
The centrally placed main entrance contains a single door that is now covered with a security door. A picture window is located to the left, or south, of the door, and a single small square window is located to its right, or north. The opening in the roof dormer contains three-double hung sash windows separated by mullions.

*East elevation. Staff photo, October 25, 2023.*

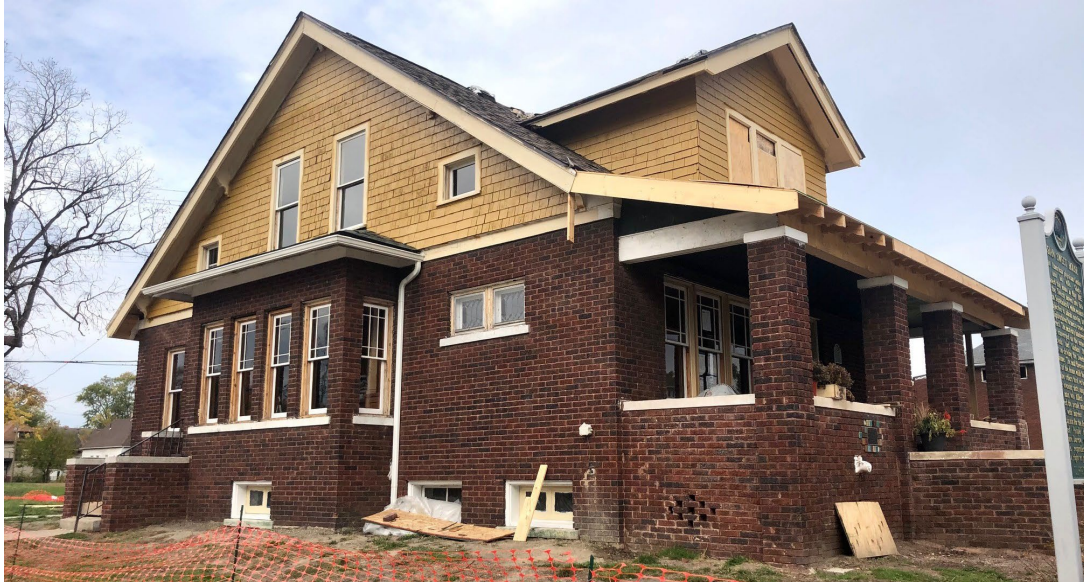
The large side-facing gabled ends of the roof have raking verge boards. The south side elevation, facing Charlevoix, features a secondary entrance and a box bay. A pair of small, horizontally rectangular leaded glass

windows, quite typical of bungalows, punctures the wall eastward of the box bay, though they appear to be later replacements. Similarly sized and shaped basement windows circle the perimeter. The box bay is covered by a shallow hipped roof. Its depth is one elongated double hung sash window; its width contains four similar windows sharing a common sill.

*South elevation that faces Charlevoix. Staff photo, October 25, 2023*

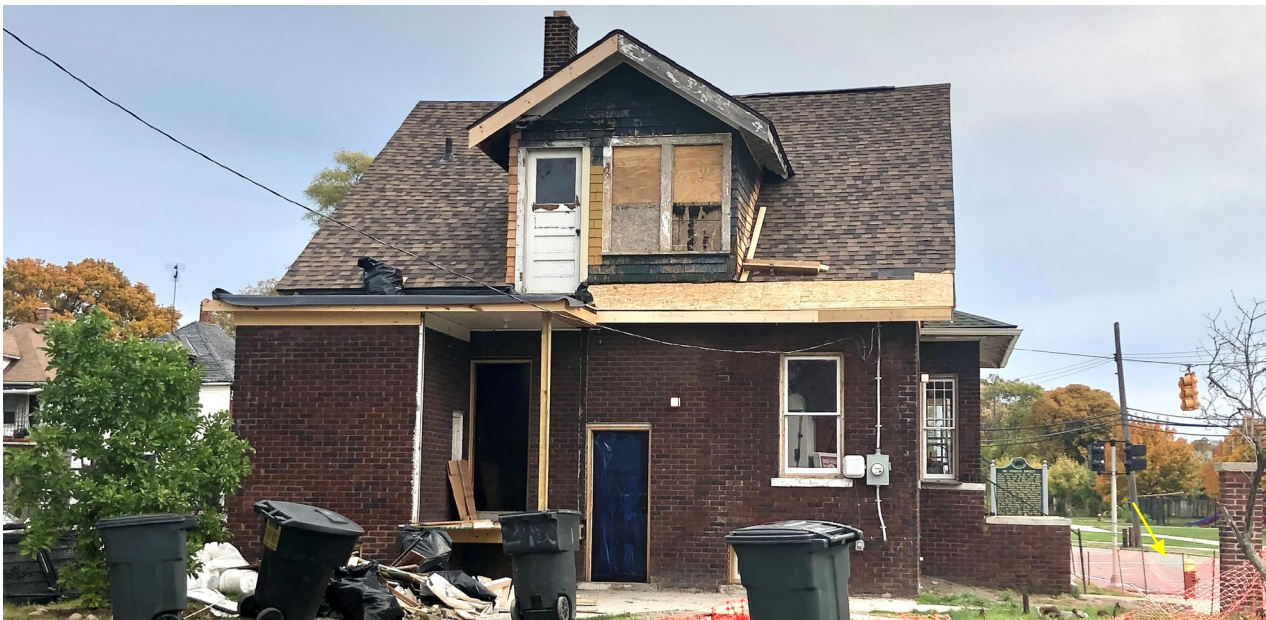
A small backyard extends west from the house; gravel covers the area where the concrete pad for the garage had been located. A concrete walkway adjacent to the concrete pad bisects the rear yard at a southeast angle towards the first story rear entrances.

*Rear-west elevation. Staff photo, October 25, 2023.*

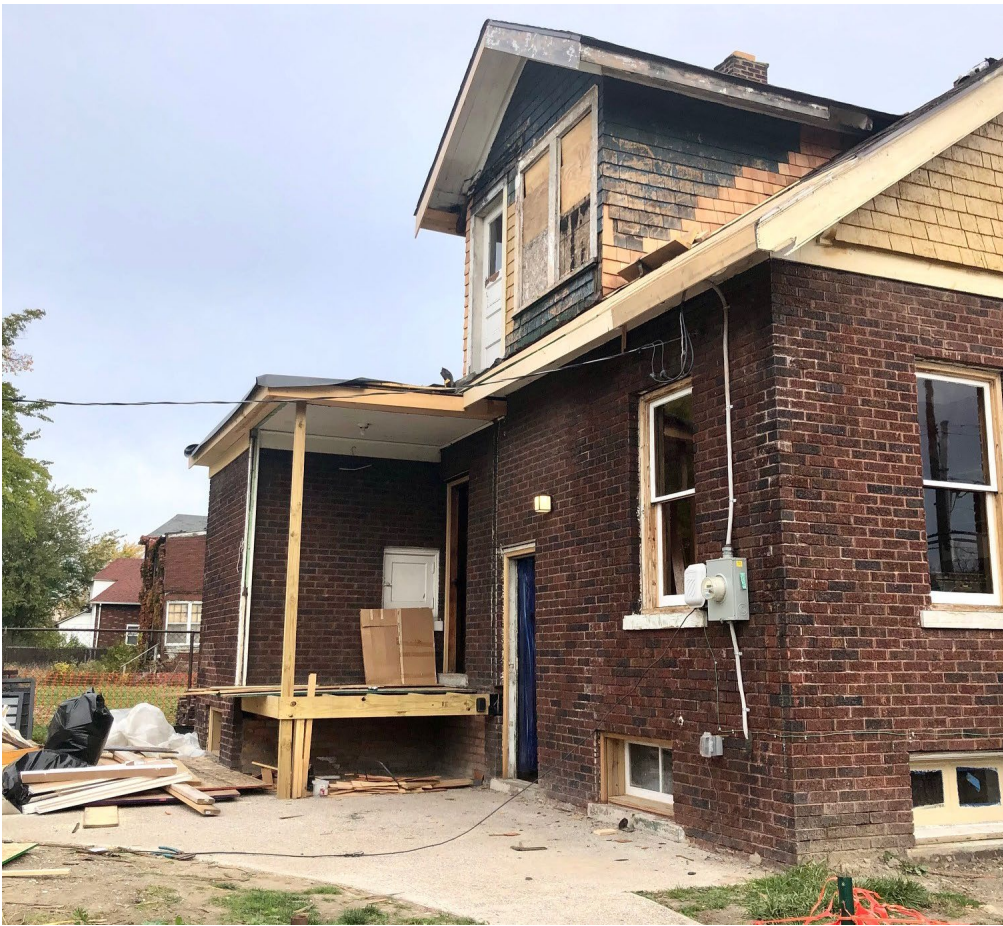
The massing of the rear elevation is similar to the front elevation. A centrally placed gabled dormer protrudes from the steeply sloped roof, and is faced with wood shake shingles that matches the walls of the front dormer and side gable walls. The dormer wall is filled with two mullied double-hung windows and a single wood/glass door which led to an upper porch. The windows and door were placed to the far right and left end of the wall, respectively, to allow an area for a porch railing to tie into the house.

*Rear elevation elevation, looking north. Staff photo, October 25, 2023.*

The rear elevation's raised porch is in the process of being rebuilt and will be accessed by a set of wood stairs to the south. An at-grade exposed rear door to the right of the porch will open inward.

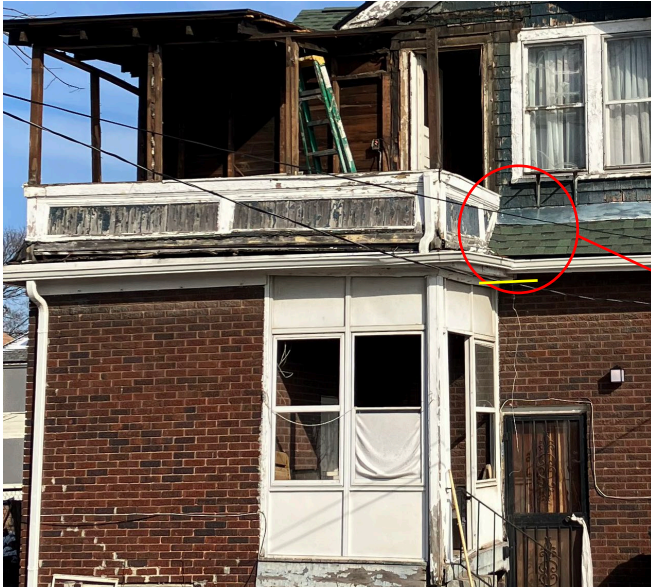
- The area in the close-up photos shown below is the wall surface that was uncovered when the porch knee wall was removed.

*Above: Undated applicant photo documenting demolition of the second floor rear porch. Note that the top of the knee wall is in line with the top of the first row of wood shingles.*

- As noted previously, the second story portion of the rear porch was removed without HDC approval. Staff can't say with 100% certitude the lower wall was extant at the time of the historic events, however had it not been demolished, it is likely HDC staff would have not recommended its demolition as the low wall is historic age and staff doesn't have documentation that a different railing was in place in 1925. It is staff's opinion that the proposed railing height was not typical for bungalow houses in 1925; it is too tall for this historic setting and location and would alter the features and spaces that are vital in telling Ossian and Gladys Sweet's story.

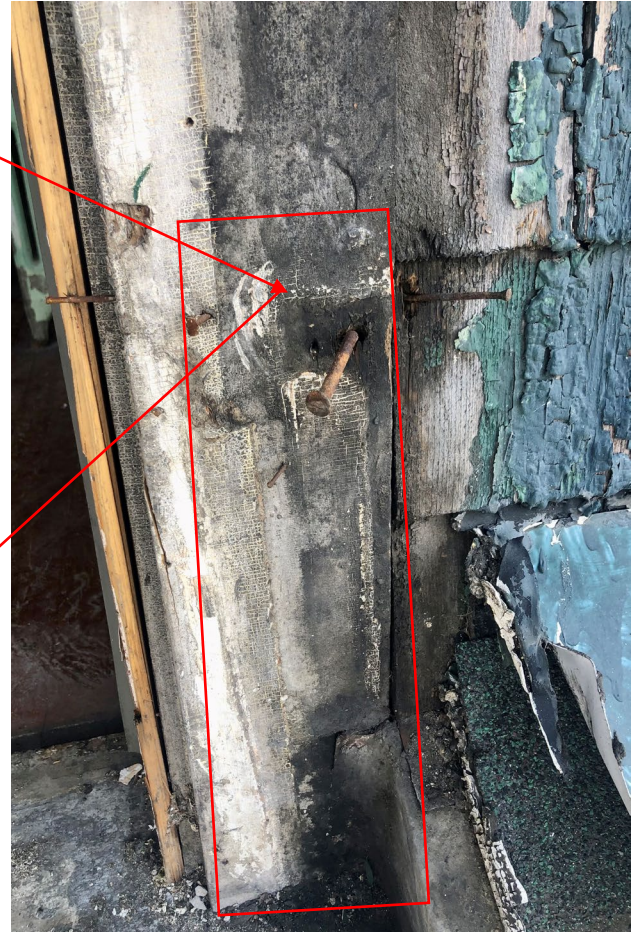
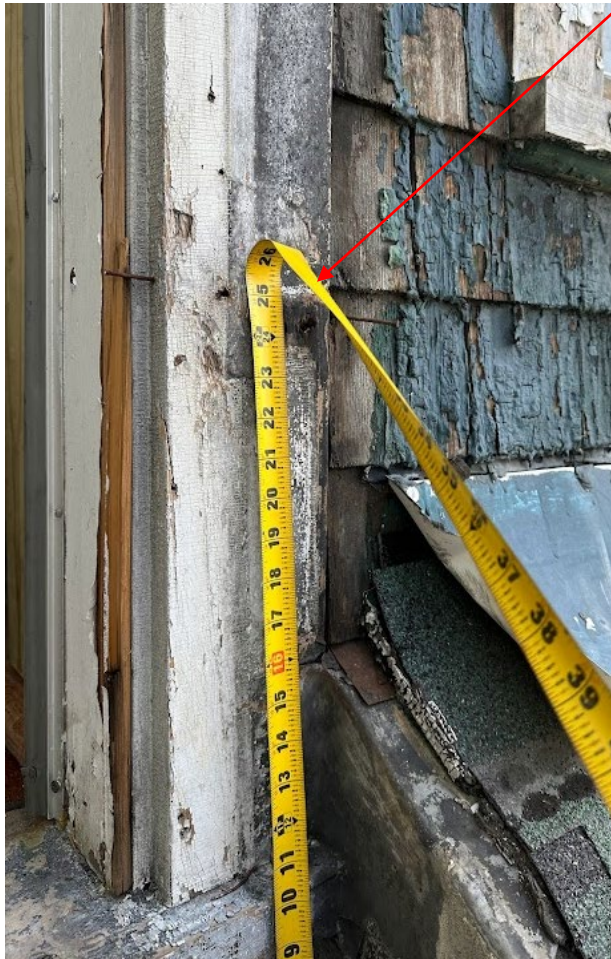
*Right: Staff photo, March 6, 2023. Some visual evidence of the upper porch railing is evident.*

*Below: Recent applicant photo. The tape measure confirms an approximate 25-inch height of former railing/knee wall.*

- The tape measure in the photo at left shows the height of the former deck enclosure was about 25-inches, and the step down to the deck is approximately 10-inches.

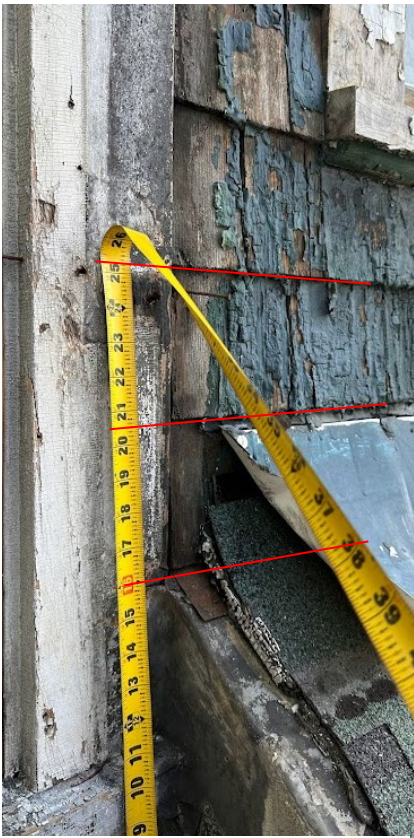
- Using the measuring tape as a guide, the exposure of the wood shingles is 4-1/2 inches.
  - Starting at the historic 25-inch railing height, which ends at the top of the first row of visible shingles, adding just under three rows of shingles (15 inches) would bring the top of the railing to the requested 40-inch height. Staff added vertical lines to the middle photo to denote the difference in the historic and requested height. The below photos offer an idea of the impact a tall railing would have at this location.

*Applicant photo. The exposure of one row of shingles is 4-1/2 inches.*

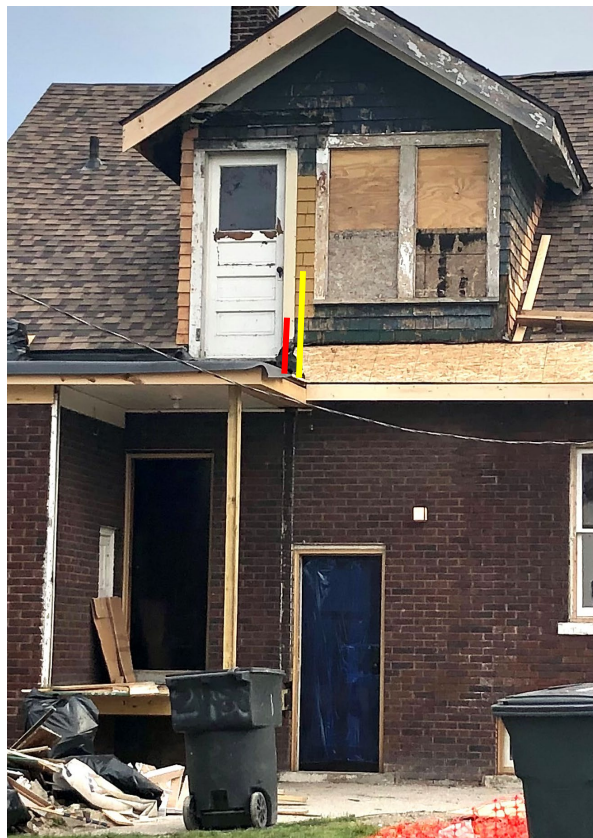
*Staff photo, October 25, 2023. The red line identifies the height of the historic knee wall. The yellow line identifies the height of the proposed wood railing.*

- The applicant mentioned in a recent email that residential code for a guard rail is 36-inches, yet a 40-inch finish height that exceeds current building code is requested.

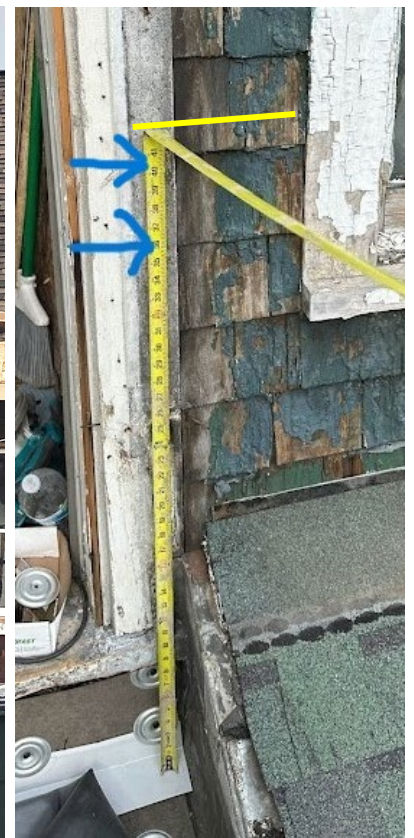
*Applicant photo. The proposed height is measured against the wall and is similar to the staff mock-up at center.*

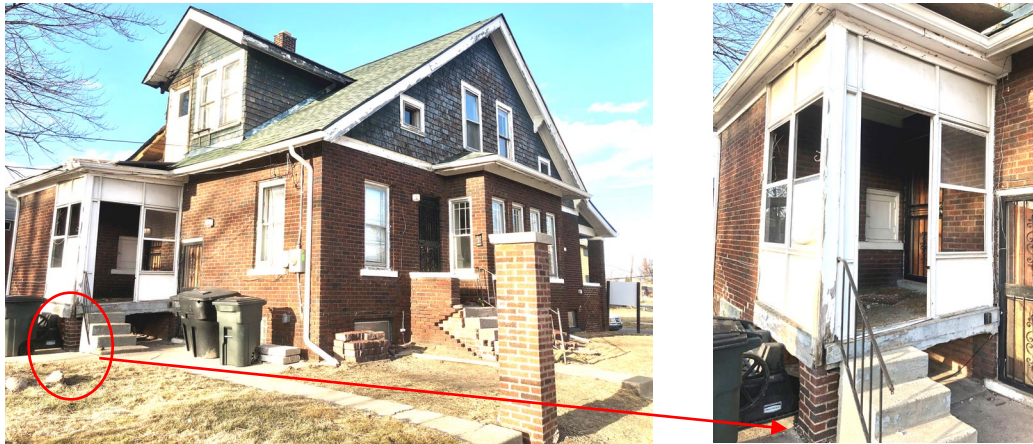
Staff photos, February 21, 2023.

- Staff questions the use of a 1 x 6 wood support post to grade to support the outer corner of the first floor porch deck. The previously existing condition had a brick pier supporting the deck, which matched the condition at the side and front entrances.

A brick pier was proposed in the drawings that accompanied the Historic Structure Report. At the May 2023 meeting, the rear porch proposal only discussed the wood perimeter railings and the stair/railing leading to the first-story porch. Therefore, the use of a wood post as supporting unit has not been approved and it is staff's opinion the wood post is not appropriate in this location.

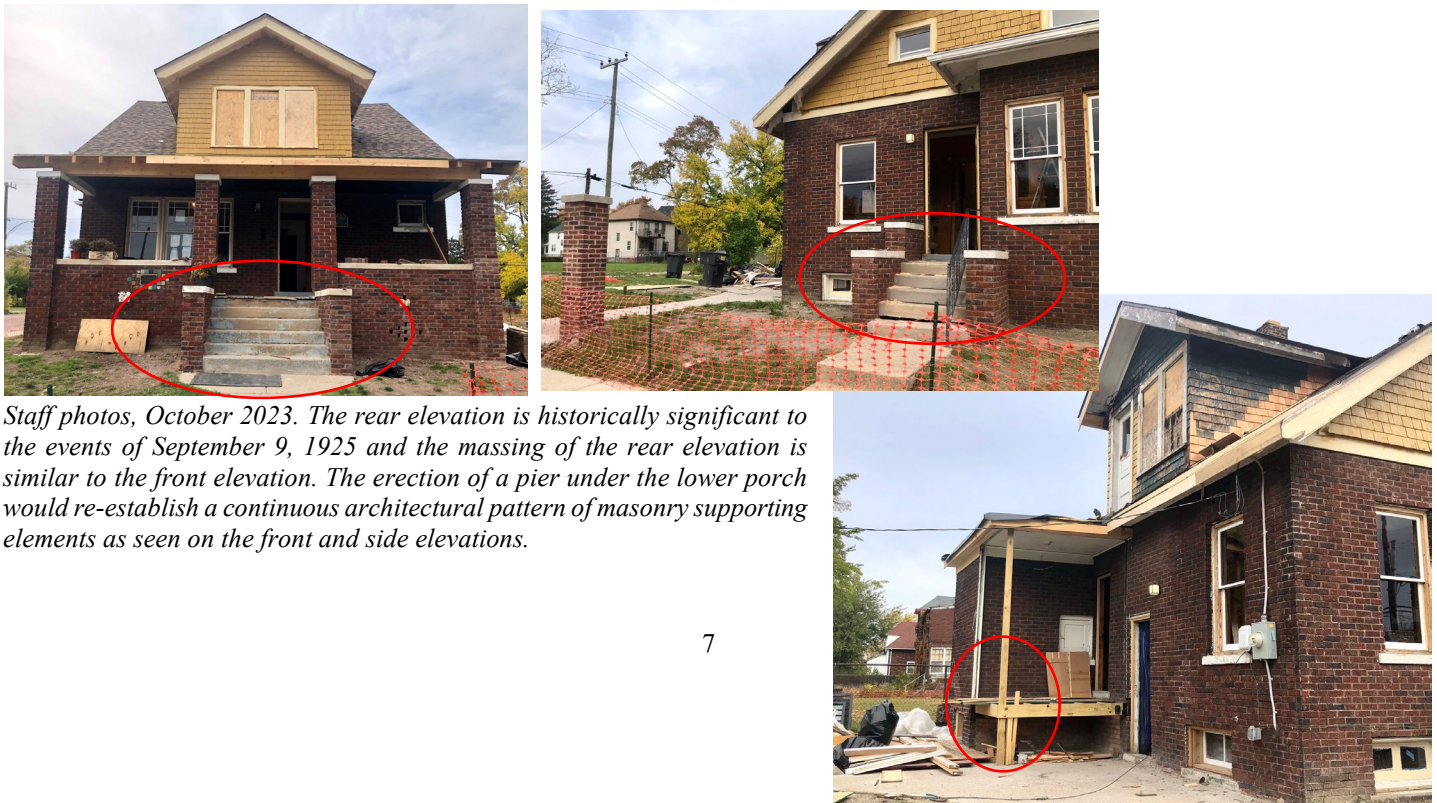
Staff photos, October 2023. The rear elevation is historically significant to the events of September 9, 1925 and the massing of the rear elevation is similar to the front elevation. The erection of a pier under the lower porch would re-establish a continuous architectural pattern of masonry supporting elements as seen on the front and side elevations.

- The previously approved drawings of the first-floor porch identified that a new brick pier would be erected to match the existing condition. The massing of the rear elevation is similar to the front elevation, and the erection of a pier under the lower porch will re-establish a continuous architectural pattern of masonry supporting elements as seen on the front and side. The use of a wood post as a supporting unit was not approved and is not appropriate to this location.
