STAFF REPORT: FEBRUARY 7, 2024, REGULAR MEETINGPREPAREDAPPLICATION NUMBER: HDC2024-00024ADDRESS: 18 W. ADAMSHISTORIC DISTRICT: GRAND CIRCUS PARK LOCALAPPLICANT: LAWRENCE WORDEN, GALAXY SIGNSPROPERTY OWNER: 18–24 WEST ADAMS LLCDATE OF PROVISIONALLY COMPLETE APPLICATION: NOVEMBER 29, 2023DATE OF STAFF SITE VISIT: JANUARY 24, 2024

### SCOPE: INSTALL THREE PROJECTING SIGNS

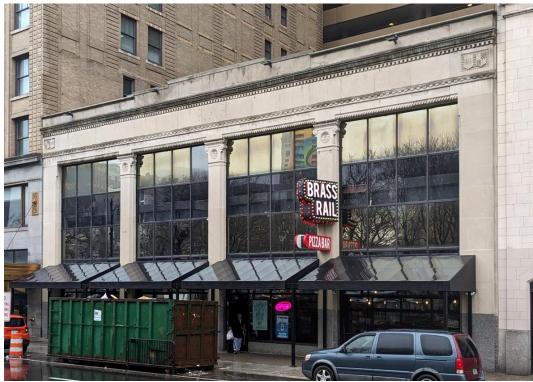
The subject property viewed from Grand Circus Park across the street. The Brass Rail sign depicted is a violation. January 2024 photo by staff.

This Neoclassical building was built in 1924 as the First National and Central Savings Bank. It sometimes known as 18–24 W. Adams, reflecting in the range of addresses assigned to the building. It consists of two, tall stories, separated by limestone pilasters into four bays. Like most buildings in the Grand Circus Park Local Historic District, it is sited on the lot line and directly abuts the public sidewalk. At some point in the late twentieth century, the historic storefront openings were eliminated and all four intercolumnal spaces were closed in with fixed glazing; with no doors, the building was entered through the adjacent building at 28-36 W. Adams. More recently, doors were added to create distinct storefronts. At present, a projecting identification sign is mounted on one of the pilasters. This sign appears to have been installed without approval of the Historic District Commission.

• Removing the existing sign is permissible, as it was installed without approval.

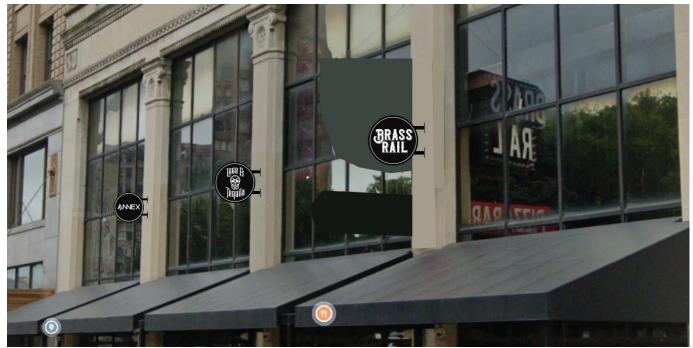
The applicant proposes to remove the existing sign and install three new projecting, internally illuminated signs.

Rendering of proposed work. Image from application documents, cropped by staff.

• It is not clear from the proposal how the signs will be affixed to the building. The *Sign and Awning Guidelines* state that signs should "install into mortar joints—no fastening into brick, stone or arch details." *Preservation Briefs 25: The Preservation of Historic Signs* (National Park Service, 1991) directs that "new signs should be attached to the building carefully … fittings should penetrate mortar joints."

• The signs must be anchored to mortar joints rather than stone, with such details subject to staff review prior to permit approval.

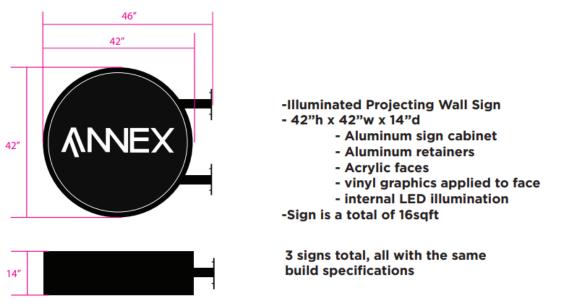
Dimensions and specifications of proposed signs. Image from application.

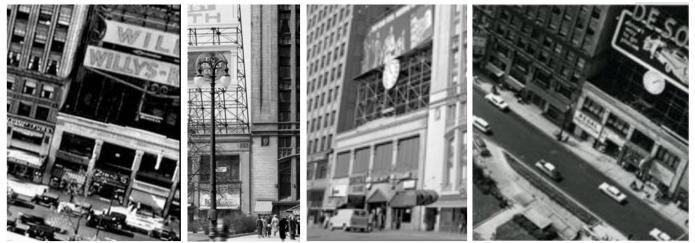
- Large signs, projecting from the pilasters at the second floor or mezzanine level, were a feature of this building from the 1930s through the 1950s, if not earlier. The HDAB report notes that, by 1935, a shoe repair business located in the building "placed an oversized boot hanging from the frieze to signify their business trade." Historical photos also show a series of such signs occupied the façade throughout the mid-twentieth century.

- There were often several different signs on this building at the same time, denoting separate businesses or occupants.
  - Possibly due to the relationship between this building and the open spaces of Grand Circus Park and Woodward Avenue, signs on this building were often large in scale and oriented to be seen from a distance.

Left to right: Unsourced 1931 photo (found on Facebook), undated photo (Detroit Public Library), undated photo (Detroit Public Library), 1957 photo (Detroit Historical Society).
