STAFF REPORT: APRIL 10, 2024, SPECIAL MEETING **PREPARED BY:** T. BOSCARINO
APPLICATION NUMBER: HDC2024-00039
ADDRESS: 702 W. CANFIELD
HISTORIC DISTRICT: WEST CANFIELD
APPLICANT: HANNAH BAILEY, KENDALL DESIGN BUILD
OWNER: ELLEN R. STRABER
DATE OF PROVISIONALLY COMPLETE APPLICATION: FEBRUARY 7, 2024
DATE OF STAFF SITE VISIT: FEBRUARY 27, 2024

SCOPE: REPLACE WOOD WINDOWS WITH ALUMINUM-CLAD WOOD WINDOWS

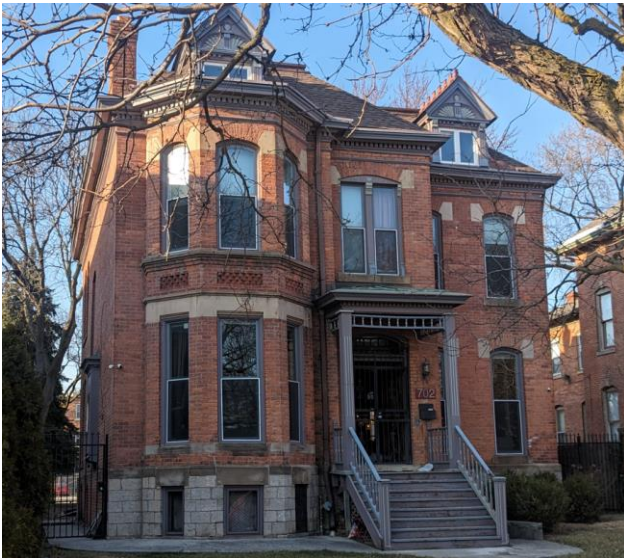
This building faces south in the one-block West Canfield Historic District. It is a grand, two-and-a-half story, hip-roof, brick building built in 1880. It is richly embellished with Queen Anne details including patterned brickwork, dentil cornices, decorated gable dormers, and bonded-arched, stone-tabbed window openings.

February 2024 photo by staff.

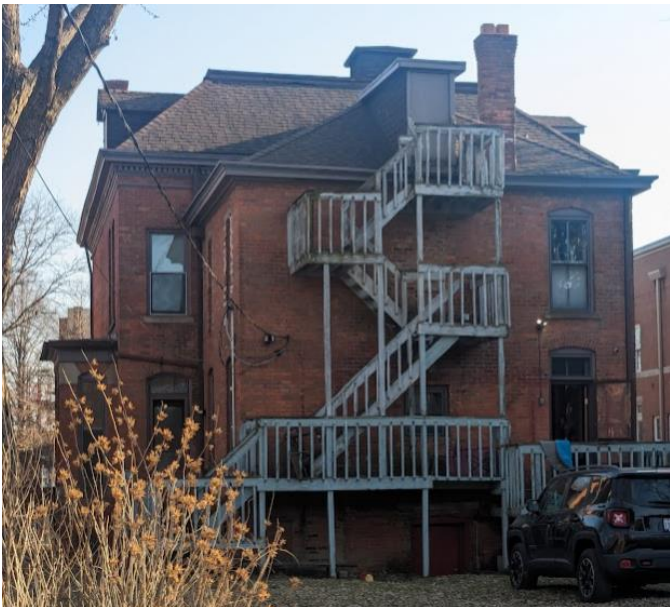
February 2024 photo by staff. Reduced window openings with non-historic windows are visible at the east (left of photo) elevation, second floor.

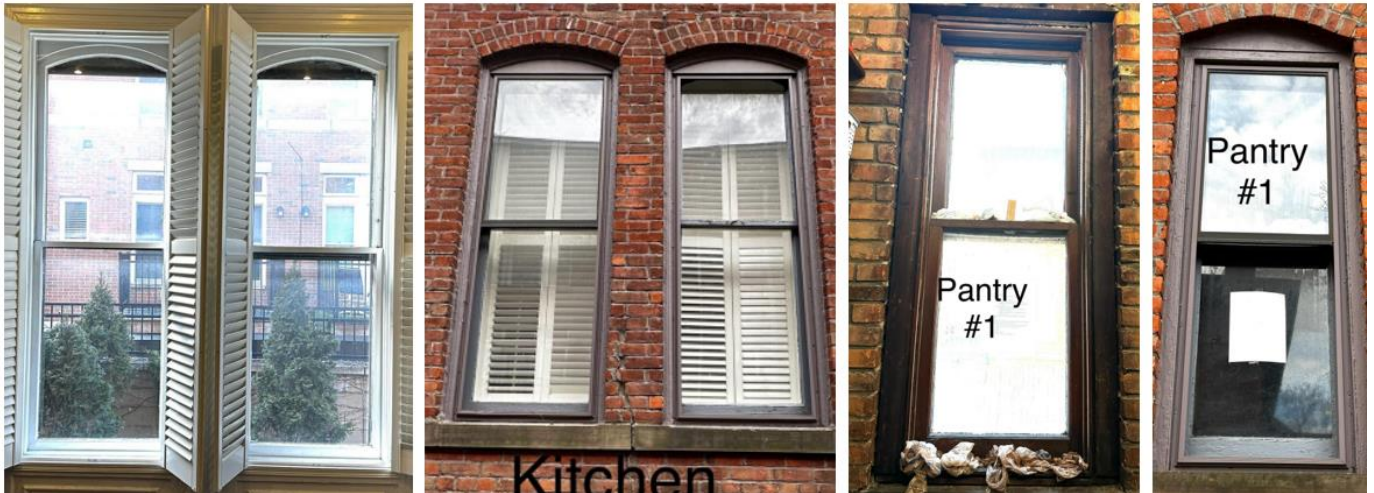
Three examples (interior and exterior views of each) of windows proposed for replacement; images from application, cropped by staff. Please see application for additional, higher-resolution photos.

- Based on configuration, materials, and style, the windows appear to be original to the building. The Secretary of the Interior’s Standards (quoted below) direct that historic elements be retained.

- Five of the thirteen windows proposed for replacement have arched upper sashes. These add a distinctive character to the building exterior that is difficult to replicate with new windows. Likewise, the Secretary of the Interior’s Standards direct that they be preserved.

- Most windows (see application photos) appear to have exterior tracks to accommodate storm windows or screens. Only a few storm windows are installed.

- The Secretary of the Interior’s Standards require that historic materials and features be retained and preserved (Standard #2, quoted below). The Standards allow windows to be replaced with matching new windows if they are deteriorated beyond repair (Standard #6, quoted below). However, the existing windows do not appear, to staff, to be beyond repair.

- The shortcomings mentioned in the application and supplemental letter can be addressed with maintenance and repair. The National Park Service provides helpful guidance, *Preservation Briefs 9: The Repair of Historic Wooden Windows*, describing how to repair these conditions. According to the National Park Service, this work is labor intensive but “uncomplicated” and “allows the do-it-yourselfer to save money” due to the far greater expense of new windows.¹

- Staff also notes that drafts can be reduced, and energy efficiency increased, with the installation of storm windows. The openings already appear to be prepared to accept exterior storm windows; interior storms are also possible.

- All thirteen windows are historic elements that have not been shown to be deteriorated beyond repair.
- For the five windows with arched sashes, proposed work replaces distinctive, curved features with non-matching, rectangular features, noticeably changing the appearance of the building from its original design.

Therefore, staff recommends that the Commission issue a Denial for the proposed window replacement as the proposed work fails to meet the Secretary of the Interior’s Standards for Rehabilitation, in particular:
