STAFF REPORT: OCTOBER 9, 2024 MEETING

APPLICATION NUMBER: HDC2024-00489

ADDRESS: 1550 TRUMBULL (1451 BAGLEY)

SCOPE: PAINT MASONRY FACADE

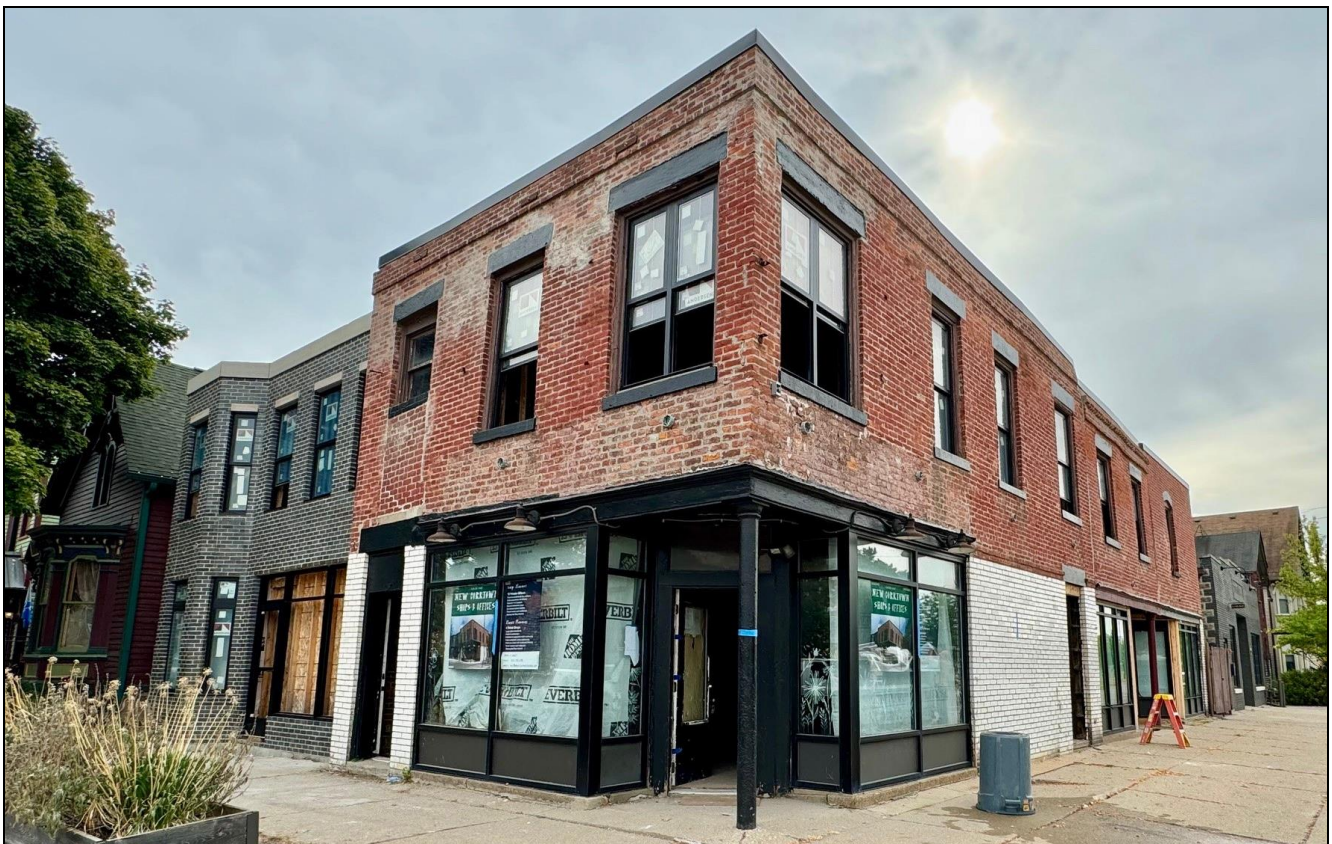
The two-story structure is located on the southeast corner of Bagley and Trumbull. Previous changes to the exterior elevations are evident through the ghost outline of a removed second floor door facing Bagley, mottled surface texture and thicker mortar joints for the brick areas above the corner storefront (which was a painted area at time of district designation) and white brick clads the first floor of the building on both facades. A metal coping system offers a finished edge at the roof. Non-historic storefront systems are located at the corner of the building, as well as the southern end of the Trumbull façade. Historic supporting iron columns remain in place at the center of both storefront entrances. Newly installed Anderson aluminum-clad one-over-one double-hung units are in place at the second floor window openings and the wood brick mould remains in place.

Above: Looking southeast; Bagley (left) and Trumbull (right) elevations. Staff photo, September 20, 2024.

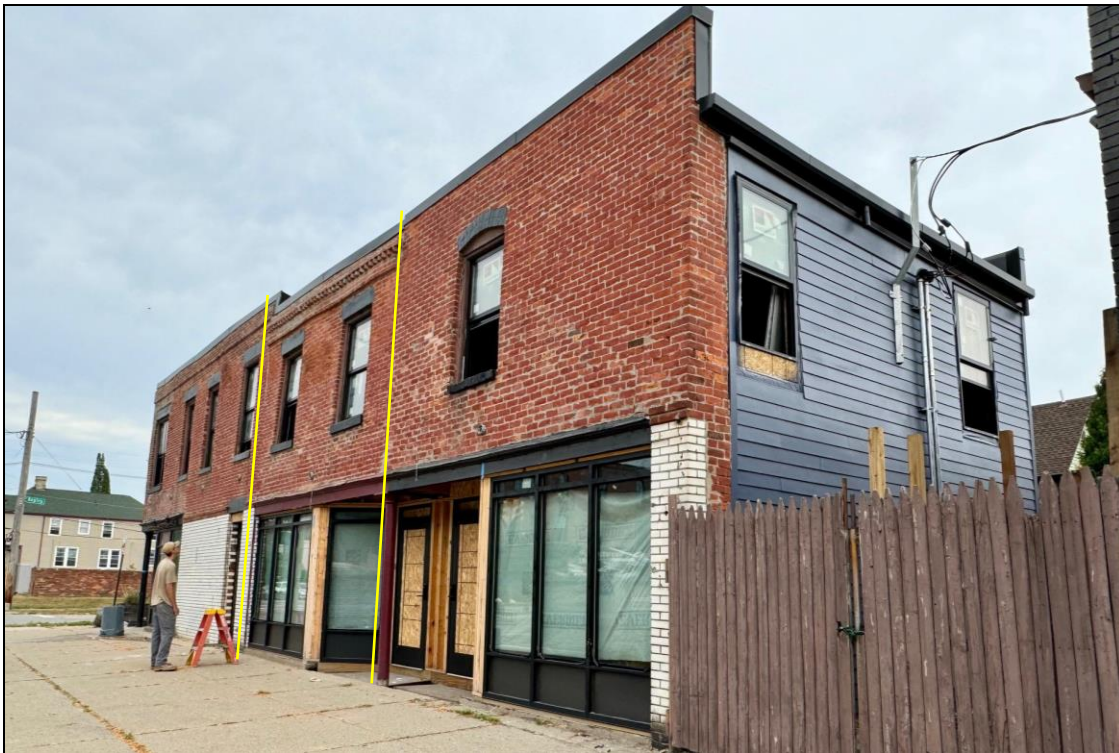
Trumbull elevation looking northeast. Staff photo, September 2024. The building has a registered address of 1451 Bagley, but the section/storefront subject to this application is identified with the address of 1550 Trumbull. (area between the yellow lines).

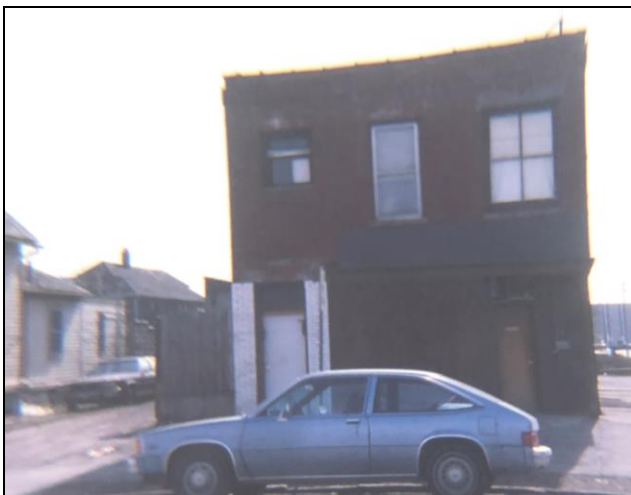
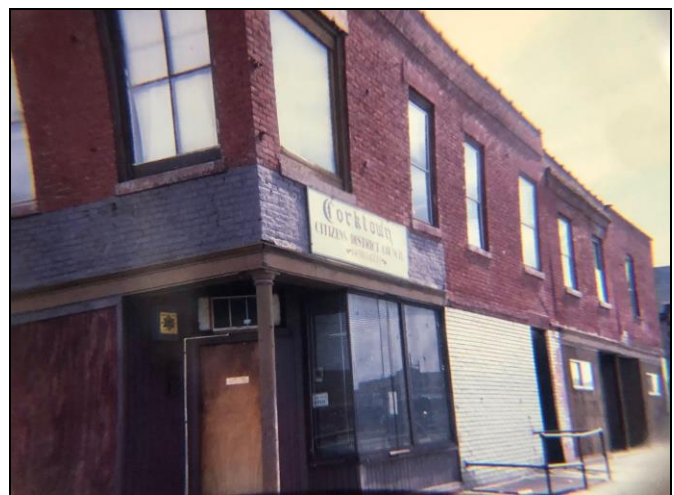
Designation photos, HDAB, 1984

- Staff does not know when the white glazed brick was installed at the first floor on the Trumbull and Bagley facades, however it was in place at time of the 1984 district designation. It is staff's opinion the glazed brick may have been installed as a wall repair.

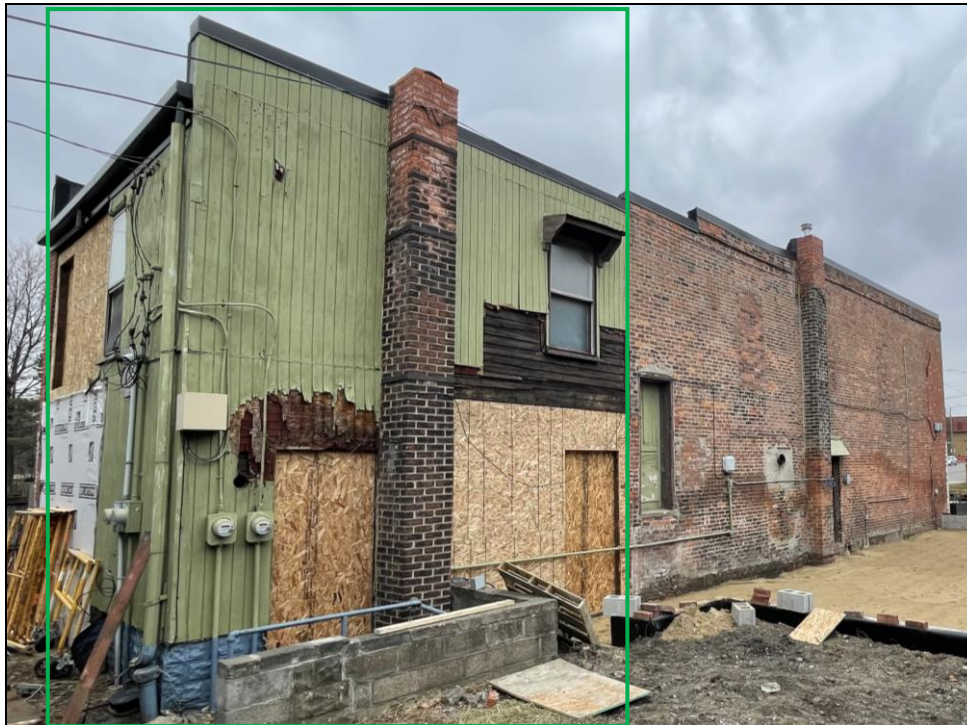
View of east wall in early 2024. Photo provided by building owner.

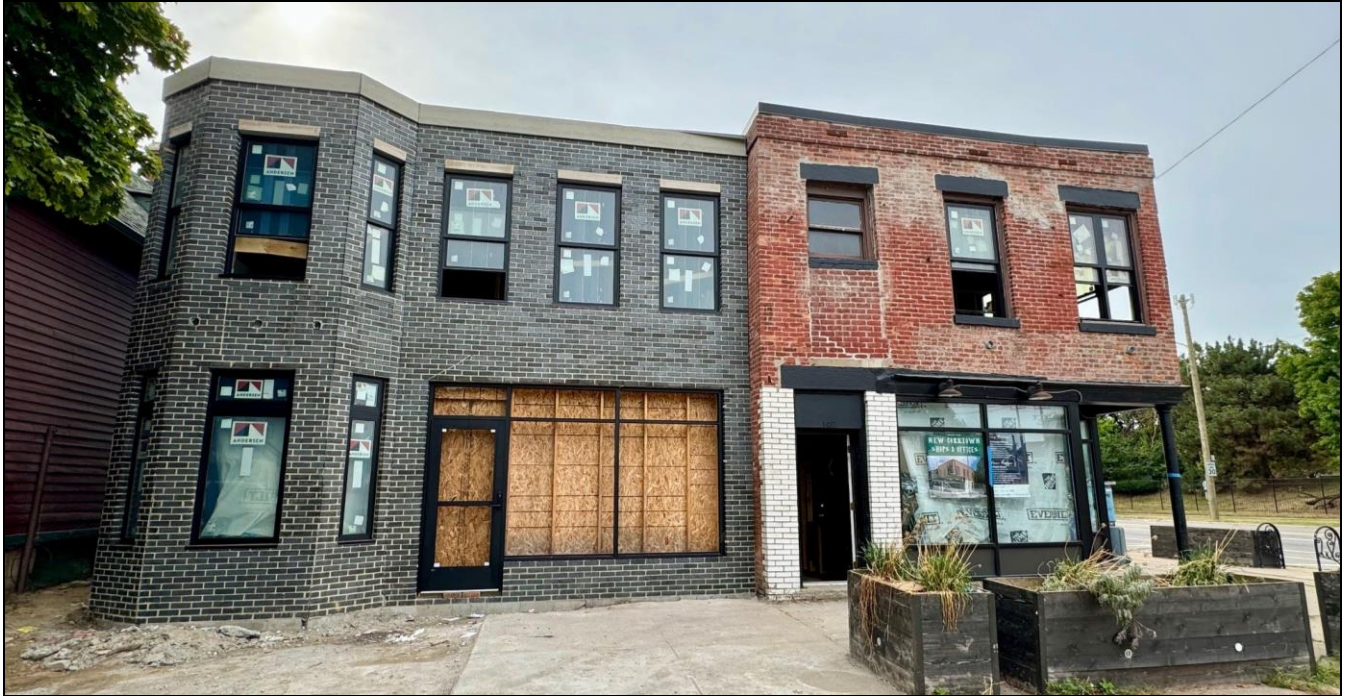
1451 Bagley façade. Staff photo, September 2024.

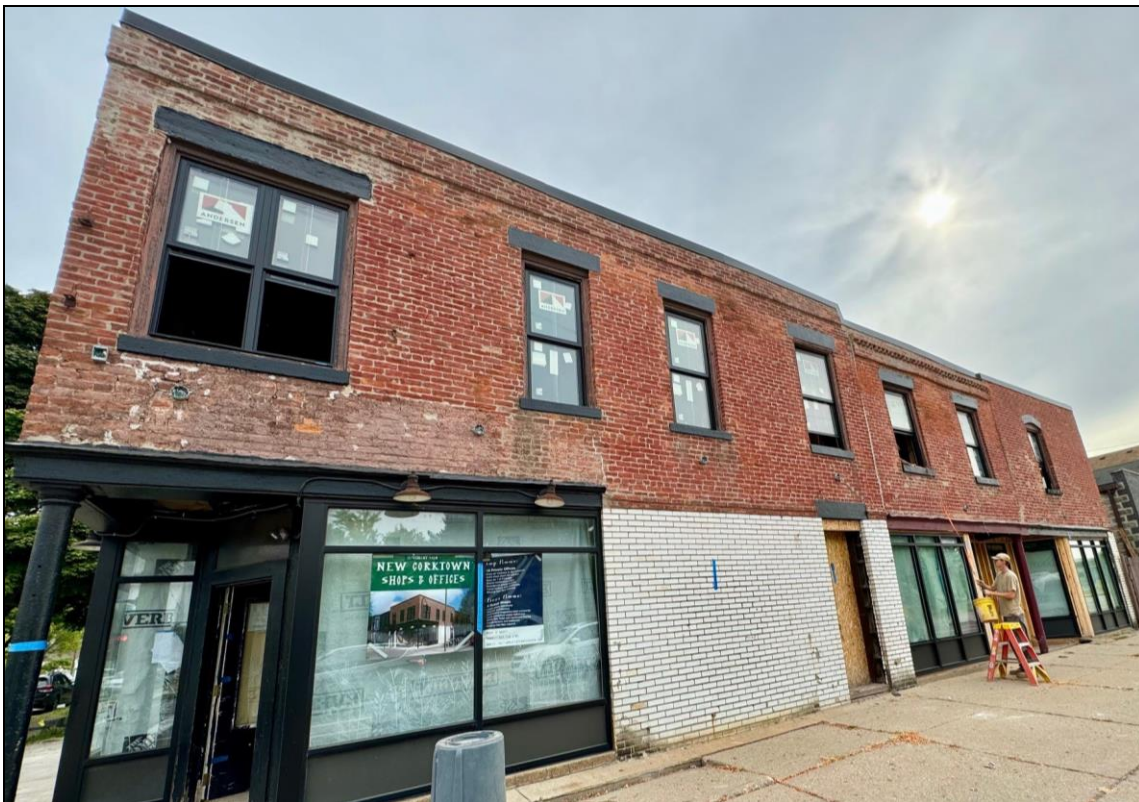
Trumbull façade, looking southeast. Staff photo, September 2024.

- Physical evidence of the additions to the original structure includes changes in roof height, vertical joints within the masonry, differing masonry details including shapes of window headers.

- The facades of the existing structure at the first floor have been altered (glazed brick, storefronts, altered door opening at second floor facing Bagley). The new storefronts are compatible with the architectural style of the building and the glazed brick covers a minimal amount of wall surface and its uniform installation at the first floor created its own consistency of color and pattern.

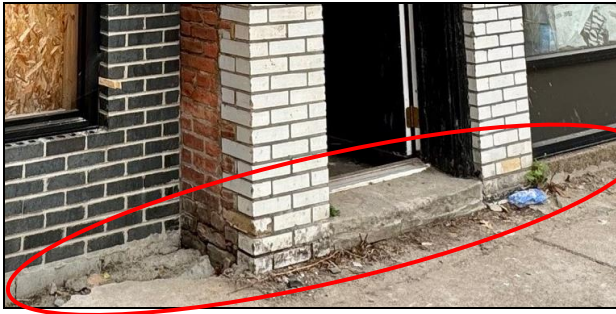
- Looking closely at the building, the brick extends to grade as opposed to sitting upon a stone/block foundation. The latter condition is in place at the adjoining new construction at 1451 Bagley, as well as the similarly-aged 19th-century masonry building at the east end of Bagley (at 8th street).

Transition from storefront to brick at 1451 Bagley

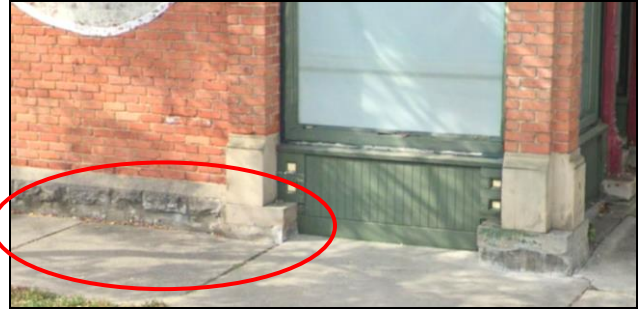
Consistent stone base at 1401 Bagley.

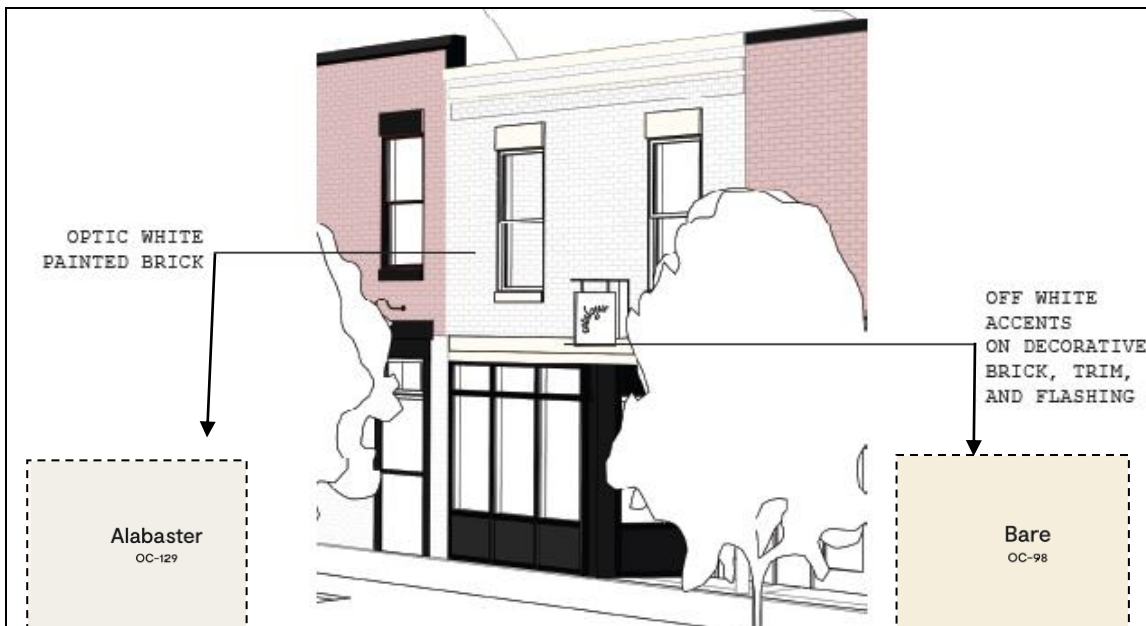
- Painting the brick of the central bay a solid “alabaster” white, with accenting “bare” white window sills, headers, and ½ of the steel lintel at the store entrances, will obscure the decorative brick coursing near the parapet as well as create a disjointed appearance to the Trumbull façade by the disruption of the dark color palate present on both facades of the building. Furthermore, the alabaster and bare paint colors will be adjacent to the white glazed brick, creating an additional contrast of color.

Applicant's rendering and submitted color samples.

Staff therefore recommends that the Commission issue a Denial for the work as proposed, as it does not meet the Secretary of the Interior's Standards for Rehabilitation, specifically Standards 2 and 5:
