**ADDRESS: 232 W. GRAND RIVER AVENUE (1410 WASHINGTON BOULEVARD)**

**APPLICATION NO: HDC2024-00231**

**HISTORIC DISTRICT: WASHINGTON BOULEVARD**

**SCOPE: INSTALL ENGRAVED STONE AT SOUTH FAÇADE STOREFRONT**

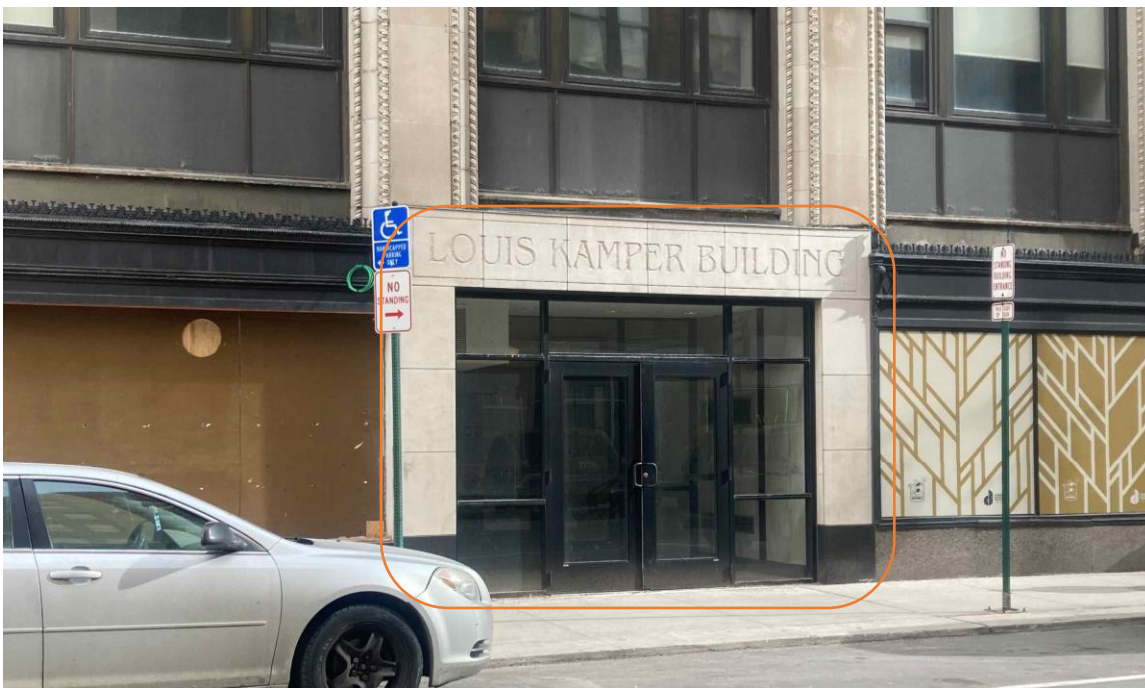
The building’s main entrance faces towards Grand River and displays a new limestone panel stone surround, glass transom and sidelights. This storefront was installed without Commission approval. An historic photo (see below) indicates this entrance was originally inset and the surround appeared to have been granite.

**232 W. Grand River. Primary entrance (outlined in orange). Photos by HDC staff, 1/28/2025**

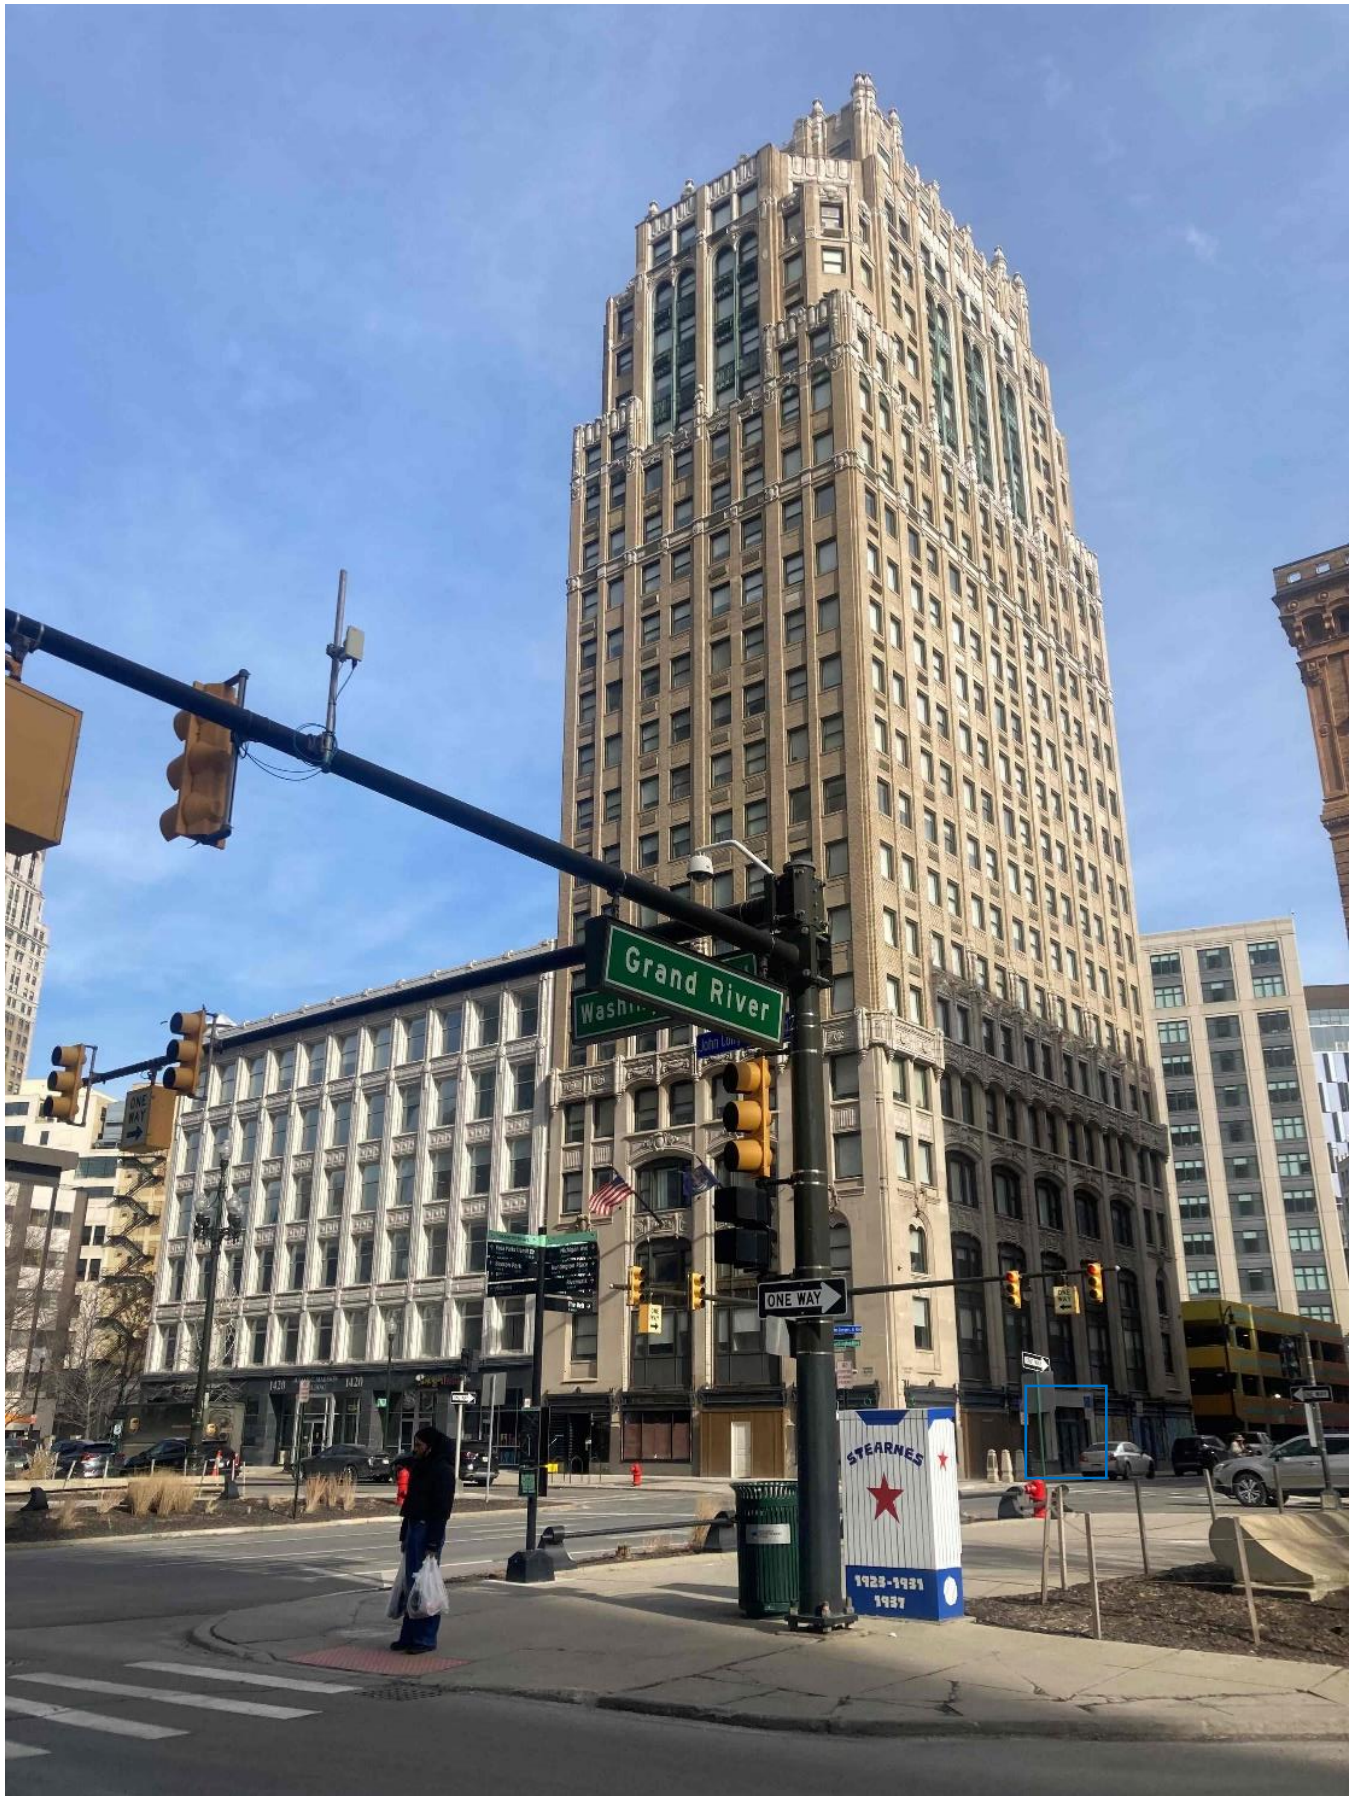
232 W. Grand River. Primary entrance outlined in blue. Photos by HDC staff, 1/28/2025

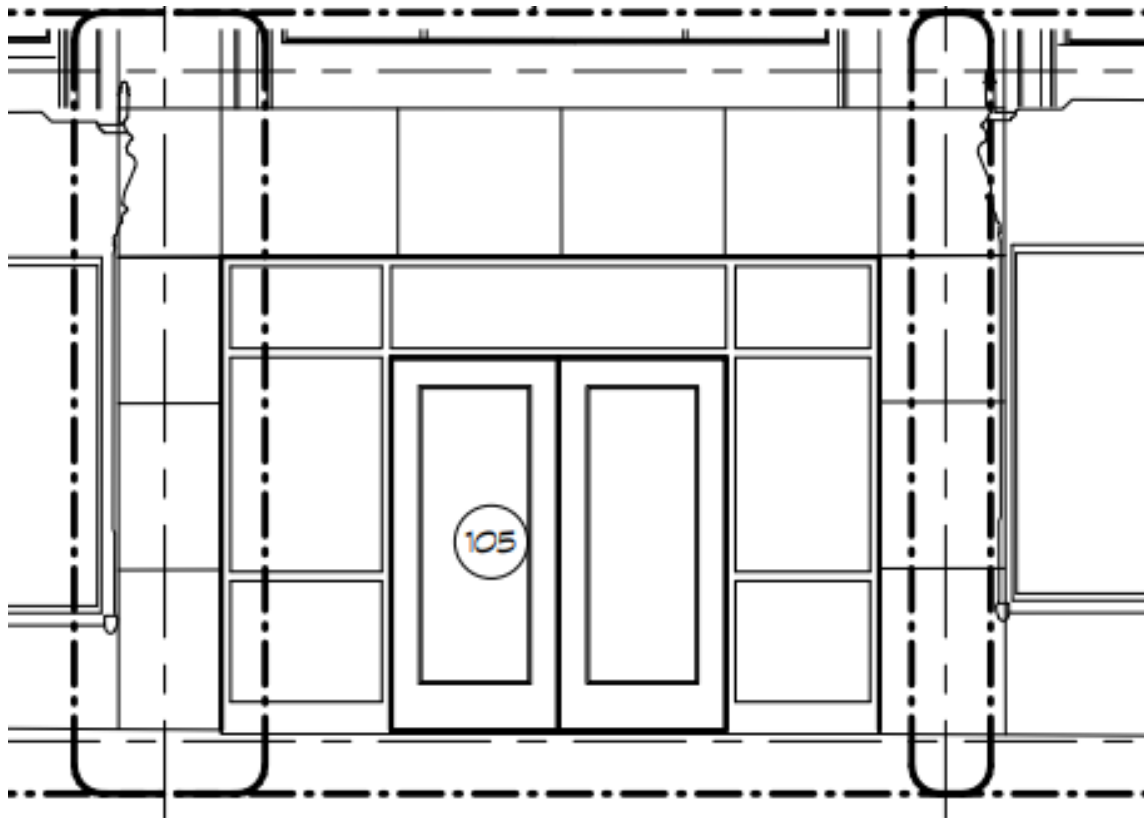
Elevation of new inset aluminum storefront approved by the Commission in 2017 for installation at the primary/south facade entrance.

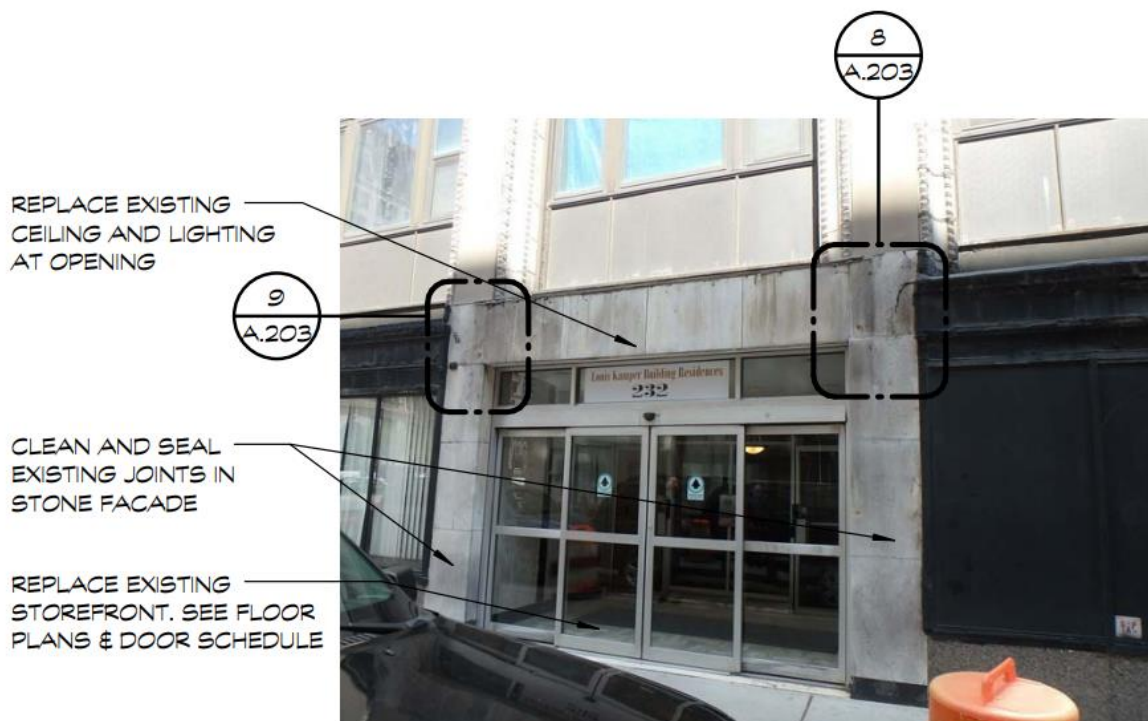
Scope approved by the Commission in 2017, showing appearance prior to unapproved work.

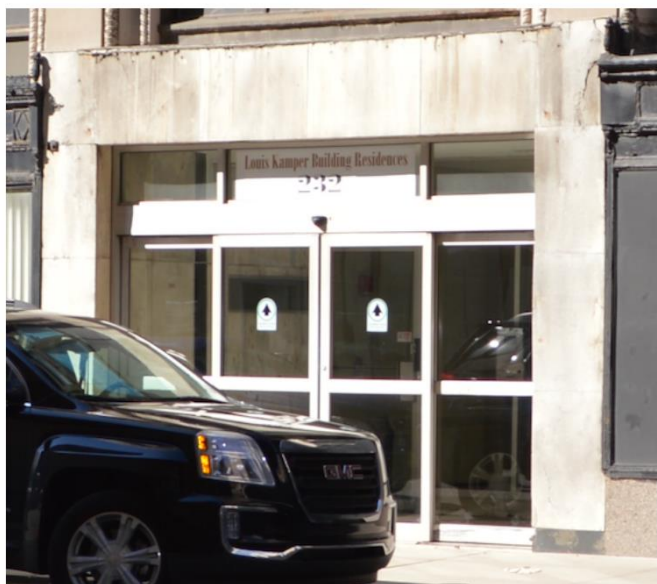
- The applicant has stated that prior to the current unapproved work, the surround “...was EIFS and the underlying structure, including the door opening lintel, was failing. It had been modified many times over the building’s history. It was determined that the best solution was to install a new limestone surround and lintel with the building name engraved to replace the EIFS.” He further noted that the new doorway was installed at its current location/flush with the façade in “...order to accommodate possible tenants and provide maximum available floor space the recessed storefronts were changed. New exterior doors were installed in line with the storefronts to increase security and protect the property from the elements.”

Appearance in 2016, prior to unapproved work. Photo by applicant.

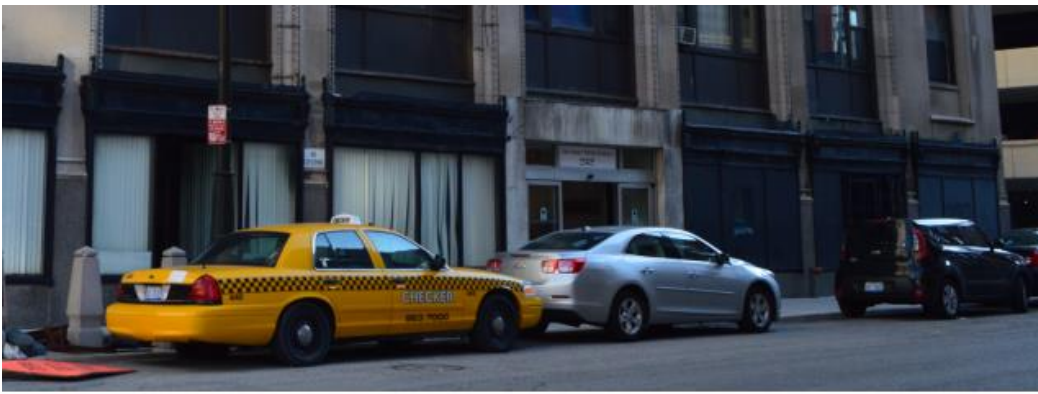
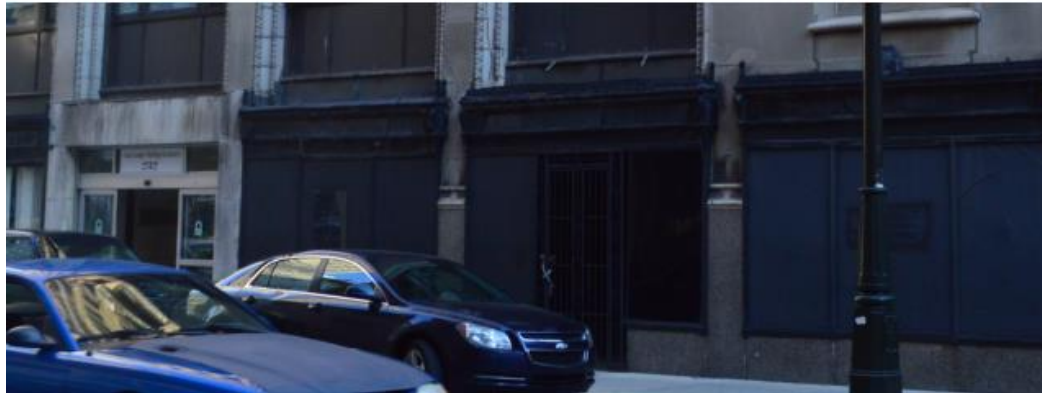
Appearance in 2016, prior to unapproved work. Photo by applicant.

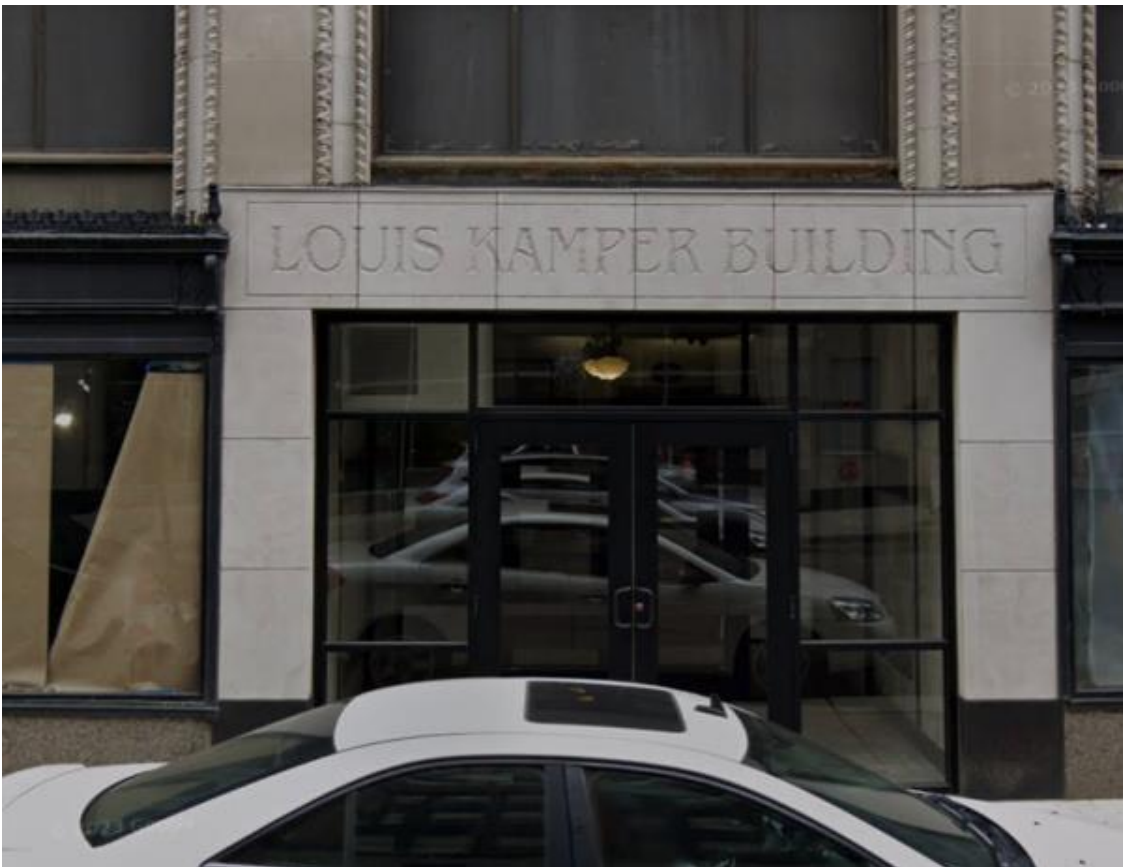
Current appearance. Photo by applicant

- The 2017 drawings indicate that the doorway surround was “masonry.” The application notes that the masonry was clad with EIFS and was in poor condition. Also, the Commission’s 2017 approval did allow for the in-kind replacement of all deteriorated masonry where necessary. The new surround is limestone and generally appears to be compatible in appearance with the building’s historic character.

- The Commission approved the addition of a new painted sign/rebranding of the structure as the “Kamper Building” at a prominent location/at the building’s rear roof. The new engraved sign at the primary entry door surround is consistent with the previously approved signage, will not destroy historic materials that characterize the property, is generally compatible with the building’s historic character, and if removed in the future, the essential form and integrity of the property would not be unimpaired.
