**ADDRESS: 644 SELDEN**

**APPLICATION NO: HDC2025-00012**

**HISTORIC DISTRICT: WILLIS-SELDEN LOCAL**

**SCOPE:ADD NEW PRIMARY ENTRY DOOR, INSTALL AWNINGS, AND REPLACE SIGN**

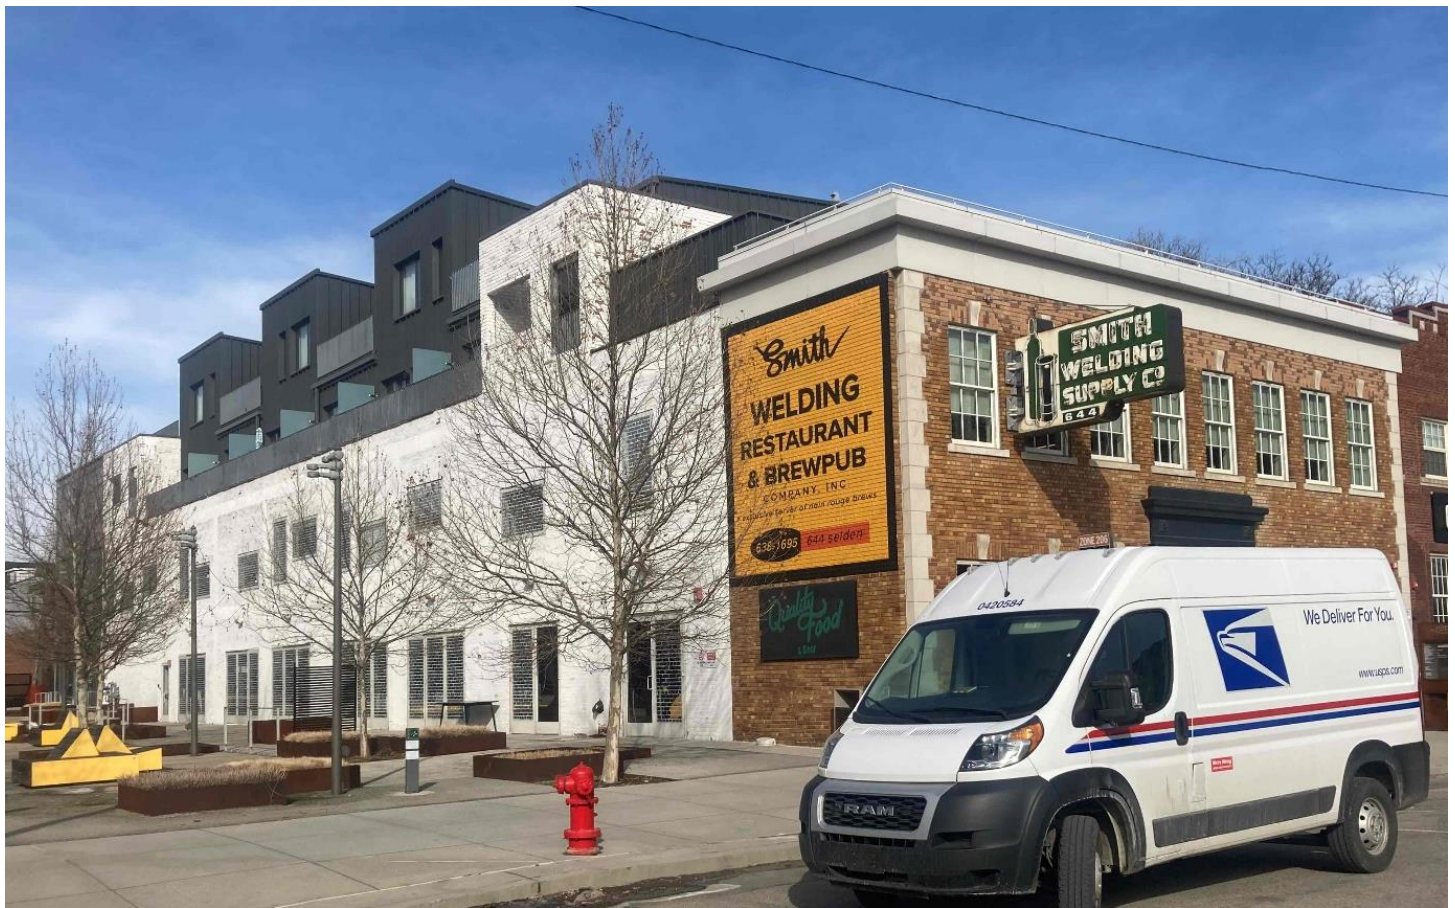
The building located at 644 Selden was erected in 1927 and was originally known as the Owasso Casket building. The Georgian Revival style building was designed by Weston & Ellington, architect. The original portion of the building is two-stories in height and is topped with a modern two-story rooftop addition. The front façade features brick cladding with limestone quoins and a centrally located primary entrance with a limestone door surround (recently painted black without HDC approval). A synthetic cornice/parapet, installed ca. 2019, tops the front wall. A ca. 1950 metal blade sign which reads “Smith Welding Supply Co.” has been affixed to the front façade’s second story. The west façade walls are painted brick. Windows are recently installed, 6/6 double-hung aluminum windows at the front façade and aluminum fixed and awning units at the side wall. The primary/front entrance is a single metal door with a sidelite while those located at the west façade are paired aluminum doors.

**644 Selden, current appearance. Photo by staff.**

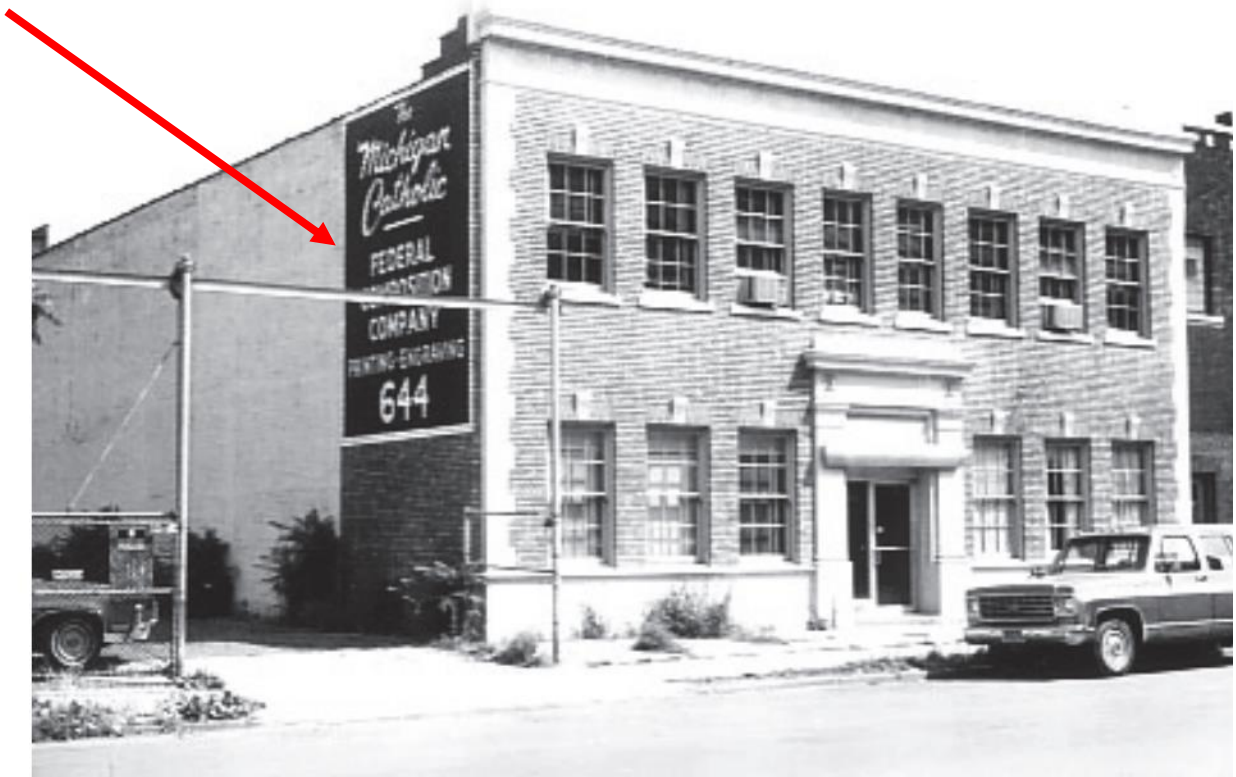
644 Selden, ca. 1980. Note painted sign at side/west elevation.

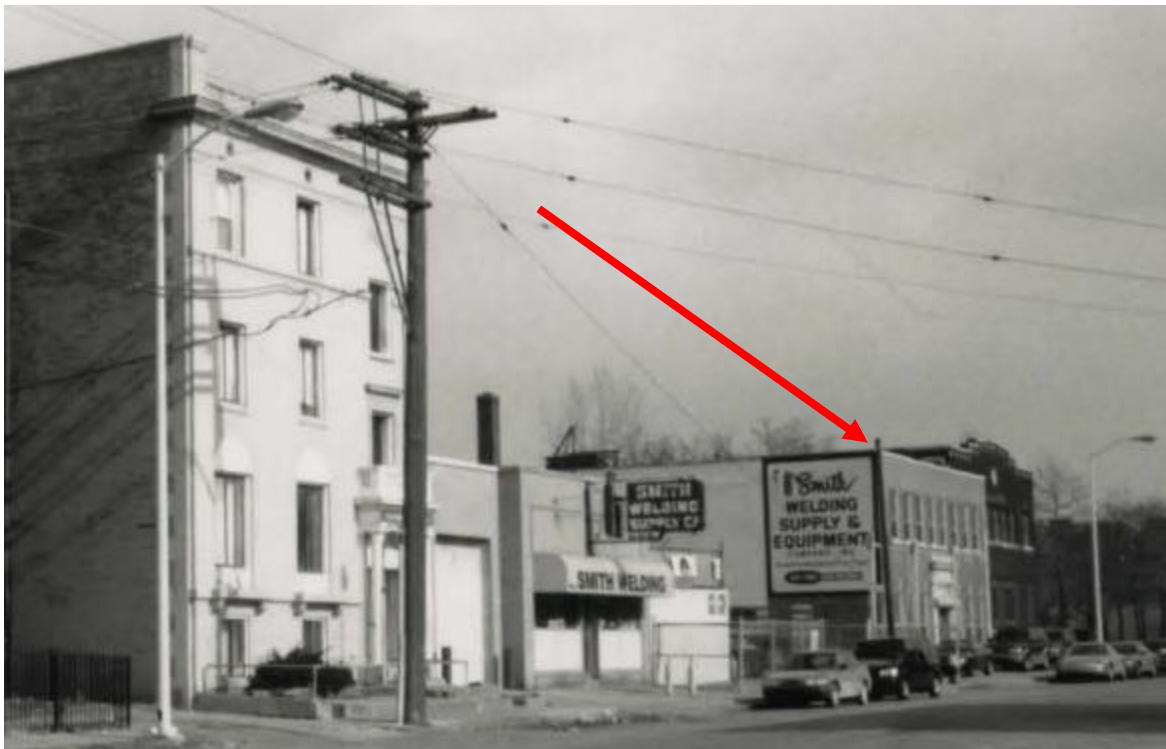
644 Selden, ca. 1997. Note that painted sign now reads "Smith Welding Supply & Equipment"

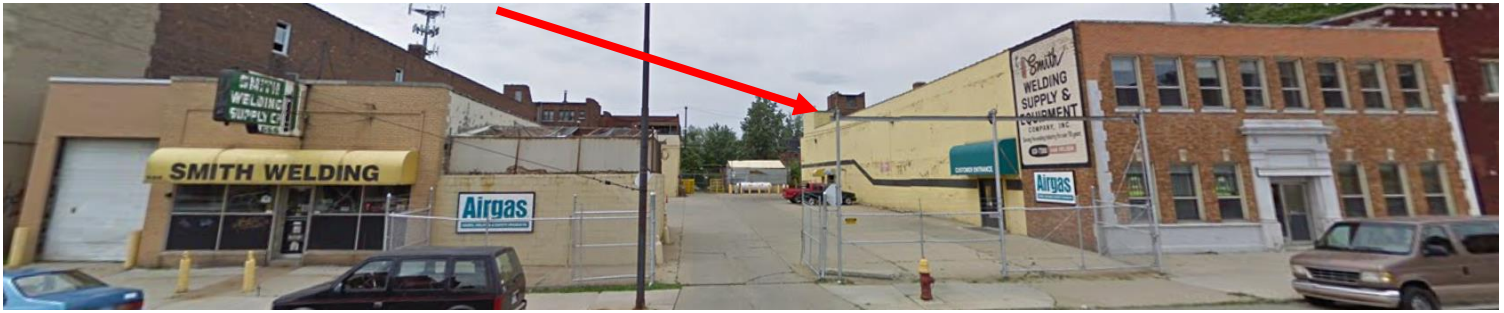
**644 Selden, appearance in 2007, prior to local designation and 2019 rehabilitation**

- The current “Smith Welding” painted mural which is proposed for replacement at the west façade was added during the 2019 rehabilitation effort (see below to note that the mural was repainted to include text which reads “RESTAURANT AND BREWPUB”). A review of the above photos show that painted murals/signage has been at the location of the proposed new mural since the 1980s. As the existing Smith Welding mural itself is not an historic character-defining feature of the property, staff supports its replacement with a new painted sign as long as the new mural does not expand outside of the boundaries of the current sign/does not encroach onto brick which is currently unpainted

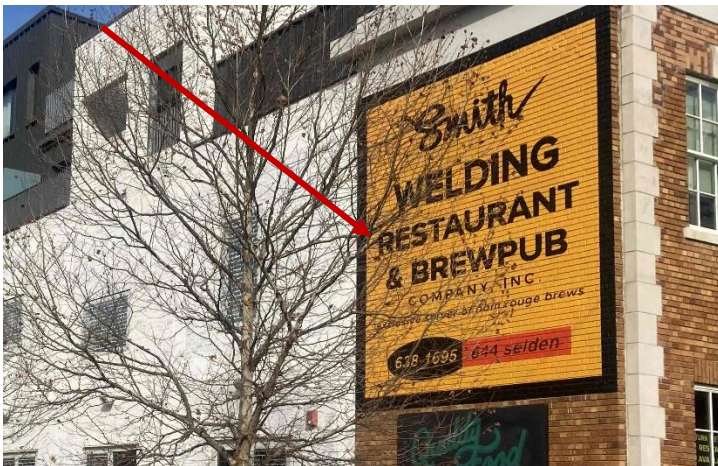
**Staff photo, showing current painted mural which is proposed for replacement. This mural was added in 2019**

- The mural proposed for installation at the west side façade shall does not expand outside of the boundaries of the current painted mural/shall not encroach onto brick which is currently unpainted
- The unapproved black paint shall be removed from the limestone door surround at the building's front/south elevation. The applicant shall use the gentlest means possible to avoid damaging the limestone during the removal of the paint.

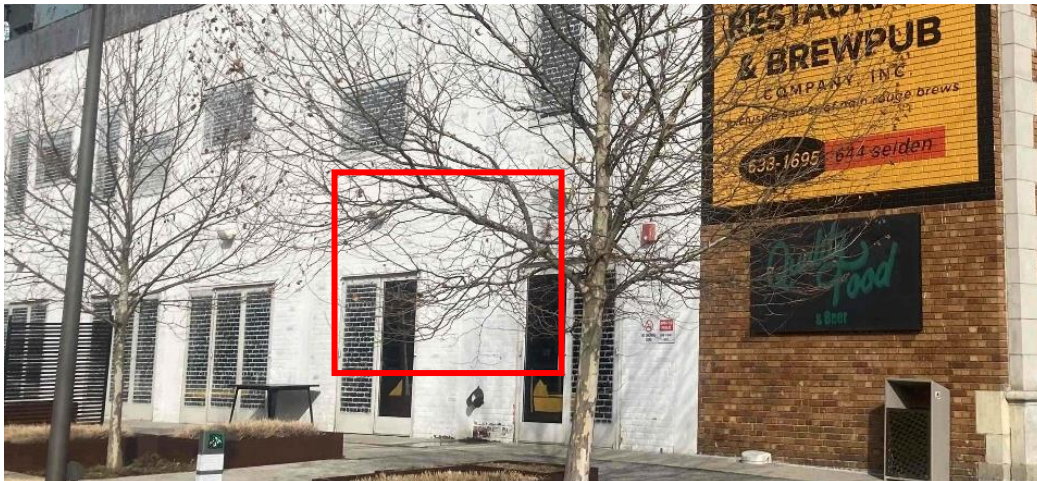
- As noted above, the applicant is seeking to replace the existing southernmost non-historic aluminum entry doors at the west façade with a set of paired arched wood doors. Please see the below. As these doors will serve as the building's new primary entry, the applicant is seeking to install a new tile finish and limestone trim within the bay. While staff supports the installation of the new wood doors to replace the existing non-historic aluminum doors at this location, it is staff's opinion that the proposed tile finish does not relate to the existing exterior materials. Also, the proposed tile application is uncommon with the district. Please see the below relevant Elements of Design which outline the following:

Per the above, most buildings within the district, including 644 Selden, are faced with brick with stone or cast stone trim. Also, per Element # 8, within the district textural interest is typically achieved via the use of patterned brickwork or the juxtaposition of brick cladding with mortar joints or stone trim. It is therefore staff's opinion that the proposed tile cladding is not compatible with the building's historic character. Staff therefore recommends that this scope item be denied.

**Location of proposed new primary entry doors and tile cladding. Photo taken by staff showing current conditions**

- With respect to the proposed tile and limestone application at the west façade southernmost doorway bay:
  - The proposed tile cladding does not relate to the building's existing exterior materials. Also, the proposed tile application is uncommon with the district. The work is therefore not compatible with the building's and/or the district's historic character

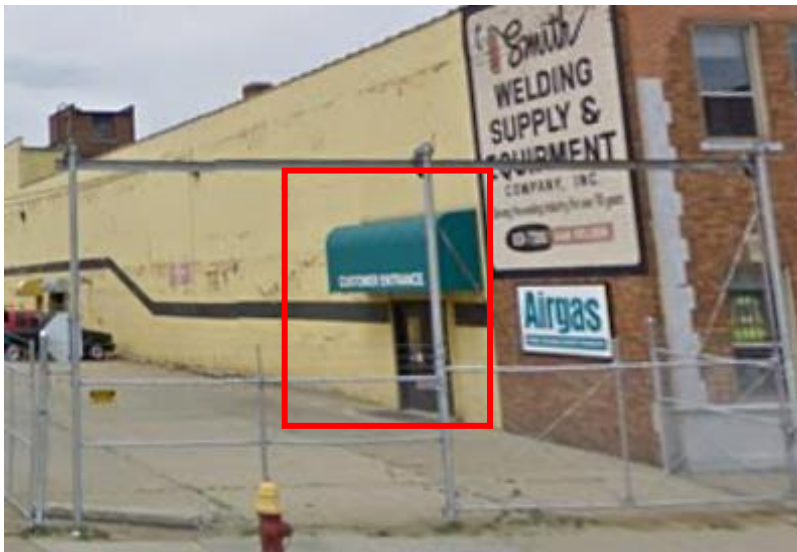
Location of proposed new primary entry doors and tile cladding. Google Streetview image dating from 2007. This opening was widened to accommodate the current set of paired aluminum doors during the 2019 rehabilitation

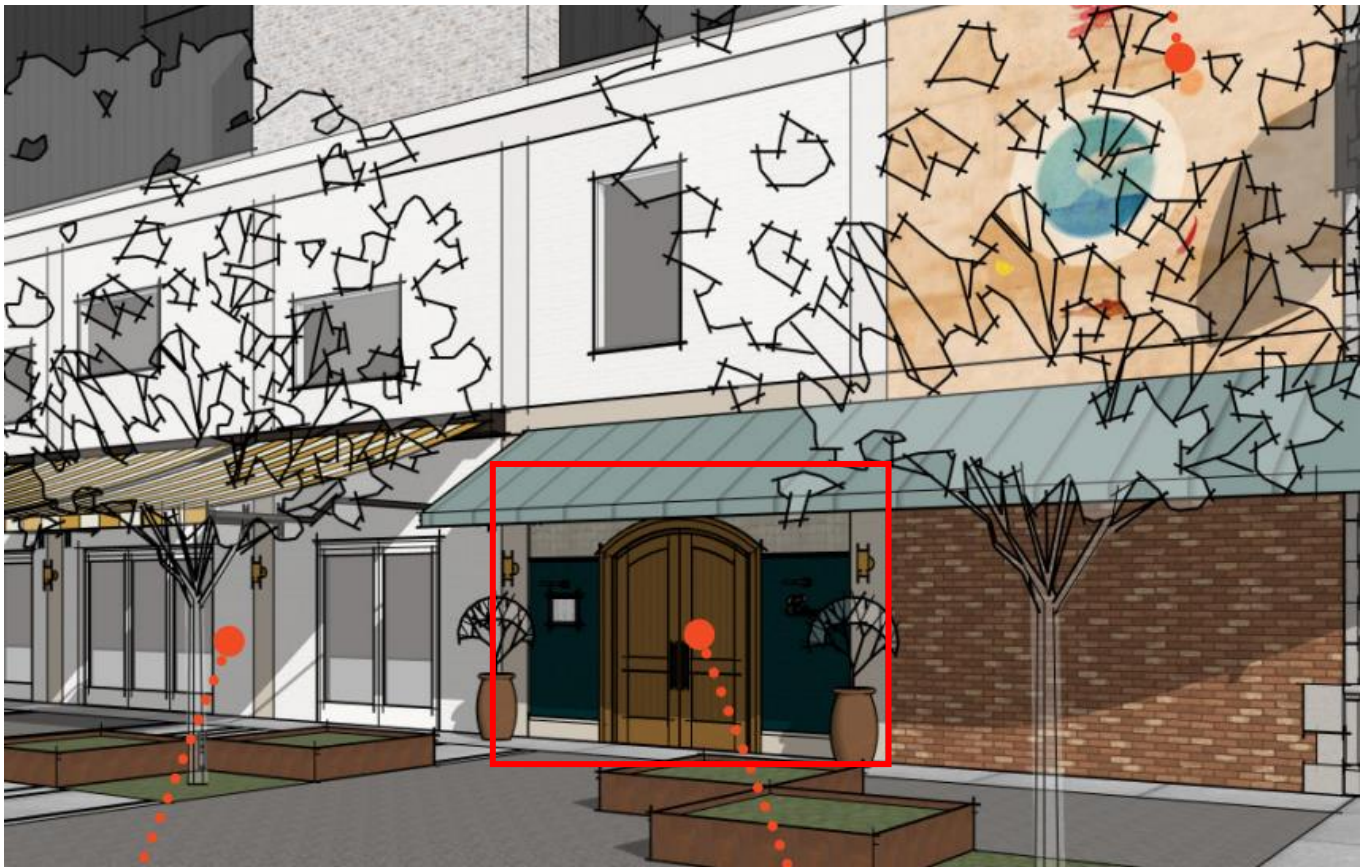
Proposed new wood entry doors. New tile and limestone trim will be installed within this bay

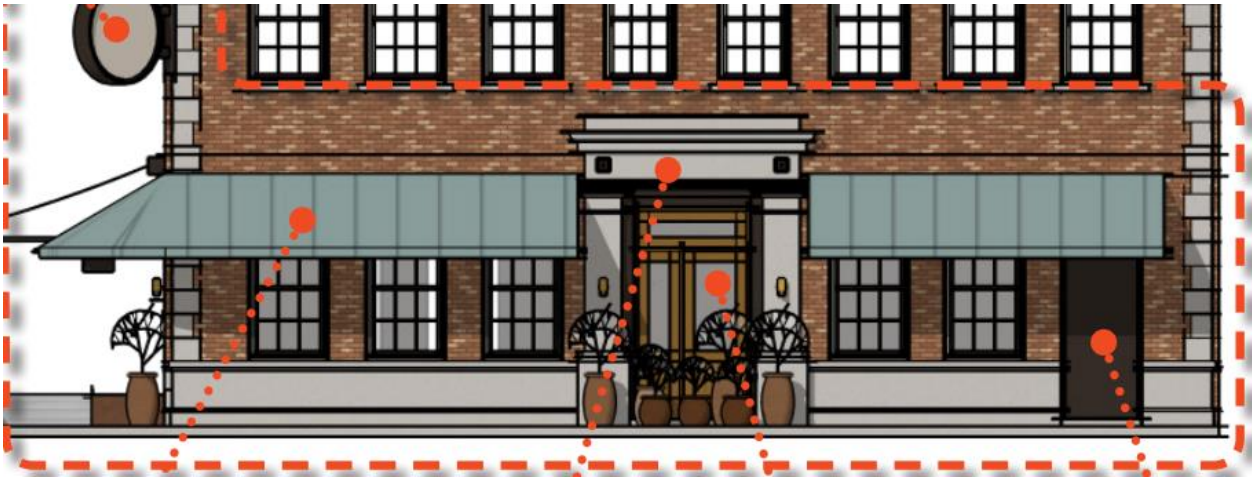
- Install a fixed, standing seam metal awning to the east of the entrance at the front elevation
- Install a fixed, standing seam metal awning to the west of the entrance at the front elevation which wraps around the west side of the building to extend over the new paired wood doors/primary entrance
- Install canvas awnings on the west façade over the four northernmost entry doors

Proposed new awnings, front façade. Source, applicant

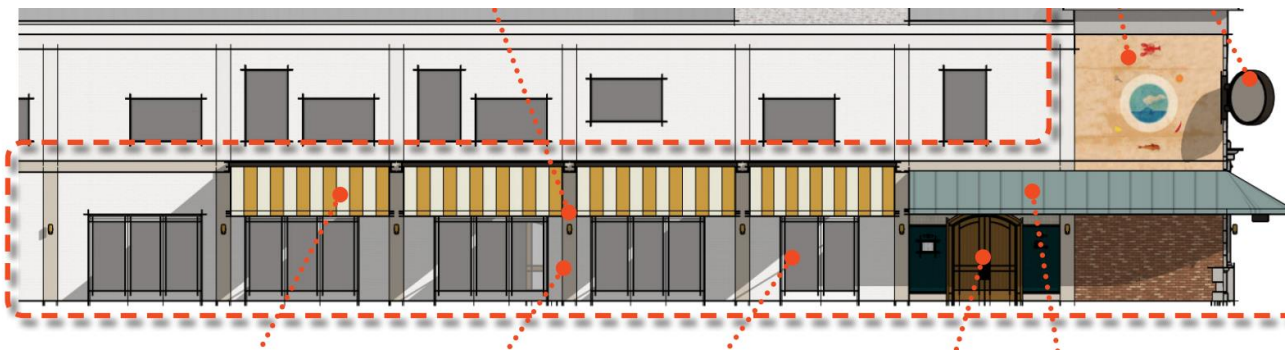
Proposed new awnings, side façade. Source, applicant

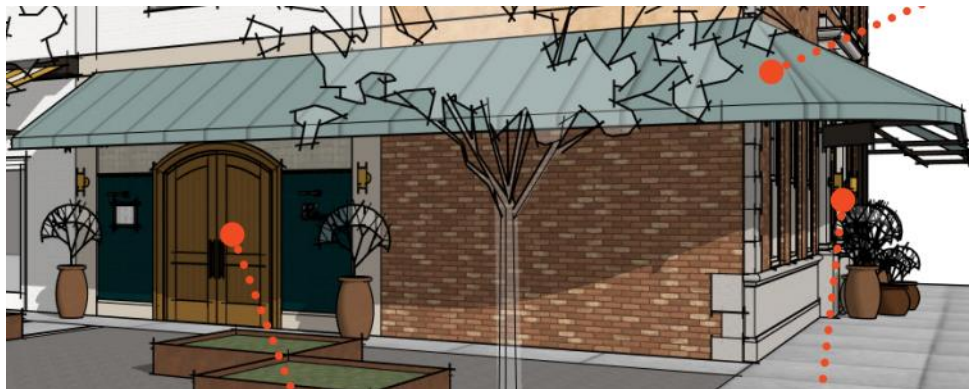
- **Massing and Placement** – Contrary to the NPS guidance, the metal awning which is proposed to wrap the front and side facades extends past the window openings that they shelter and obscure the distinctive architectural features per the below image

**This awning extends from the front façade around the corner, well past the front façade windows to obscure the front façade's quoins and cover a portion of the side façade which does not include fenestration. The awning at this location *should not* wrap around the corner in staff's opinion. Rather, the front three windows and the side doorway in this rendering should be sheltered by a single awning which does not extend past/cover the quoins**

- **Material.** Contrary to NPS guidance, the proposed metal awnings would present a reflectivity and texture which is not in line with the appearance of historic canvas awnings. Also, it is staff's opinion that the metal awnings' industrial appearance is not compatible with the elegant Georgian Revival style detailing displayed at the building's primary façade. Finally, awnings of this material are not commonly found within the district.

- With respect to the proposed metal awnings:
  - The metal awning which is proposed to wrap the front and side facades extends past the window openings that they shelter and obscure the distinctive architectural features

- The proposed metal awnings would present a reflectivity and texture which is not in line with the appearance of historic canvas awnings.
  - The metal awnings' industrial appearance is not compatible with the elegant Georgian Revival style detailing displayed at the building's primary façade.

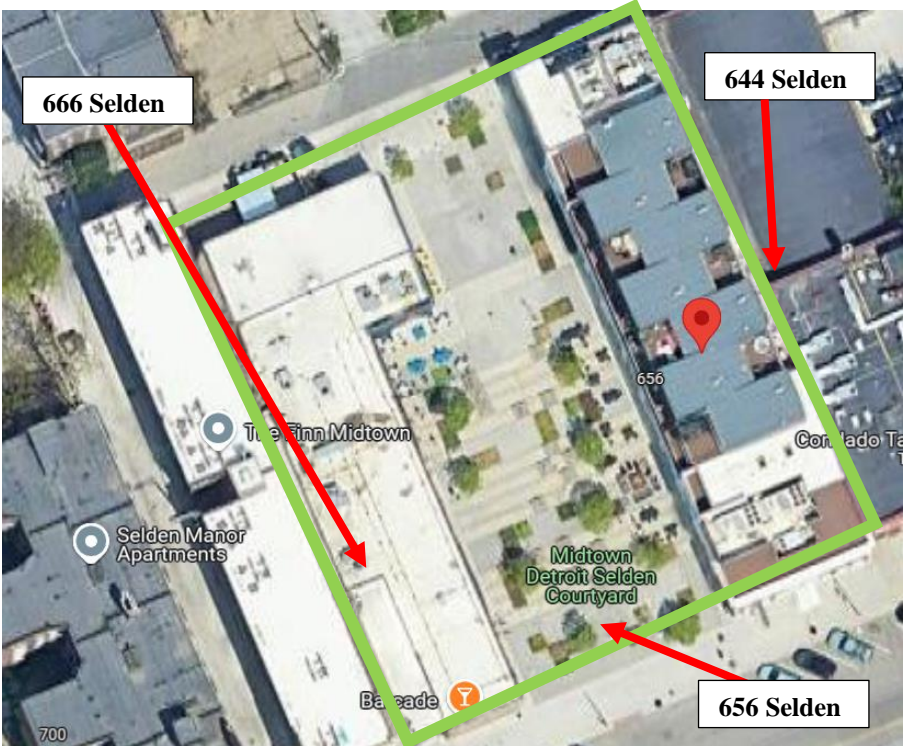
644,656, and 666 Selden. All 3 parcels are owned by the same developer. All parcels were rehabilitated under a single COA/application submitted to the HDC in 2016. Google Streetview, 2023

- Note that both buildings, as well as the vacant lot in between, were rehabilitated under a single COA/application submitted to the HDC in 2016, under the ownership of a single developer. The properties remain under the ownership of the same single developer (see the below map).

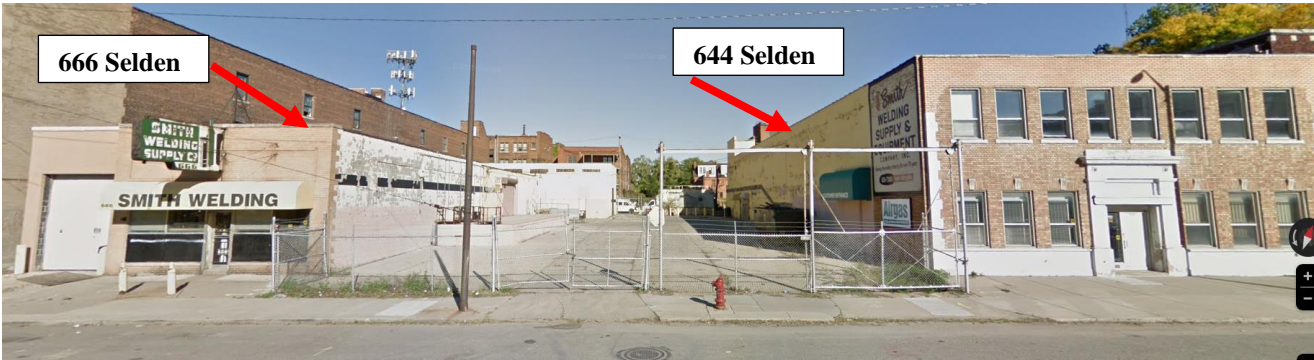
Appearance of 644-666 Selden in 2016, prior to the redevelopment of the parcels and the sign’s removal from 666 Selden/installation at 644 Selden. Google Streetview, 2016

- Staff notes that the sign was originally located at 666 Selden, the former Smith Welding Shop building. The sign likely dates from 1950, when the Smith Welding Shop Building/666 Selden was erected. It was removed from its original location in 2019 when 666 Selden was rehabilitated for use as a bar/arcade. At that time the sign was restored and installed at its current location/644 Selden and served as the business sign for the Smith and Co. restaurant.

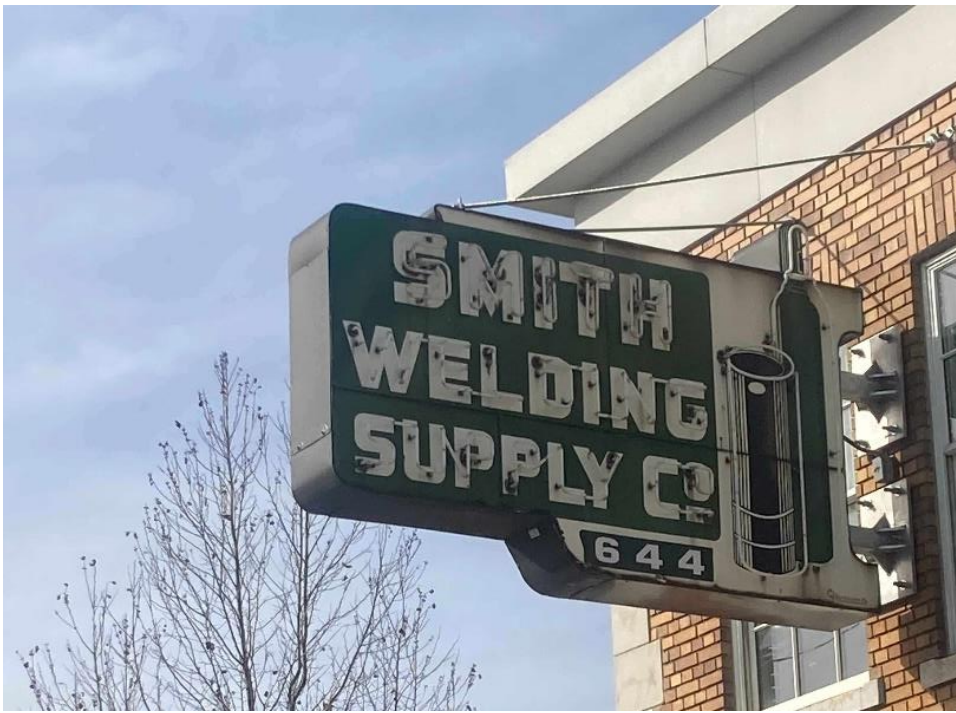
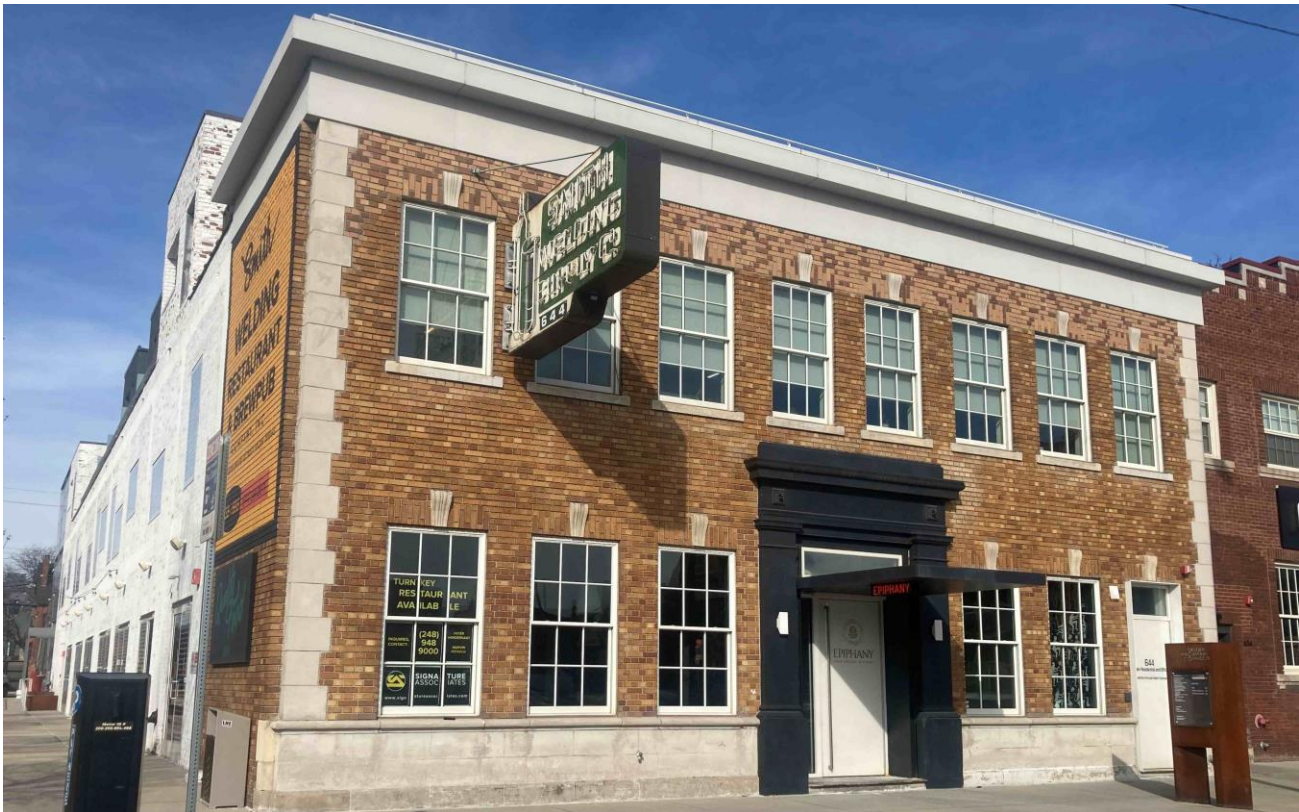
- The applicant is seeking to replace the existing neon blade sign at the building’s SW corner which reads “Smith and Company” with a new sign (design not specified)

Current appearance as installed at 644 Selden. Photo by staff, 1/28/2025

- Despite staff's recommendation, the Commission approved the application at the February 2019 regular meeting.
- Staff has undertaken research for the **current application** and notes that historic age, neon signage has grown rare within the historic district. Six years have passed since the sign's restoration and installation at 644 Selden and the rehabilitation of the adjacent properties as a courtyard/community space and mixed-use commercial venue. Within this period, the sign has emerged as a landmark in its own right, apart from 644 Selden/the building to which it is attached, and is recognized as a focal point in the neighborhood. Staff also acknowledges that such neon signage is characteristic of a specific period within the district's history and does represent what the NPS guidance defines as a "great twentieth-century contribution to the signmaker's art." It is therefore staff's opinion that the sign is a distinctive character defining feature of the neighborhood itself/the immediate environs of 644 Selden. NPS

Staff therefore recommends against the approval of the current proposal to remove the sign further recommends that it either be retained at this current location or reinstalled at 666 Selden, which is its original location.

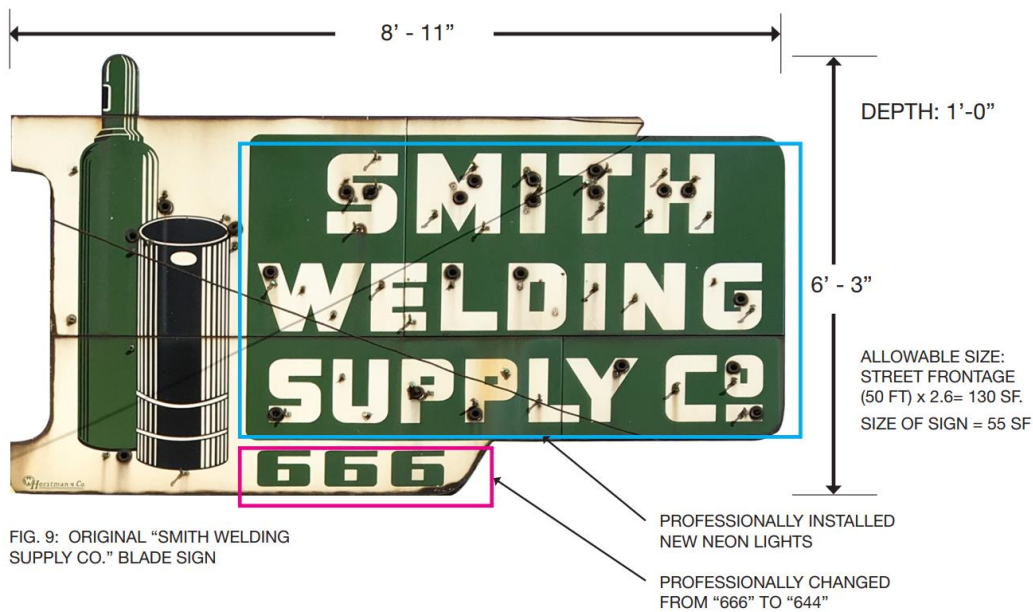
FIG. 9: ORIGINAL "SMITH WELDING SUPPLY CO." BLADE SIGN

not leave the site. In addition, our client is willing to professionally paint/change the sign's "666" to "644." See the below image, excerpted from the 2019 application.
