STAFF REPORT: 04/09/2025 MEETING
APPLICATION NUMBER: HDC2025-00063
ADDRESS: 114 ERSKINE
HISTORIC DISTRICT: BRUSH PARK
APPLICANT: RACHEL D. SALTMARSHALL / T AND M ROOFING LLC
PROPERTY OWNER: KING DAVID LODGE / FRATERNAL CIVIC CENTER
DATE OF PROVISIONALLY COMPLETE APPLICATION: 03/24/2025
DATE OF STAFF SITE VISIT: 03/29/2025

SCOPE: REMOVE DORMERS, REPLACE ASPHALT ROOF WITH ASPHALT ROOF

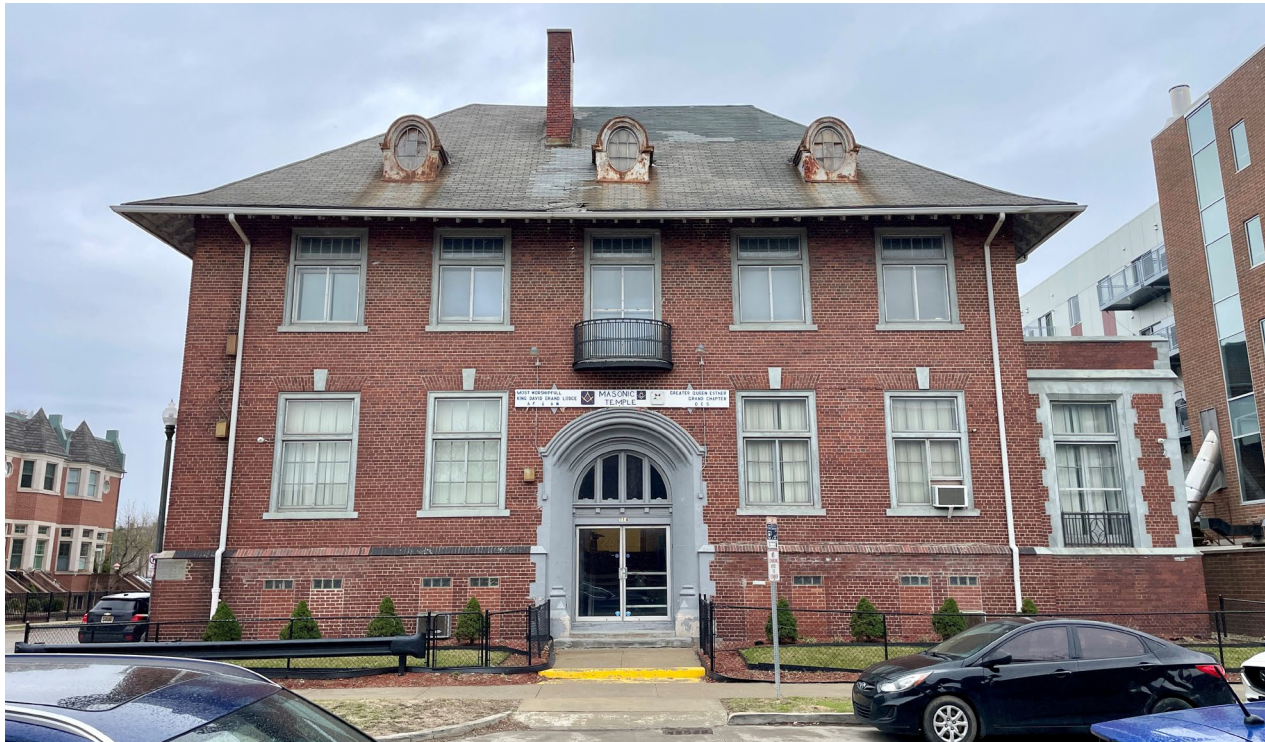
Staff photo, 03/29/2025. North elevation faces Erskine St.

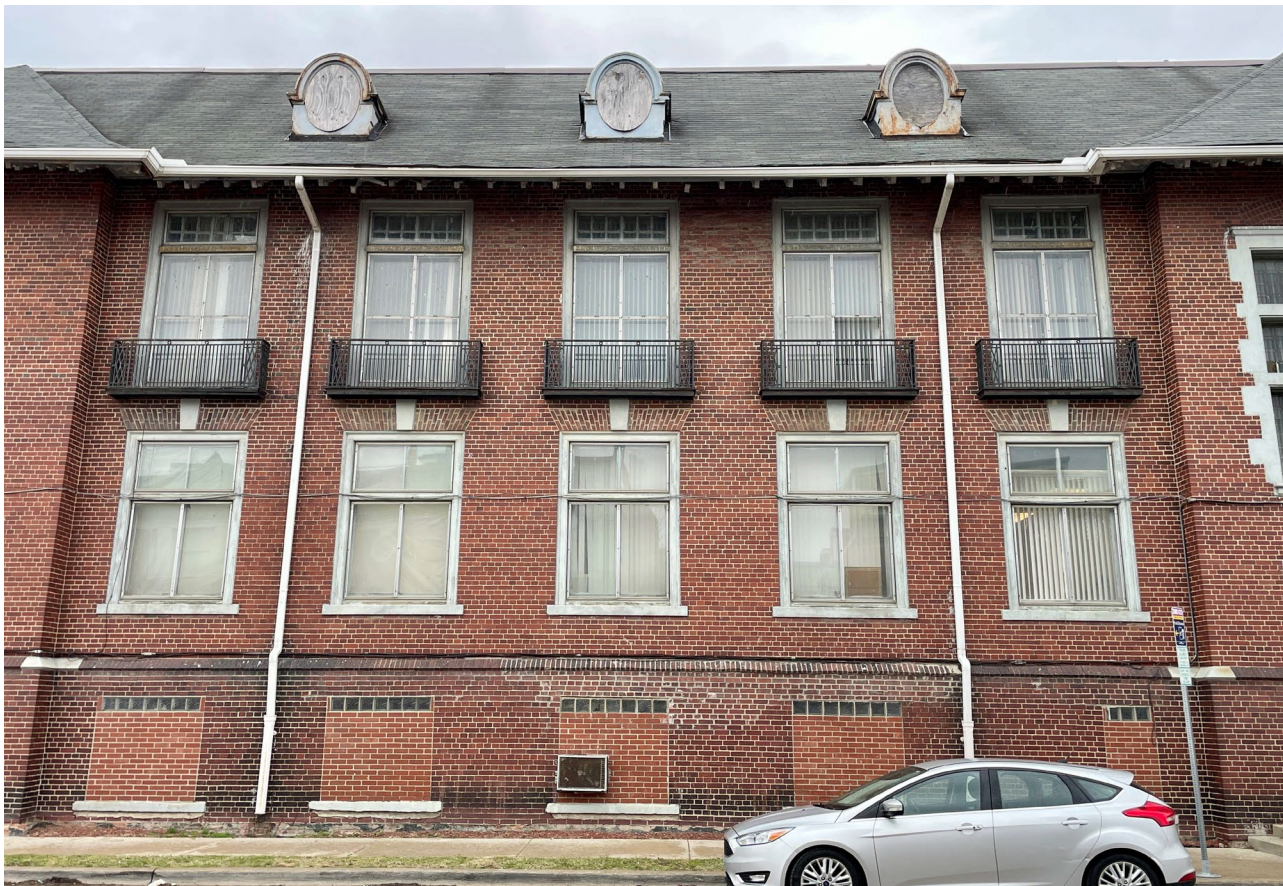
Staff photo, 03/29/2025. East elevation faces John R St.

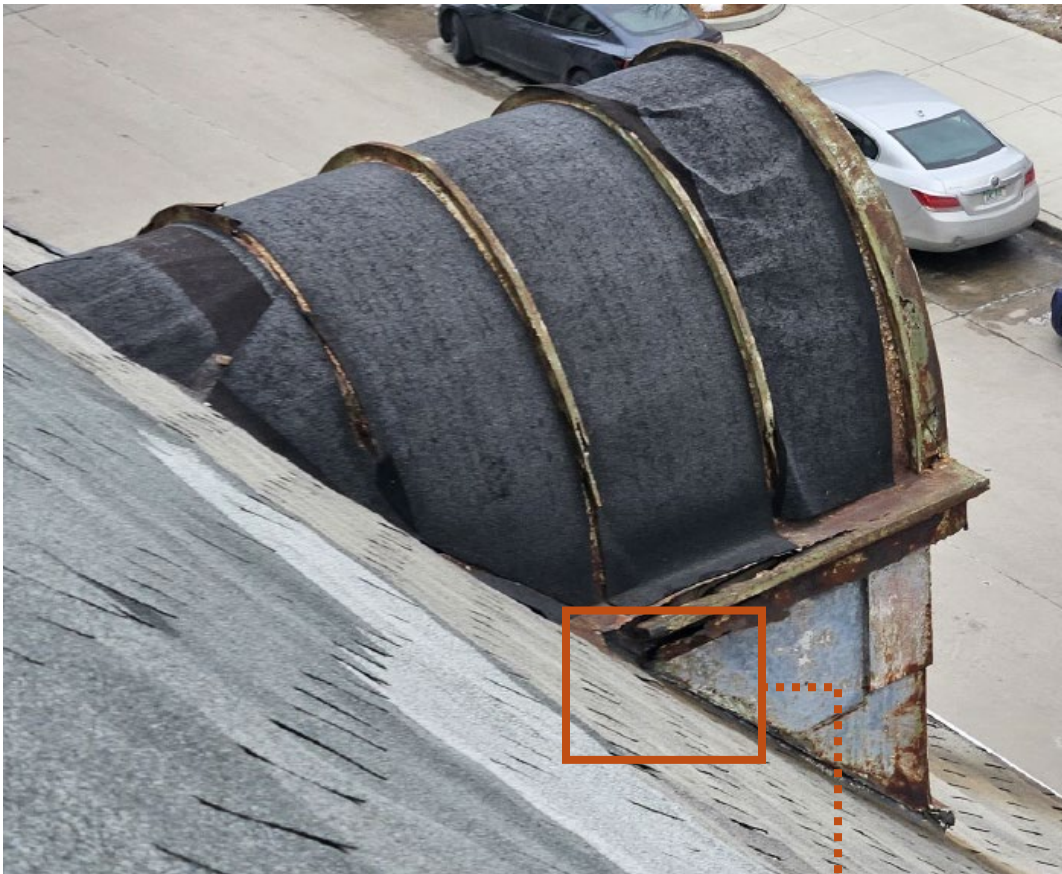
- The copper barrel dormers are certainly historic and unambiguously distinctive character-defining features that are important to the historical character. They are also described in the Elements of Design, adding a prominent visual component to the building.
 - The Elements of Design #10 (Sec. 21-2-120) mention “sheet metal was common” for treated areas such as “dormers” for architectural detail.
- The applicant states the dormers are in disrepair and are “causing much of the damage to the interior” and “have been repaired numerous times over the years” but “continue to leak due to the metal rusting and numerous holes appearing.”

Photo from application showing deteriorated metal.

Recommendation 1 of 2 – Denial – Removal of six historic dormers

- The dormers proposed for removal are historic and distinctive materials and features that contribute to the character of the property.
- The submitted documentation did not indicate that the dormers are deteriorated beyond repair.
- If replacement of the character-defining dormers is necessary, the application does not include information that indicates that it is unreasonable or infeasible to replicate the dormers in-kind.

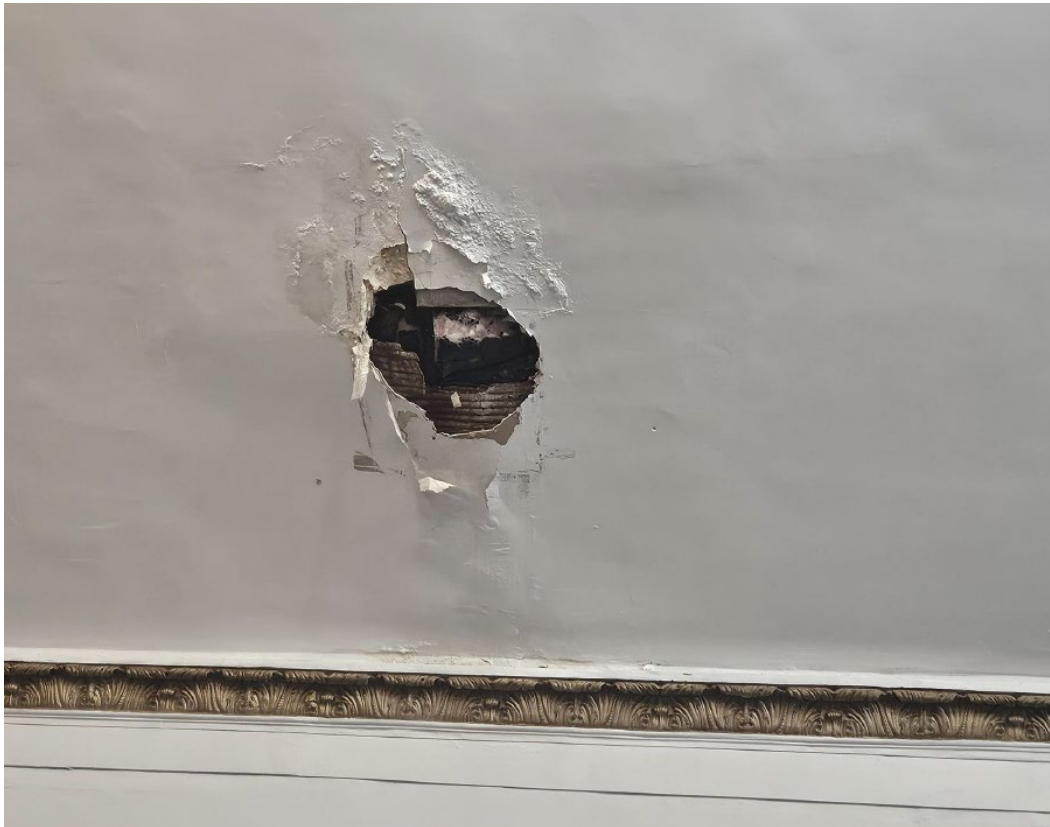
- The applicant states that “Ornate plaster work was restored back in 2020/2021” for “over 40K” and now “requires a second restoration.”

Photo from application showing interior water damage to plaster.

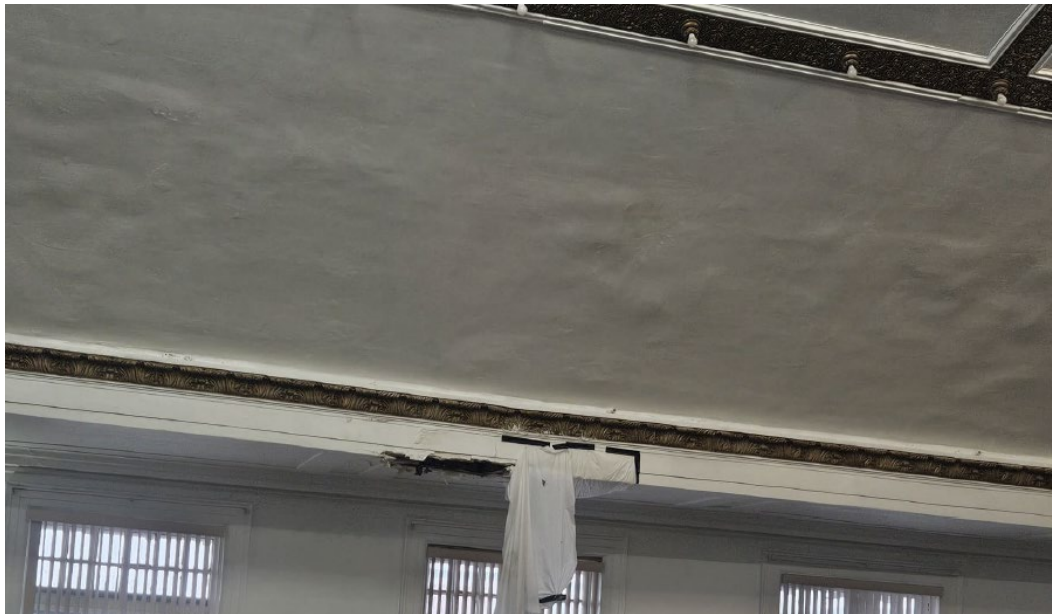
Photo from application showing interior water damage to plaster.

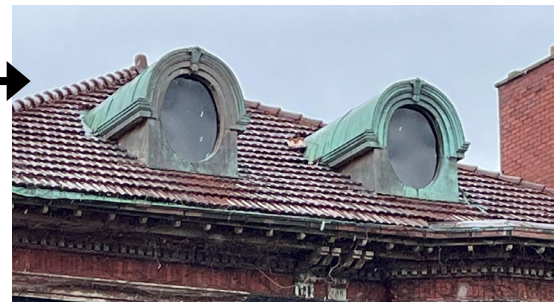
Staff photo of 266 Erskine, 03/29/2025

- A similar set of copper barrel dormers adorns a house at 266 Erskine, located down the street from 114 Erskine and constructed in 1911.
