**ADDRESS: 4245 FULLERTON****APPLICATION NO: HDC2025-00109****HISTORIC DISTRICT: RUSSELL WOODS-SULLIVAN****APPLICANT/OWNER: TARSHISH NEWBERRY****DATE OF STAFF SITE VISIT: 04/25/2025****DATE OF PROVISIONALLY COMPLETE APPLICATION: 03/10/2025**

**SCOPE: DEMOLISH GARAGE & REMOVE TREES (WORK COMPLETED WITHOUT APPROVAL), ERECT GAZEBO**

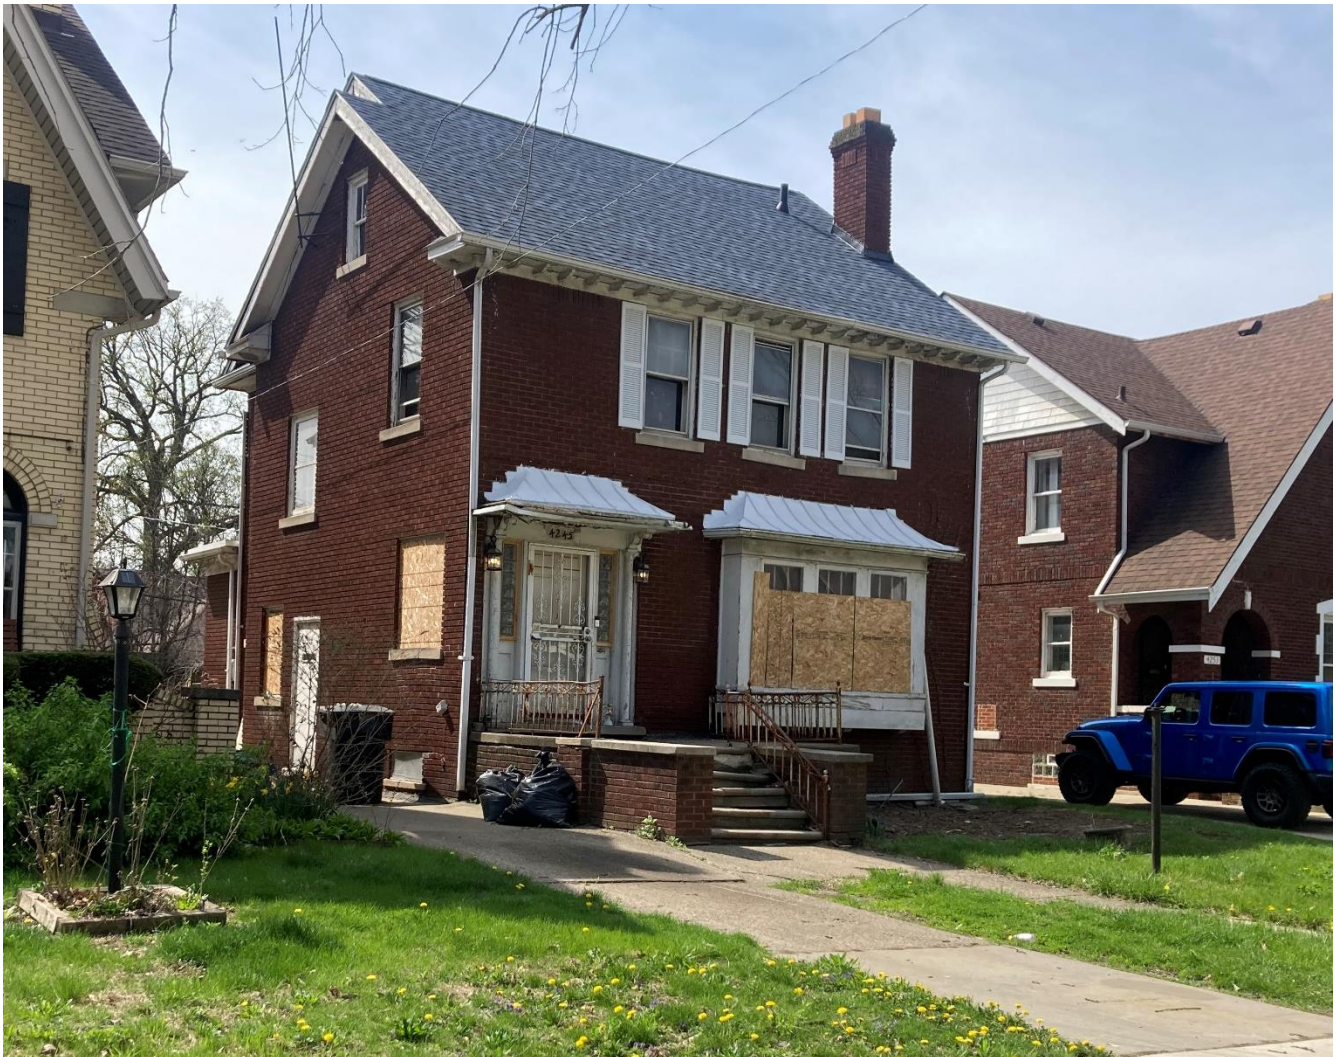
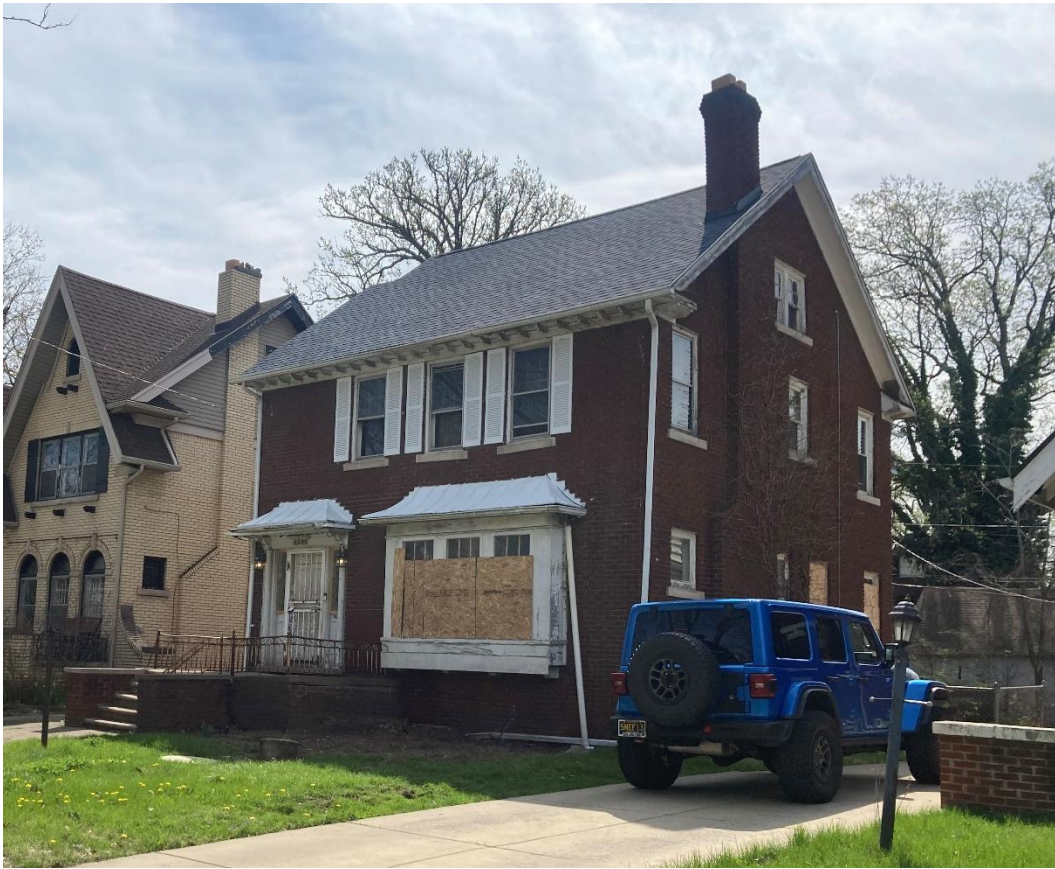
The parcel addressed as 4245 Fullerton includes a two-story, single-family dwelling that was erected ca. 1920. The building features a side-gabled roof with wood fascia and soffits, decorative brackets, and Classically-inspired eave returns. Exterior walls are clad with red brick and windows are the original double-hung wood units. Note that several windows on both sides of the house have been covered with plywood. It is therefore unclear if the original sash remains in these openings. Louvered wood shutters flank windows at the building's front façade, second story. A partial-width brick porch with original metal guardrails and handrails remains at the front façade.

**4245 Fullerton, current appearance. Taken by staff on 4/25/2025**

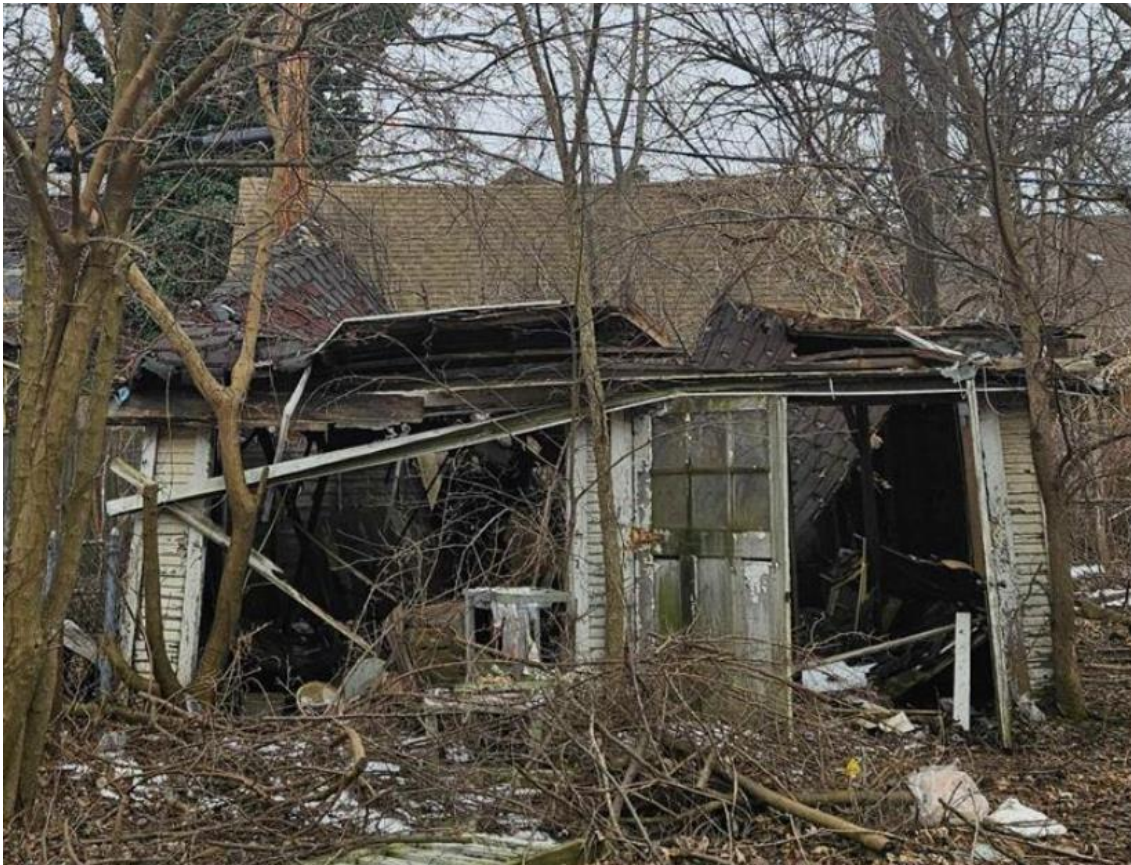
- The property owner has provided the below photo which documents the condition of the garage prior to its demolition. Note that the garage sat in a state of ruin, with the roof having caved in and the walls being partially collapsed. Although the building was of historic age, it HDC staff's opinion that it lacked the integrity necessary to contribute to the site's and/or the district's historic significance due to its poor condition. It is HDC staff's opinion that the remnants of the garage merited removal.

**4245 Fullerton, appearance of garage prior to demolition. Photo provided by applicant**

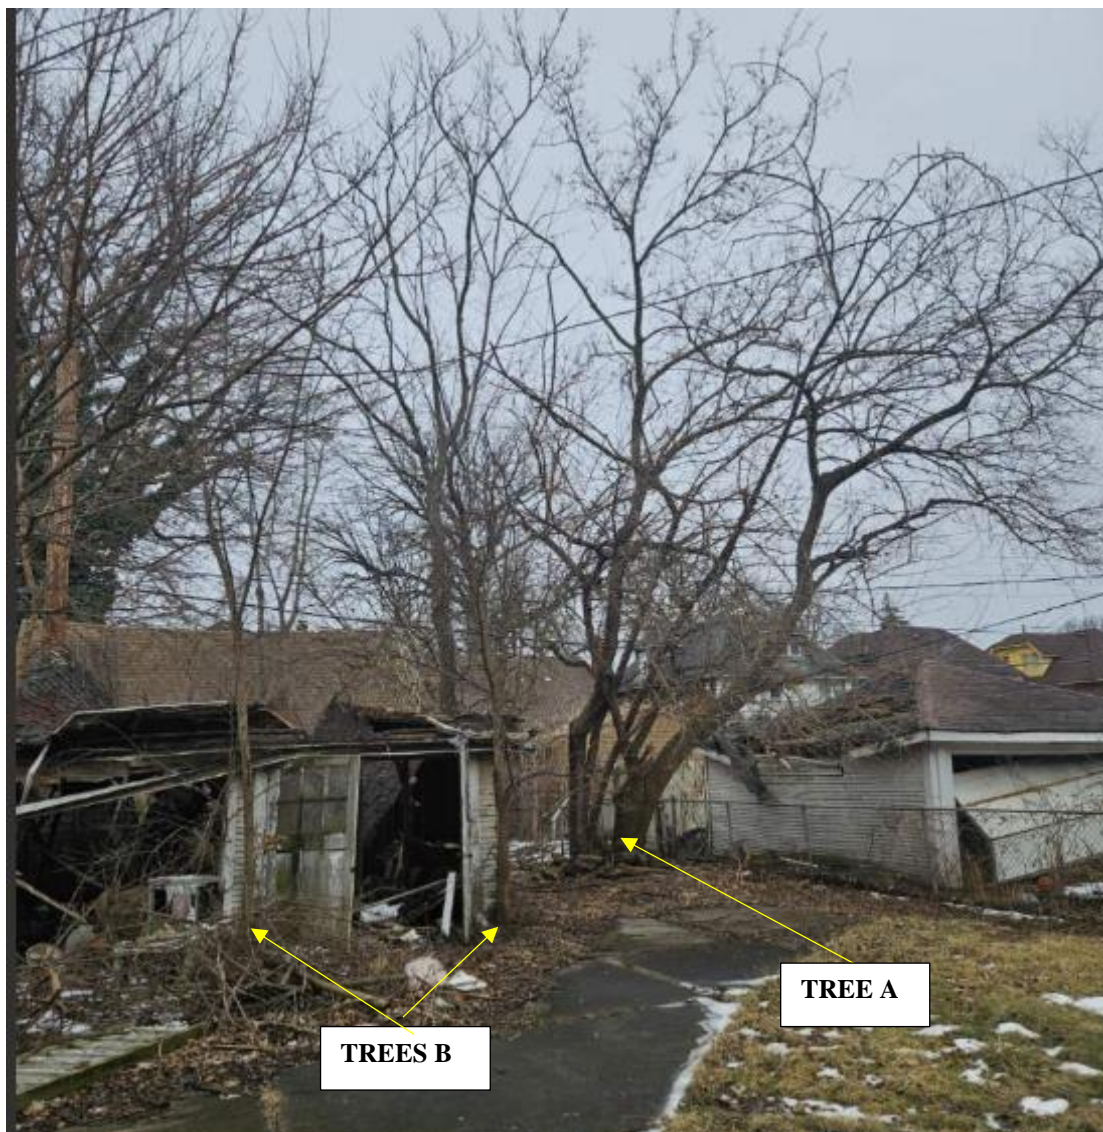
- With respect to the landscaping which was removed without HDC approval, please note the following:
  - See the below photo of the trees that were removed from the property's backyard without HDC approval. The applicant noted that the tree at the fence line which is labeled as "Tree A" in the below photo was "...dying and hanging over on neighbor's property," while the trees labeled as "Trees B," appear to have been removed when the garage was demolished. Staff reviewed the submitted photo and was unable to confirm that the tree at the fence line (Tree A) was dying. However, staff can discern that it was a large mature tree which was in need of limbing to prevent it from hanging into the neighboring yard and overhead power lines. It is staff's opinion that the removal of Tree A was inappropriate because it is unclear that it was diseased and in need of removal. However, the trees which were to the front of the garage (Trees B) appear to have been junk trees of a relatively recent age. It is staff's opinion that these trees/Trees B merited removal as they did not contribute to the property's historic character.

**Garage and trees (labeled Tree A and Trees B) removed without HDC approval. Photo provided by applicant**

- The application does not include documentation which indicates that mature tree that was removed from the property's rear yard, near the fence line was diseased/dying. Therefore, a new shade tree should be planted in the rear yard to replace it.

- A new shade tree shall be planted in the property's rear yard to replace the mature tree that was removed without approval. Staff shall have the final authority to review and approve the species and location of the tree prior to the issuance of the project's permit.

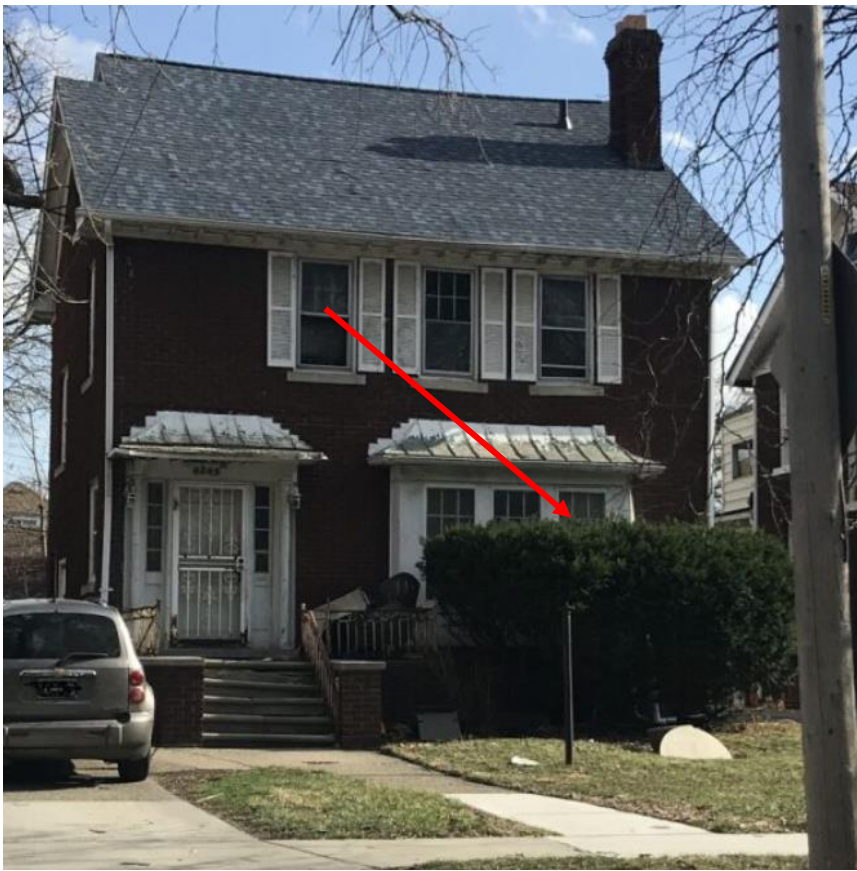
- The property owner also removed foundation plantings/shrubs at the property's front yard. See the following photo to note the appearance of the foundation planting/shrub at the front yard that was removed without HDC approval. Per the district's Element of Design, # (13) *Relationship of significant landscape features and surface treatments*, "...foundation plantings, often of a deciduous nature and characteristic of the period 1920-1960, are present virtually without exception." Although it is not likely that the shrub itself was historic age, the Elements do note that it is typical to find foundations plantings within the district. Staff therefore recommends that new landscaping/foundation plantings "...of a deciduous nature..." be planted in the same location as the shrubs that were removed without HDC approval. The shrubs should be maintained at a height that is lower than the existing window sill.

**4245 Fullerton, staff photo taken in 2024. Red arrow indicating shrub removed without HDC approval**

- Foundation plantings are a distinctive, character-defining feature of the property and district/plantings are particularly important to the character of the district. As the mature shrubs have been removed without HDC approval at the front façade foundation, they should be replaced in kind with shrubs of compatible size and maturity as feasible

- New landscaping/foundation plantings "...of a deciduous nature" be planted in the same location as the mature shrubs that were removed without HDC approval, ie. at the house's front façade foundation. As feasible, plantings of appropriate size shall be selected

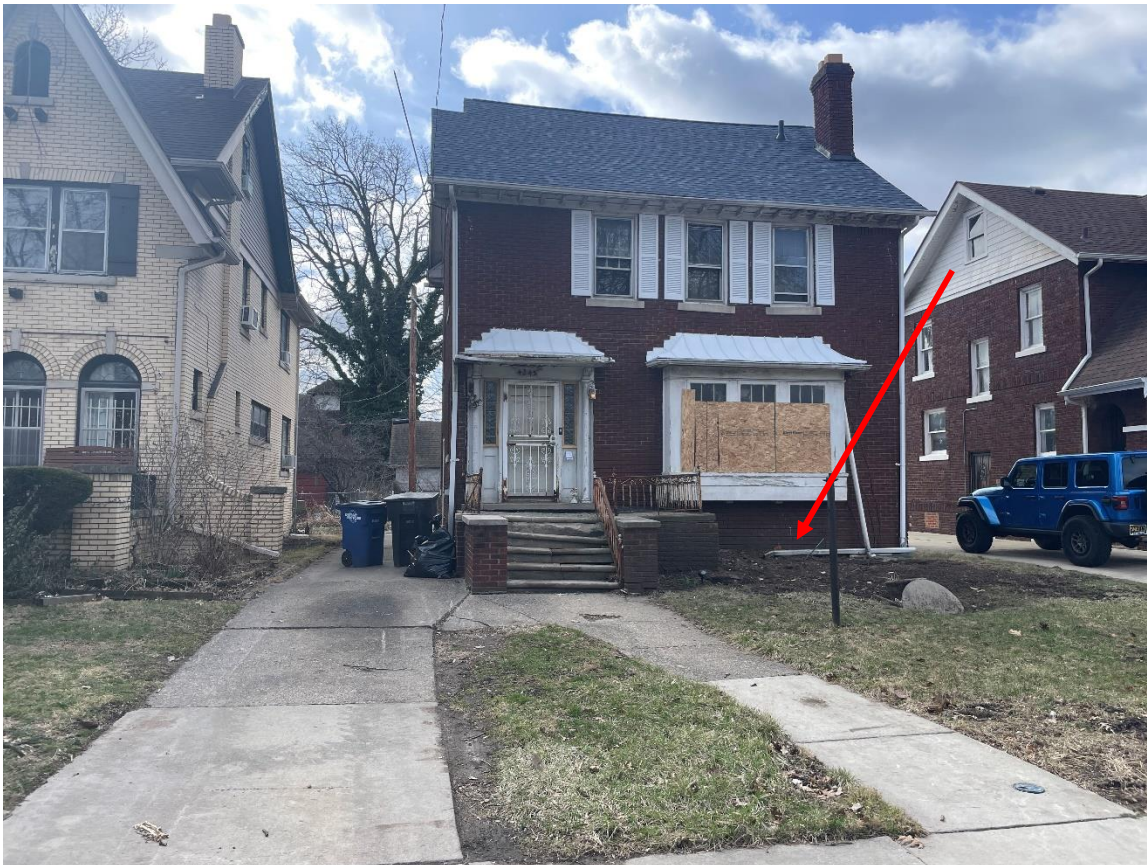
**Staff photo showing current conditions/location of shrub removed without approval (indicated by red arrow)**
