STAFF REPORT: 05/14/2025 MEETING

ADDRESS: 4700 THIRD AVENUE

APPLICATION NO: HDC2025-00112

SCOPE: REPLACE STOREFRONT AND CLADDING (WORK COMPLETED WITHOUT APPROVAL)

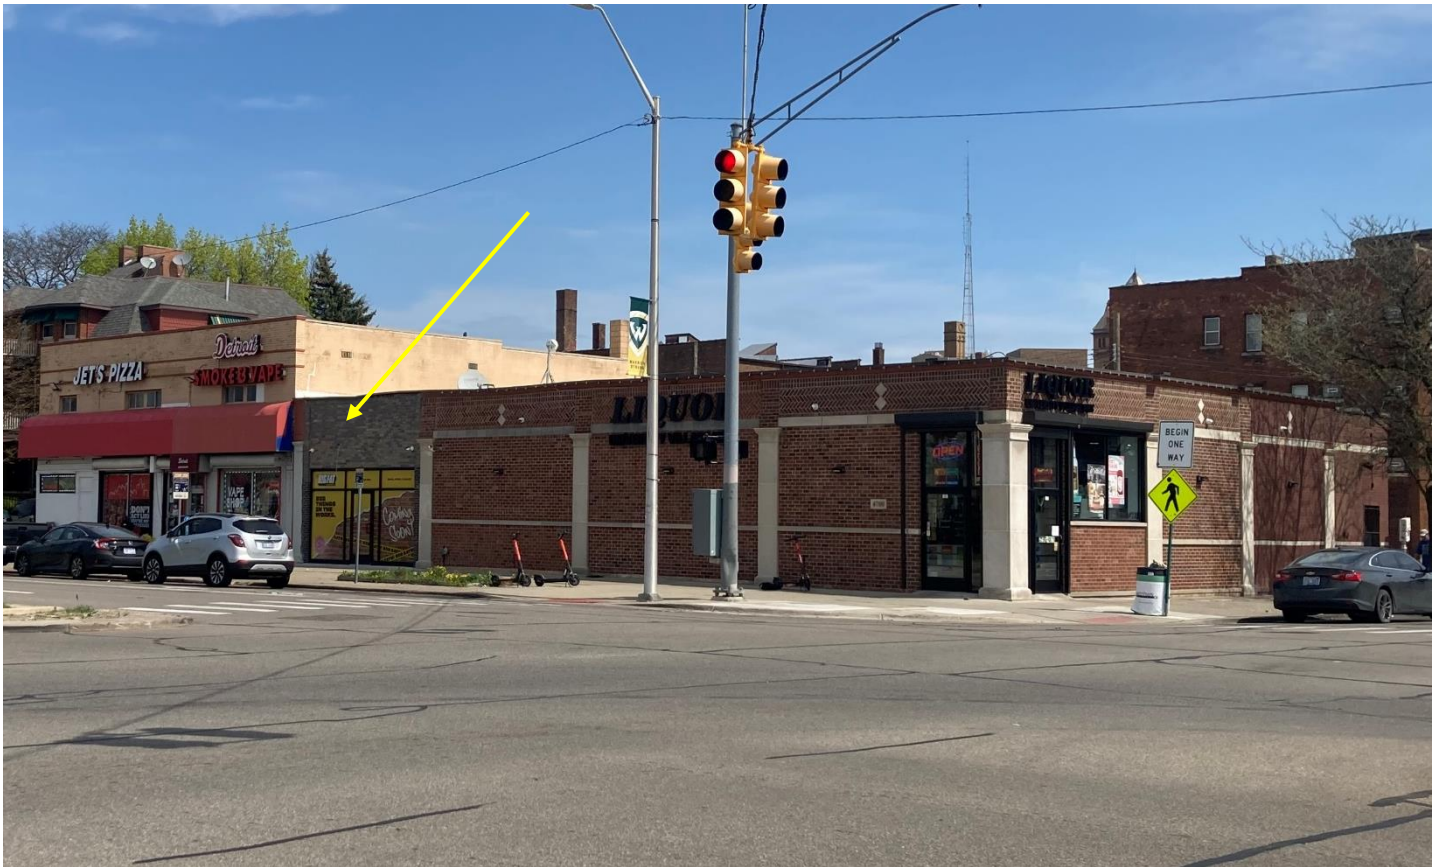
4700 Third Avenue, current appearance. The yellow arrow indicates the storefront that is the subject of the current application. Photo taken by staff on 4/25/2025

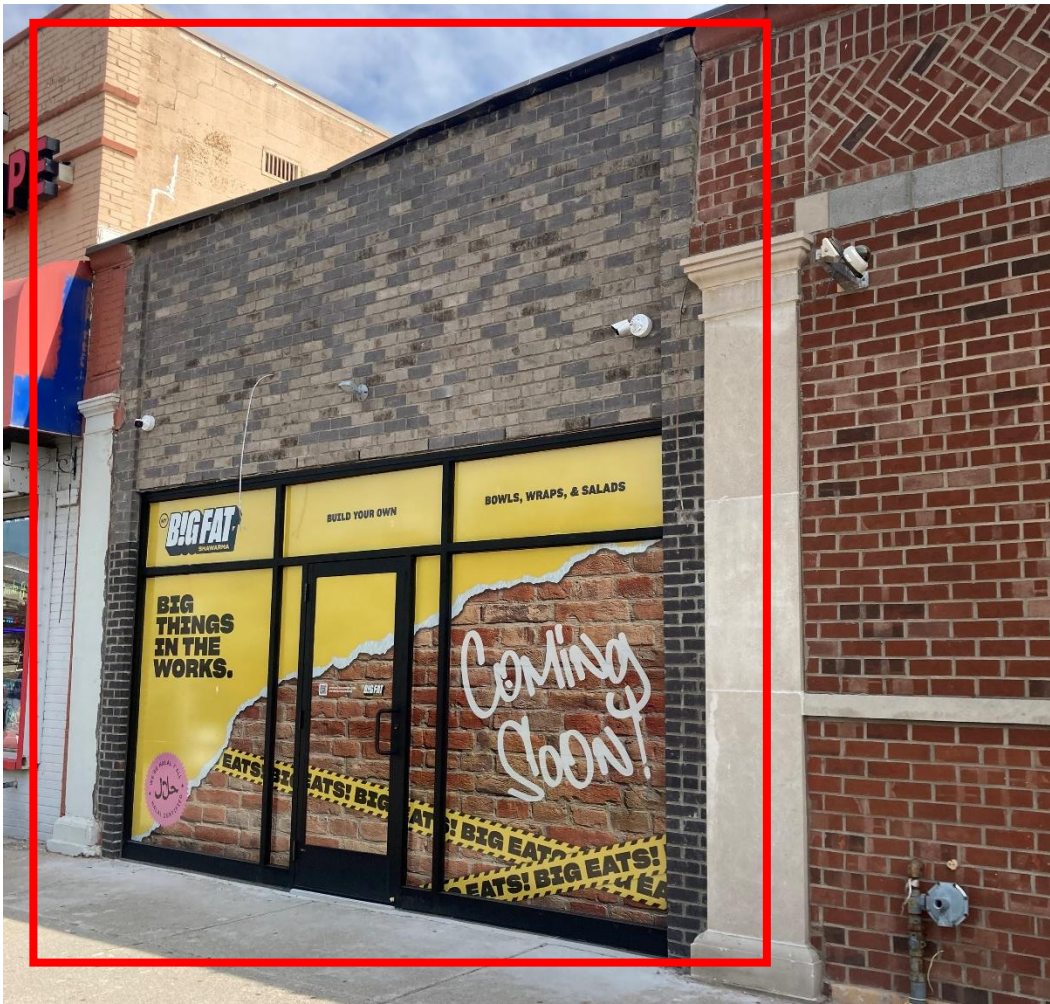
4700 Third Avenue, current appearance of the storefront that is the subject of the current application (outlined in red). Photo taken by staff on 4/25/2025

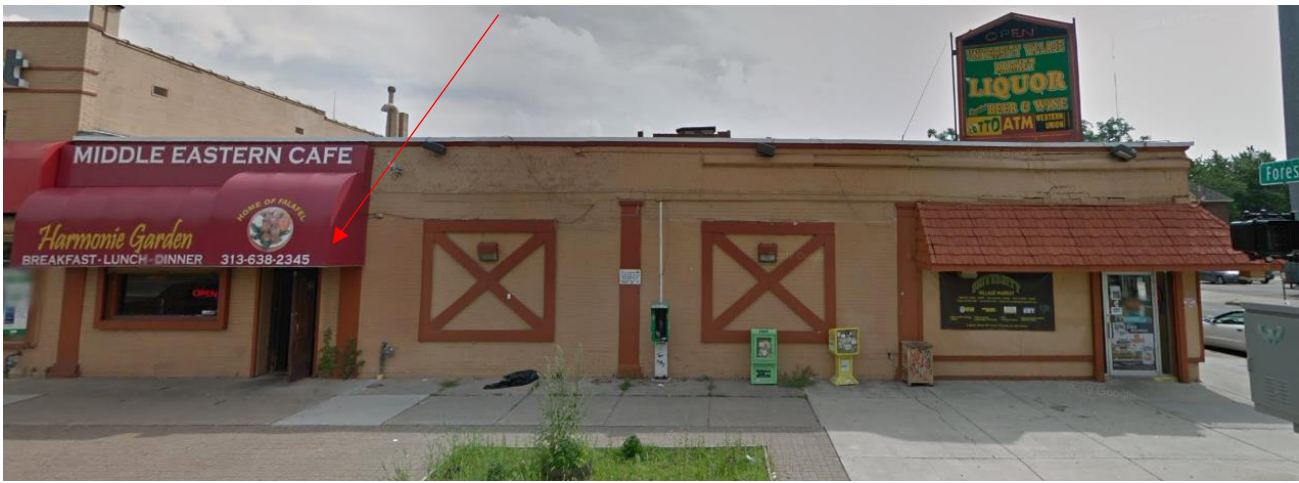
4700 Third Street. Google Streetview image taken in 2013. Red arrow indicates location of storefront involved in the current project

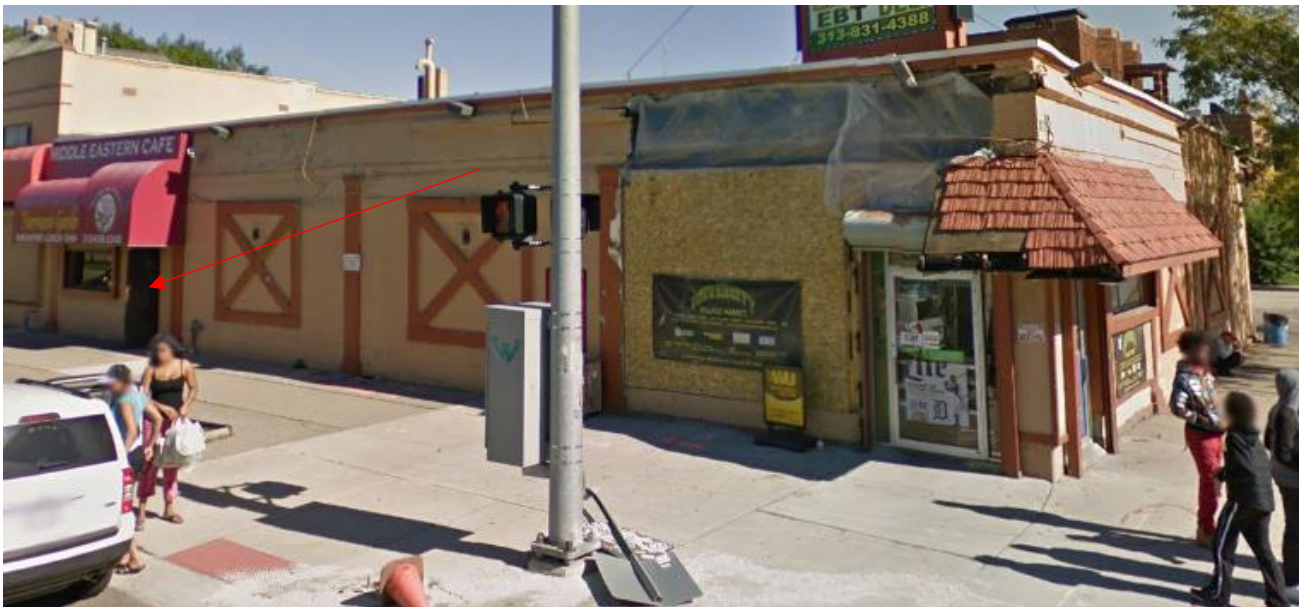
4700 Third Street. Google Streetview image taken in 2016, after a car damaged the facade. Red arrow indicates location of storefront involved in the current project

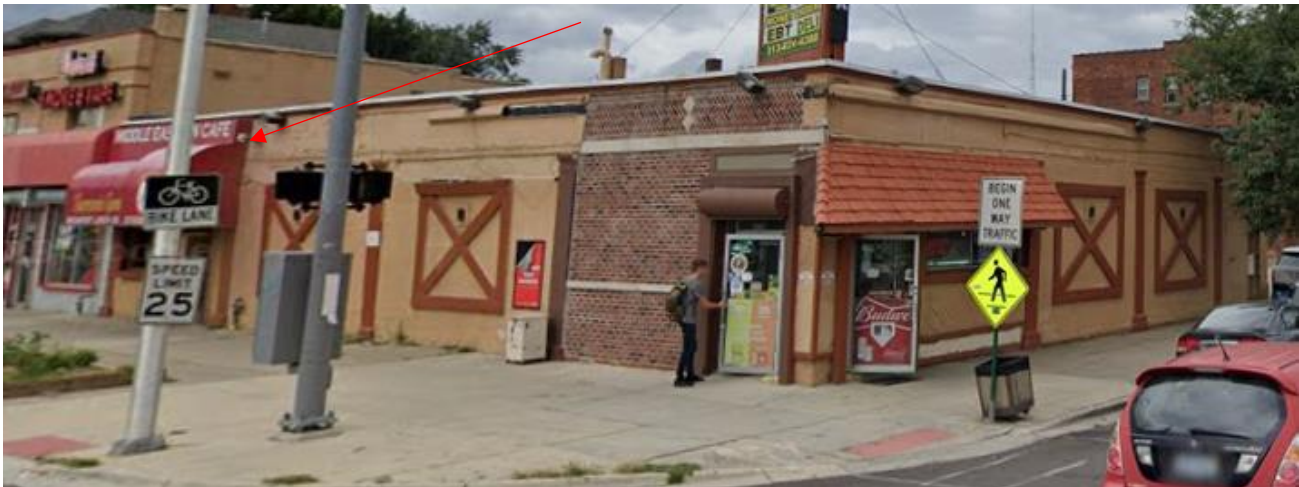
4700 Third Street. Google Streetview image taken in 2018, after approved exterior work was completed to repair damage caused by car accident. Red arrow indicates location of storefront involved in the current project

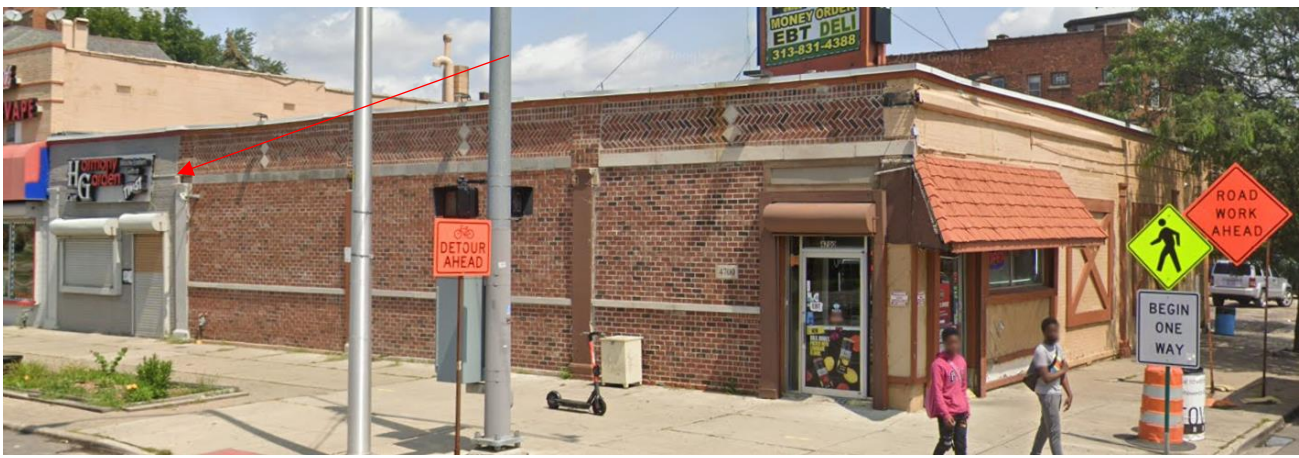
4700 Third Street. Google Streetview image taken in 2021. Note that new brick has been added at the 3rd Street façade, while the Forest Avenue façade remains intact. Red arrow indicates location of storefront involved in the current project. Note that the neither the cladding nor fenestration has changed since 2015. However, the non-historic awning has been removed and the wall has been painted grey.

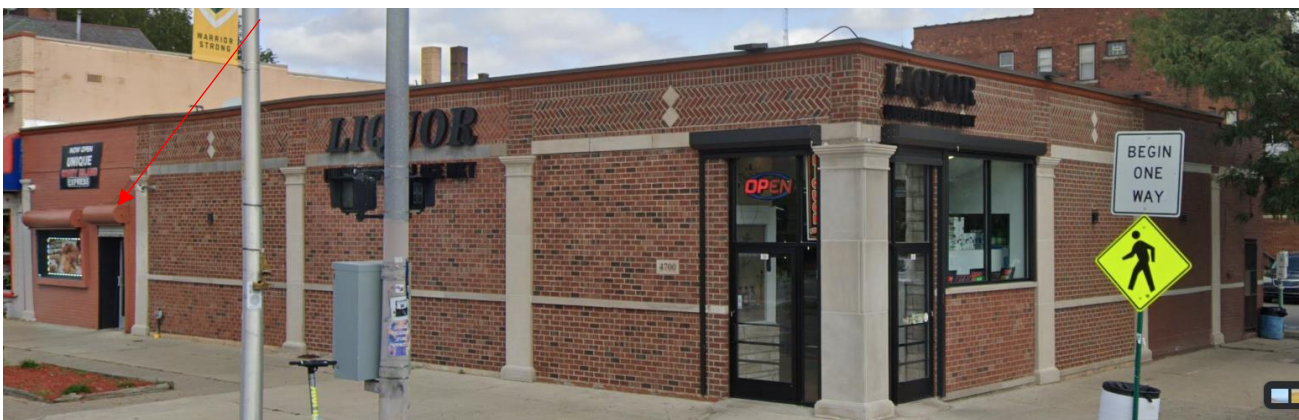
4700 Third Street. Google Streetview image taken in 2023 after the installation of staff approved pilasters to replace inappropriate rusticated limestone elements. Red arrow indicates location of storefront involved in the current project.

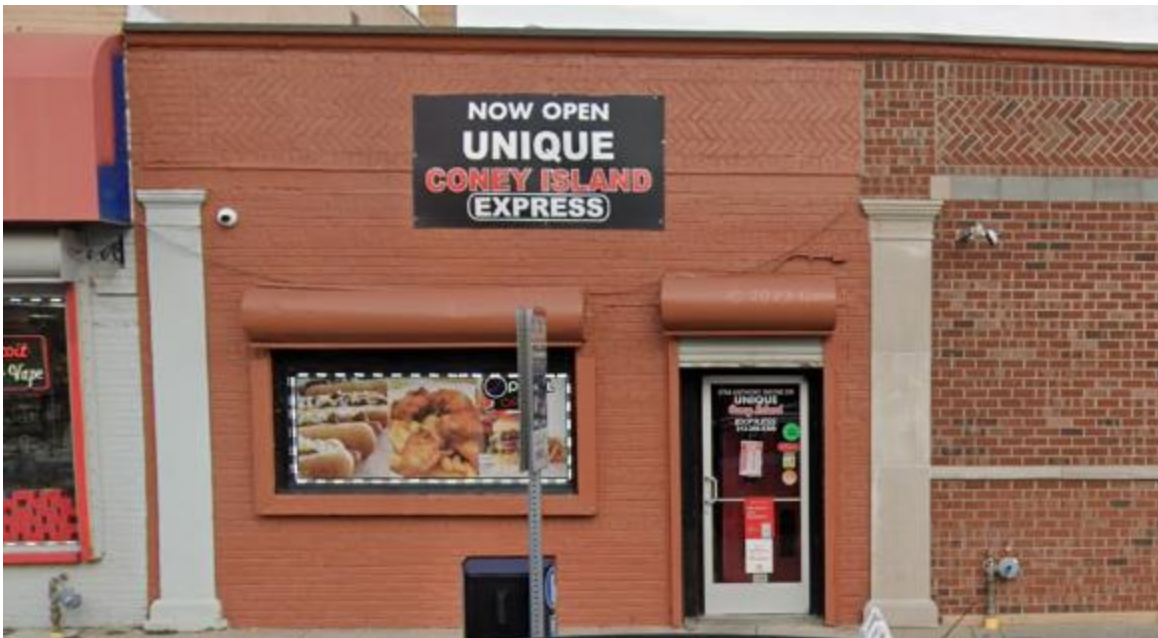
4700 Third Street. Google Streetview image of the area of the building involved in the current project taken in 2023 after the installation of staff approved pilasters to replace inappropriate rusticated limestone elements. Note the herringbone pattern at the parapet, the limestone band below the parapet, the remaining limestone pilaster, and the brick pattern.

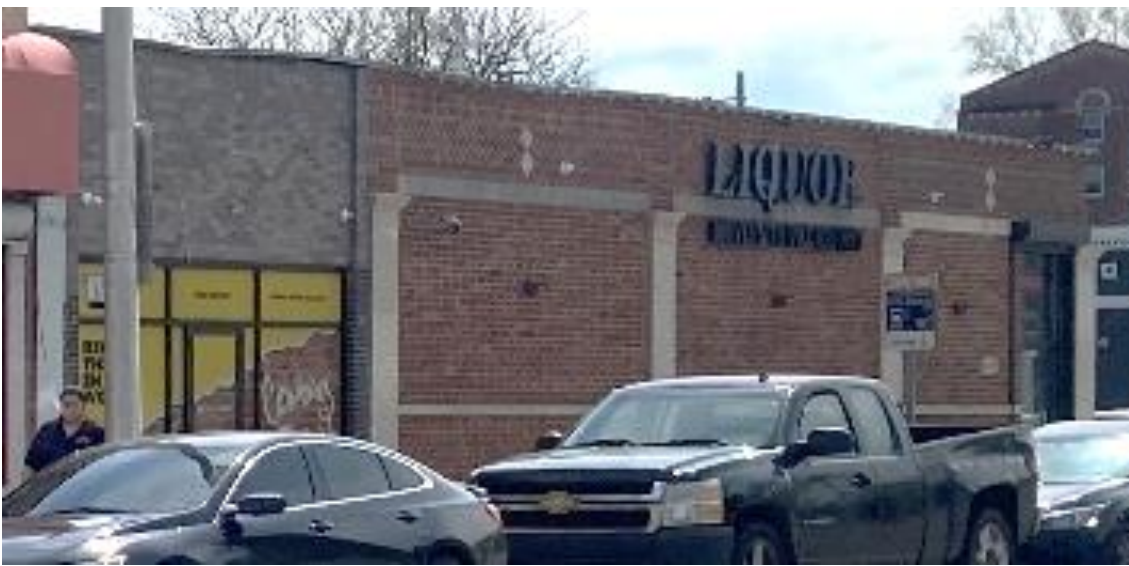
4700 Third Street. Staff photo taken on 4/25/2025 showing current conditions after unapproved brick replacement and storefront installation proposed for approval with the current application (see red arrow). Note incongruous appearance with the rest of the building/façade.

- The current application does not include documentation that the brick cladding that was replaced was deteriorated beyond repair. Also, the current grey brick is not appropriate to the building's historic character as it does not match the existing or the original in texture, dimension, bond, or color. The herringbone pattern/design which once existed at the parapet and the limestone band below the parapet were not repeated with the current recladding. As a result of this unapproved work, the current storefront appears incongruous with the remaining portions of the building's front and side facades. The work therefore does not meet the Standards. Staff also notes that the EIFS cladding proposed in the building permit drawings is also an inappropriate cladding because it is not an adequate replication of the brick which was removed without HDC approval. It is HDC staff's opinion that brick and limestone which matches that which exists at the adjacent walls should be installed to replace the existing grey brick. Staff further recommends that this brick not be painted per the proposal so that presents an appearance that is consistent with the adjacent facade.

- The current cladding shall be replaced with a new cladding that better approximates the appearance of the historic brick and limestone that was removed from the façade without HDC approval. Staff shall be afforded the opportunity to review and approve the final cladding proposal prior to the issuance of the permit for the new signage.

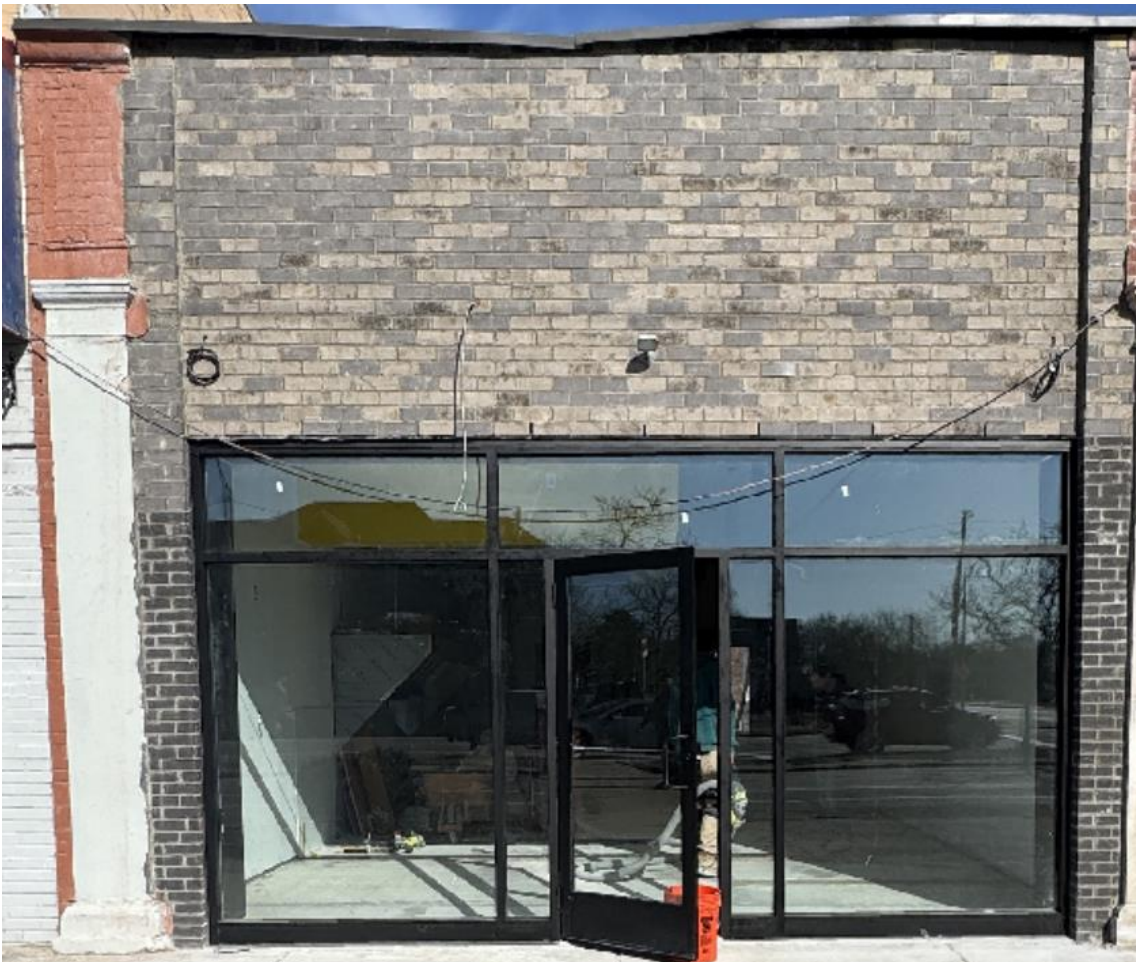
4700 Third Street. Photo from applicant showing current conditions after unapproved brick replacement and storefront installation proposed for approval with the current application (see red arrow). Note all original herringbone pattern at parapet and the limestone band which was below the parapet is no longer present. It appears that the only original portion of the cladding that remains is the limestone pilaster to the left of the new aluminum storefront.

- The current application does not include documentation that the brick cladding that was removed without approval was deteriorated beyond repair
- Neither the current grey brick cladding that was installed without approval nor the EIFS cladding proposed in the building permit set (unapproved by the HDC) provides an adequate replication of the original brick cladding that was removed without COA.
