STAFF REPORT: JULY 9, 2025 MEETING

APPLICATION NUMBER: HDC2025-0311

ADDRESS: 305 ELIOT

SCOPE: REPLACE SLATE DORMER SIDING (WORK COMPLETED WITHOUT APPROVAL)

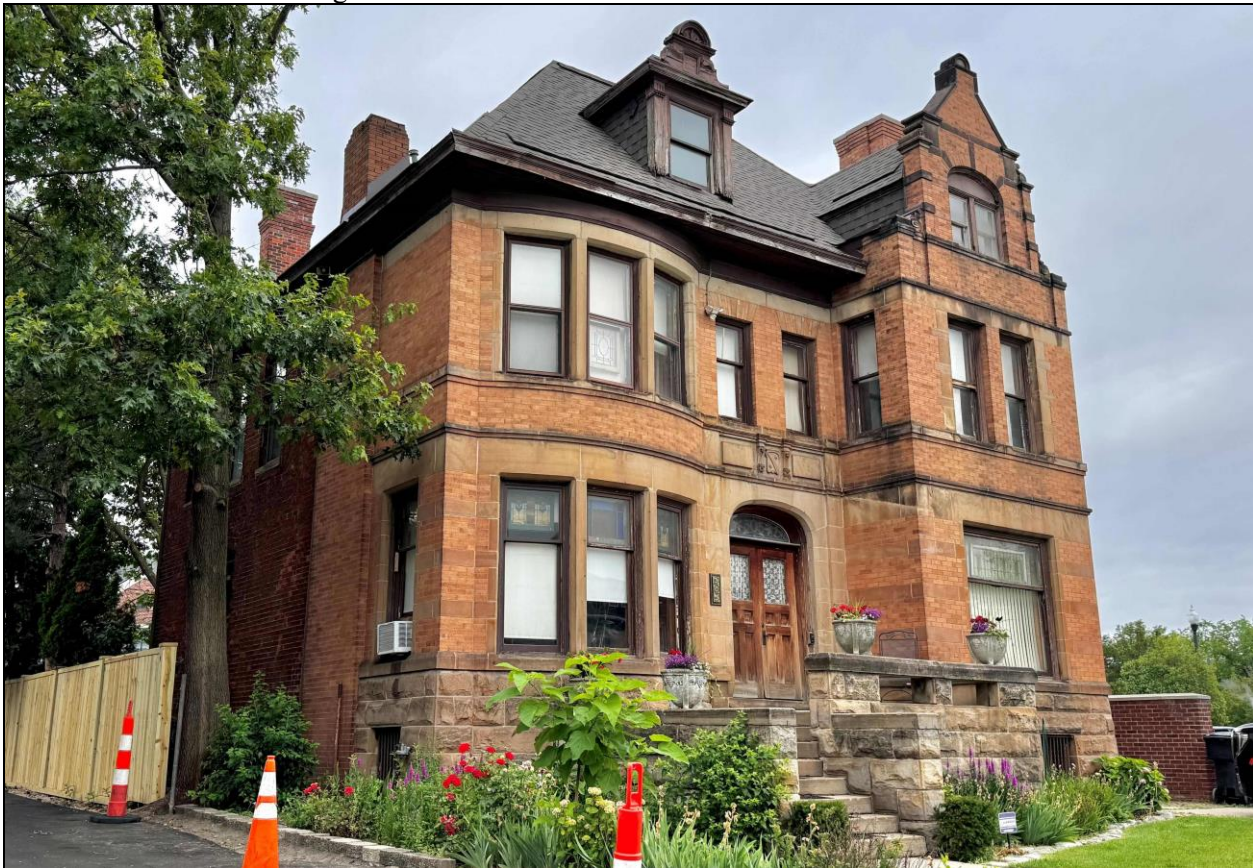
The asymmetrical massing of the façade includes a centrally placed front door, rounded two-story bay and 2-1/2 story box bay. The box bay is topped with a Flemish gable – a parapet wall that covers the extended dormer's gable roof. The parapet's half-round window opening matches the shape of the recessed front entry and the decorative stone and brickwork is echoed in the detailed wood above the single dormer, creating an inverted triangle pattern/placement of distinctive character-defining features.

View, looking northeast from Eliot, of the façade and west side wall. HDC staff photo, June 25, 2025.

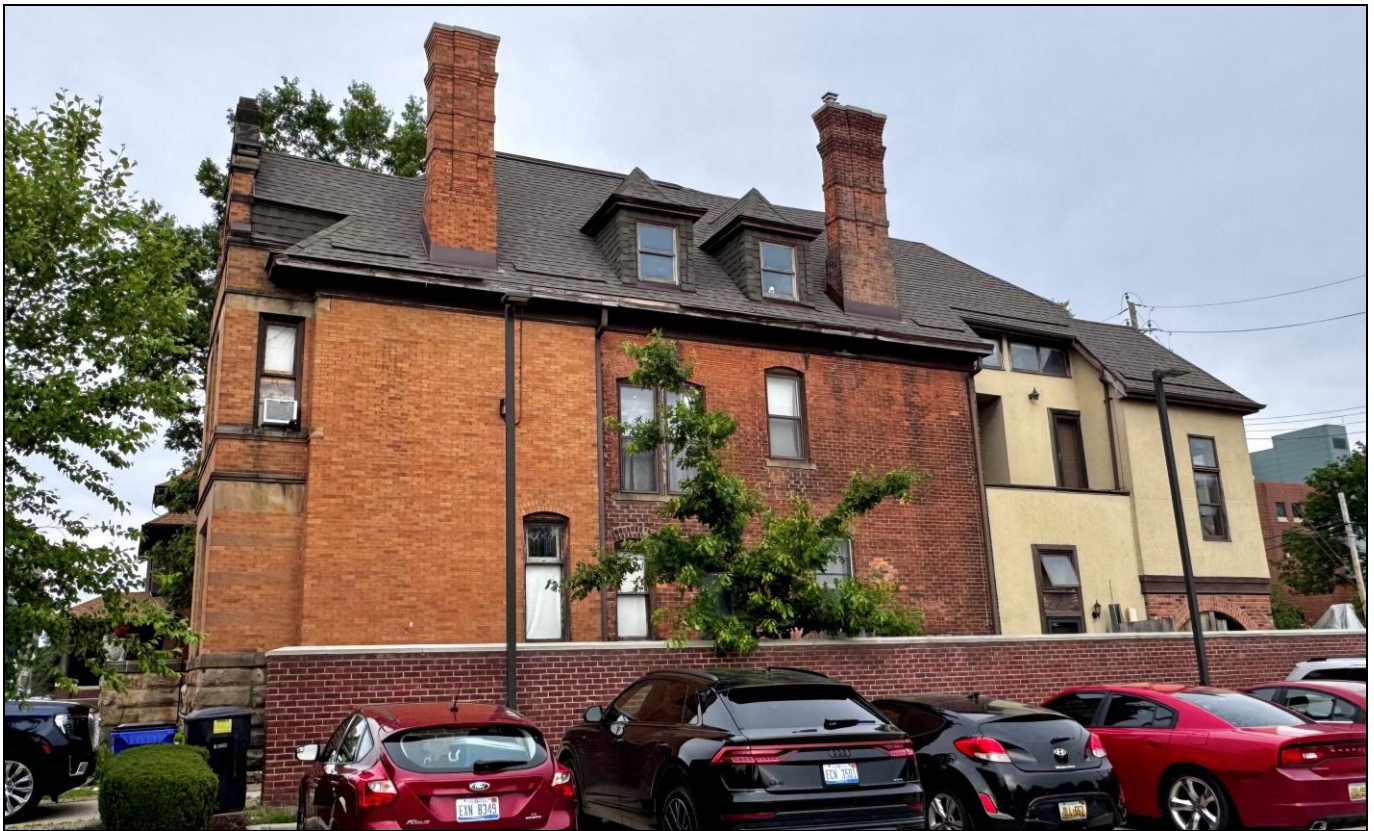
East side wall. Staff photo, June 25, 2025.

The dwelling's three chimneys (two at the east wall, one at the west wall) have multiple corbels, and the east-facing dormers have flared hip roofs. The rear addition was erected circa 1994 (HDC94-094).

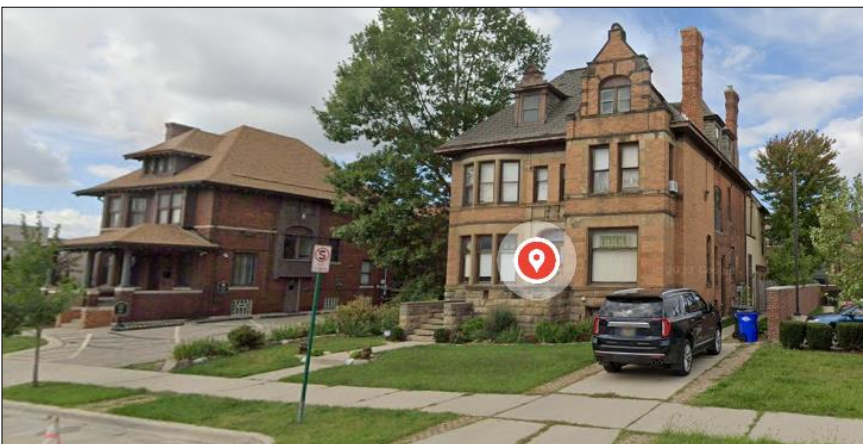
Above: Google street view, looking north, 293 (l) and 305 (r) Eliot are visible. Above right: Sanborn map - Vol. 3, 1921, image 35. 293 and 305 Eliot, outlined in red, are the remaining historic structures on the north side of Eliot between John R and Brush.

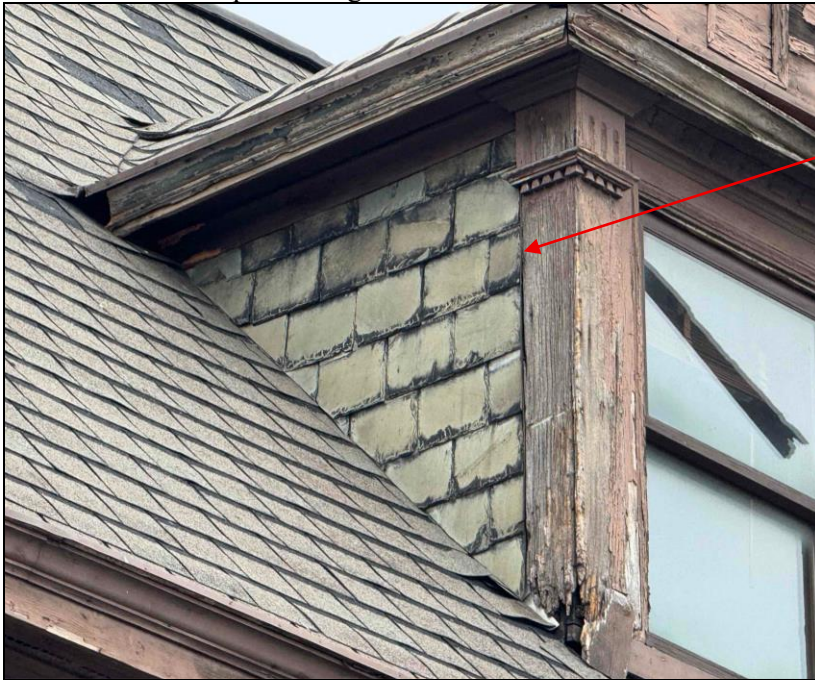
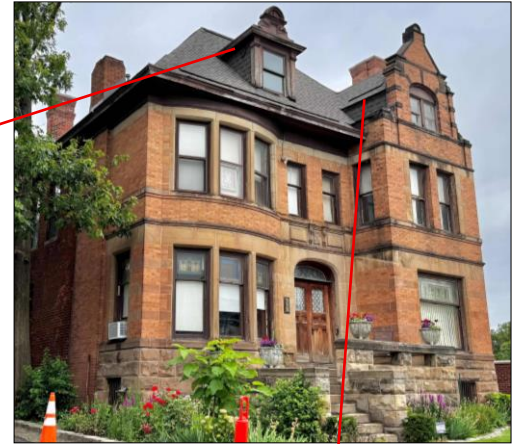
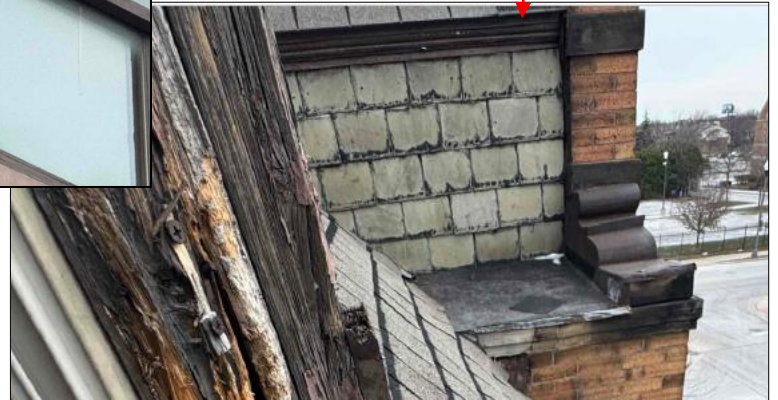
- In 2002 HDC staff issued a COA (HDC#02-140) for the repair of the dormers (slate removed, wood replaced, flashing installed, slate shingles reinstalled).
 - The photos below were submitted as part of a 2025 application for the installation of a new asphalt shingle roof (HDC2025-00701). The applicant confirmed at that time that no work was to occur at the dormers, i.e., that the existing historic slate shingles at the dormer sidewalls would not be removed. HDC staff issued a COA for the installation of asphalt shingles at the main roof surface on December 16, 2024.

Photos of slate on façade dormer walls from application HDC2025-00701.

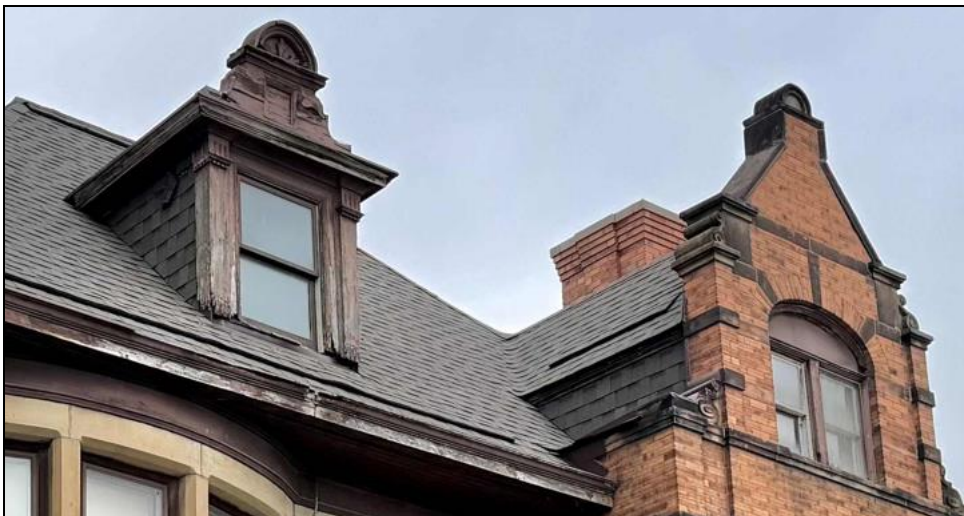
Staff photo of existing condition at façade dormer walls. June 25, 2025.

- The slate tiles were removed without HDC approval; the scope of work that would meet the requirements of the historic ordinance (Section 21-2-59(e)) is the installation of new slate tiles with a matching dimension, pattern and surface color/finish as the historic slate tiles.

- New slate, as well as salvaged slate, is readily available. The installation of natural slate matching the overall design, dimension and qualities of the historic slate can be approved at a staff level.

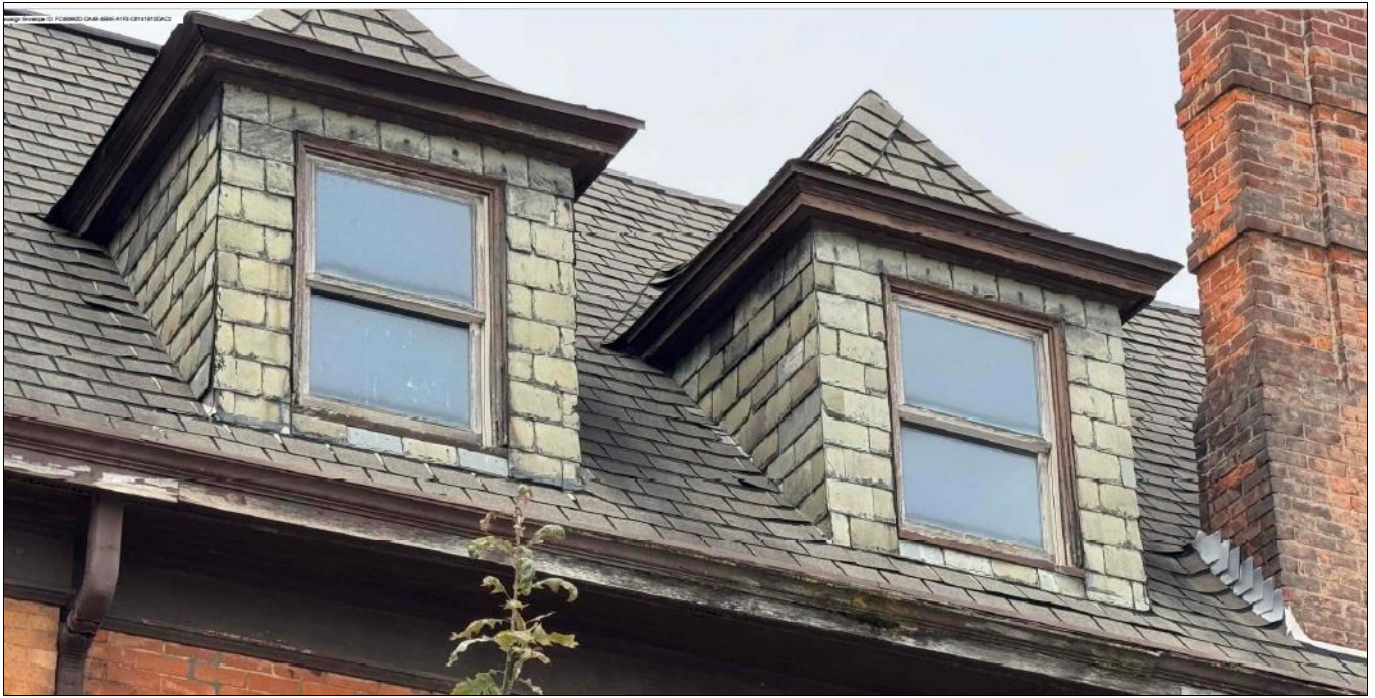
Photo of slate tiles on east dormer walls, prior to removal, from application HDC2025-00701.

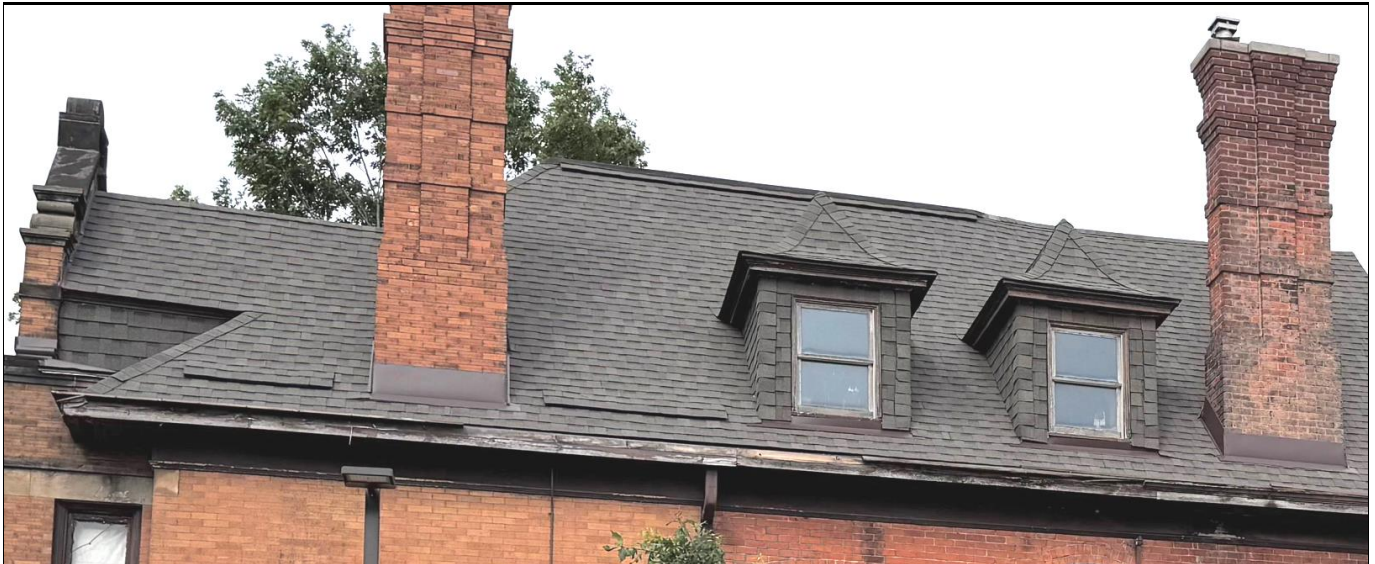
Staff photo of existing conditions at east dormer walls. June 25, 2025.
