STAFF REPORT: 08/13/2025 REGULAR MEETING

APPLICATION NUMBER: HDC2025-00391

ADDRESS: 2255 OAKMAN

SCOPE: REPLACE VINYL WINDOWS

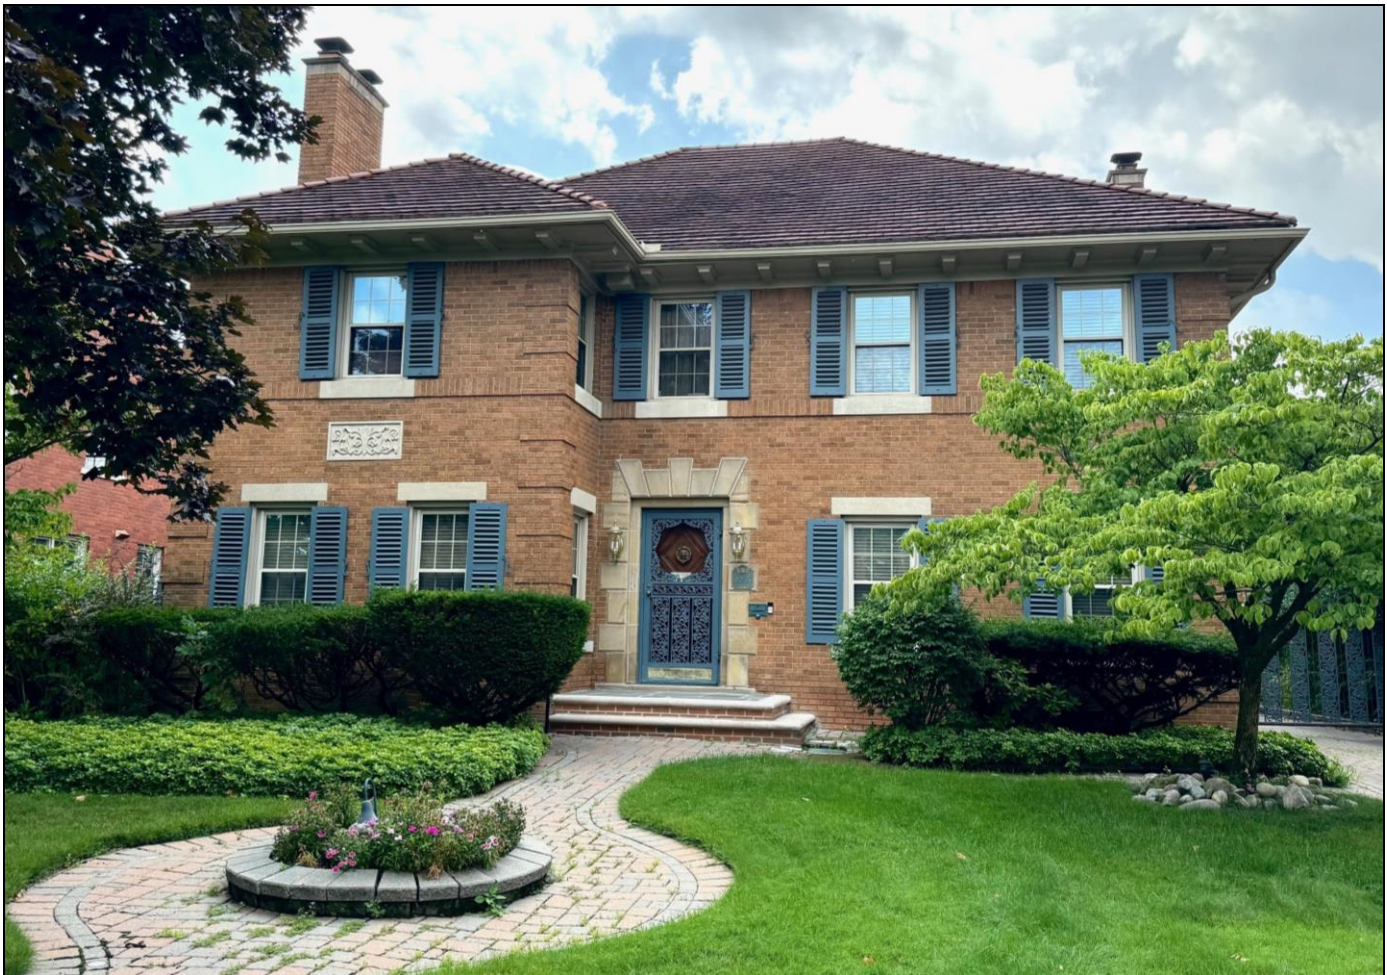
The two-story house at 2255 Oakman Boulevard is on the south side of the street, mid-block, between Holmur and Dexter Avenue. The house is clad in light brown brick. The main body of the house has a hip roof, and a pyramidal hip roof covers the front extension; both are covered with red tiles. Revival details include brick quoining at the corners of the house; cast stone quoins were used as the front door surround. Stone sills at the second floor window openings interrupt the brick soldier course that wraps around the house; the window openings at the first floor also have stone headers. The deep overhanging roof is adorned with evenly-spaced flat brackets. The six-over-six patterned double-hung windows are vinyl and were in place at time of designation.

Staff photo, July 2025.

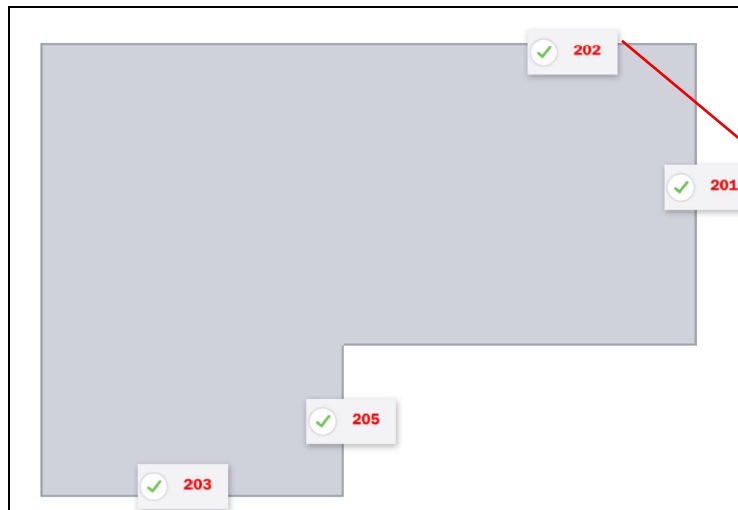
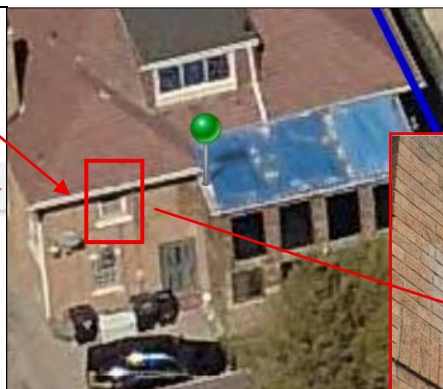
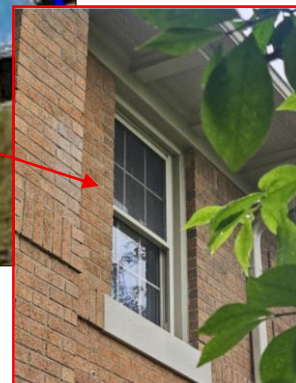
Replace five (5) vinyl windows with Renewal by Anderson Fibrex double-hung windows, six-over-six pattern.

Applicant document and photos.

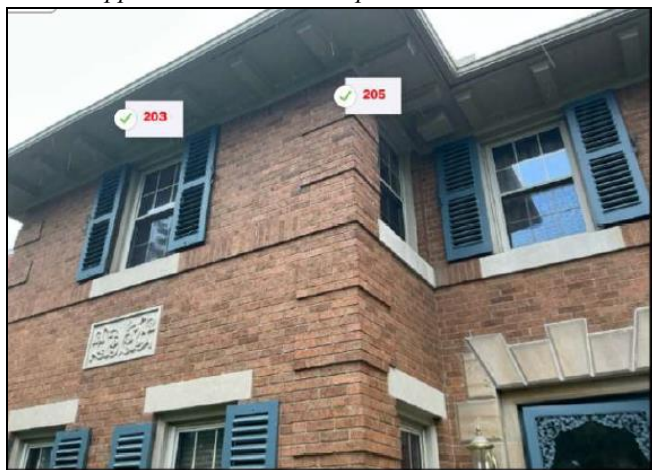
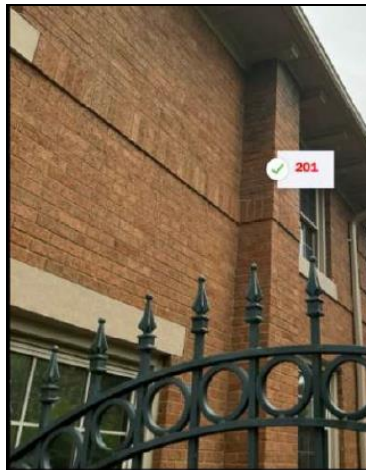
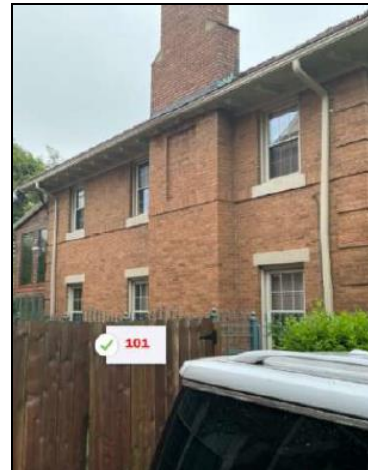
Grids: Grilles-between-glass

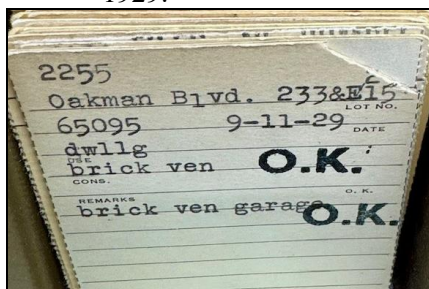
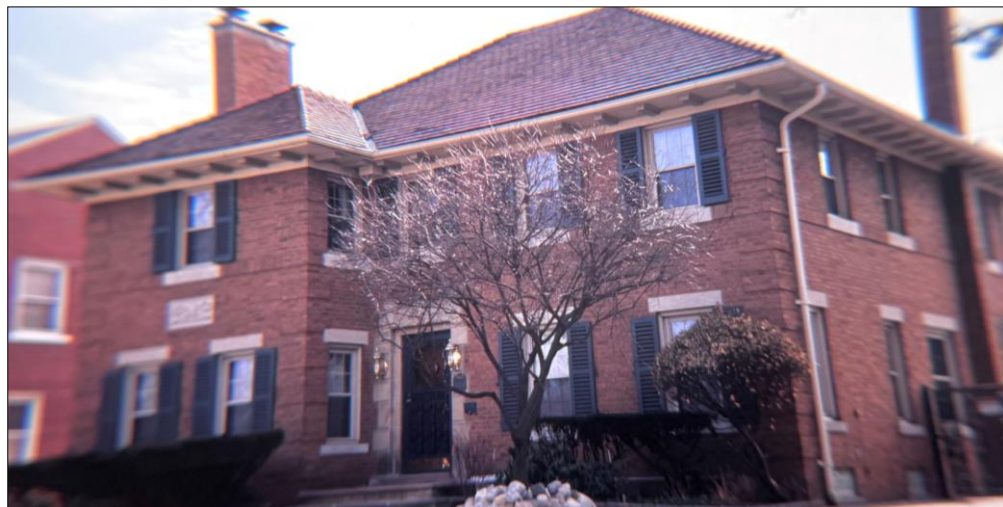
- The Oakman Boulevard Historic District was enacted on October 6, 1989.
- The building permit for the dwelling and garage were issued on September 11, 1929.

Left: BSEED permit card. Above: Designation photo, HDAB.

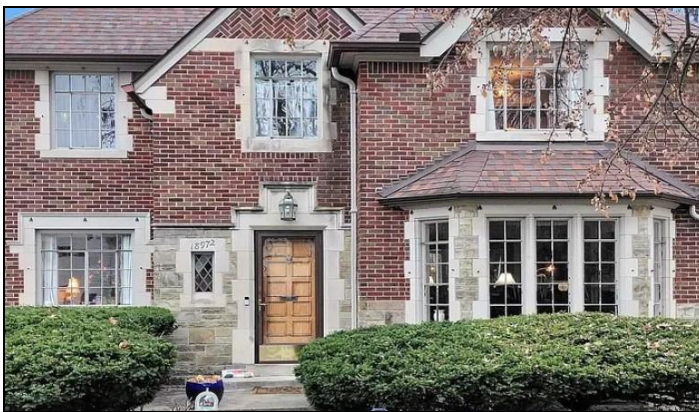
18972 Muirland

Before, Zillow photo.

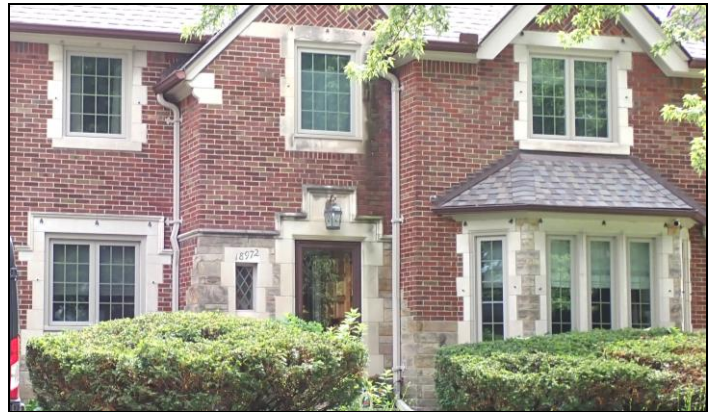
- Regarding the transparency of the selected SmartSun glass, staff isn’t clear on how transparent the selected product is relative to the Low E4 glass option. The applicant submitted completed projects from Detroit’s University District and Palmer Woods (not local historic districts), which he said had Fibrex windows with SmartSun glass installed. The examples offer different effects of transparency. Muirland appears to be a compatible option, while Wellsley, with dark brown frames/grilles (vs. the other house’s brighter tan frames and grilles) does not. Staff has requested glass samples for the Commission’s review at the meeting.

After, applicant photo.

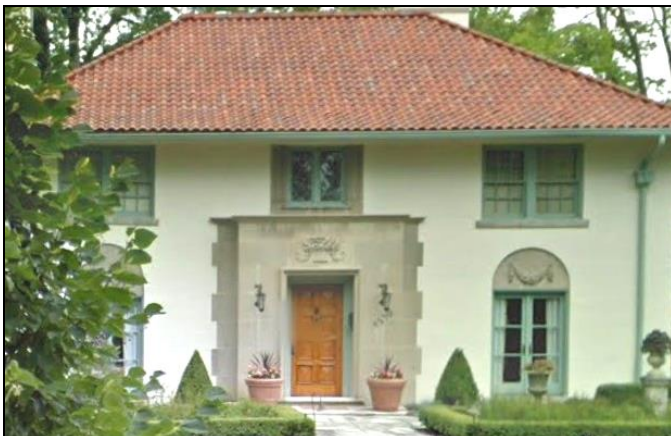
1530 Wellsley

Before, Google street view.

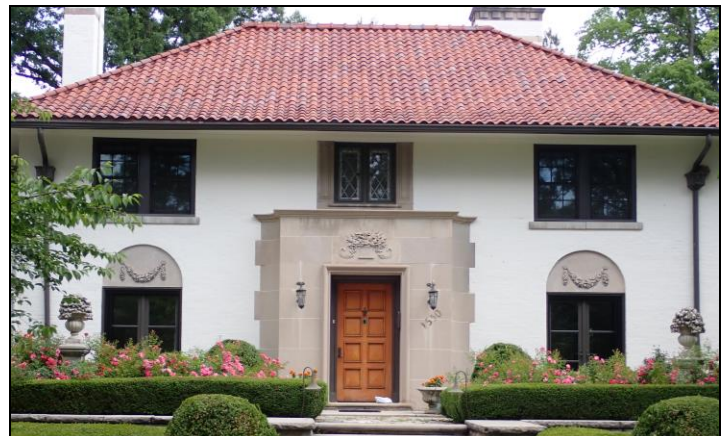
After, staff photo.
