STAFF REPORT: AUGUST 13, 2025 REGULAR MEETING

APPLICATION NUMBER: HDC2025-00418

ADDRESS: 1485 BURNS AVENUE

SCOPE: REPLACE STORM WINDOW WITH VINYL CASEMENT WINDOW

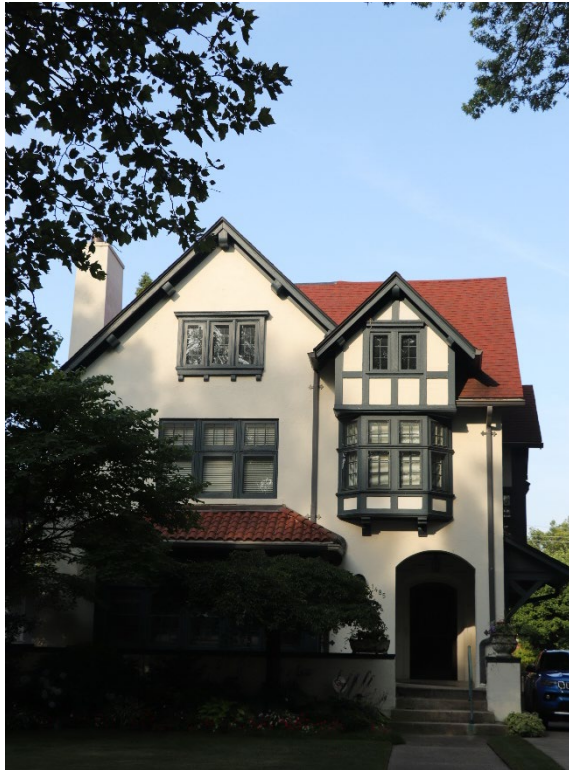
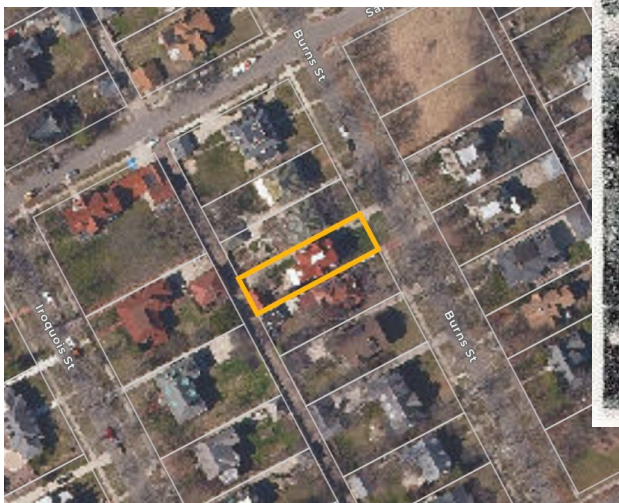
*Photo taken by staff on 07/24/2025 (Above)
Detroit Parcel Viewer (Below)*

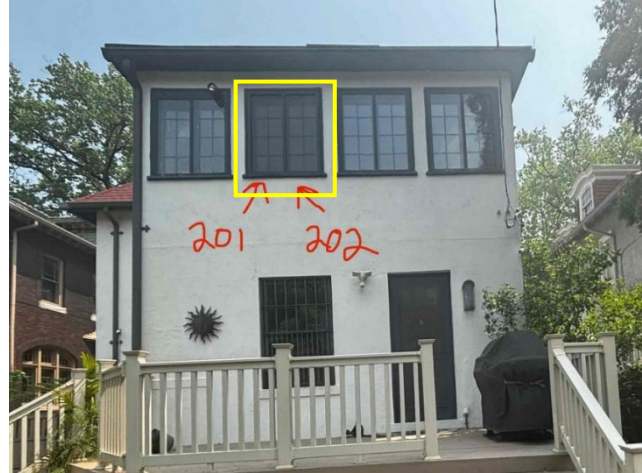
Submitted by applicant, image shows 1485 Burns rear view with second floor windows (highlighted window which is being proposed for alteration)

1. Replace the one (1) aluminum storm window with vinyl casement window on the rear side of the house
2. Paint the window trim black to match existing adjacent windows
