STAFF REPORT: SEPTEMBER 10, 2025 MEETING

APPLICATION NUMBER: HDC2025-00402

ADDRESS: 2975 OAKMAN COURT

SCOPE: REPLACE CONCRETE TILE ROOF WITH DIMENSIONAL ASPHALT SHINGLES

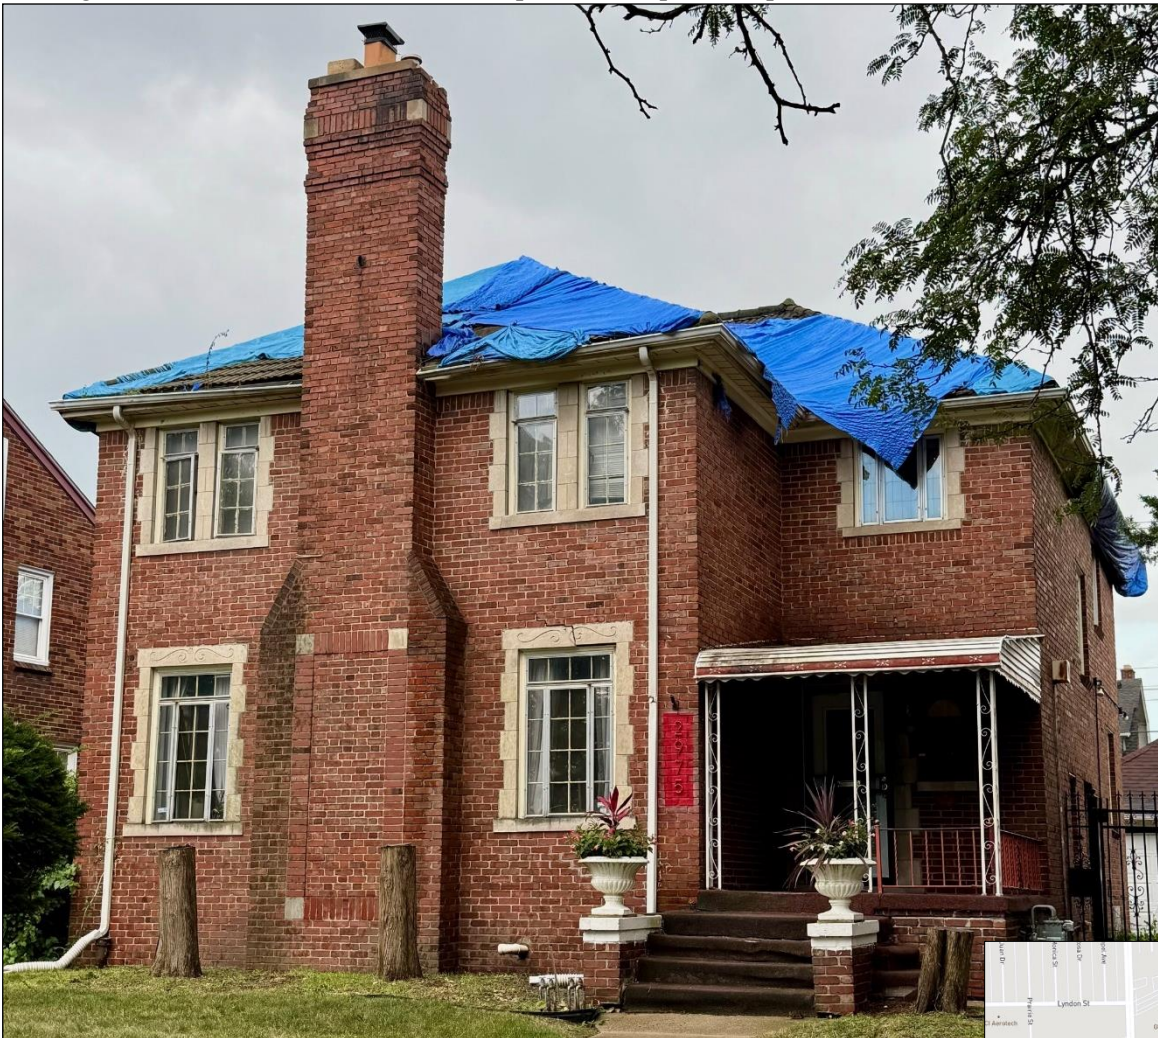
The property is located on Oakman Court, a street that extends from Oakman Boulevard at the eastern end of the Oakman Boulevard Historic District. The two-story house is clad with red brick, and the hip roof is covered with concrete tiles. The steel casement, multi-operational windows are prominently featured by contrasting stone trim and mullions. The quoining pattern on the side of the windows offers a colonial revival detail, but the overall massing, shallow-pitched roof and minimal decorative adornments create a distinctly modern, 20th century design. Dimensionality of the façade was created by the centrally placed chimney with brick and stone detailing, as well as a partially recessed front wall to the west that created a space for a raised porch/front entrance that is currently covered by an aluminum awning. A historic-age railing remains in place at the perimeter of the porch, and brick wing walls with concrete or cast-stone tops flank the porch steps.

Above: Façade. HDC staff photo, August 26, 2025.

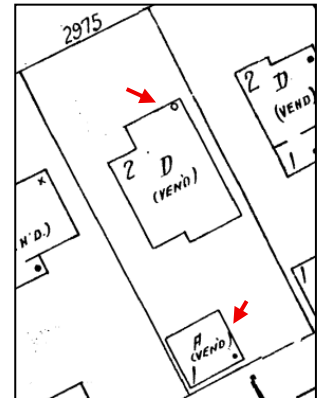
Ca. 1990s Sanborn map

- The Oakman Boulevard Historic District was enacted on October 6, 1989.
- The symbols on the circa 1997 Sanborn map, only a few years after district designation, identify a non-combustible roofing material, i.e., the concrete tiles, on the house (small circle), and a composite material (black dot) on the garage.

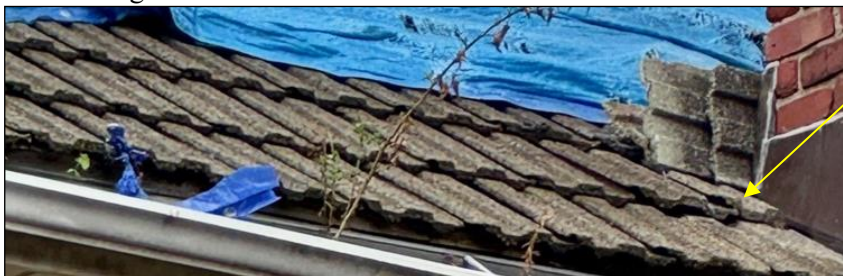
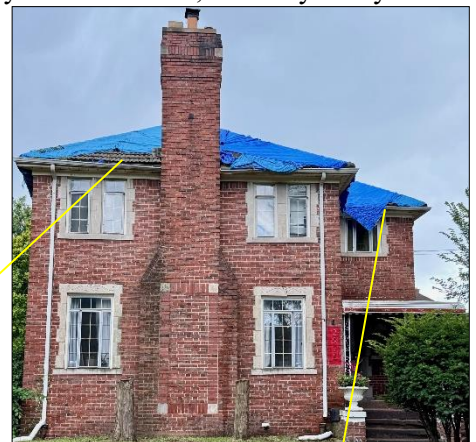
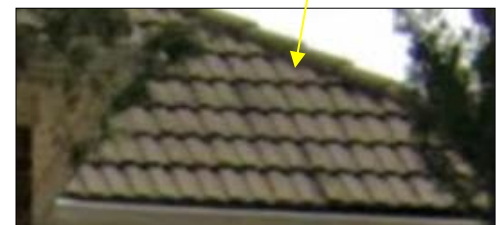
- The shallow pitch and the elongated hip roof parallelling the length of the lot only allows for the front plane of the roof to be highly visible from the public right-of-way. Currently, the roof is covered with a blue tarp, so the photos below offer the best views of the existing tile.

Above: Staff photo, August 2025. Right: Google street view, August 2018. These photos demonstrate the horizontal line of each row of shingles is dominant due to the depth of the product and its associated shadow line; whereas the vertical lines are secondary in their visibility. It is these features to keep in mind when comparing replacement roofing materials.

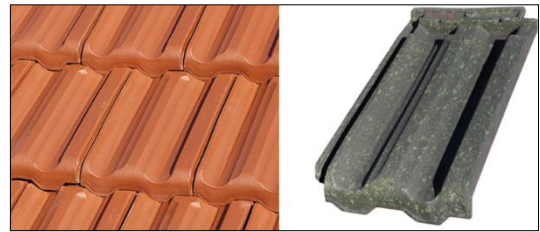
- The dimensional qualities - depth and shadow lines – will be almost identical to the concrete tiles, and French tile would be the compatible match. However, within the estimate the pattern of clay tile was not identified and staff doesn’t know if there is a significant price different between clay tile options (barrel, shingle, slate, French, etc.). Staff will ask the applicant to confirm this detail prior to the meeting.

Photo French tiles copied from ludowici.com.

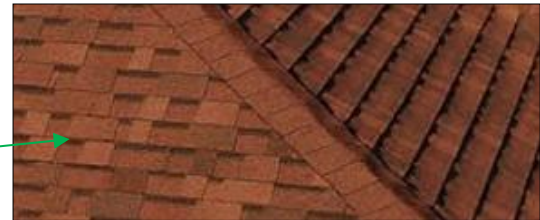
- Dimensional asphalt shingles only offer an illusion of depth, based on different patterns/perimeter shapes of the shingles and applied shading. The side view of the proposed shingles creates a strong horizontal shadow line. The front view, however, due to irregular dimensional shapes of the shingles and sprayed on shadow lines, disrupt a consistent horizontal line and does not create any regularity of a vertical pattern.

Photo of Duration shingles, terra cotta, from Owens Corning website. Proposed product.

- When viewing the shingles straight on, the irregular dimensional shapes of the shingles and sprayed shadow lines disrupt a consistent horizontal line and does not create any regularity of a vertical pattern.

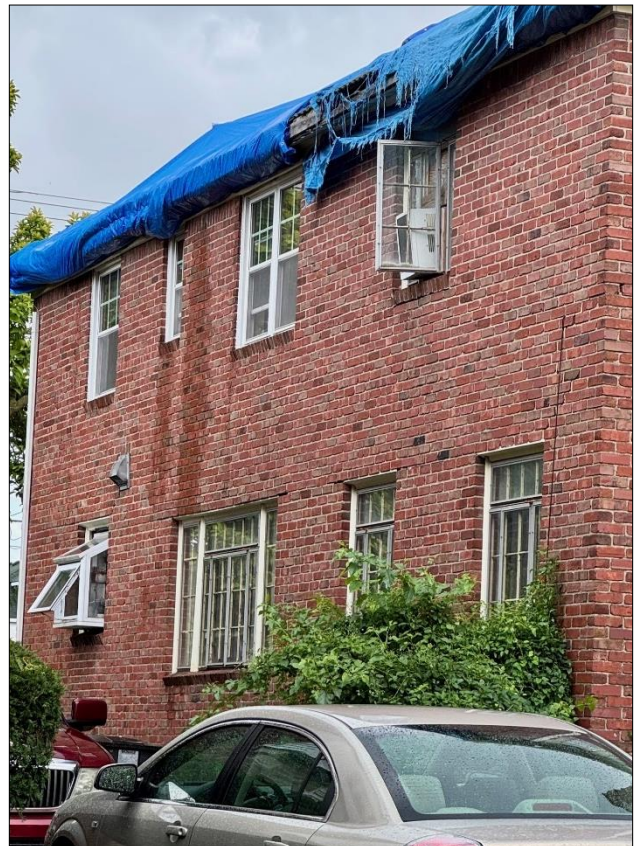
During staff's August 2025 site visit for the roof application, vinyl windows on the side/east wall were identified.

- Staff reviewed the Commission's electronic and paper files. It appears Hansons installed vinyl windows on the side and rear of the house in 2002 without Commission approval. Hansons put forth an application for the work; the Commission denied the vinyl window installation at its May 2002 meeting.

- No further reviews by the Commission of the vinyl windows were found, so the current vinyl windows (which appear to be different in design/operation than those discussed in 2002) remain a violation on the property.

Staff photo of east side wall where vinyl windows are visible from the sidewalk. August 2025.

- On Friday, August 29, staff emailed the current applicant/property owner (who was the owner of the property in 2002) alerting them to the outstanding violation and extended the offer to include these windows on their current application. Staff also mentioned the vinyl windows remain a violation and are subject to enforcement.
