STAFF REPORT: 09/10/2025 REGULAR MEETING

APPLICATION NUMBER: HDC2025-00547

ADDRESS: 3751 LESLIE

SCOPE: REPLACE STEEL WINDOWS WITH ALUMINUM-CLAD WINDOWS, REPLACE FRONT DOOR (WORK COMPLETED WITHOUT APPROVAL)

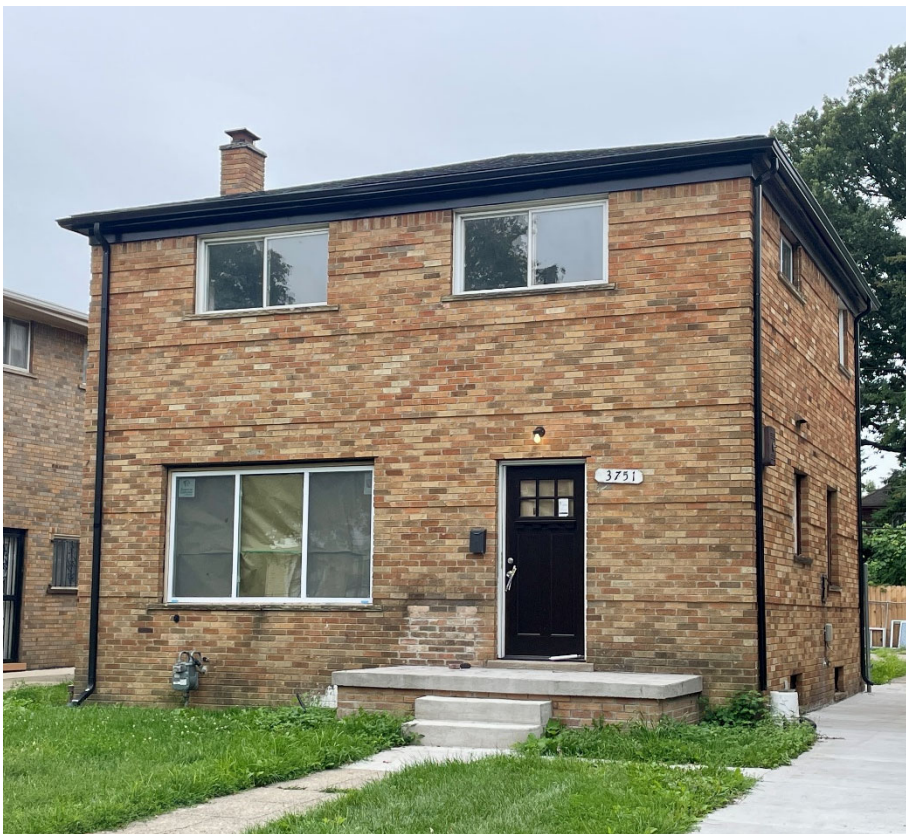
Staff photo, 08/28/2025

The installation of the front façade replacement vinyl windows and front door were installed without the approval of the Historic District Commission, which has impacted the property's historic character.

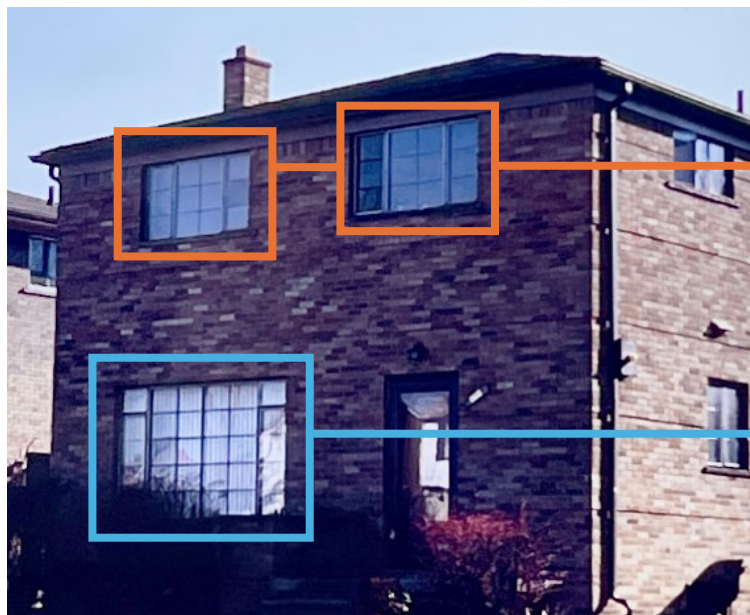
Designation photo by HDAB, 1999

- The three (3) historic steel windows that were removed and replaced with vinyl windows were unambiguously character-defining as they were steel casement windows, and as described in the Elements of Design that “houses built later in the period of development sometimes have individual windows which are balanced or somewhat wider than tall; such a window is often the main opening of the first floor front façade.”

- Staff considers the historic steel windows to be distinctive, character-defining features.
 - Steel casement windows were a popular material for window frames in the early 20th century. Their thin frames allowed for more expansive glass surface, creating a striking visual contrast to the monolithic materiality of masonry-clad walls. Additionally, the multi-operational window openings are a design feature found in only a few local historic districts. These features are identified within the Russell Woods-Sullivan Historic District's Elements of Design (emphasis by staff):

- As the windows were removed without HDC approval, the scope of work that would meet the requirements of the historic ordinance (Section 21-2-59(e)), is the fabrication and installation of new steel-framed windows with an identical pattern and operation with dimensions that match the historic windows.

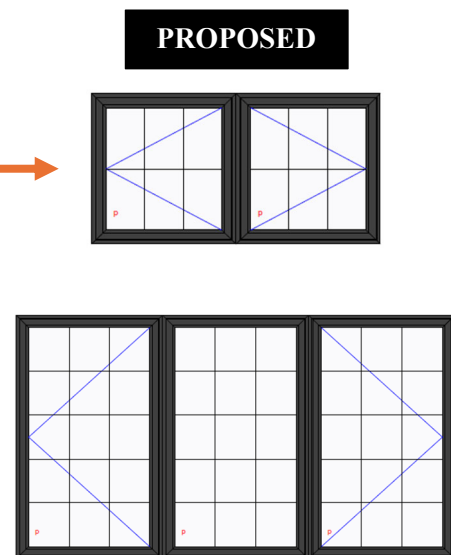
Aluminum-clad wood windows in black with 7/8" simulated divided lite bars

- The current application proposes installing aluminum-clad wood windows. Staff notes that, as the vinyl windows were installed without approval, **the Commission's review is to determine if the removal of the distinctive-character defining steel and installation of aluminum-clad wood windows meets the Standards; this application is not for the comparison of vinyl windows to aluminum-clad windows.**

- Due to the difference in strength of steel and wood, the dimensions of the aluminum-clad wood frames and muntins/grilles will likely not match the thinness of the historic width and profile of the steel window frames, muntins, and mullions.

Recommendation 1 of 2 – Denial – Replace historic steel windows with aluminum-clad wood windows

- The historic steel windows were distinctive, character-defining features and not proven to be beyond repair.
- The proposed windows are not in-kind matches to the historic windows at this property, required to restore the pre-violation condition.

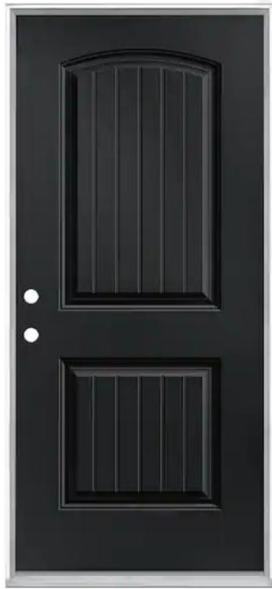
Masonite Cheyenne 2-Panel Painted Smooth Fiberglass Entry Door in Jet Black

- It is staff's opinion that the proposed front door is inappropriate, especially given its reference to earlier style doors with the multi-panel style and faux-beadboard pattern.
- Staff considers the front door a key feature of the dwelling's façade, especially considering the Art Moderne design and the clean simplicity of the International style with this house.
 - Mid-century era doors often featured clean lines, simplistic designs, and sometimes asymmetry and/or window cutouts.
- During field observations for the Russell Woods-Sullivan Historic District, staff identified houses of a similar architectural style with historic front doors.

- Architectural features/elements copied from incompatible ornamental styles (like the proposed door) are not appropriate here, and create a false sense of historic development, in direct contradiction to the NPS's Standards for Rehabilitation, Standard #3.

Recommendation 2 of 2 – Certificate of Appropriateness – Replace front door

- A new design for the replacement door shall be selected and submitted to staff for review and approval.

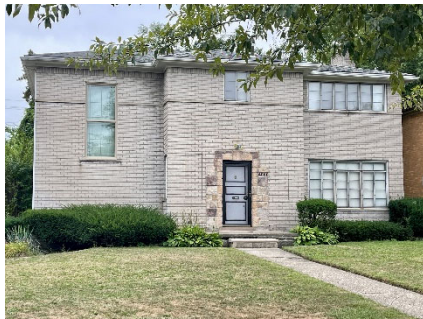
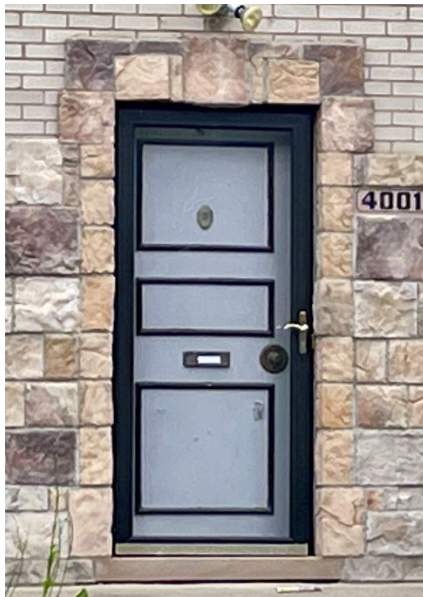
4001 Leslie, built 1954

Staff photos of nearby houses to the subject property, 08/28/2025
