**STAFF REPORT: OCTOBER 8, 2025 MEETING**

**APPLICATION NUMBER: HDC2025-00249**

**ADDRESS: 6325 W. JEFFERSON AVENUE, AKA FORT WAYNE**

**SCOPE: REPLACE HISTORIC FENCE, RENOVATE PRIMARY ENTRANCE, SITE IMPROVEMENTS, REPLACE PARK SIGN**

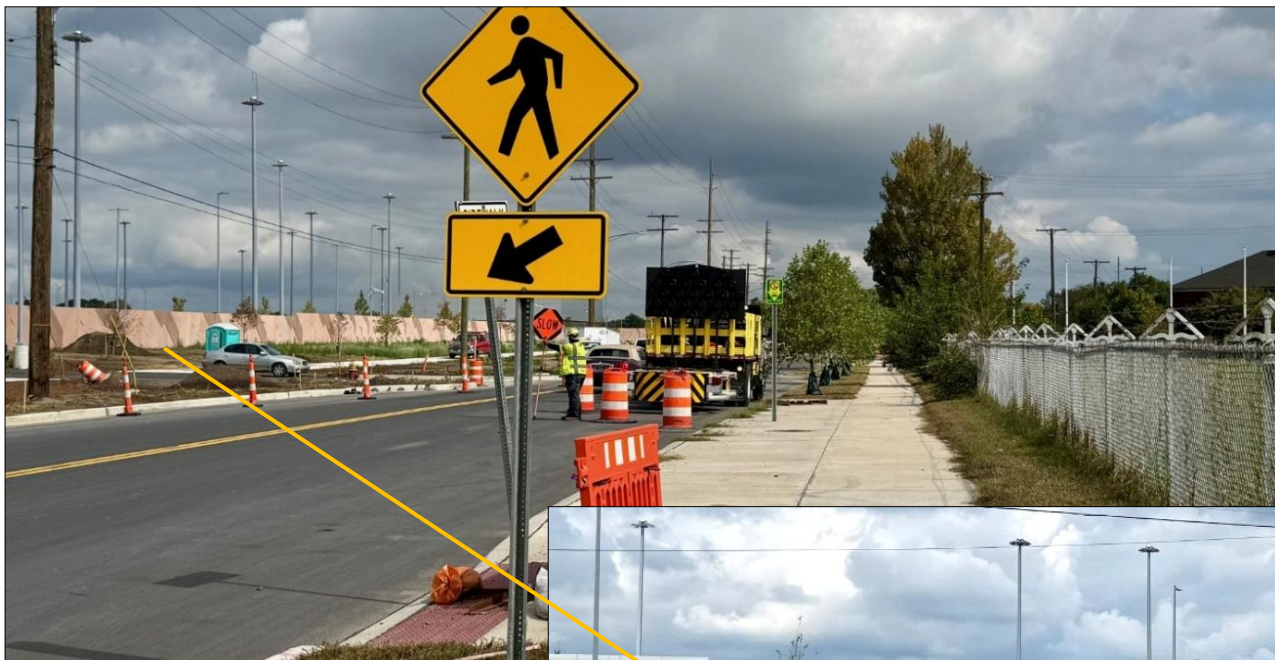
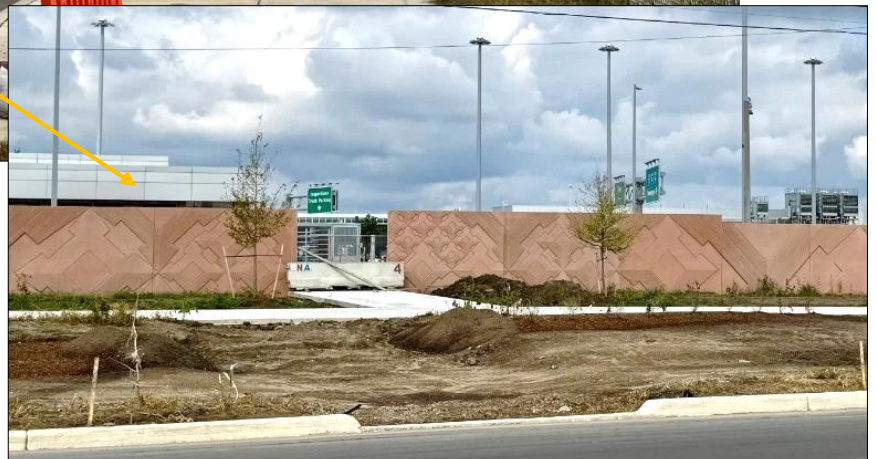
Bottom Left: Comparison of W. Jefferson site enclosures – newly constructed POE security wall on left; Fort Wayne's historic security fence on right.

Bottom Right: Full view of newly constructed security wall facing W. Jefferson and Fort Wayne. Staff photos, September 25, 2025.

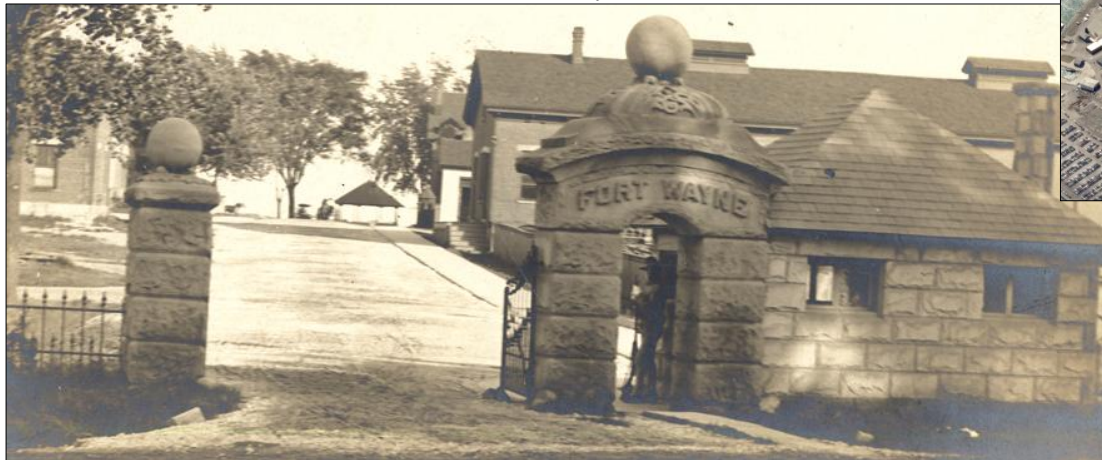
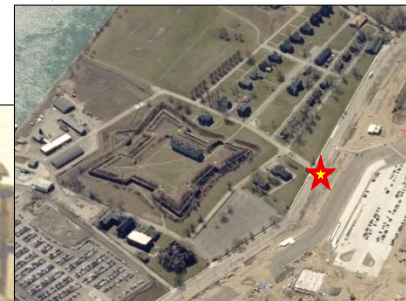
Above: Aerial view of W. Jefferson, looking southeast. Star identifies location of the fort's west entrance. ConnectExplorer image.

Undated, but likely early 1900s, photo (looking south from W. Jefferson) of Fort Wayne's west entrance at then-named Artillery Avenue (more commonly known as Livernois). Once inside the fort, this street is called Brady. At the time of this photo, this was not the primary entrance; the back of the photo states "Officers Gate". The stone building on the right is a sentry house. Burton Collection

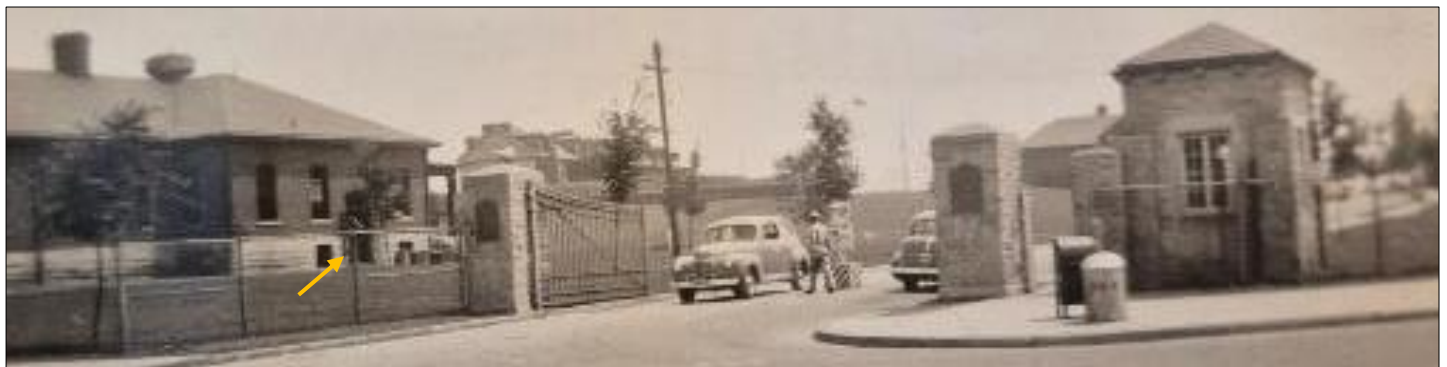
Early 1940s view of the same entrance, now the primary entrance, looking southeast from W. Jefferson. The gate/fence pillars and sentry office are of different designs, sizes, and stone material/pattern; however, the placement and physical relationship to each other and W. Jefferson remains essentially the same (single pillar on the east, two pillars on the west for pedestrian pass through which remains sitting forward of sentry structure). The roadway appears wider; however, this is due to the smaller sentry building and the filling of that space by the relocation of the pedestrian passageway onto the sidewalk (in the earlier photo the pillars/pass through was in the road). Note the wrought iron gates and chain-link fence with barbed wire toppers. (arrow). Detroit Historical Society.

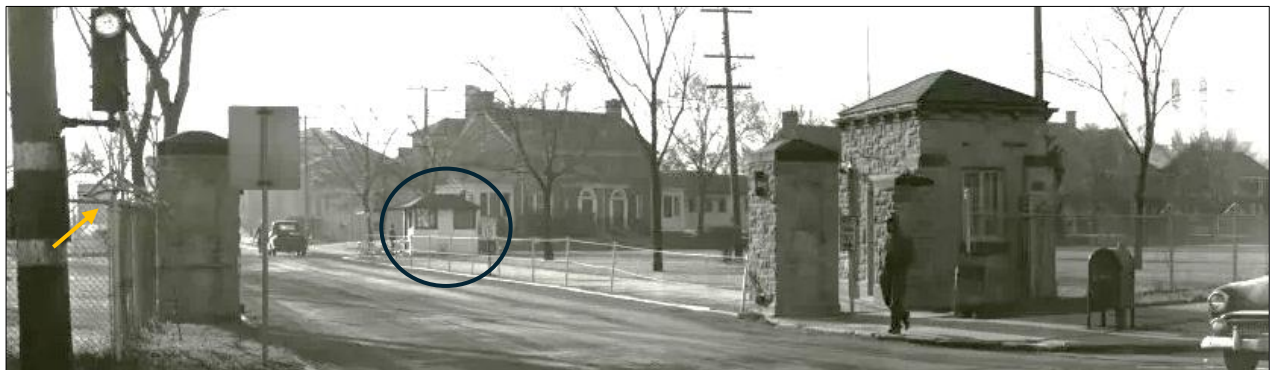
Ca. 1950 Artillery/Brady entrance at W. Jefferson looking southwest. The wrought iron gates are gone, and this photo offers another view of the chain link with barbed wire toppers. A small guard house is now located at the northwest corner of Brady and Meigs and is visible near the center of the photo. The general size, massing, and design of this guard house has been used in the subsequent guard houses erected in the 1970s and 1990s; a similar design for the proposed new guard house is included in this application.

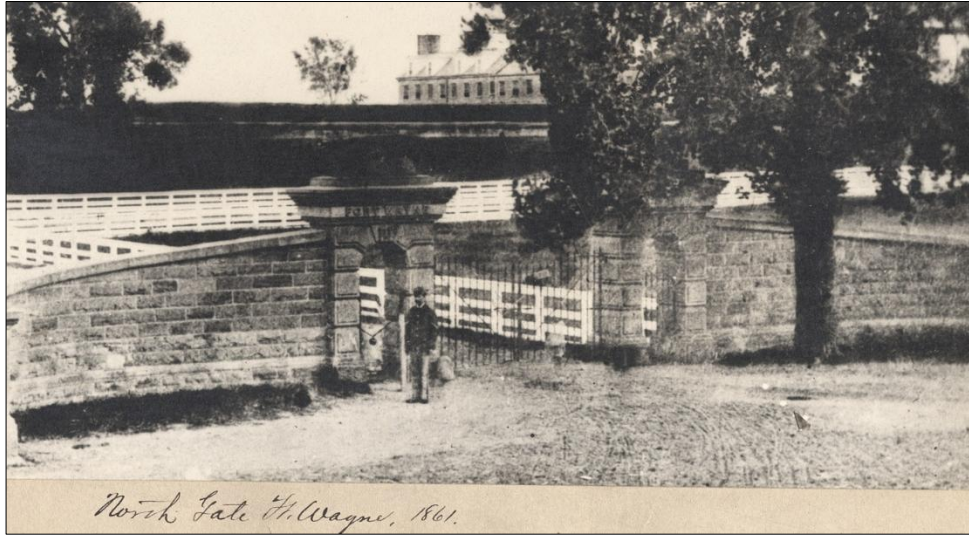
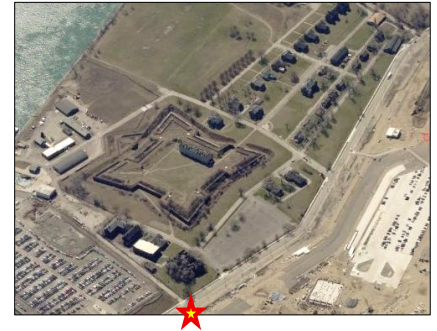
Above: Aerial view of W. Jefferson, looking southeast. Star identifies location of the fort's east entrance. ConnectExplorer image.

1861 photo of the east entrance which included two pedestrian entrances, a wrought iron gate enclosing the roadway, and gently sloping curved stone walls.

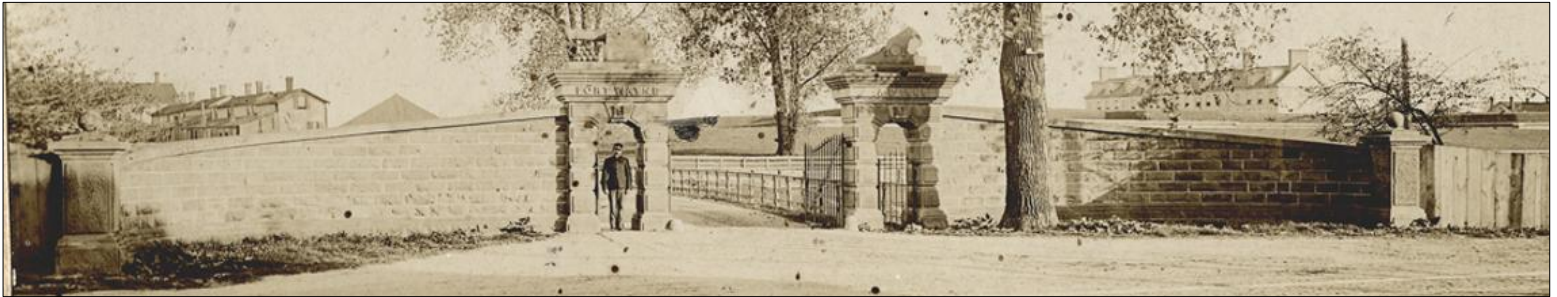
Undated photo, likely from the 1860s-1880s due to the army uniform and no buildings near this entrance (the first residential barracks at this entrance was erected in 1890). Taken from W. Jefferson looking south, this expanded view shows the full length of the stone walls, as well as a portion of a wood fence extending along W. Jefferson. A carved cannon is located on the top of each arched gated entrance (the small stone-arched entrances were identified on the back of the photo by the term "wicket").

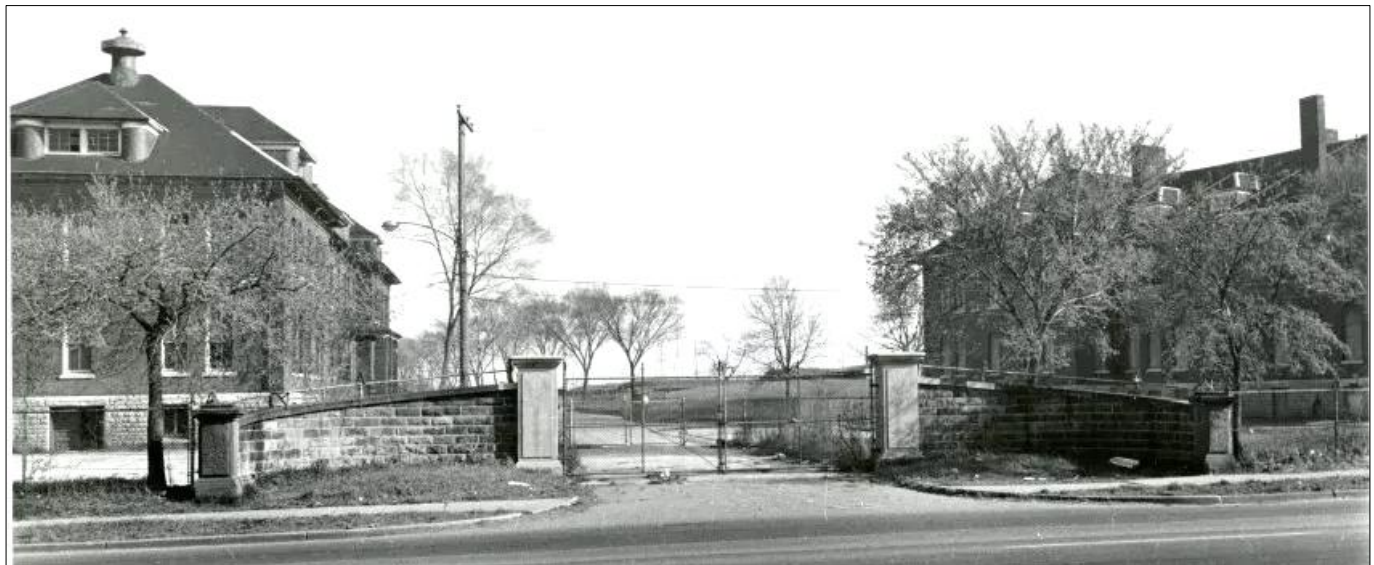
Ca. 1974 photo, with writing "Original main gate W. Jefferson". It is not clear when the "wickets" were removed and the single rectangular piers erected, nor if the cannons were relocated elsewhere on the property. The barracks building at right was demolished by the DHS a few years after this photo was taken for the establishment of a parking lot; the replacement of the parking lot lighting is part of this application. Detroit Historical Society.

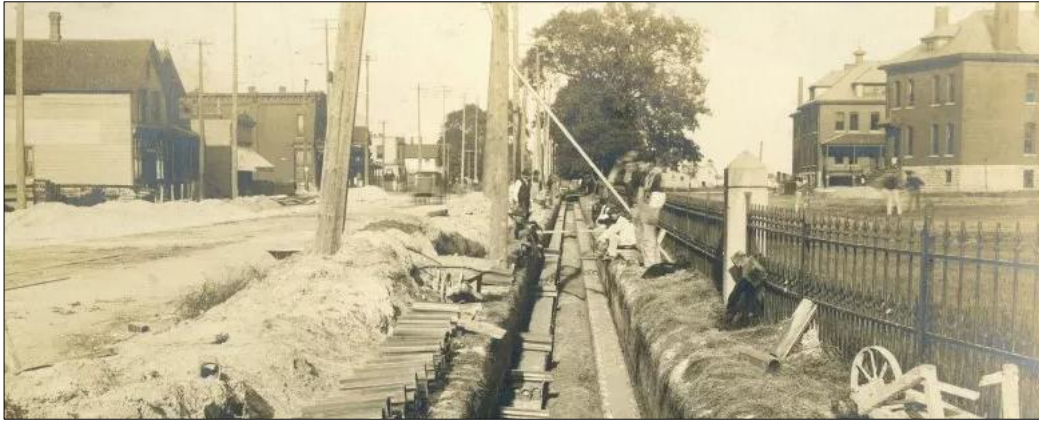
This 1898 photo is looking east down West Jefferson. A trench has been dug, and the street's first electrical conduit is being installed. The position of this picture is about half-way between the fort's east and west entrances. The wooden fence (visible in the 1861 photo of the east entrance) has been replaced with a wrought iron fence and obelisk-shaped concrete or stone posts. The two barracks buildings visible within the fort are on Cram, just south of the east entrance (both of which are shown in the 1974 image on the previous page).

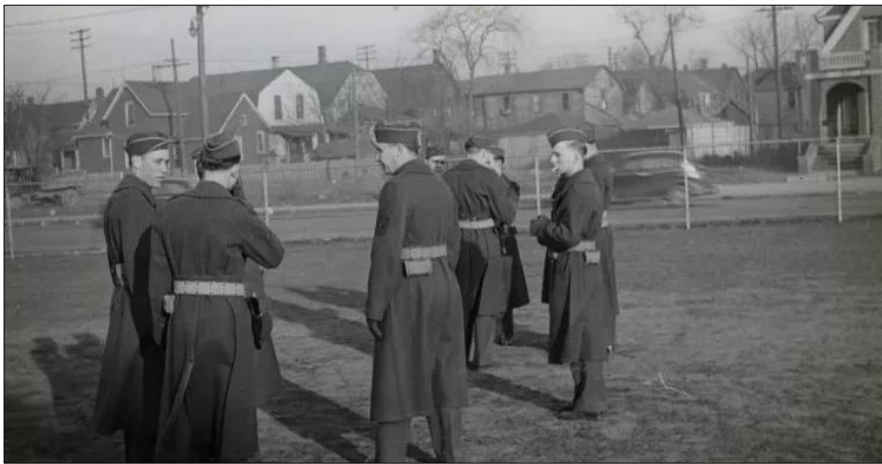
This 1941 photo of Army privates is taken from within the fort on the "Jefferson Field" and looks out towards the residential neighborhood to the north. Standard chain link fencing along W. Jefferson is now place. Detroit Historical Society.

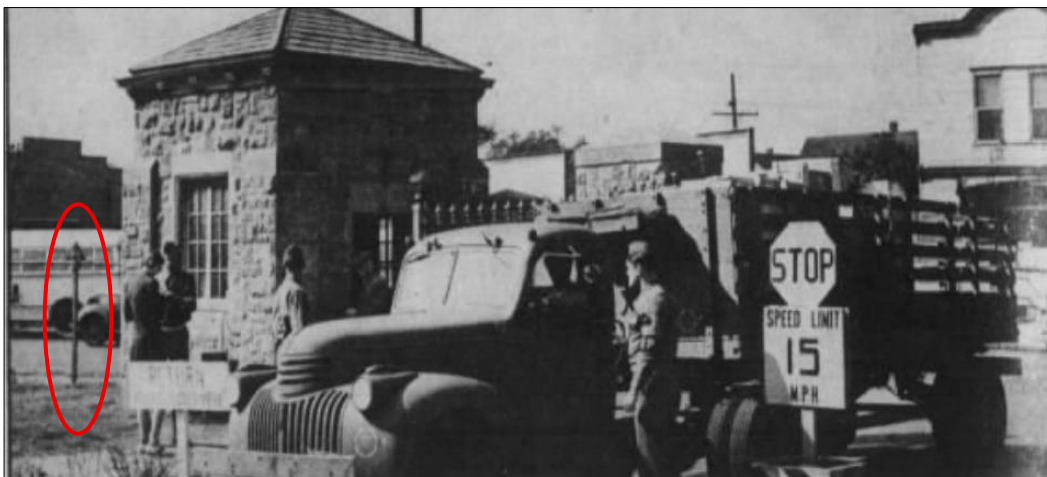
1943 interior fort photo of the primary "west" entrance looking (northwest) towards W. Jefferson. The chain link fence, visible to the left of the sentry structure now has thicker posts and "A"-shaped barbed wire toppers. Burton collection.

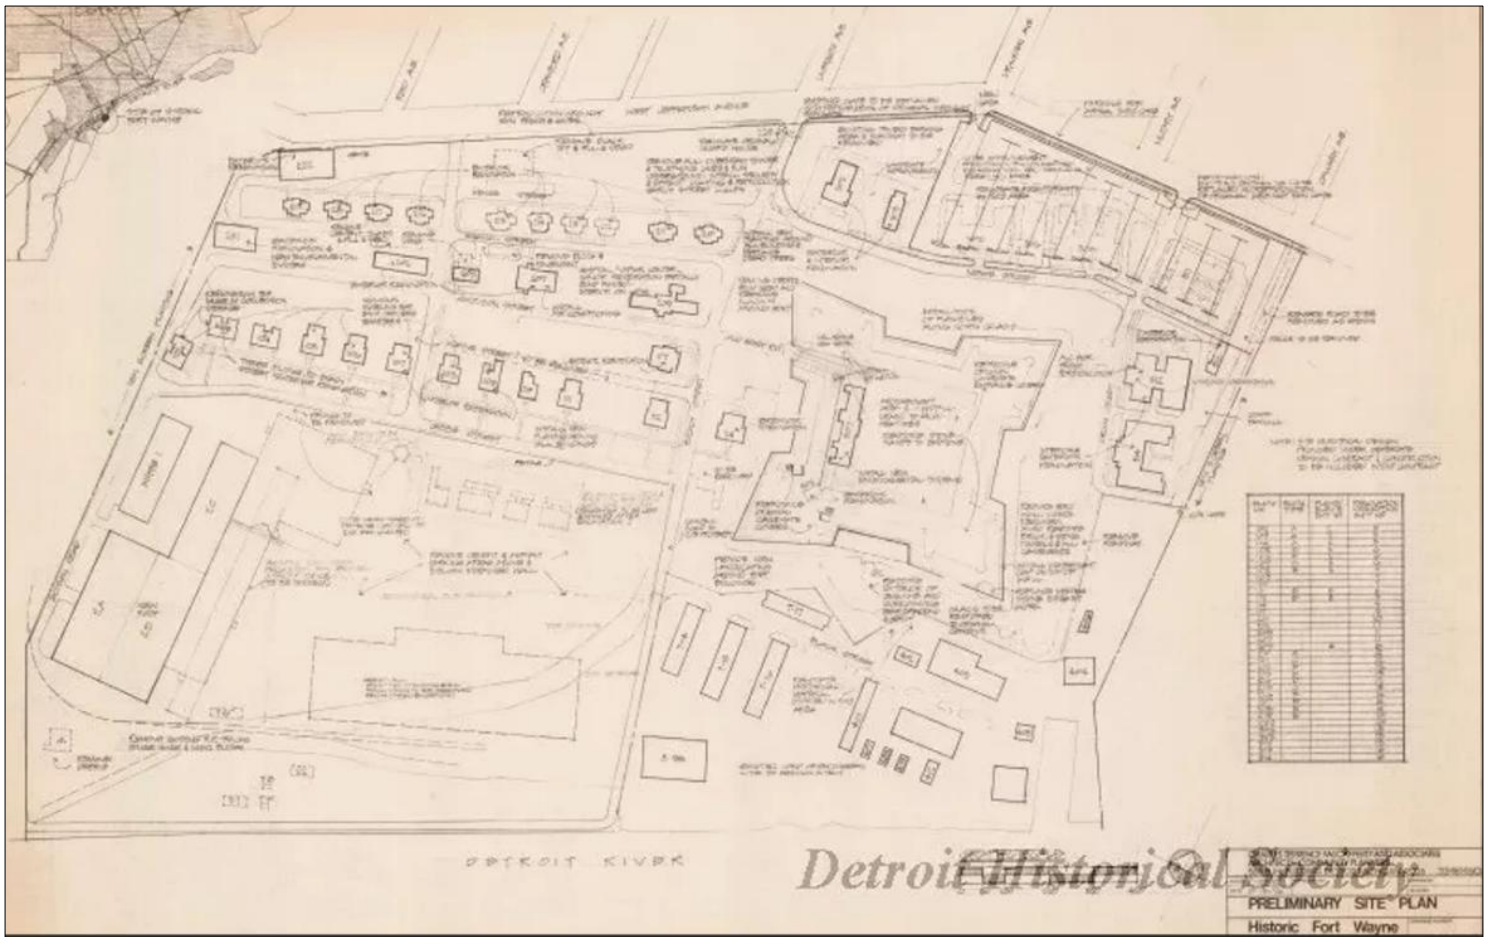
1974 site plan for renovation of site. Ghost lines of the demolished barracks at the northeast corner of the property buildings are visible within the parking lot; dotted lines of buildings in the southwestern quadrant of the site also denote demolished structures.

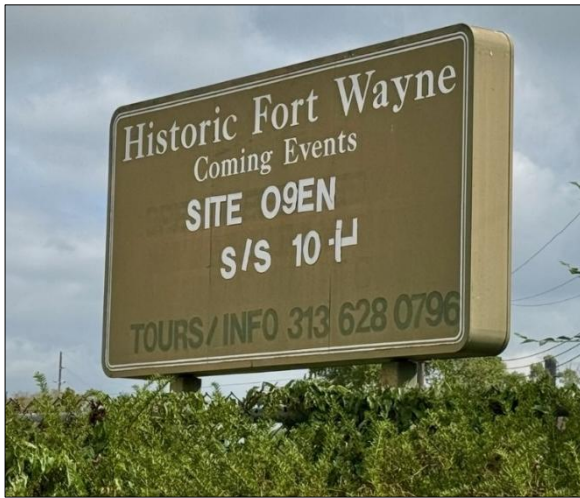
*Exterior sign facing W. Jefferson east of the main entrance. DHS has a copy of a “sign package” dimensioned drawing in which various types/sizes of signs, are shown). Staff photo, September 25, 2025.*

- The existing flag poles, flanking Brady Street will be removed. They are not historic age and were installed in the late 1970s-early 1980s.
- The existing entrance sign, installed ca. 1984, will be removed.
- The concrete drive and walkways will be replaced with new concrete drive and walkways.
- A new sign and set of three (3) flags will be located outside the entrance and perimeter fence.

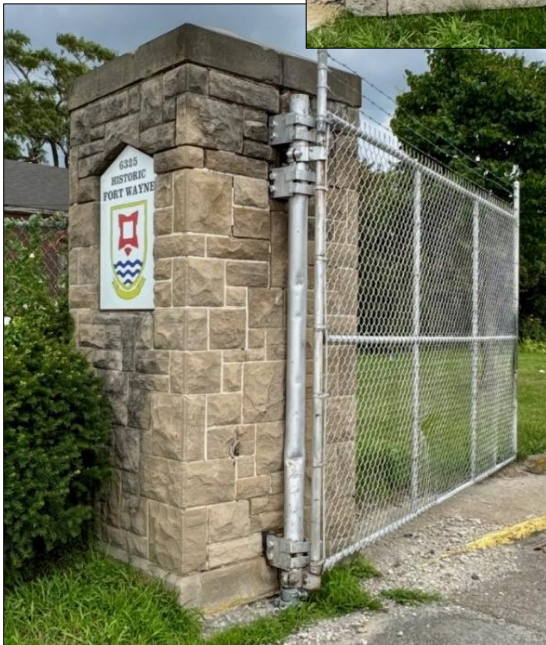
- Each pier has areas of missing mortar, cracked, dirty and/or stained stone. The applicant’s drawing, specifically Page A1.0, states the masonry cleaning and repointing of all failed masonry mortar joints will be consistent with the NPS briefs: “Cleaning and Water-repellent Treatments for Historic Masonry” and “Repointing Mortar Joints for Historic Masonry Buildings.”

*Staff photos, July 17, 2025.*

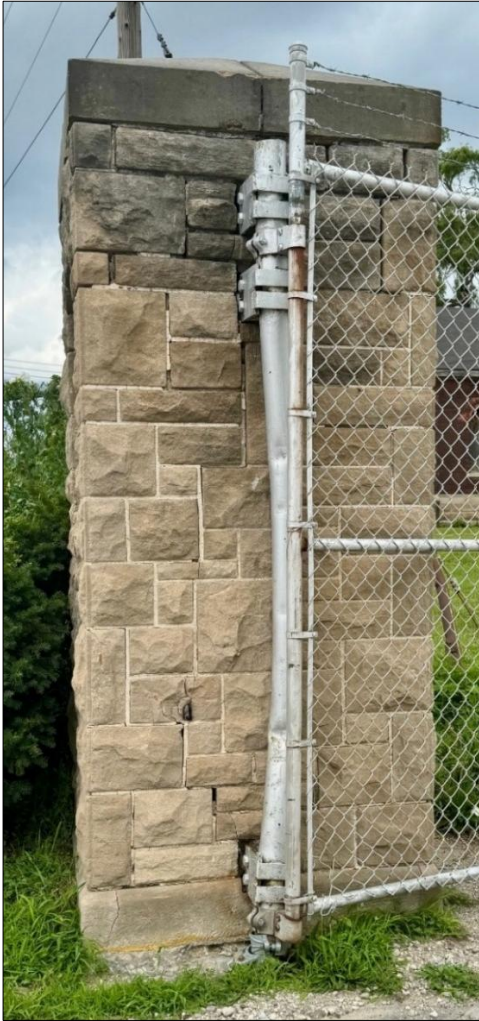
*Above: The entry gate piers and sentry house have areas of missing mortar, cracked and discolored stone, as well as existing holes used for the installation of the chain link gates. Staff photos, July 17, 2025.*

- The existing chain link gates are not historic age and can be replaced. The selected iron gates offer a compatible design, material and color for this primary entrance. However, an installation drawing for the proposed iron gates is needed to confirm that additional holes will not be created to hang the new gates.

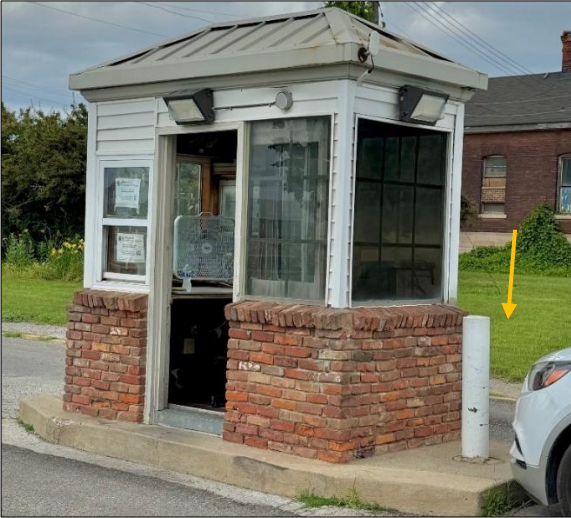
- The existing guard house, pictured below, was likely erected in the late 1990s or early 2000s as the location was moved to the center of Brady Street. The previous guard house had been placed in the lawn area, close to where the arrow is positioned. This guard house has no historic significance and can be replaced.
- The new guard house will be in the same location and will rest on a similarly designed/sized concrete pad with a bollard at the front and rear walls. Its design is similar to the existing structure - the brick base, mostly transparent glass upper walls and metal hip roof is a compatible, unadorned utilitarian design that will not visually conflict with the surrounding historic masonry structures.

Above left: Existing guard house. Staff photo, July 17, 2025.

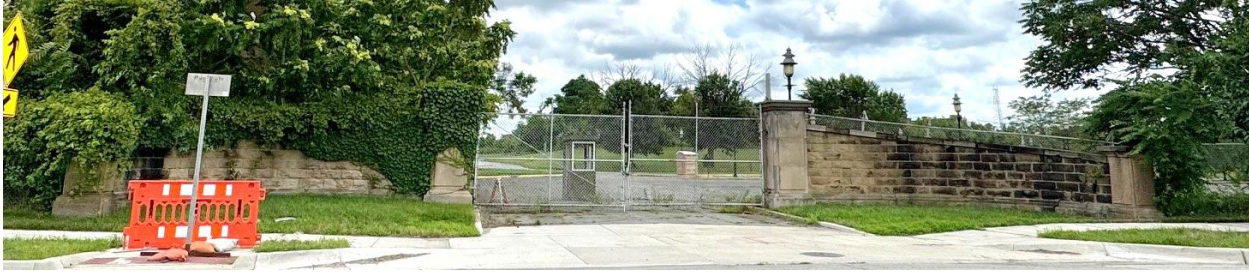
Staff photo, July 17, 2025.

- This is the most public-facing element that remains from the first phase of the fort's construction and was in place no later than 1861. The existing stone curved walls and lower piers remain intact; staff doesn't know when the original pedestrian passageways were replaced with the tall stone piers, but can confirm this took place during the property's period of significance and are historic elements. The walls and piers are in need of cleaning (both dirt and plant material) and re-pointing. The chain link fencing is in place atop the stone walls.
- The applicant included NPS Preservation Brief #1 "*Assessing Cleaning and Water-Repellent Treatments for Historic Masonry*" with their application materials, however the HDC's *Masonry Cleaning Guidelines* should be used as they offer specific instructions/review process for completing this work in a local historic district.

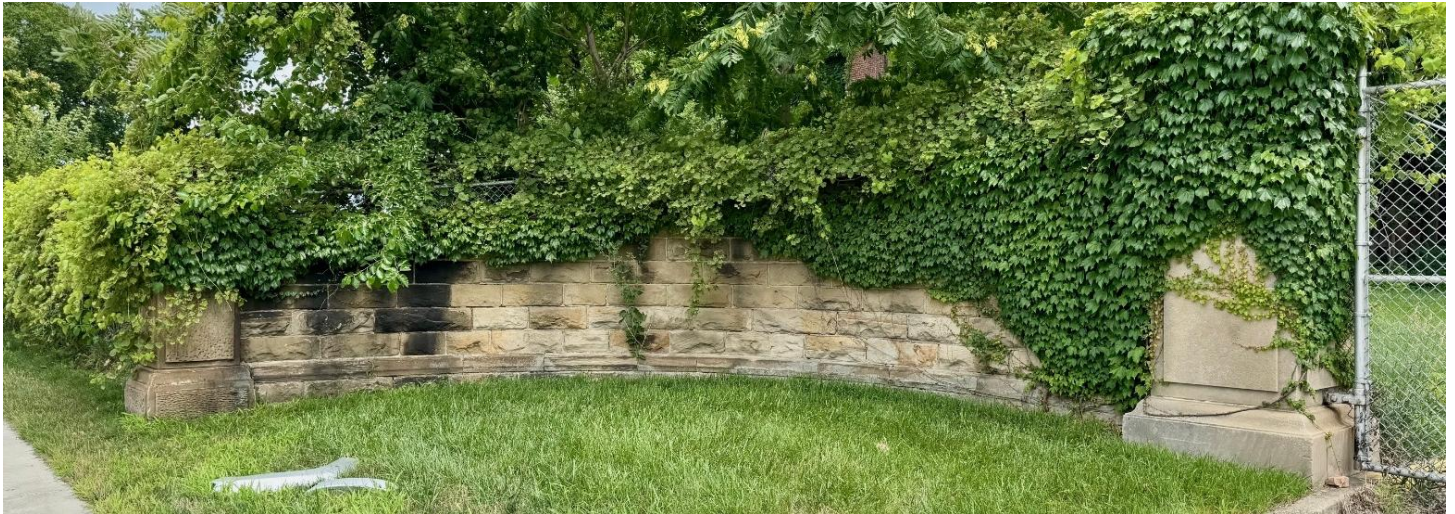
West side wall. Staff photo, July 17, 2025

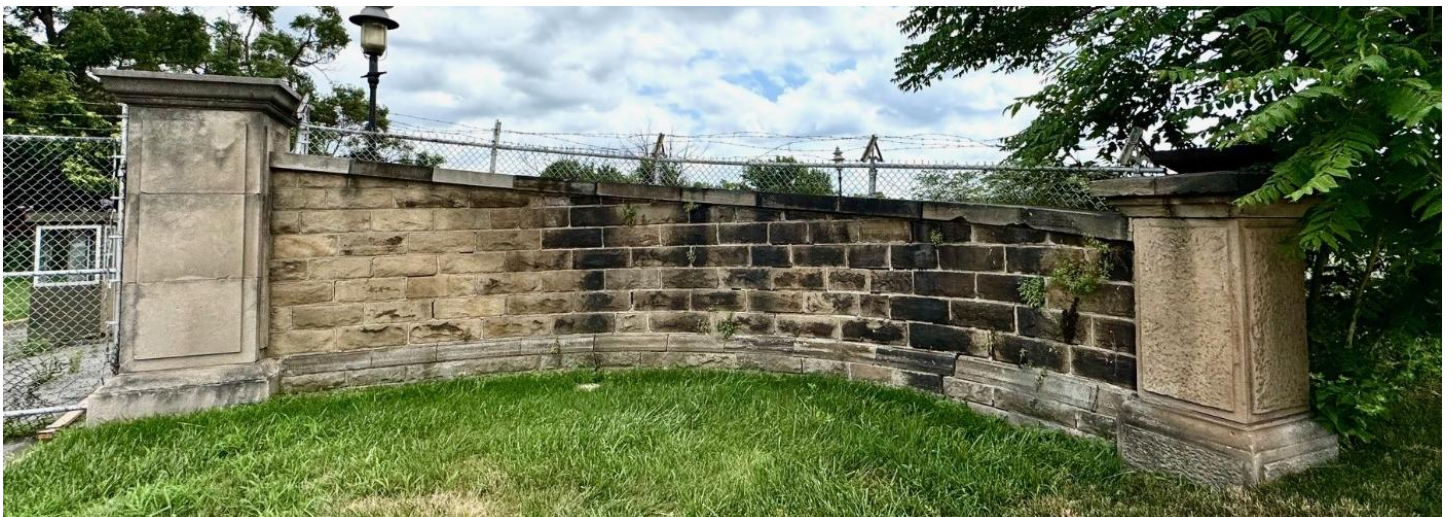
East side wall. Staff photo July, 17, 2025. This view clearly shows the different design and surface texture of the ca. 1860 pier (right) in contrast with the smooth surface texture of the taller pier (likely installed early 20<sup>th</sup> century, or when the chain link fence was installed on the stone wall).

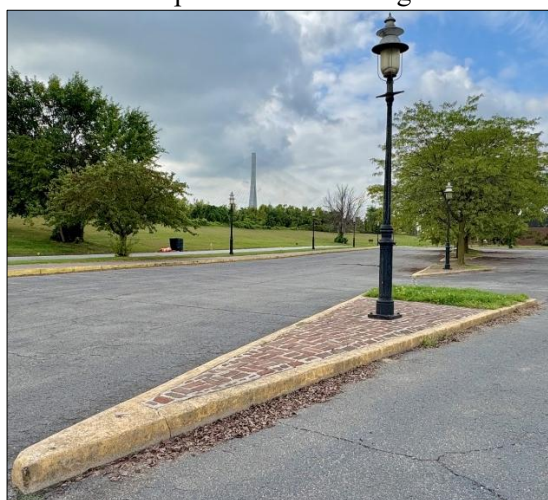
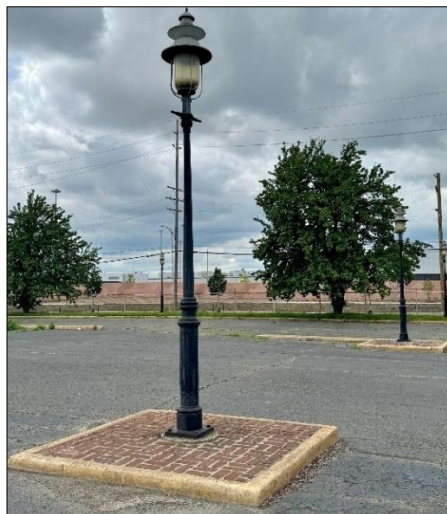
- Existing single pole/lamp parking light fixtures, a “historic” reproduction design, installed in the late 1970s, will be replaced. The existing concrete and masonry pads will remain.

*Left: Triangular concrete and masonry pads separating the parking lot (on right) and Meigs Street (on left).*

*Right: Square pads placed within the parking lot. These foundational items will remain – only the lamposts/lights will be replaced.*

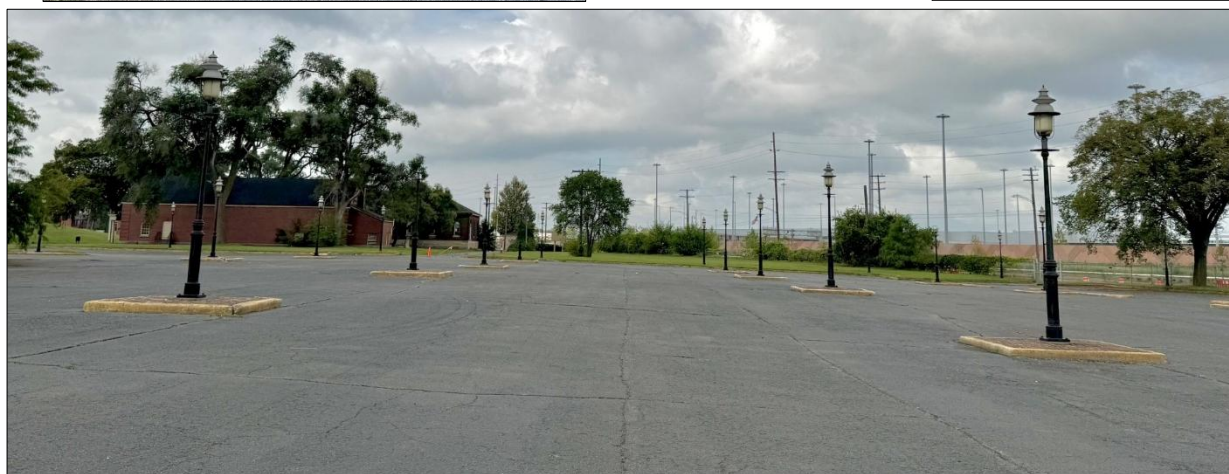
*View looking southwest of triangular islands, separating the parking lot (on right) from Meigs Street (on left)*

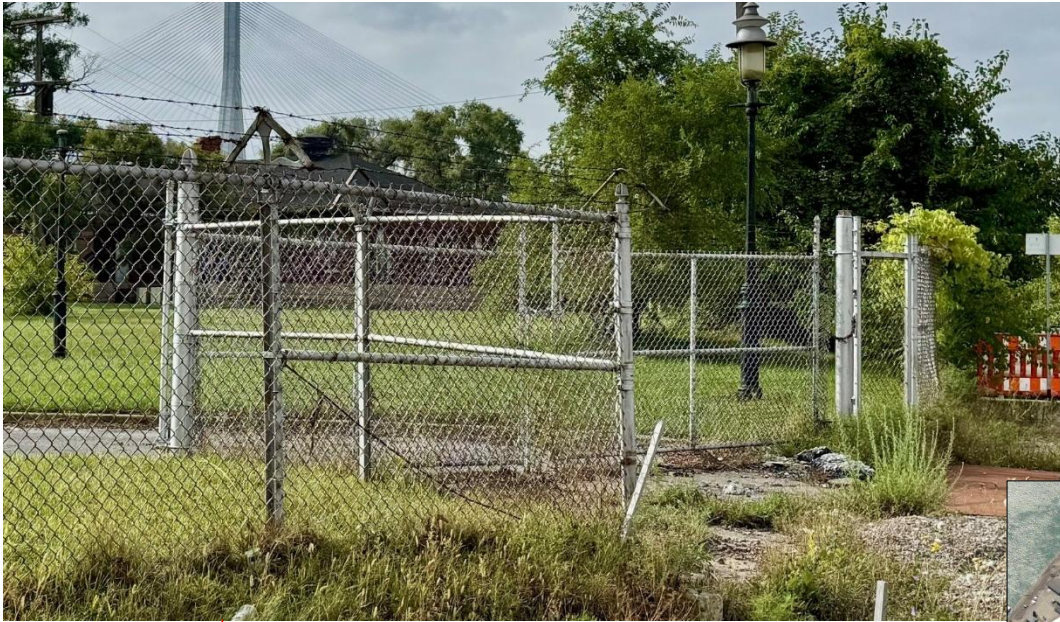
Parking lot gate ★

- Four gates are proposed for replacement in this application – the gates at the east and west entrances (2), one at the west entrance to the parking lot, and one at the west entrance to the “Jefferson Field” (the large grassy area that extends between Brady and Rademacher Street. The same aluminum “wrought iron” style gate, as discussed at the entrances, and to match the proposed new perimeter fence, is proposed.

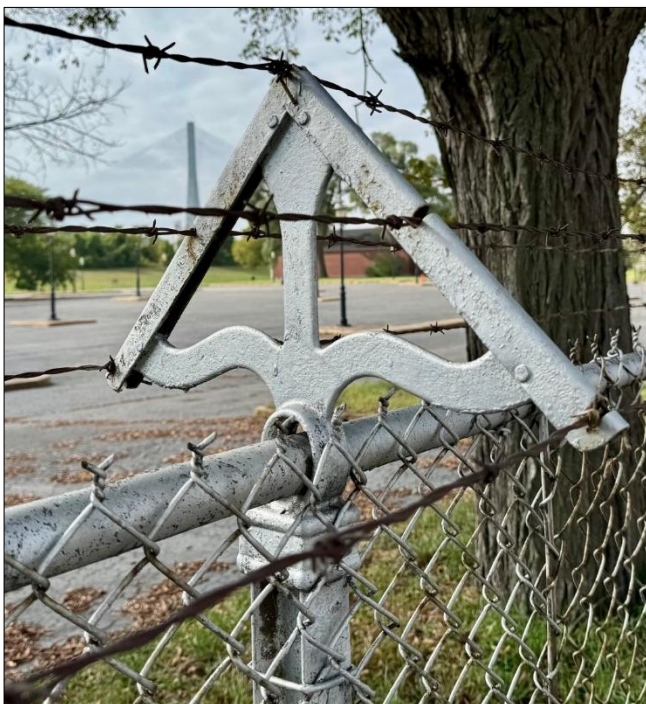
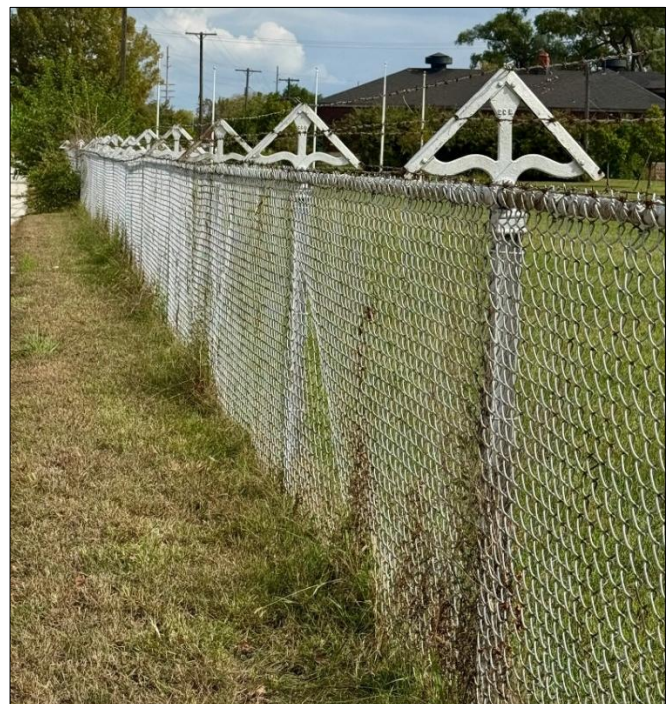
*The non-climbable fence at W. Jefferson Avenue. Staff photo, September 25, 2025.*

- The fence is in repairable condition and offers a striking contrast to the 19<sup>th</sup> century buildings, star fort, burial mound and the property's currently dominant quiet and contemplative sense of place. It is staff's opinion that the barbed wire can be removed without severely altering its integrity, as the "A"-shaped extensions offer the visual clue to the fence's design and security measure.

- The fence fabric (i.e., the chain link itself) is likely non-historic and a later replacement, and thus eligible for replacement.
- Additionally, there was some discussion during the creation of the MOA work plan that suggested painting the existing fence black. Staff believes this could be done without altering the fence's historic and architectural integrity.

### **Recommendation 1 of 2, Denial: Removal and replacement of the historic chain link fence; and gates at west parking lot and Jefferson Field**

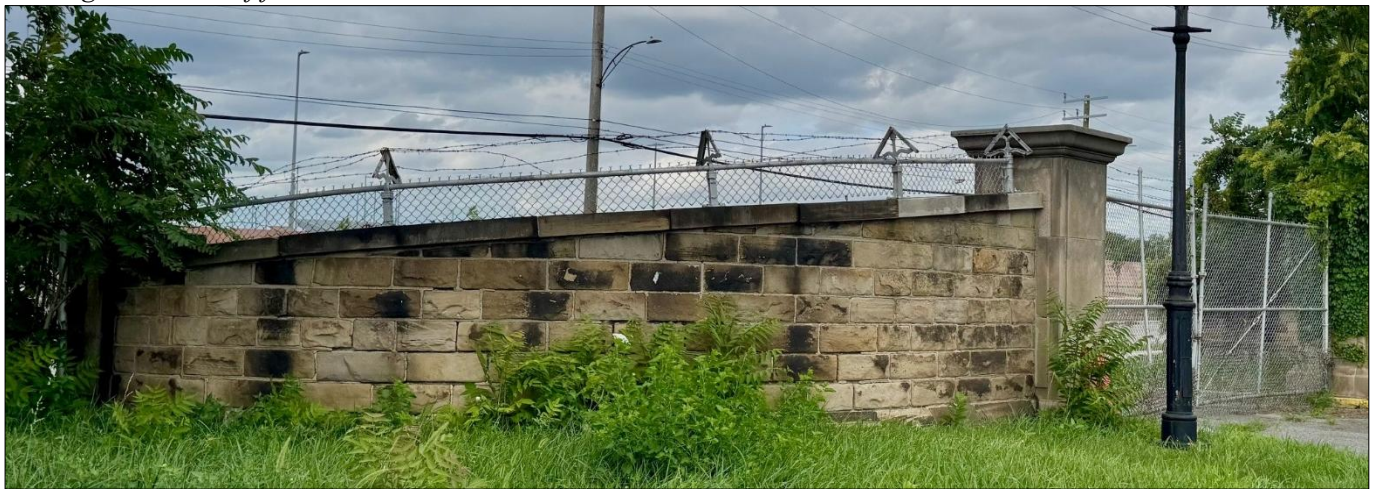
*Interior view (looking northeast towards W. Jefferson) of the 1860s entry walls shows how the non-climbable fence was installed on top of the stone walls at the east entry gate, and the existing chain link gate retains barbed wire at the top. Staff photo, July 17, 2025.*

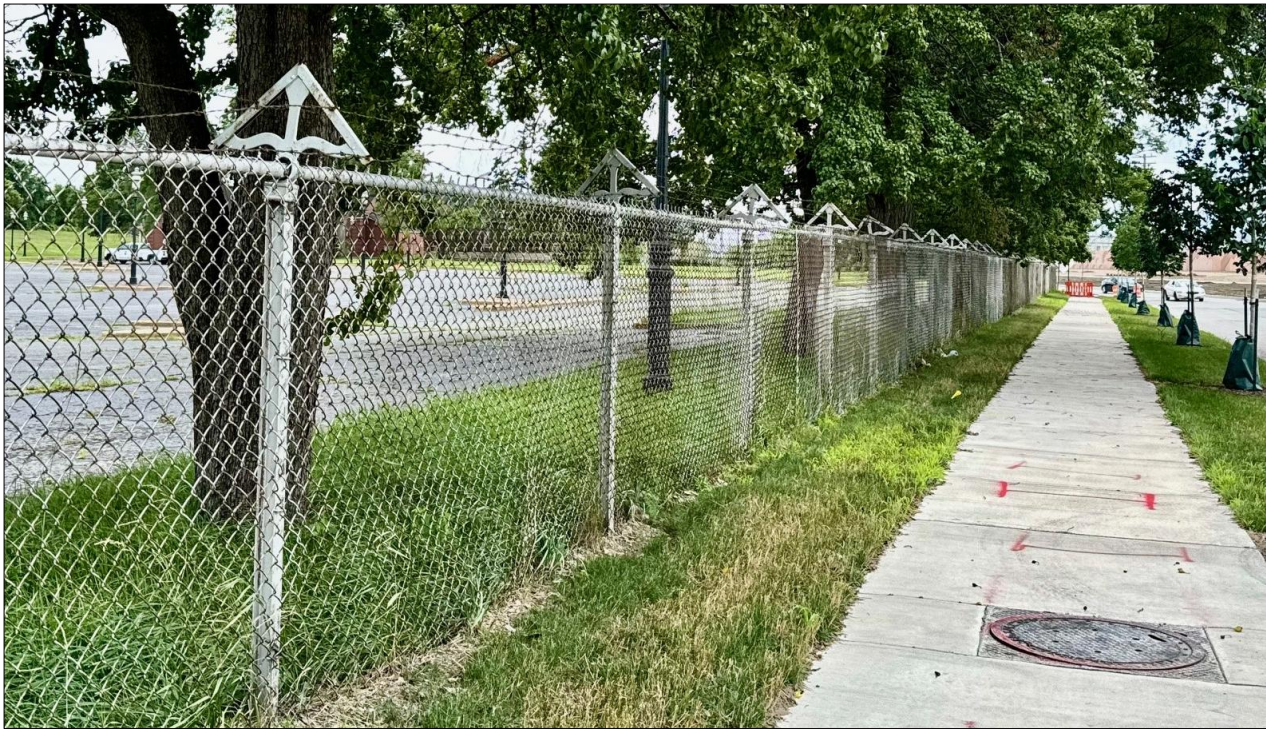
*Fence between Cram and Brady streets; the visitor parking lot is visible through the fence.*

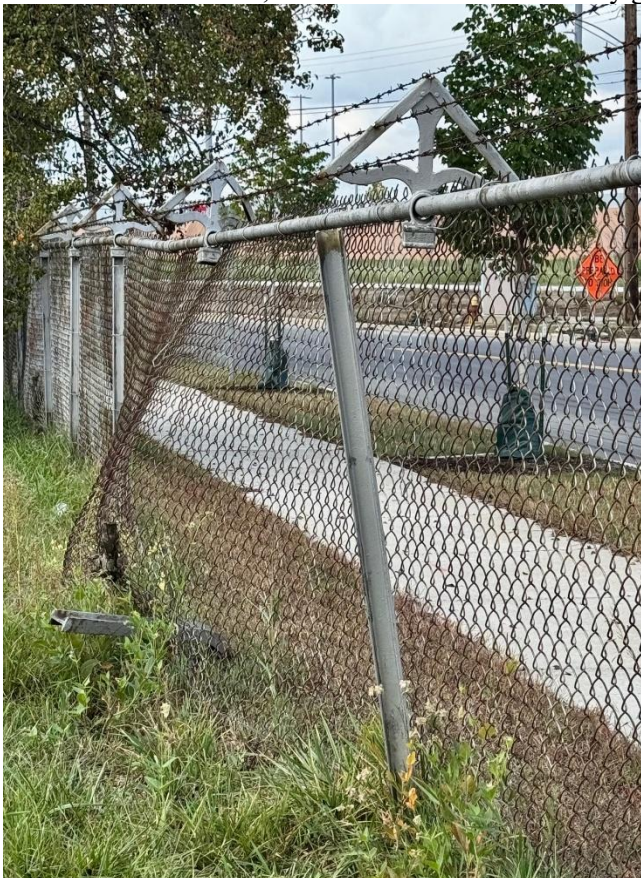
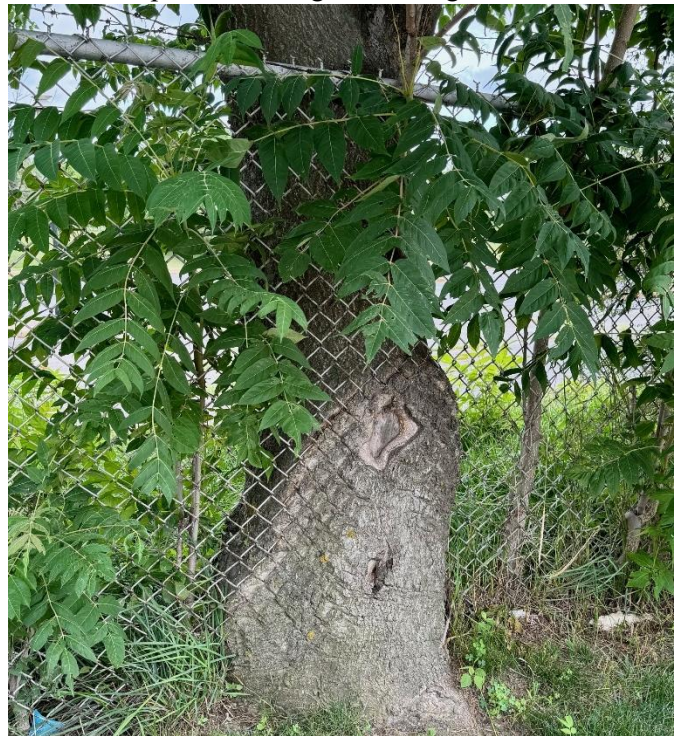
*Staff photos, July 17 and September 25, 2025.*

- However, there are occasional areas where the fence needs attention due to missing or leaning posts, as well as one instance in which a tree grew into and ultimately around/through the fence. Also, some of the toppers have surface rust, which could be eliminated by gentle surface repairs/scribbling/refinishing.

- The fence is in repairable condition and offers a striking contrast to the 19<sup>th</sup> century buildings, star fort, burial mound and the property’s currently dominant quiet and contemplative sense of place. The barbed wire can be removed without severely altering the fence’s integrity, as the extensions offer the visual clue to the fence’s design and method to secure the property.

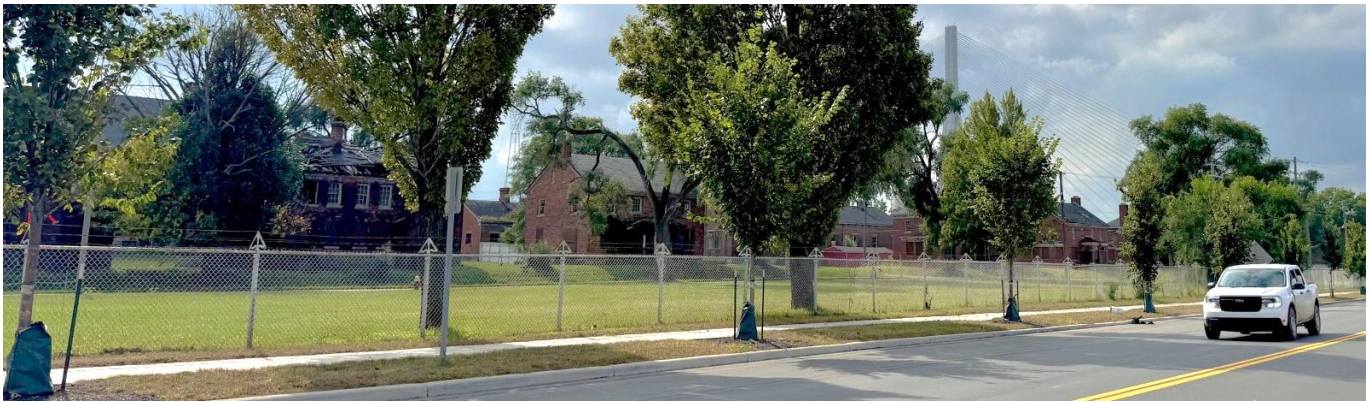
*This view looks southwest into the western section of the property; the Gordie House bridge is visible in the background.*

- The photos attest to the “invisible” nature (as described in the company’s catalog) of the chain link fence, offering an almost unobtrusive view into and out of the fort. The extension arms, which hold five strands of barbed wire, also “blend” into the surroundings which makes for a quiet yet formidable security fencing (especially in contrast to the new bold security wall erected across the street).

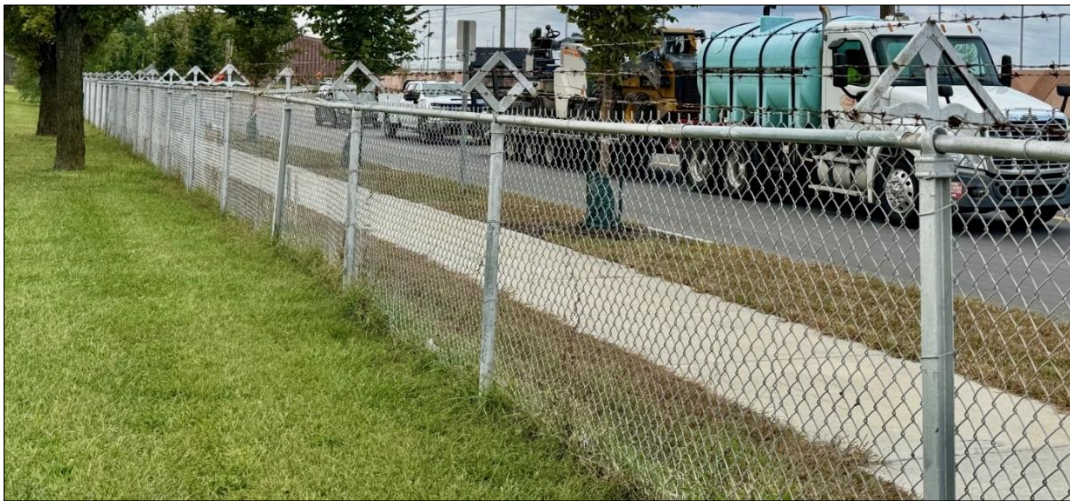
*Closer to the western property line, there are sections of the fence at “Jefferson Field” that have different “arms”, likely replacements installed while still serving as a federal military site. Above: looking west. Below, look east. Staff photos.*

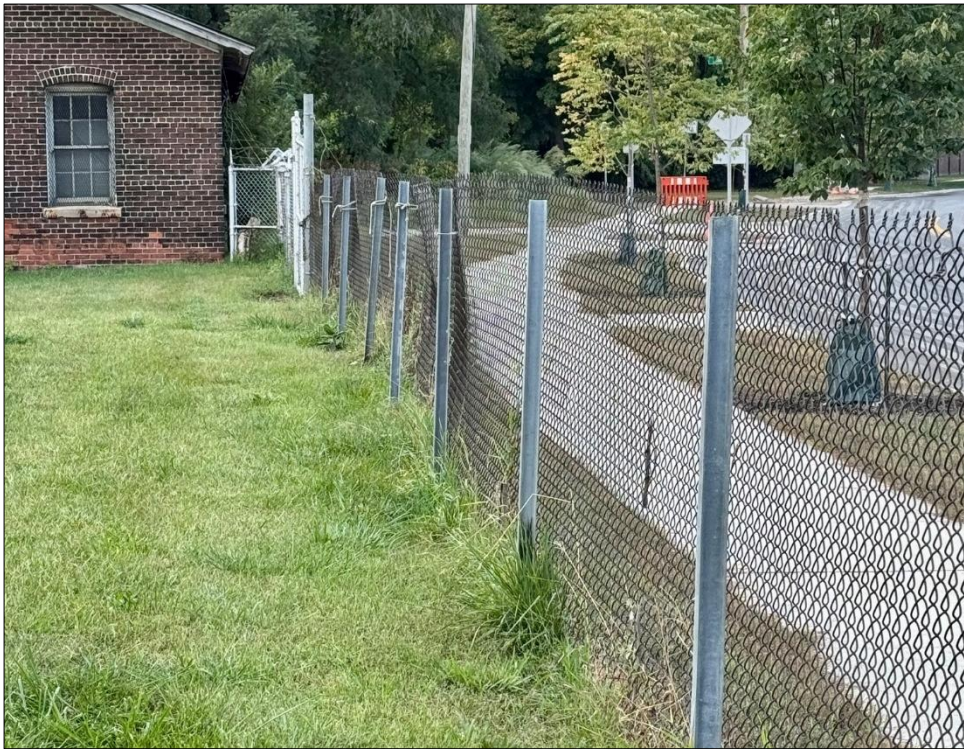
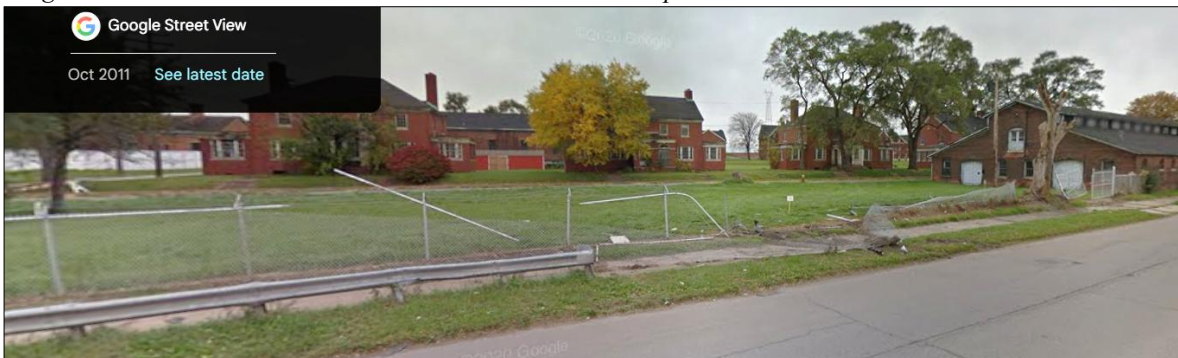
*This section of fence is new; it was installed between 2011 and 2013 due to the destruction of the historic fence likely caused by a car or truck (below photo). The new fence has sat incomplete for over 12 years, as it is missing a top rail. It must be noted that the installation of this section of new fence took place before Fort Wayne was designated a local historic district – however it should be completed.*

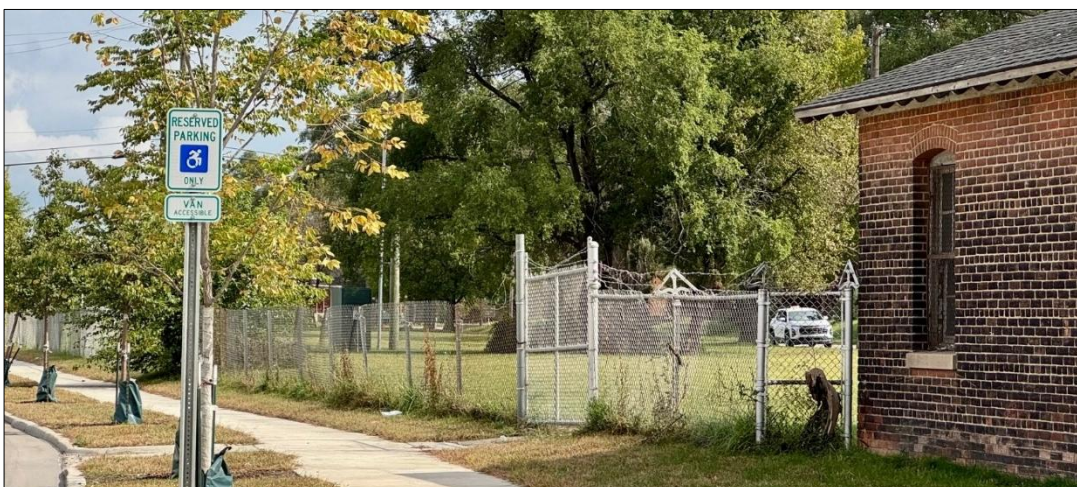
*The northwest corner of the fence returns to the corner of the stable building. Visible is the “Jefferson Field” gate that is proposed for replacement.*

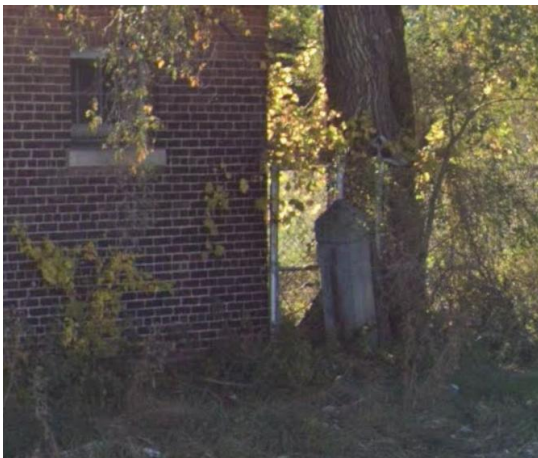
*November 2023*

- During staff's recent site visit, a remnant from the 19<sup>th</sup> century fence was identified at the corner of W. Jefferson and Rademacher, just west of the stables. This element, even as a solo structural item, is a distinctive and historic character-defining feature. This application doesn't include any reference to this feature, so staff doesn't believe its removal is imminent.
- Staff also identified, when reviewing different Google street view images, another concrete or stone obelisk adjacent the stable. Staff will visit the site to confirm if it is still there.
- When overgrowth is removed from this area, additional historic elements of the fort may be identified.
- Removal of historic features cannot be completed without the Historic District Commission's approval.
