**STAFF REPORT: OCTOBER 8, 2025 MEETING**

**APPLICATION NUMBER: HDC2025-00249**

**ADDRESS: 6325 W. JEFFERSON AVENUE, AKA FORT WAYNE**

**SCOPE: REPLACE HISTORIC FENCE, RENOVATE PRIMARY ENTRANCE, SITE IMPROVEMENTS, REPLACE PARK SIGN**

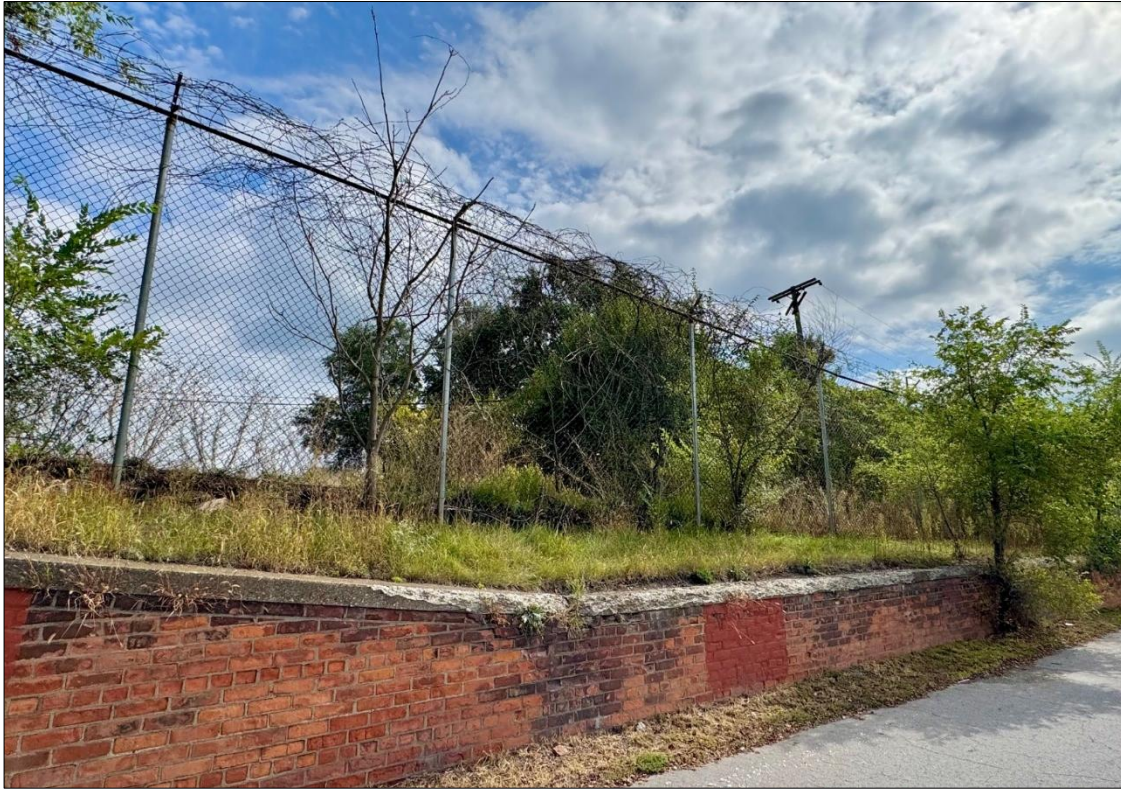
*Staff photos, September 2025.*

- The non-climbable fence along Rademacher Street is taller and has “V” shaped extensions, and likely installed at a later time.
