**STAFF REPORT: OCTOBER 8, 2025 MEETING**

**APPLICATION NUMBER: HDC2025-00249**

**ADDRESS: 6325 W. JEFFERSON AVENUE, AKA FORT WAYNE**

**SCOPE: REPLACE HISTORIC FENCE, RENOVATE PRIMARY ENTRANCE, SITE IMPROVEMENTS, REPLACE PARK SIGN**

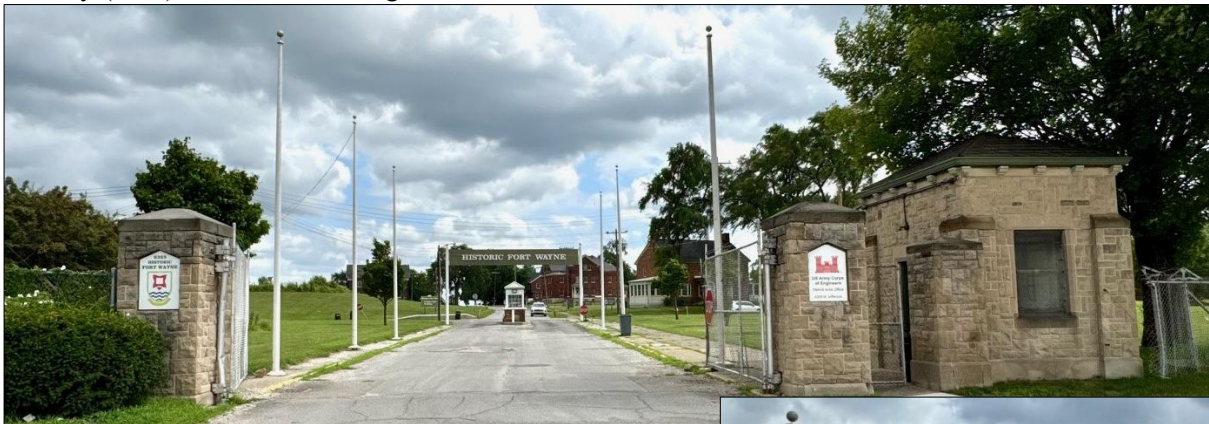
Primary (west) entrance - existing entrance erected ca. 1938

*Current design of the primary entrance. The 1938 stone elements and most of the design elements from the 1980s entrance redesign remain intact. The existing guard house is now centrally located on Brady Street; the proposed new guard house will be erected in the same location. Staff photos, July 17, 2025.*

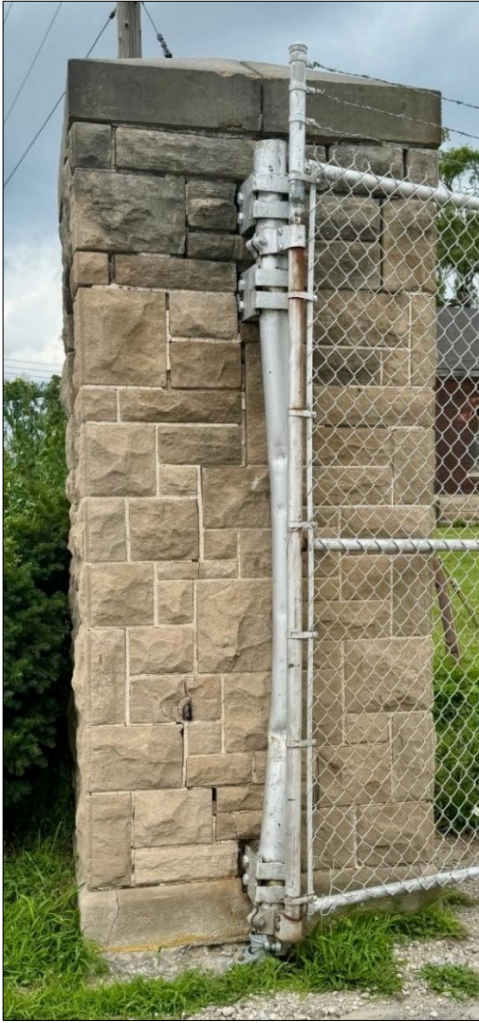
- The existing chain link gates are not historic age and can be replaced. The selected iron gates offer a compatible design, material and color for this primary entrance. However, an installation drawing for the proposed iron gates is needed to confirm that additional holes will not be created to hang the new gates.

*Above: The entry gate piers and sentry house have areas of missing mortar, cracked and discolored stone, as well as existing holes used for the installation of the chain link gates. Staff photos, July 17, 2025.*

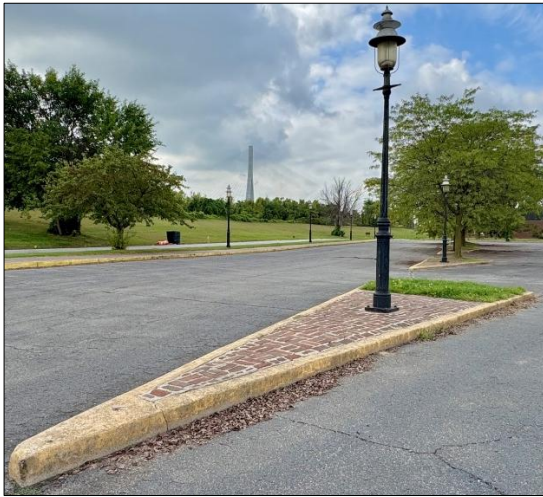
- Existing single pole/lamp parking light fixtures, a “historic” reproduction design, installed in the late 1970s, will be replaced. The existing concrete and masonry pads will remain.

*Left: Triangular concrete and masonry pads separating the parking lot (on right) and Meigs Street (on left).*

*Right: Square pads placed within the parking lot. These foundational items will remain – only the lamposts/lights will be replaced.*

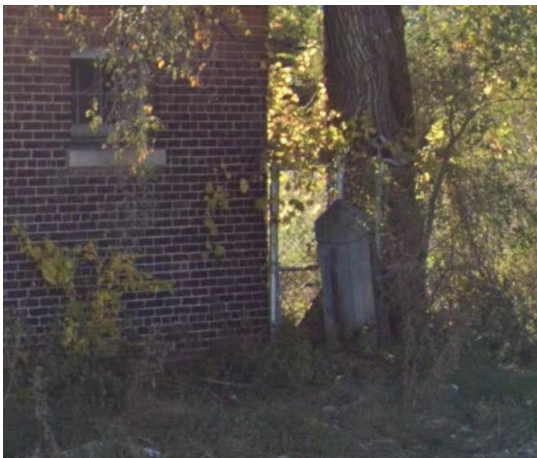
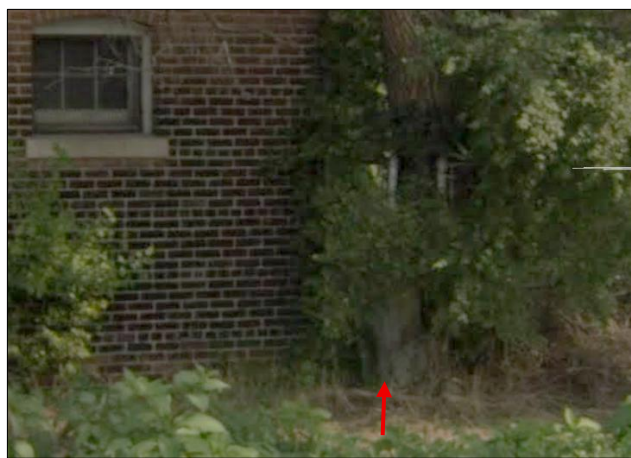
- During staff's recent site visit, a remnant from the 19<sup>th</sup> century fence was identified at the corner of W. Jefferson and Rademacher, just west of the stables. This element, even as a solo structural item, is a distinctive and historic character-defining feature. This application doesn't include any reference to this feature, so staff doesn't believe its removal is imminent.
- Staff also identified, when reviewing different Google street view images, another concrete or stone obelisk adjacent the stable. Staff will visit the site to confirm if it is still there.
- When overgrowth is removed from this area, additional historic elements of the fort may be identified.
- Removal of historic features cannot be completed without the Historic District Commission's approval.

*November 2023*

*August 2024 – it appears hidden behind the overgrowth.*
