STAFF REPORT: 11/12/2025 REGULAR MEETING PREPARED BY: A. DYE

**APPLICATION NUMBER: HDC2025-00575**

**ADDRESS**: 2733 SECOND AVENUE (AKA CASS PARK)

SCOPE: ALTER & REHABILITATE PARK, REVISE INTERNAL PATH LAYOUT

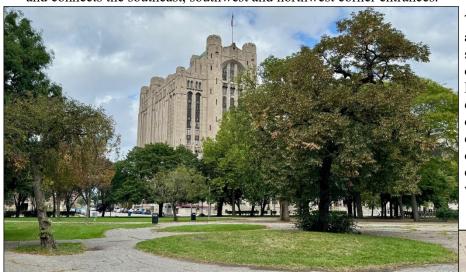
Top left: View looking northeast, from the center of the park. Masonic Temple is visible in the background. Staff photo, September 25, 2025.

Above: Aerial view of the park looking southeast. ConnectExplorer, 2024.

Bottom left: Front of Robert Burns monument that faces Second and Temple Streets).

Bottom center: Front of current Cass Park monument with sign and flagpoles that faces Second and Ledyard Streets).

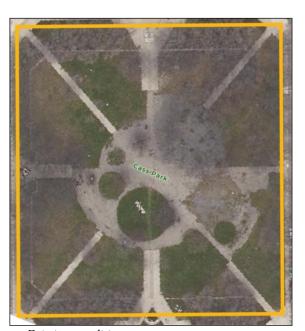
EX. CASS PARK SIGN

EX. "PINIK LANDSCAPE - THREE
TRUSSES PLUS" SCULPTURE,

& FLAG POLES

Existing conditions

Applicant rendering of proposed design.
