**STAFF REPORT:** 11/12/2025 REGULAR MEETING

**APPLICATION NUMBER:** HDC2025-00596

**ADDRESS:** 4324 (4314-4316) W. VERNOR

**SCOPE:** REMOVE BRICK VENEER AT FAÇADE, INSTALL NEW BRICK CLADDING AND STOREFRONT

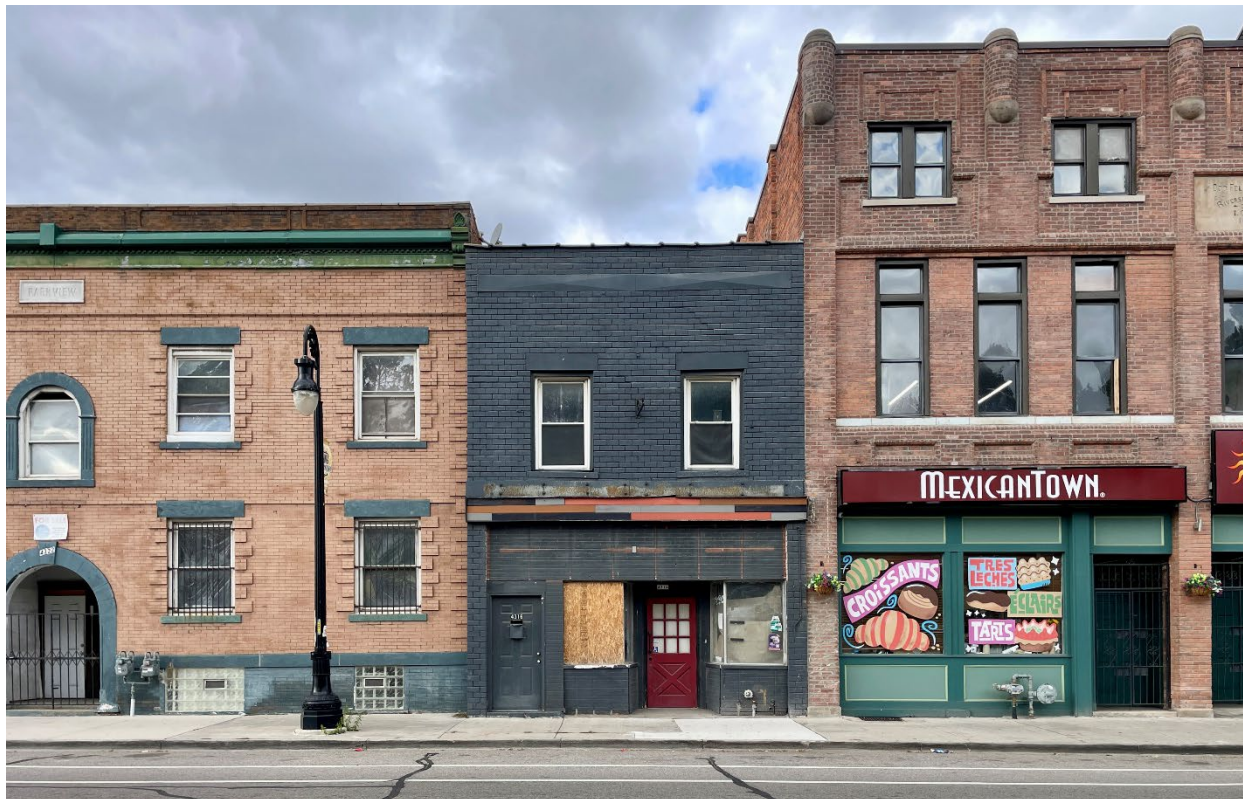
This two-story early 1900s commercial building has brick veneer and features a simple rectangular form typical of small urban storefronts from that era. The brick veneer is laid in running bond and painted a dark gray color. The upper story includes two double-hung, non-historic windows with flush lintels and modest projecting brick sills. At or under the parapet, a horizontal decorative band has been affixed over the historic masonry. The ground level storefront has been heavily altered with a later brick infill, with the original display windows and entry configuration replaced and partially enclosed. The entry door is slightly recessed, and a secondary door at the left (addressed 4316) likely provides access to the upper floor.

*Staff photo, 10/24/2025. Front of the building, taken from W. Vernor.*

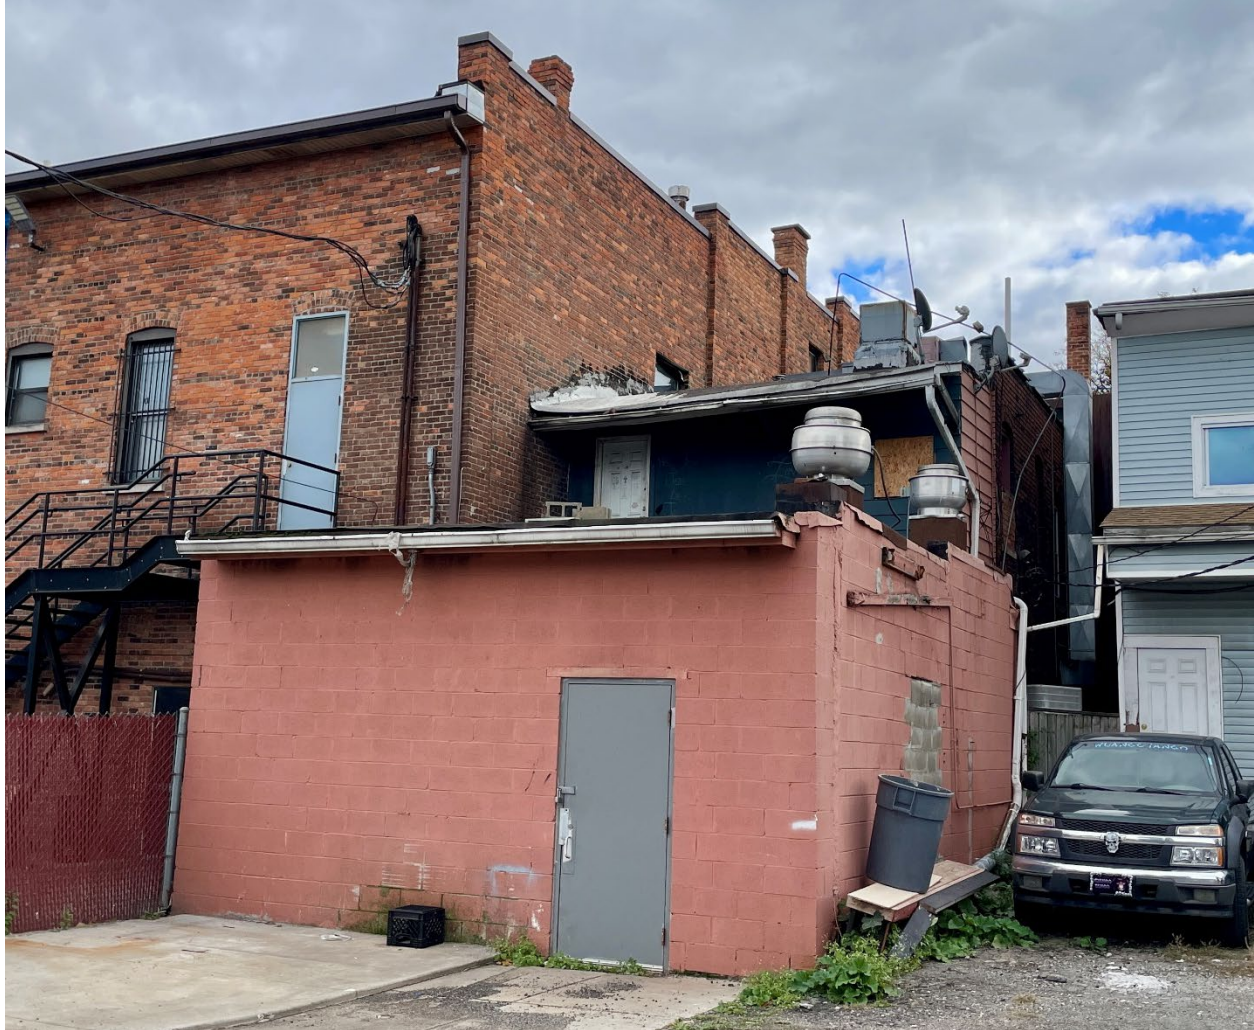
*Staff photo, 10/24/2025. Rear of the building, taken from the alleyway to the North of the building.*

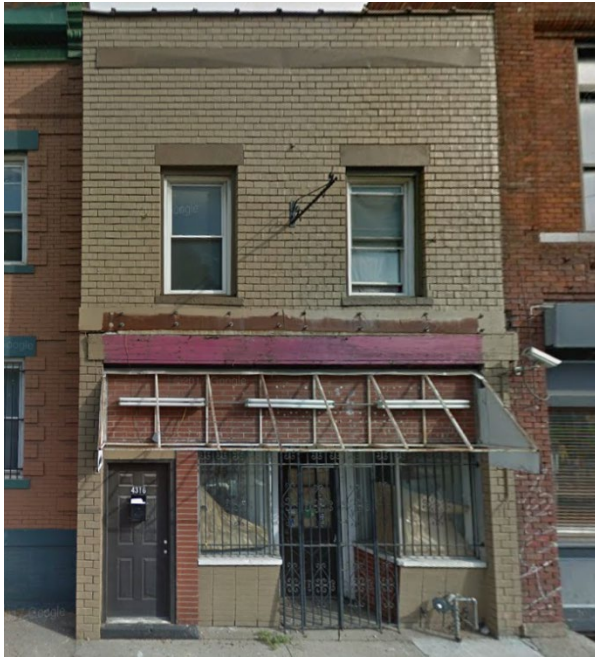
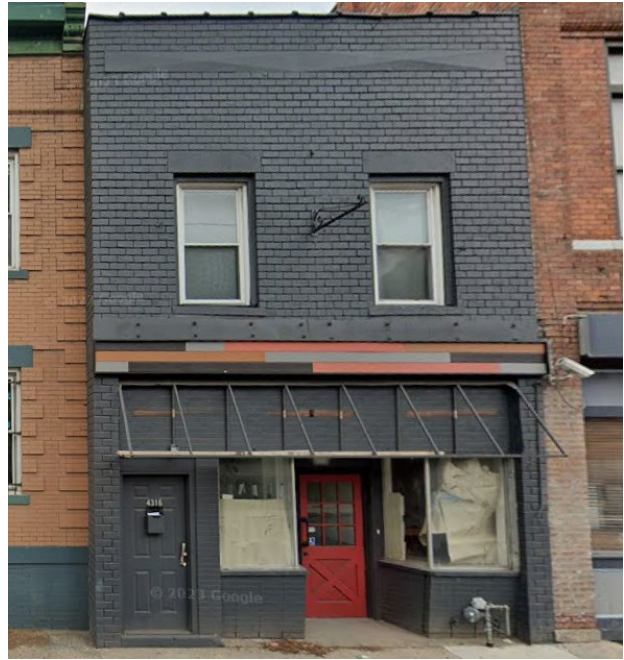
- Sometime between 07/2017 and 07/2018, the building was painted and the colorful, wood boards were added above the first story. No Certificate of Appropriateness (COA) was found for these alterations.

*Google Street View, 07/2017*

*Google Street View, 07/2018*

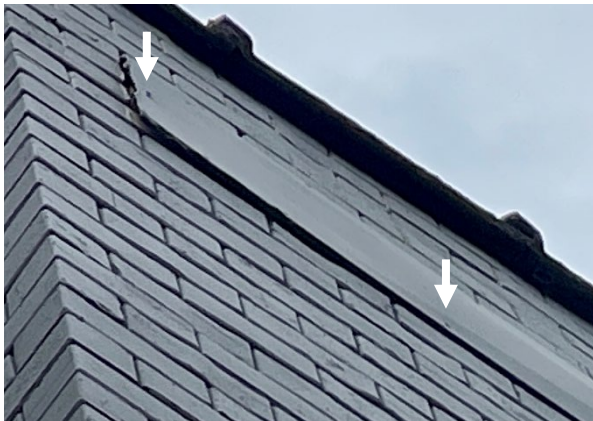
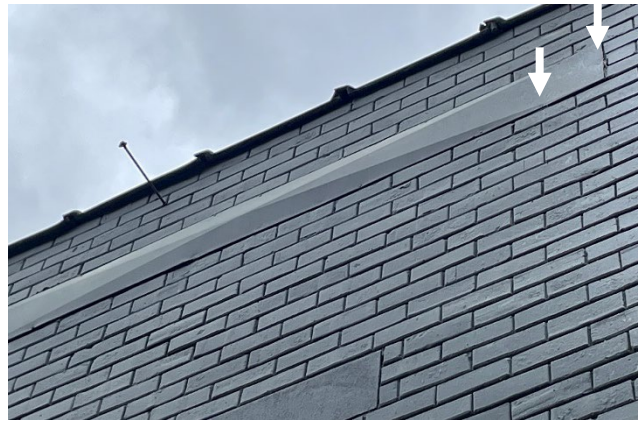
*Staff photos, 10/24/2025*

- It is staff's opinion that the horizontal band near the parapet is a non-historic, decorative addition due to the visible nails affixing it to the masonry.

**Recommendation 2 of 2 – Certificate of Appropriateness – Replace storefront at existing opening, remove wood boards above storefront**

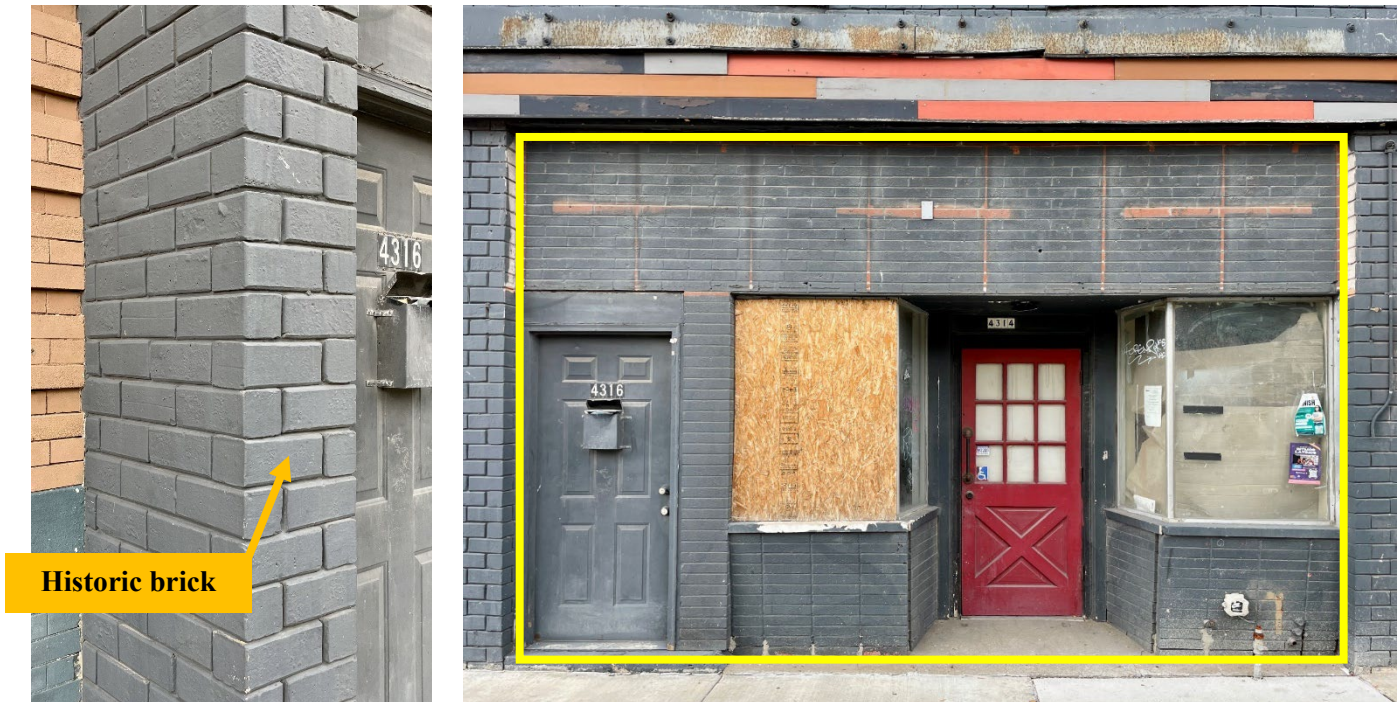
- The existing storefront, characterized by its mostly brick infill and minimal detailing, appears to reflect a more modern, mid-century design. This is evident in the use of thinner, elongated bricks, which contrast with the more ornamental features, such as decorative wood panels, typically found in earlier historic storefronts.

Staff photos, 10/24/2025. No elements within the yellow box are historic.

- The large display windows, transom windows, and double-doors are to be single-lite configurations.
- The proposed storefront system dimensioned drawings and specifications shall be provided to staff for review and approval.

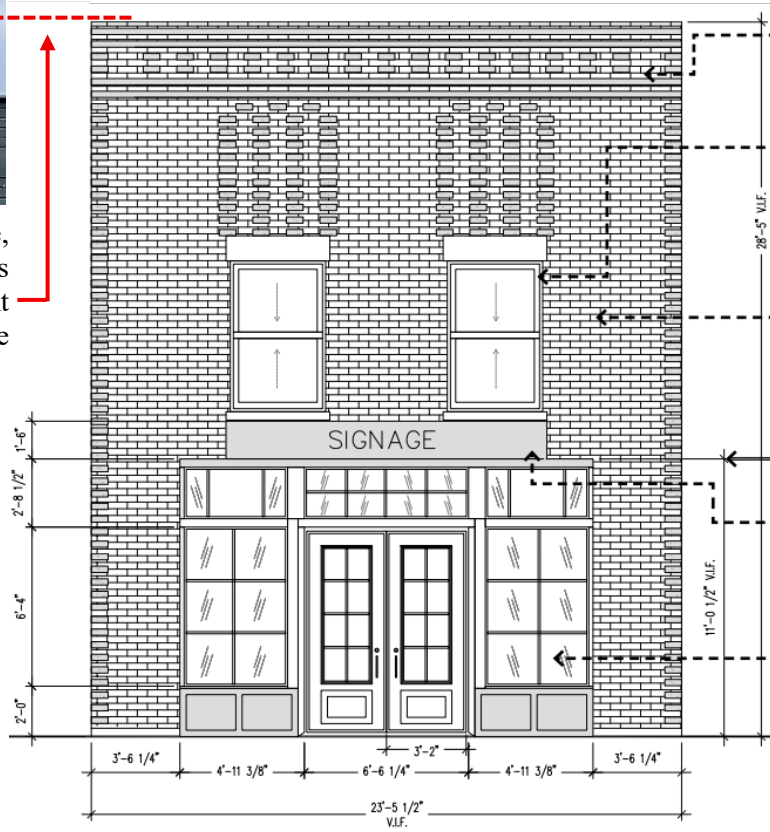
With the new façade, the applicant proposes to increase the height to align with the building to the West.

*Brampton Brick  
Old Chicago*

- It is staff's opinion that the applicant's proposal to remove the existing historic brick veneer at the façade is inappropriate, as the existing brick veneer is a distinctive, character-defining feature and has not been demonstrated to be beyond repair. Furthermore, the proposed new brick cladding, with its cornice and brick patterning, conveys a misleading representation of historic brick architectural details and creates a false sense of historical development. These elements are incompatible with the building's authentic and simplistic historic character.

#### **Recommendation 1 of 2 – Denial – Remove brick veneer at façade, install new brick cladding**

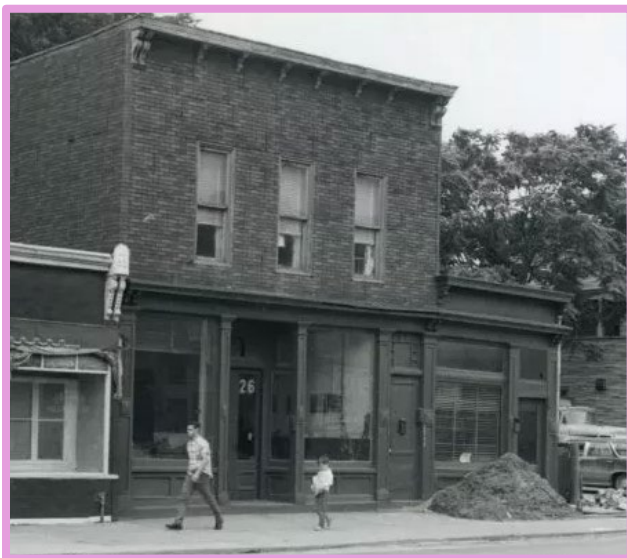
- Staff notes that, to better understand the proposed storefront system, a detailed, dimensioned drawing of the transom window configuration was requested; however, no response was received from the applicant.
- Regarding the proposed storefront system: the use of panels, a recessed double-door entry, and transom windows is appropriate and consistent with typical storefront designs from that era and location. However, it is staff's opinion that the multi-lite design in the large display windows, transom windows, and double-doors is not historically accurate for early 20th-century storefronts in this area. Examples of nearby historic storefronts shown below illustrate this difference.

*Detroit Historical Society, 4026 W. Vernor, 07/1968*

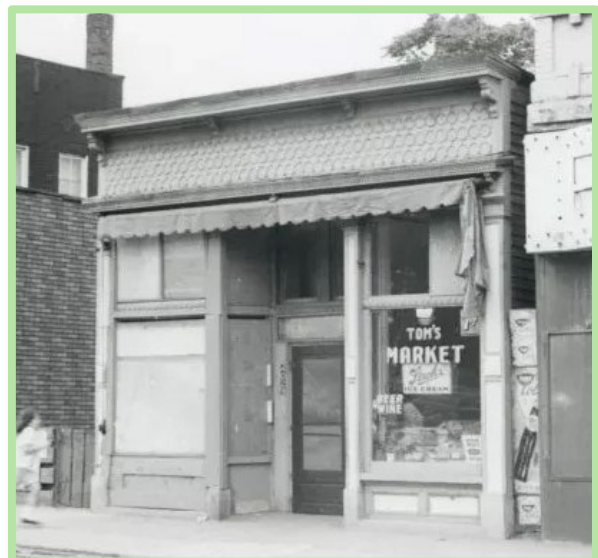
*Detroit Historical Society, 4029 W. Vernor, 07/1968*
