STAFF REPORT: 02/11/2026 REGULAR MEETING

APPLICATION NUMBER: HDC2026-00004

ADDRESS: 4825 FULLERTON

SCOPE: DEMOLISH REAR TWO-STORY PORCH, ERECT REAR TWO-STORY PORCH

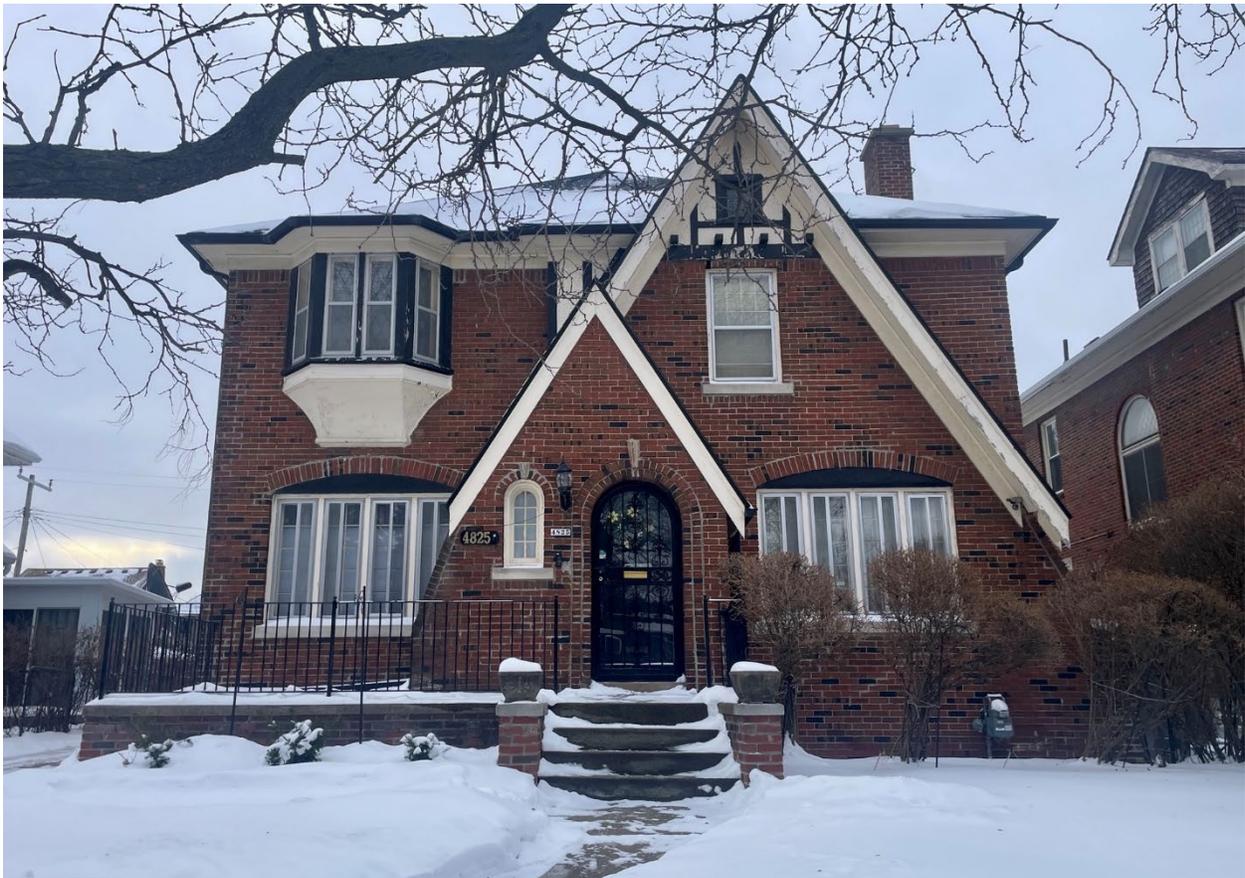
Built in 1926, this Tudor Revival residence is located in the Russell Woods–Sullivan Historic District. The home features a red brick façade accented with decorative half-timbering and stucco. The structure is topped by a hipped roof and includes wood multi-lite casement windows on the first floor, along with a second-floor bay window containing leaded glass. A round-arched door and window are set within the nestled front gable and paired with a partial-width brick porch, contributing to the dwellings asymmetrical façade.

Staff photo, 01/29/2026

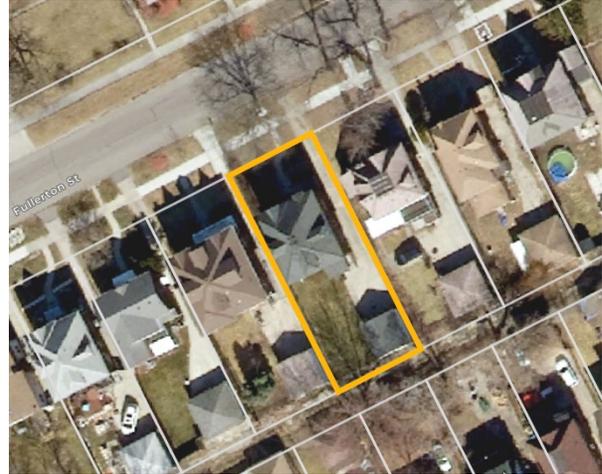
Detroit Parcel Viewer

- The second story of the rear porch was added sometime before 1979, when the current owner(s) purchased the house. Based on its construction, the addition was likely built no earlier than the 1950s, which falls outside staff’s derived period of significance for residential structures in the district (i.e. 1920-1949, based on our interpretation of the HDAB report).
- Regarding the reason for replacement, the applicant states that the “current two story rear porch has multiple safety hazards. First floor wood support column is failing, causing first floor ceiling to crack, dip and cave in.”

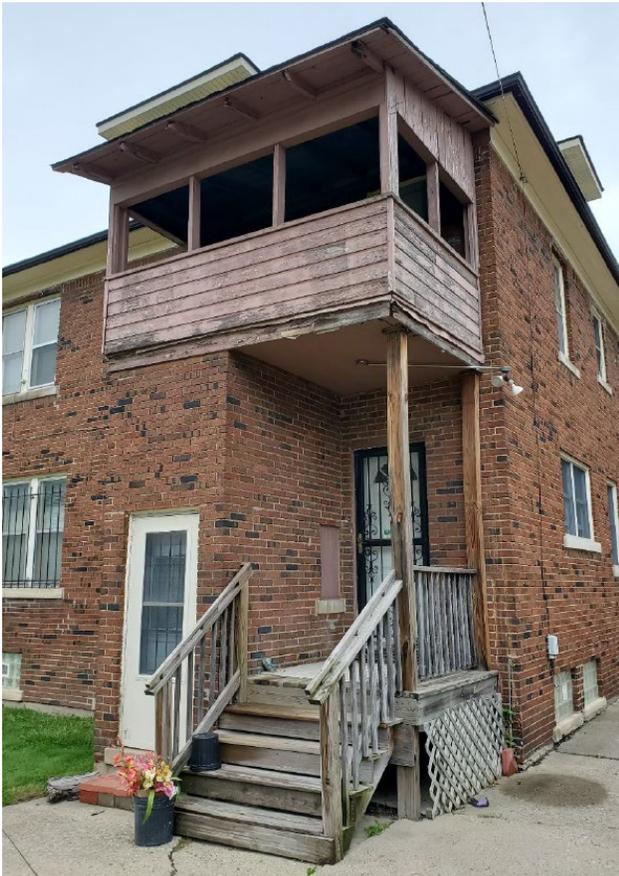
Photo from application of existing condition

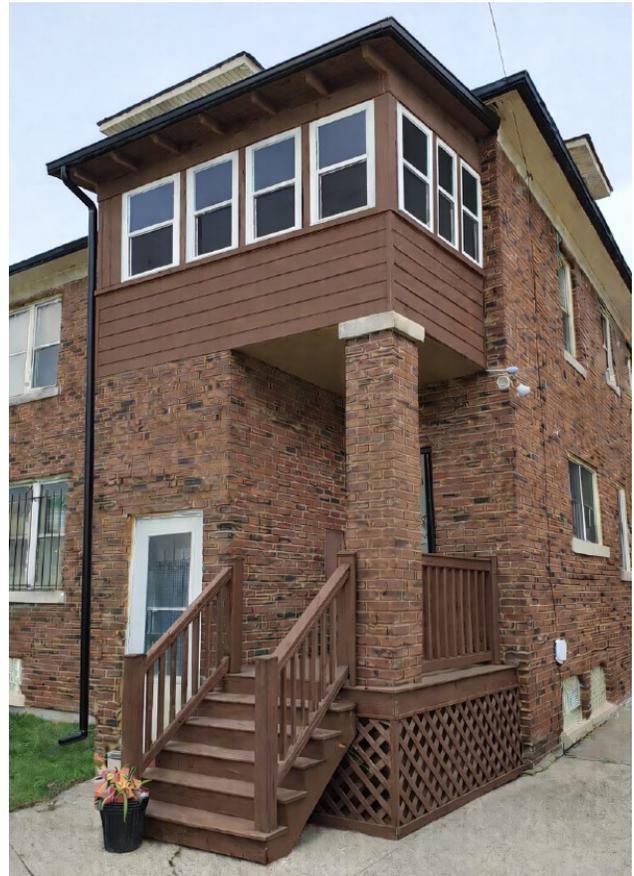
A.I. rendering from application of proposal

- Considering the existing second story enclosure is likely not original and is at the rear, it is staff's opinion that the replication of the massing, style, and materiality of the proposed two-story porch is generally compatible. Additionally, it follows the National Park Services' 'The Secretary of the Interior's Standards for Rehabilitation' Standard #9, quoted below.

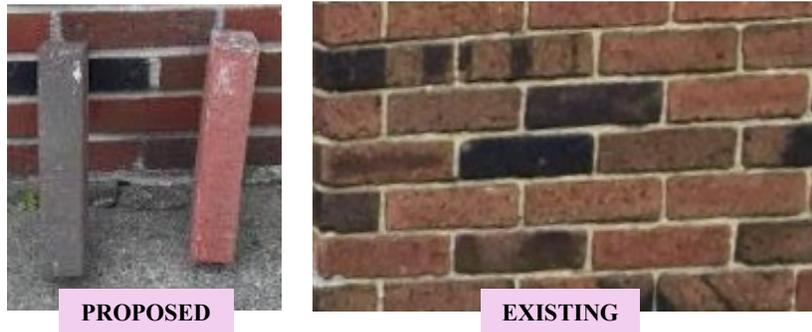
- For the brick column, the proposed brick does not match in size or color of the existing historic brick at the rear of the house.

- The proposed column bricks are not compatible with the adjacent historic brick.

- The product information identifying the proposed replacement brick and colorway(s) and a photo of the sample new brick next to existing historic brick provided to staff for review and approval to ensure that it is compatible in texture, color, and dimension with the adjacent historic brick.
