**STAFF REPORT:** 02/11/2026 REGULAR MEETING

**APPLICATION NUMBER:** HDC2026-00018

**ADDRESS:** 4324 (4314-4316) W. VERNOR

**SCOPE:** REMOVE BRICK VENEER AT FAÇADE, INSTALL NEW BRICK CLADDING AND STOREFRONT SYSTEM

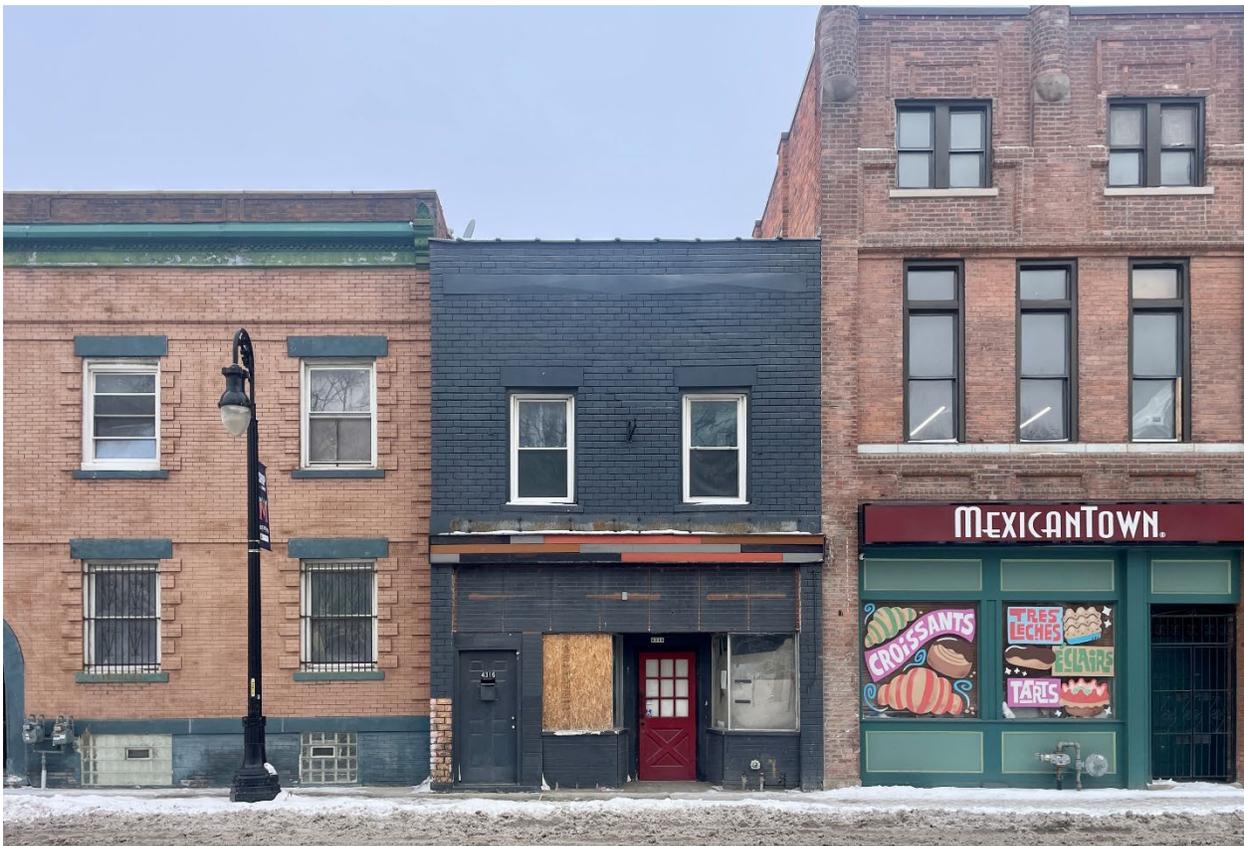
This two-story early 1900s commercial building has brick veneer and features a simple rectangular form typical of small urban storefronts from that era. The brick veneer is laid in running bond and painted a dark gray color. The upper story includes two double-hung, non-historic windows with flush lintels and modest projecting brick sills. At or under the parapet, a horizontal decorative band has been affixed over the historic masonry. The ground level storefront has been heavily altered with a later brick infill, with the original display windows and entry configuration replaced and partially enclosed. The entry door is slightly recessed, and a secondary door at the left (addressed 4316) likely provides access to the upper floor.

*Staff photo, 01/29/2026. Front of the building, taken from W. Vernor.*

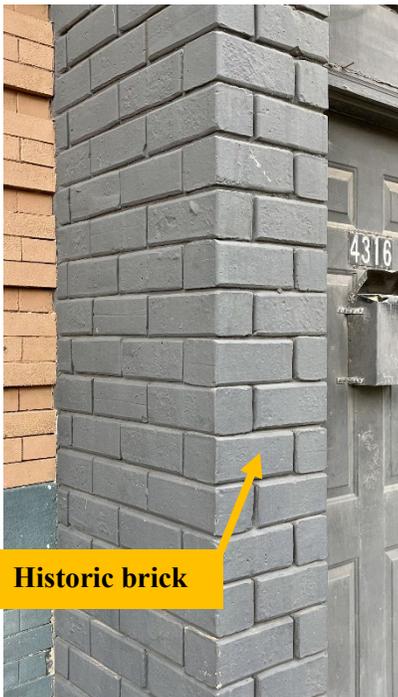
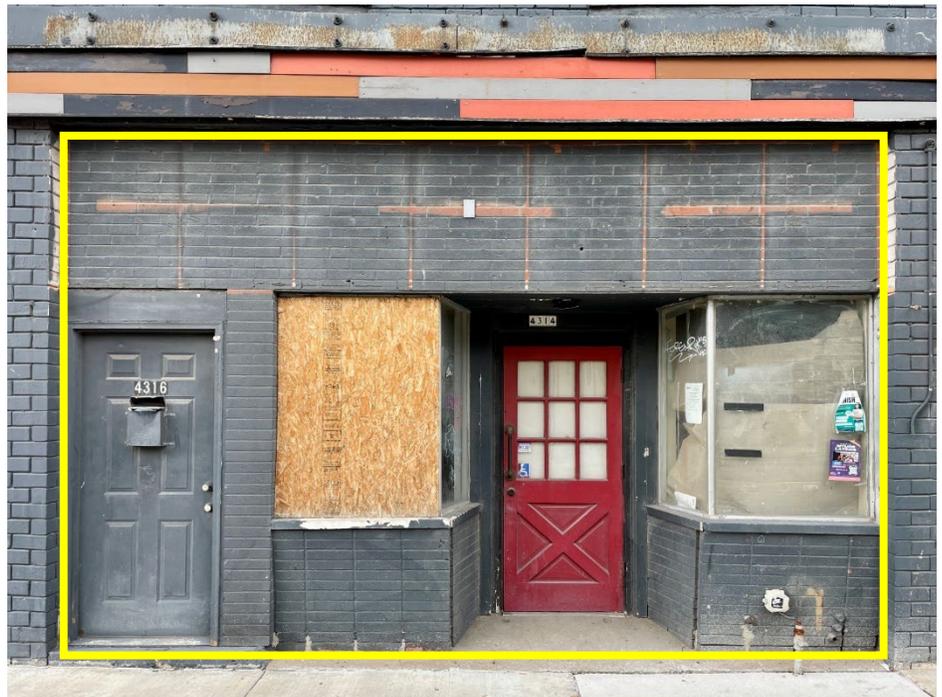
- The existing storefront, characterized by its mostly brick infill and minimal detailing, appears to reflect a more modern, mid-century design. This is evident in the use of thinner, elongated bricks, which contrast with the more ornamental features, such as decorative wood panels, typically found in earlier historic storefronts.

Staff photos, 10/24/2025. No elements within the yellow box are historic.

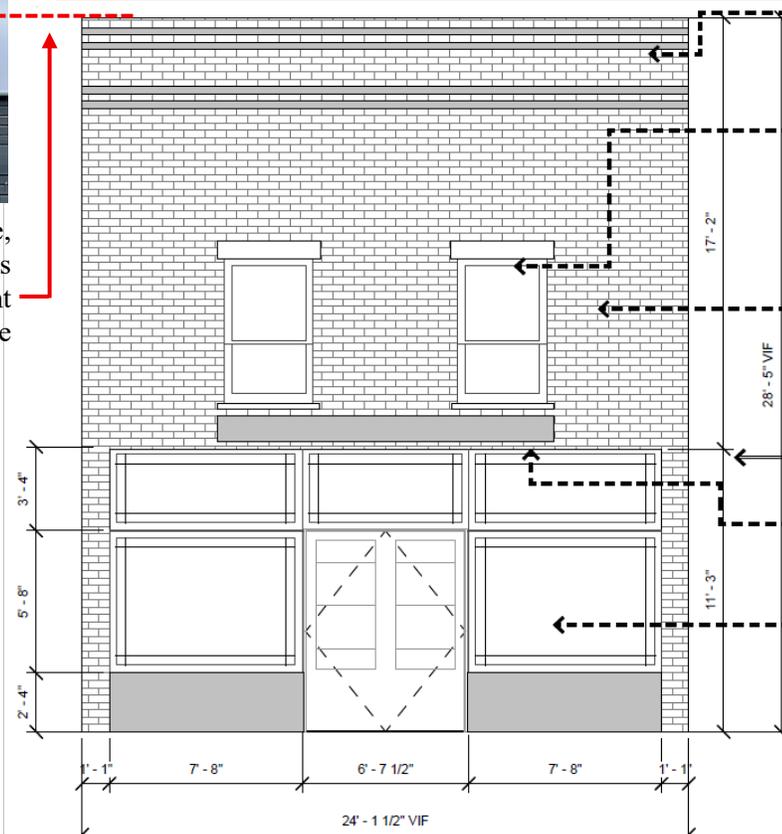
*Brampton Brick  
Old Chicago*

- Staff would like to note that the proposed new brick size does not match the existing historic brick in size. If replacement brick veneer was warranted (that is, if the historic brick veneer was demonstrated to be beyond repair), the new brick veneer would be required to “match the old in design, color, texture, and other visual qualities, and where possible, materials” (Standard #6, quoted in full below).
