SR-2 – ADVISORY STAFF REPORT (03-06-2026)

ADDRESS: 1965 ORLEANS

APPLICATION NUMBER: HDC2026-00023

SCOPE: REPLACE ALUMINUM WINDOW SYSTEMS WITH FIBREX WINDOW SYSTEMS

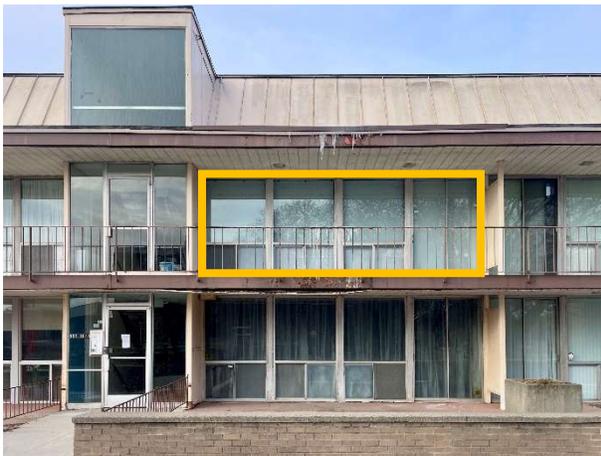
Staff photo, 02-24-2026. Northeast elevation.

- *Structural and Operational Deterioration: Many of the current windows have rusting or pitted frames, compromised locking mechanisms, and non-functional sashes, creating not only aesthetic issues but also safety and egress concerns.*

- *Moisture Infiltration: Several units have reported water penetration at the window perimeters, creating risks of mold, interior damage, and long-term structural decay.*

- Although the existing aluminum window systems are distinctive and historic character-defining features, considering the amount of deterioration and the lack of individualized components causing the inability to complete repairs, it is staff's opinion that the existing historic aluminum window systems are beyond reasonable repair.

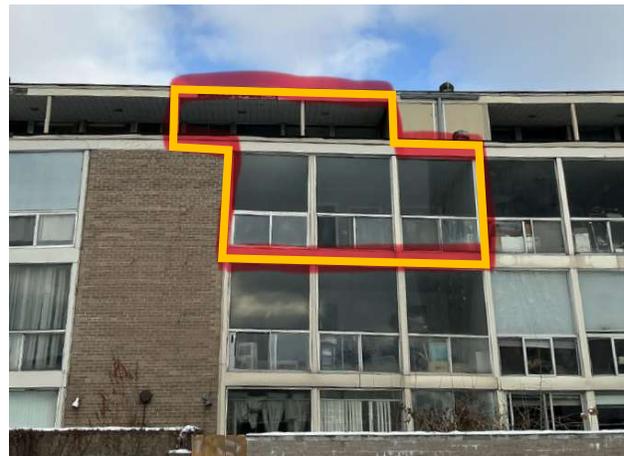
Photo from application. Southwest elevation.

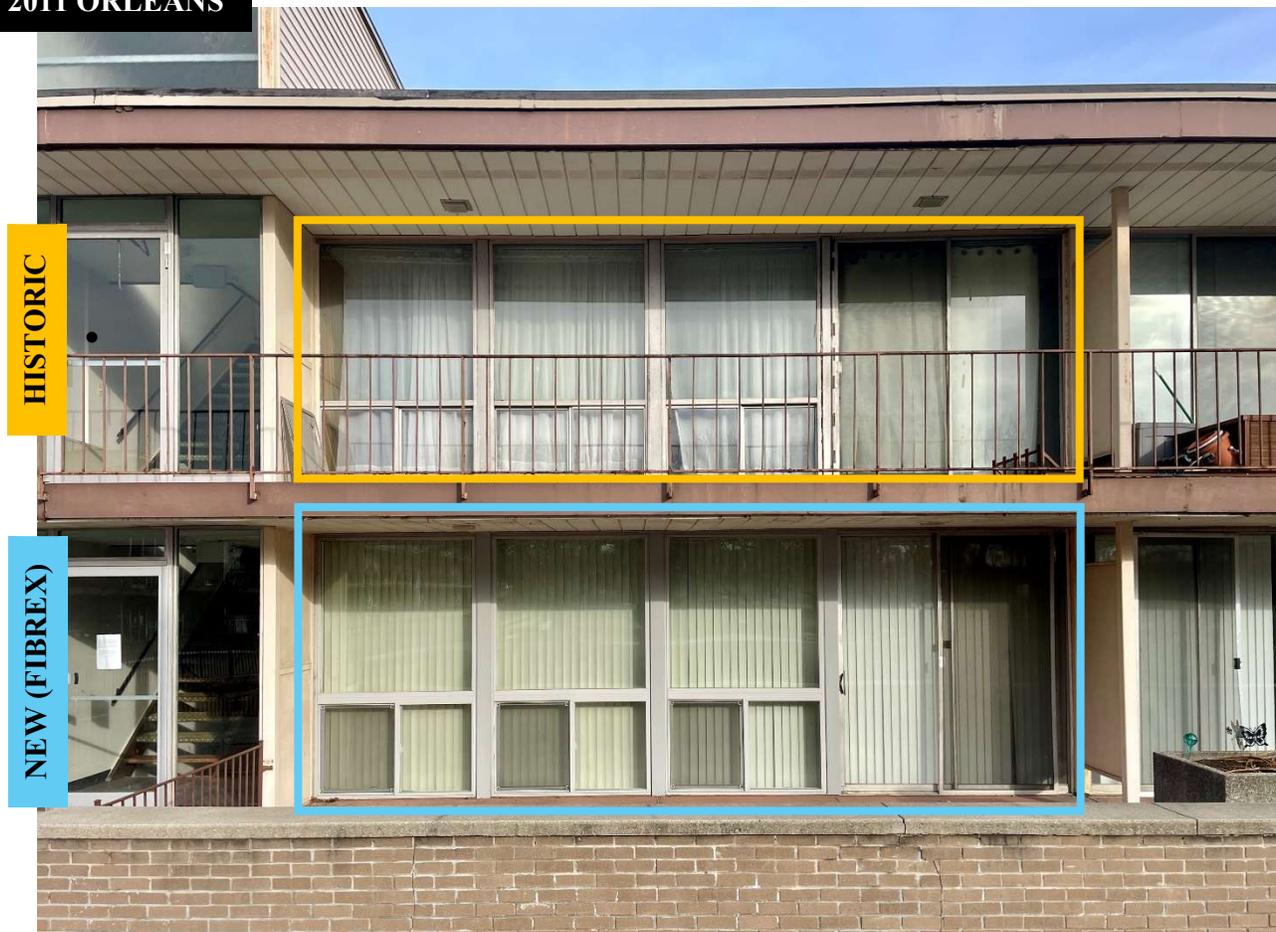
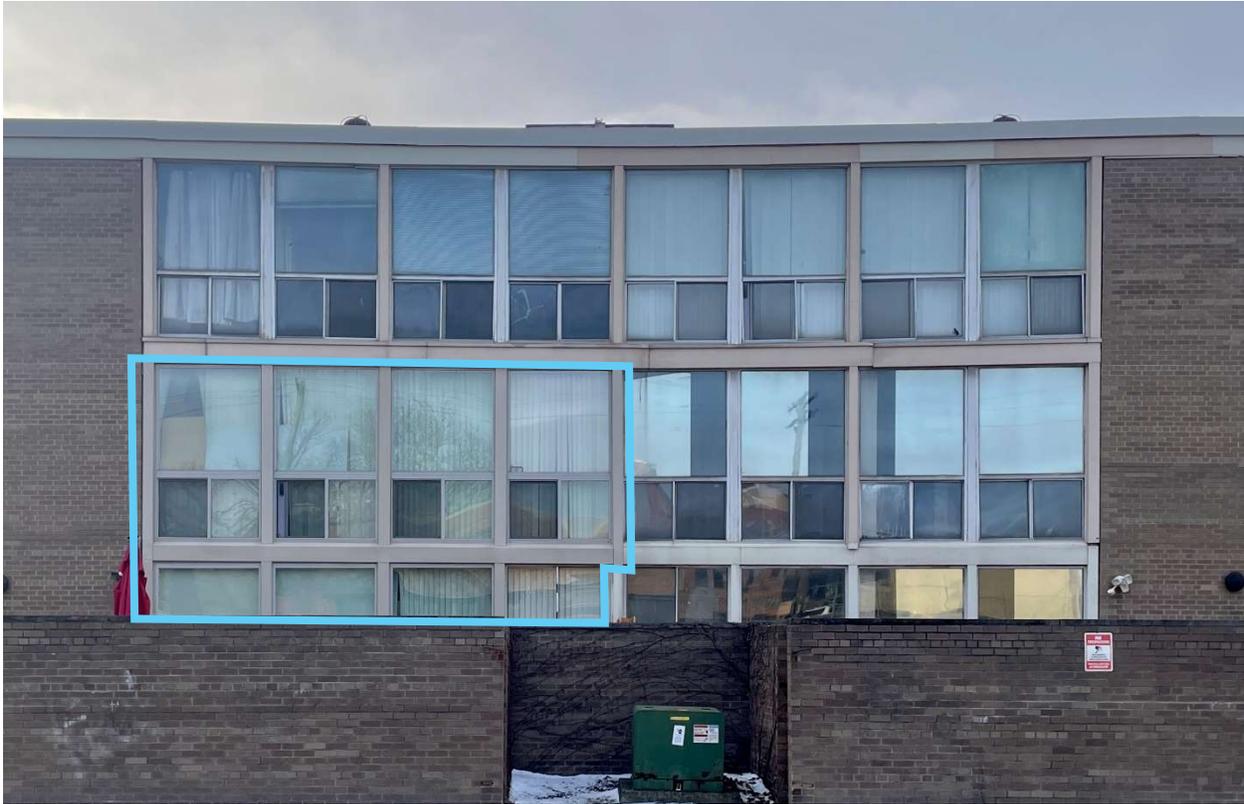
2011 ORLEANS

- Units in the same complex, 2011 Orleans (HDC2025-00461) and 2025 Orleans (HDC2025-000464), received a Certificate of Appropriateness (COA) from the Commission at the 10-08-2025 meeting for the same scope of work and product. 2011 Orleans installed their new Andersen 100 Series / Fibrex window systems, as shown below.

Staff photo, 02-24-2026.

- It is staff’s opinion that the replacement window systems are appropriate, since they match the historic windows in design, operation, color, and other visual qualities, as demonstrated by the installation at 2011 Orleans.
