SR-2 – ADVISORY STAFF REPORT (03-06-2026)

ADDRESS: 1069 MANISTIQUE

HISTORIC DISTRICT: JEFFERSON-CHALMERS HISTORIC BUSINESS

SCOPE: ERECT TRASH ENCLOSURE, REHABILITATE BUILDING

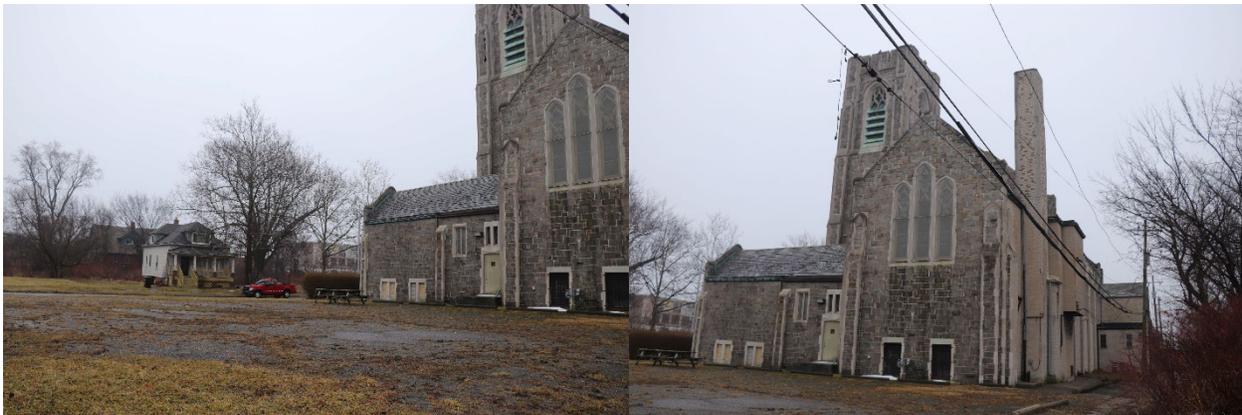
Photos taken by staff on 02/19/2025. Left: Rehabilitation of parking lot in relation to building. Right: Area of proposed trash enclosure, installation of mechanical units, and rear sliding door additions

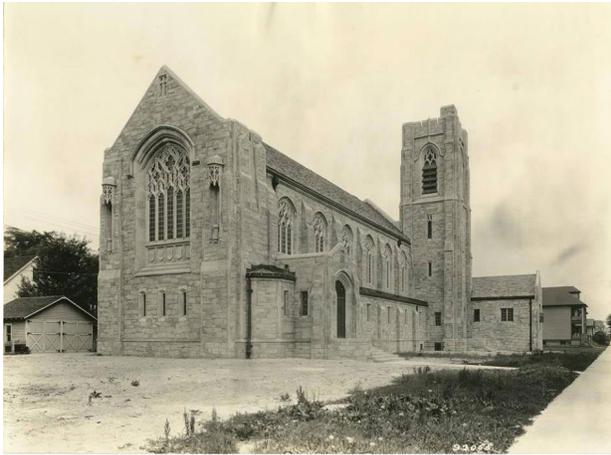
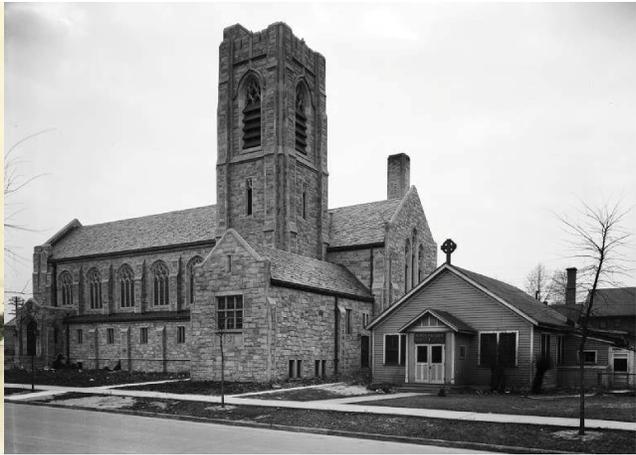
Photos taken from Historical Detroit Area Architecture, Facebook Page. LEFT: An image of the church from Indiana University's Building a Nation: Indiana Limestone Photograph Collection, circa 1927. RIGHT: An image of the church from Wayne State University's Virtual Motor City Collection circa 1930.

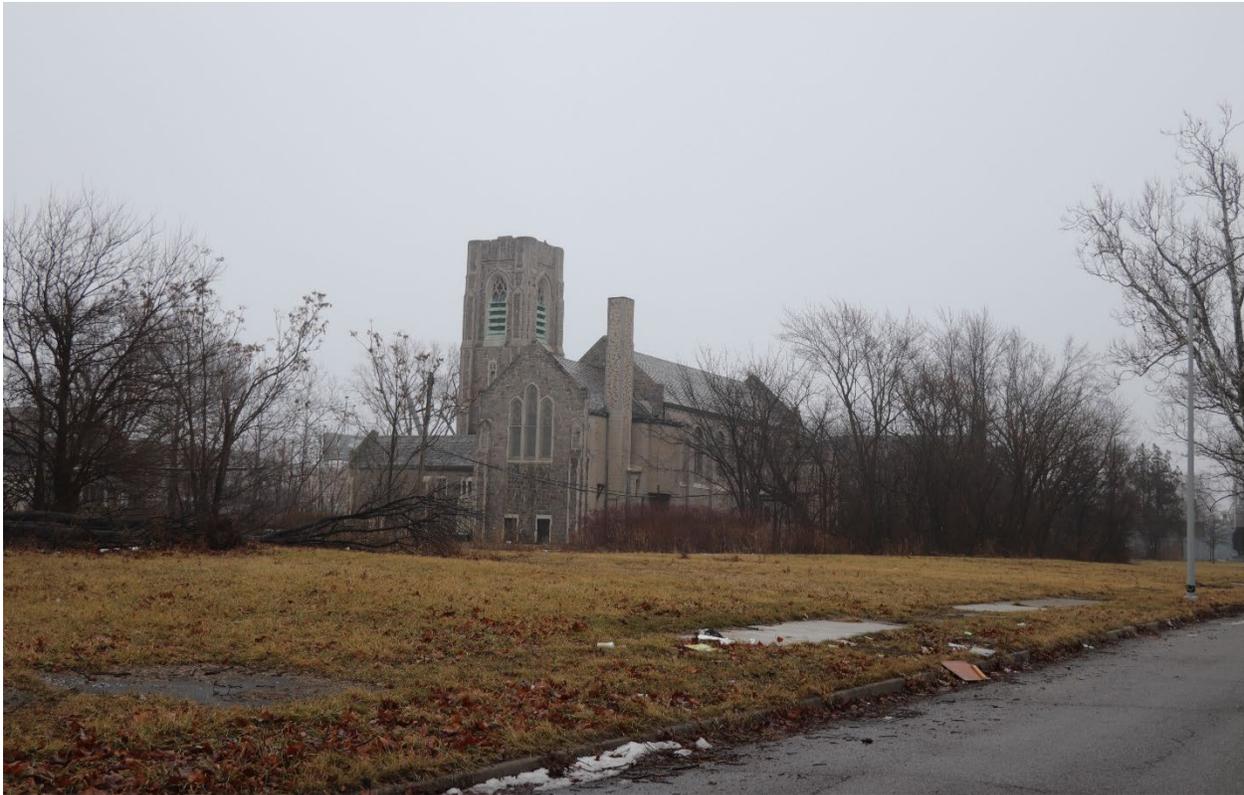
Photo taken by staff on 02/19/26, View of St. Columba Church from Philip Avenue. The parcels adjacent to the church are currently empty lots and fall outside of the district's boundary.

- It should also be noted that the parcels surrounding 1069 Manistique fall outside of the historic district's boundary line. Any future developments on these currently vacant lots, while subject to site plan review, will not have to adhere to the historic districts design standards.

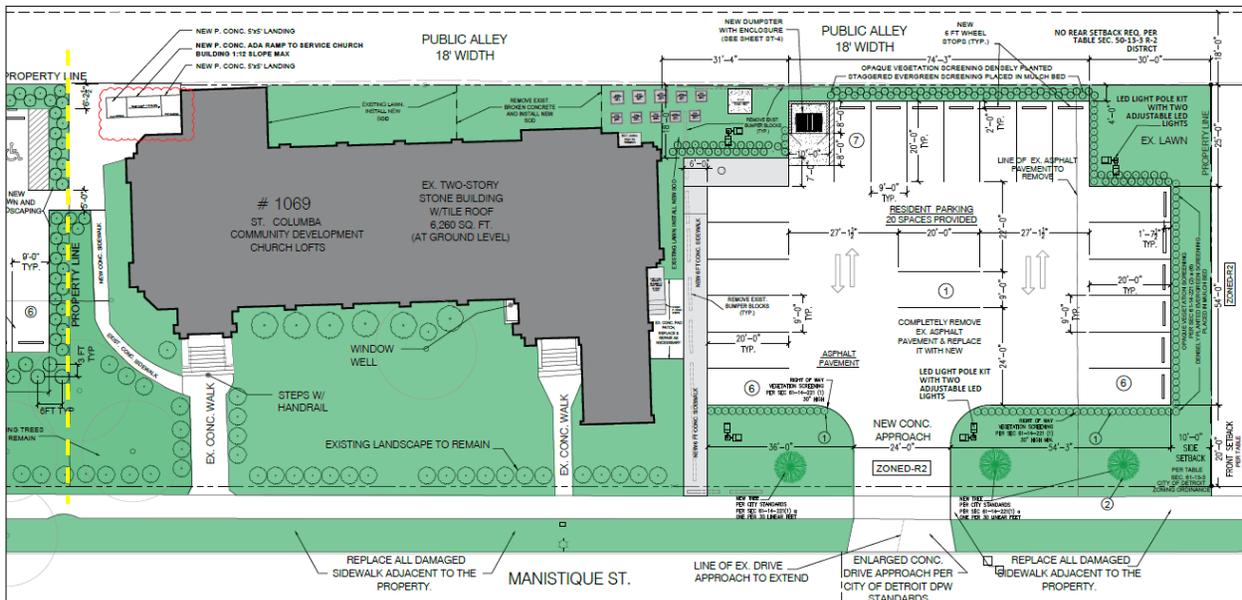
Site Plan provided by applicant.

- It should be noted that the first parking lot, located south of the existing church, is shared with the St Columba Parish Building at 14635 East Jefferson. This property came before the commission in October of 2025, where a similar trash enclosure was proposed and approved by the commission.

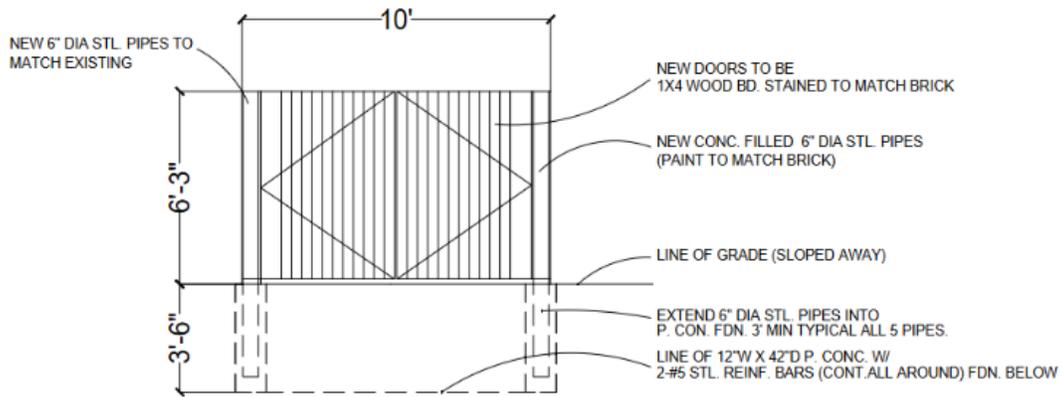
3 FRONT ELEVATION
ST-4 SCALE: 1/8" = 1'-0"

Proposed trash enclosure, drawings applicant's submission.

- Staff do not have the authority to approve the construction of new trash enclosures, as it is considered 'new construction' per Section 21-2-77 of the City Code. Therefore, this portion of the project has been submitted to the Commission for review and approval via the current application.
- It is Staff's opinion that the proposed location of the trash enclosure is suitable for its surrounding context as it is inconspicuous and would not be visible to the public facing areas.

1. The limestone wall will not be a compatible wall type for the proposed trash enclosure; a more utilitarian style beige brick would be more appropriate.

1. The utilitarian beige brick be a used for the proposed trash enclosure.

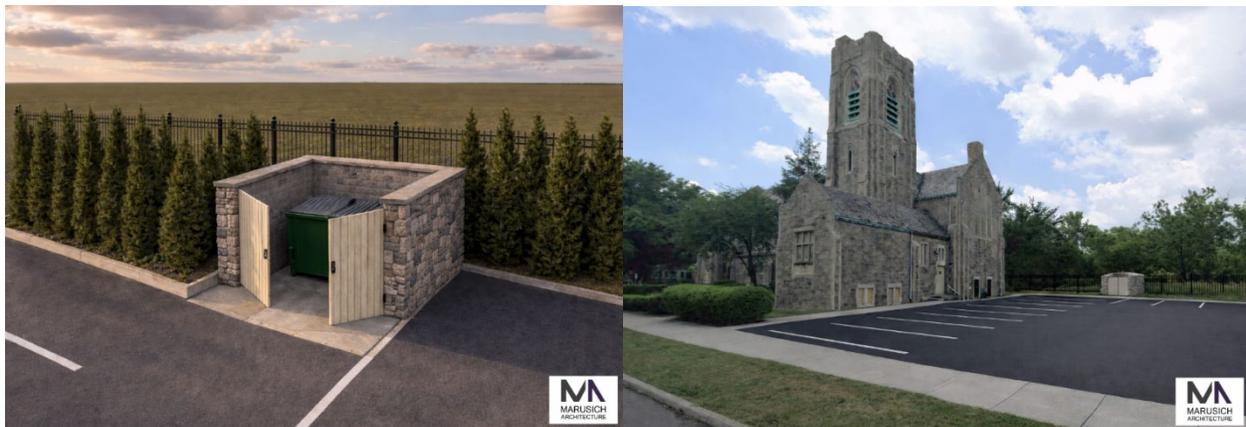
- However, the rendering provided by the applicant (shown below), shows the trash enclosure uses contemporary stone cladding to mimic the limestone wall, which differs from the architectural drawings provided that show the proposed brick to match the rear, west elevation
- It is staff opinion that the beige brick, as depicted in the drawings, would be a more compatible material for the trash enclosure, and a less disruptive addition to the historic property. It would also be compatible with the “back of house” brick expression used at the rear of the church building.

- The limestone walls and brick at the rear use a consistent beige color tone throughout the church. Any additions (i.e. a trash enclosure) should complement this color palette.

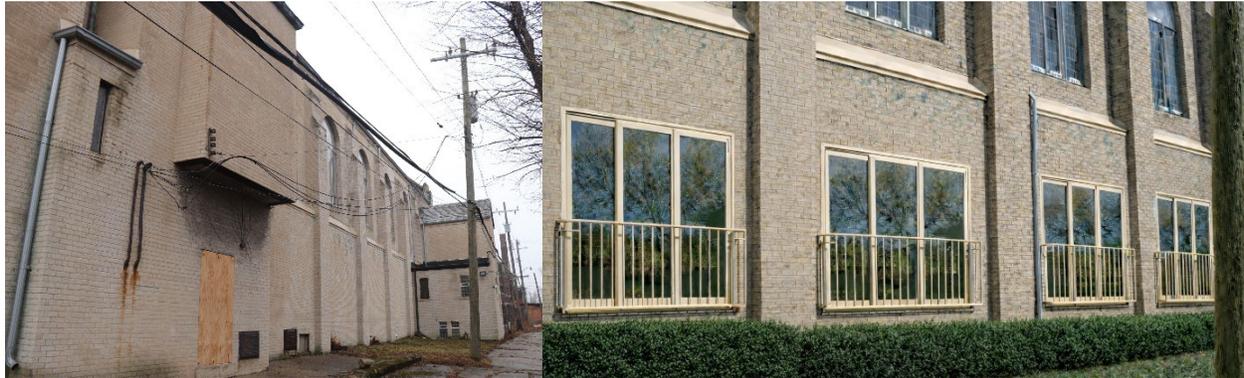
- The only part of the proposal that will impact historic material is the addition of sliding doors that will require the partial removal of the beige brick wall at the rear, within the brick bays.

Photo taken by staff on 02/19/2026, show the rear of St. Columba church

Rendering provided by applicant, shows proposal of sliding door balcony's with railing

- The rear of the church differs in material, using a more utilitarian type of beige brick, whereas the public-facing sides of the building are clad with more ornamental and distinctly character-defining limestone.

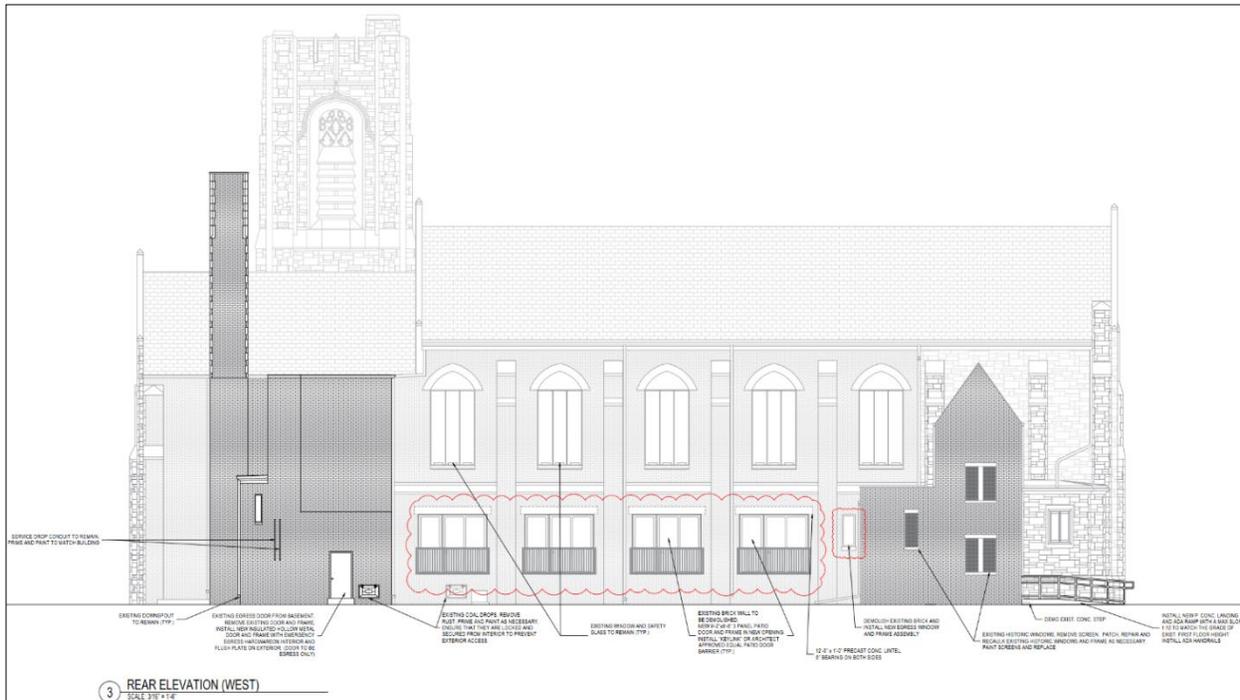
Rear elevation provided by applicant.

Highlighted: proposed four (4) sliding door additions and one (1) egress window

- It is Staff’s assessment that the addition of the sliding doors and railings will not impact the historical integrity of the building, for the following reasons:

- **Not Recommended:** *Adding new window openings on primary elevations that will negatively impact the character of the historic building.*
 - The rear location is a less visible façade and the addition of natural light will not impact any historic, character defining area of the historic church.
