677 W. Canfield

Historical District Committee Restoration Review

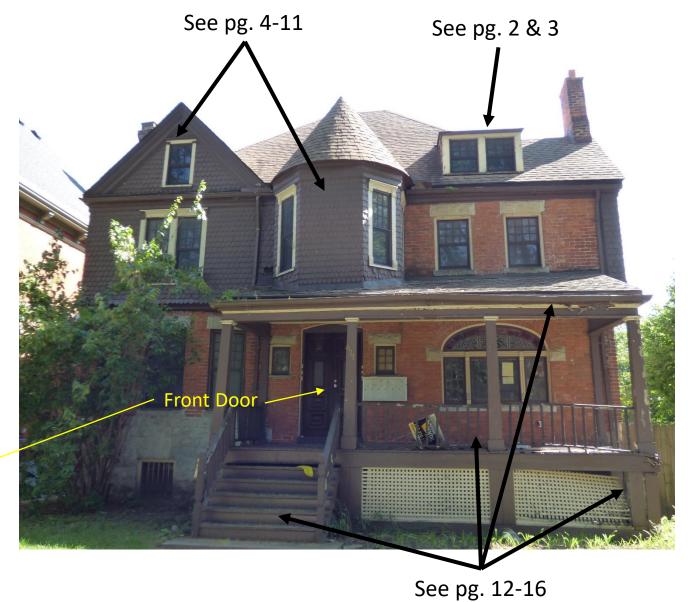
Front Elevation (2 of 16) – Roof Dormer:

Remove and replace shingle molding (existing = 3.25" x 1.5" thick) with new pine smooth molding and paint trim color. (see next page for profile)

Remove and replace flat stock surround with new 5/4 thick flat stock smooth wood and paint trim color

Remove and replace wood sill with new Cedar wood sill smooth cut to match original Profile and Paint Trim Color

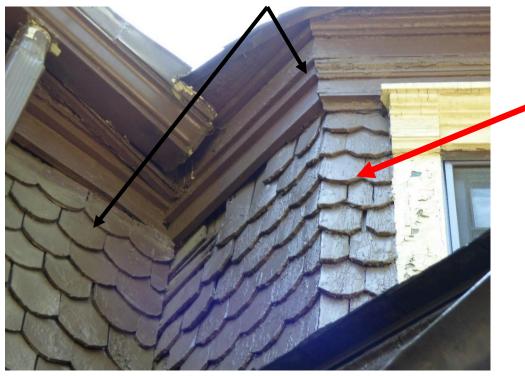
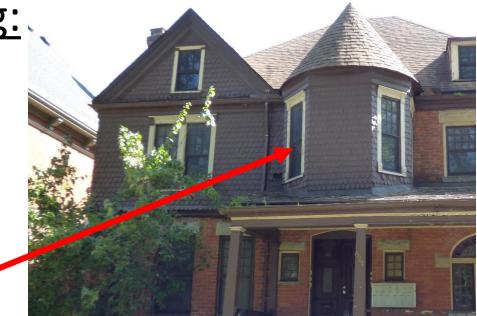
Front Elevation (7 of 16) – Siding:

A mismatched repair made with wider scallops between corner and downspout (this will be fixed with new siding) as well as this mismatched trim (about 3ft) to be repaired with salvaged trim materials

Scallop siding at front bay is different then rest of home. It is a straight bottom with angle cut corners with the same exposure and dimensions as the rest of the shingles. We are proposing to us the same scallop siding on the front bay to keep all the siding consistent.

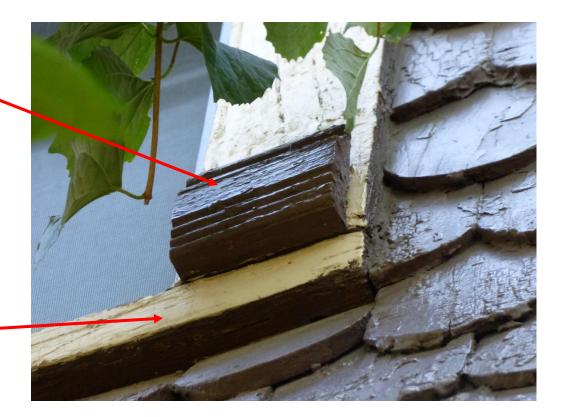
Front Elevation (11 of 16) – Window Surrounds:

Remove, strip and reinstall plinth blocks and paint trim color

Repaired or new smooth cedar sill painted trim color with matching profile to existing sill

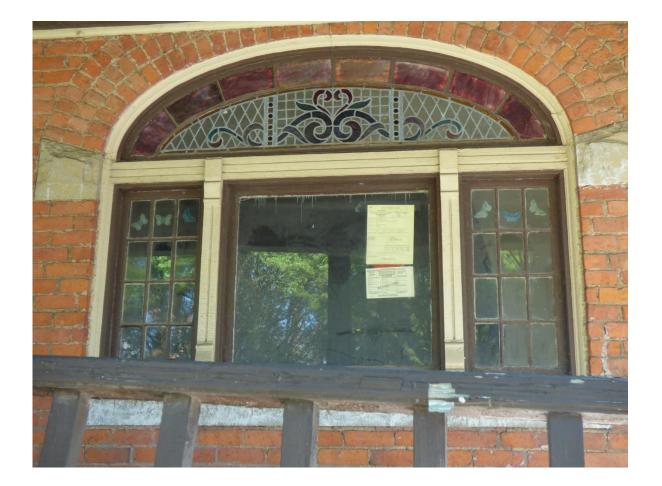
Front Elevation (12 of 16) – Window Surrounds:

Keep existing wood surround and trim - Repair as necessary and repaint with window HCD Approved color B:18 – Dark Reddish Brown

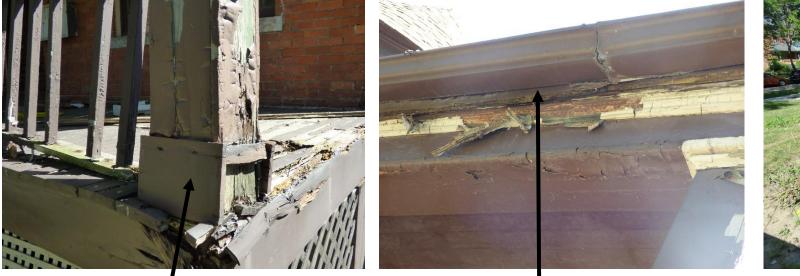
Front Elevation (15 of 16) – Front Porch:

New cedar deck boards painted for entire deck and stair treads to match 1x4 existing profile

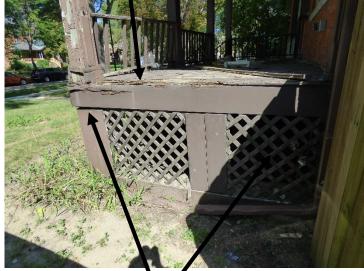
Remove and replace damaged wood at corner column with new smooth painted wood products of same dimensions Remove and replace damaged wood with new smooth painted wood product of same dimensions, about 7LF

Remove and replace damaged wood and rebuilt structure. Rebuilt trim work with smooth 1x materials painted and matching lattice to front of porch

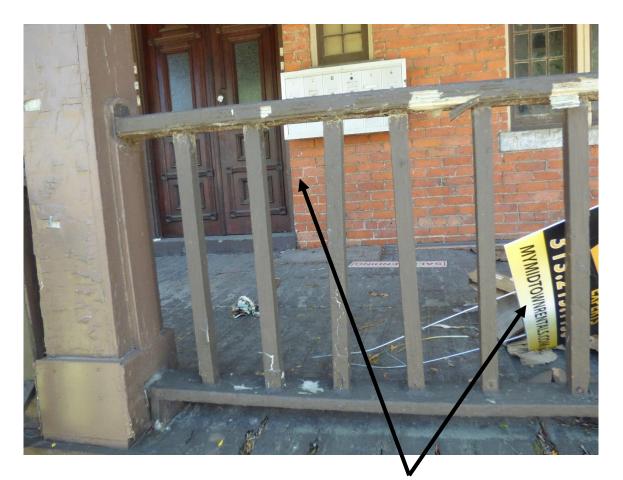
Front Elevation (16 of 16) – Front Porch:

Remove and replace railing and balusters with cedar painted wood matching existing profiles and dimensions, but spacing updated to current building code requirements.

4" minimum spacing

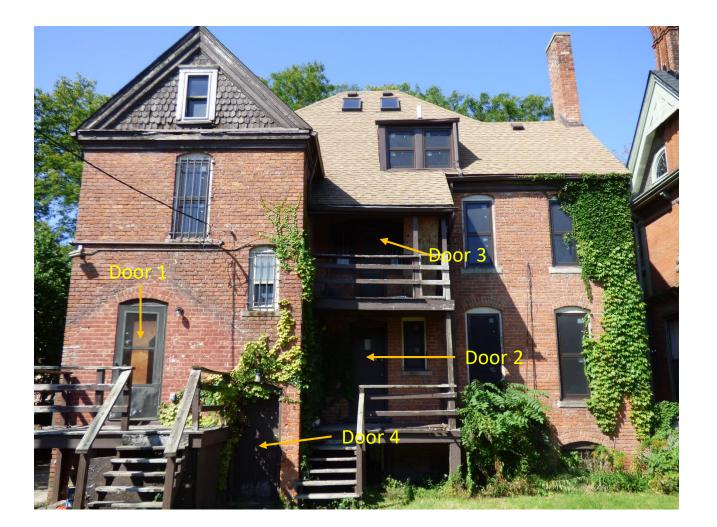
Rear Elevation (1 of 7) :

- <u>Doors</u> Replacing four entry doors on rear with new solid wood doors and stain/finished to match Front Door color and sheen. (labeled to right – see pg. 2 for door image)
- <u>Windows</u> Keeping all existing window units and glass. Non-aluminum clad windows will be painted with a color match to the existing aluminum clad windows (D-18 Dark Reddish Brown).

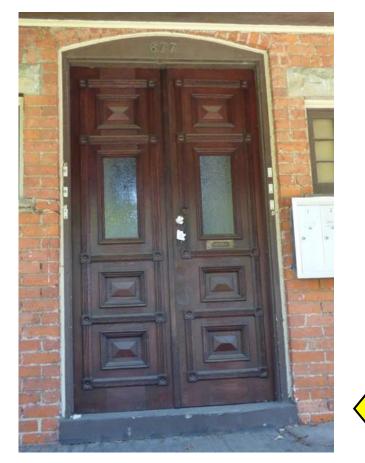
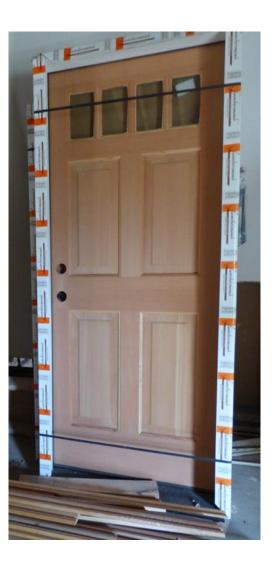
Rear Elevation (2 of 7) :

Proposed Rear Door Replacements < all four > (Color to Match the Front Door)

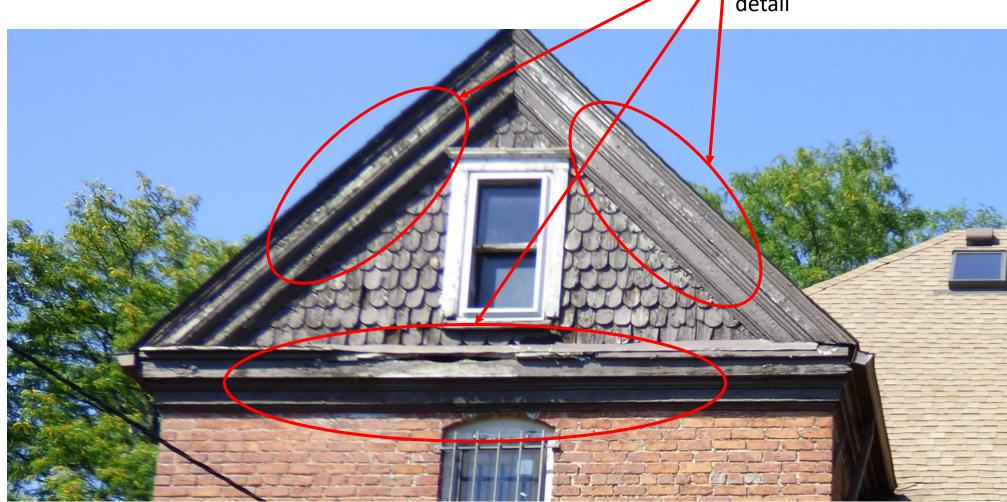
Rear Elevation (3 of 7) :

Remove and rebuilt entire gable trim and fascia that are split, rotten or damaged (about 45 lf) see next page for replica detail

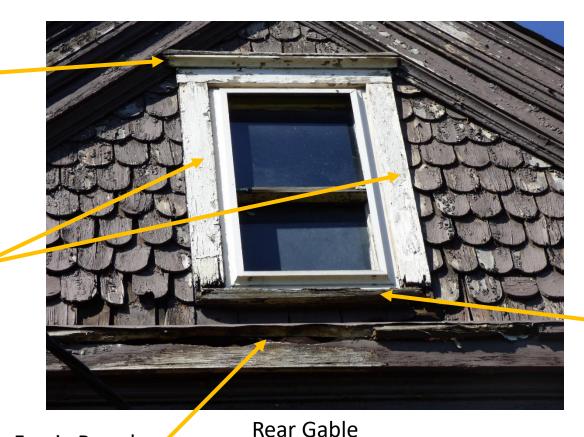
Rear Elevation (5 of 7) :

Existing 2" cove crown to be replaced with matching 2" smooth wood cove molding

Existing 5/4x4 casing and header to be replaced with new 5/4x4 flat stock smooth wood painted B:19 Black.

Remove and replace siding with new siding consistent with rest of home replacements

Existing 1.5" thick sill to be replaced with new 1.5" thick beveled washed cedar sill (cut to same profile)

Rotten Fascia Boards

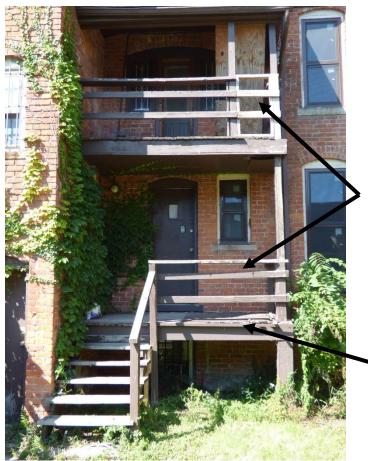
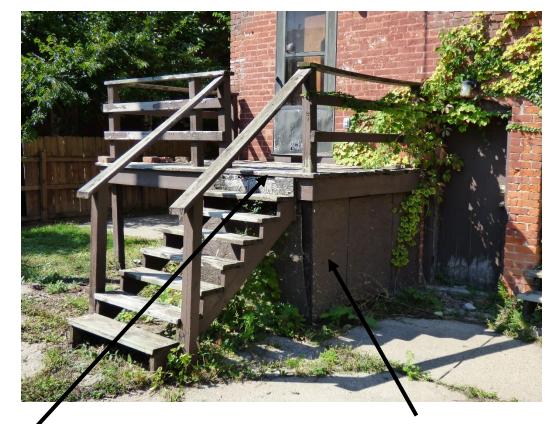
Rear Elevation (7 of 7) :

Remove stairs and railings on both rear decks and rebuilt to current building code. Railing to match front porch railing system out of smooth cedar (painted)

New deck surface to
match Front Porch –
1x4 smooth painted
cedar

Repair any deteriorated structural members or replace with exact dimensional match.

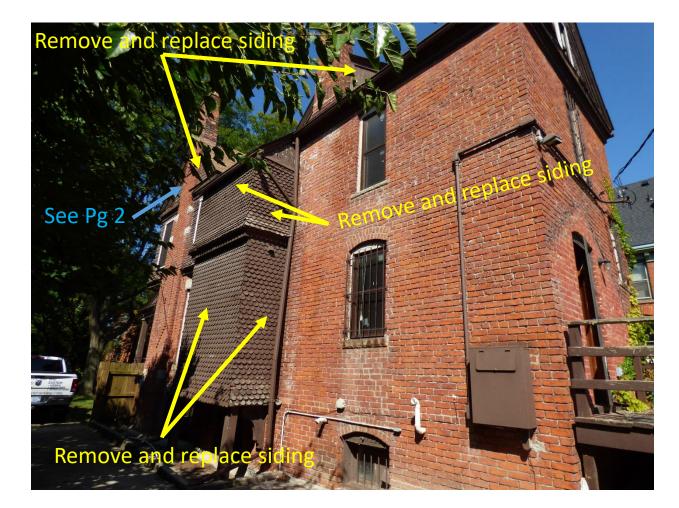
<u>Right Elevation (1 of 4):</u>

- <u>Windows</u> Keeping all existing window units and glass. Non-aluminum clad windows and wood surround windows in brick will be painted with HCD approved color B18 Dark Reddish.
- 2. <u>Siding</u> On the Bay and the two roof end gables, we propose removing the existing siding and replacing with new scallop siding to match rest of new siding on home for consistency throughout home. There is evidence of splitting and missing pieces throughout these areas. Will recreate the mitred/wrapped corner and flare out details.
- <u>Trim</u> On the two gable ends, we are proposing to replace the molding profile with the new trim profile on page 2 (there is rotten and splitting boards that need replacement)

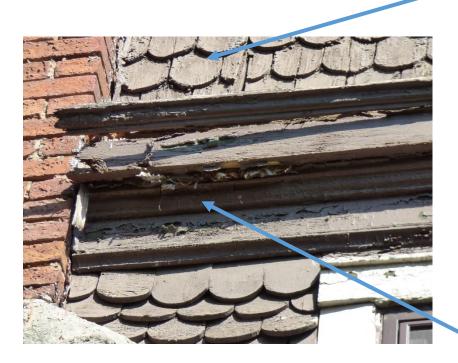
Right Elevation (2 of 4):

Remove and replace with new trim gable trim, approx. 11ft long on each side of chimney and siding (some rot and splitting)

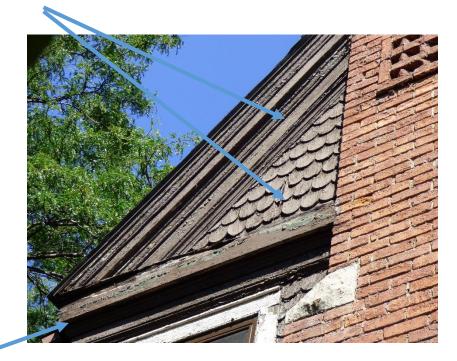
Remove and replace with new trim approx. 8ft long on each side of chimney (rotten and deteriorated)

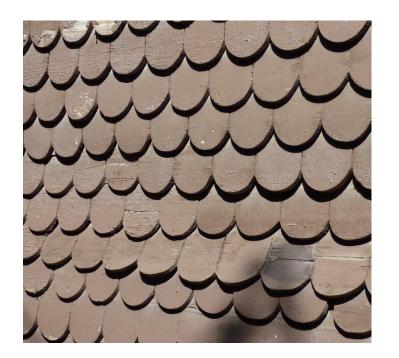
<u>Right Elevation (4 of 4) - Gable Trim:</u>

.375"thick

Existing painted wood

Dimensions of Existing

Smooth texture to be used (photo sample is textured for shape and size only)

.25" thick

Proposed: Hard shingle siding (photo courtesy: Hardiplank website)

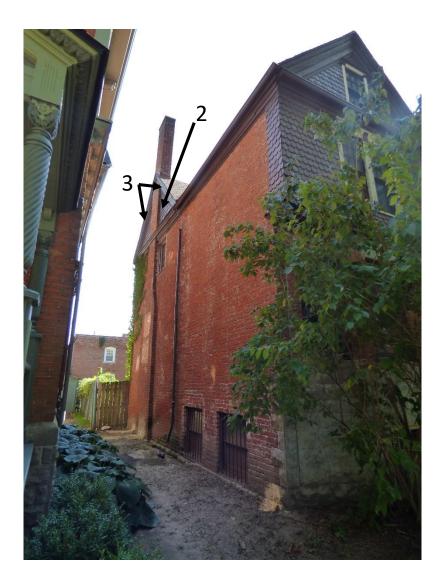
Left Elevation (1 of 3):

- <u>Windows</u> Keeping all existing window units and glass. Non-aluminum clad windows and wood surround windows in brick will be painted with HCD approved color B18 Dark Reddish.
- <u>Siding</u> Remove and Replace Siding with new scallop siding to match rest of new siding for consistency.
- **3.** <u>Trim</u> Remove and place gable trim with new molding stack profile (see pg 2)

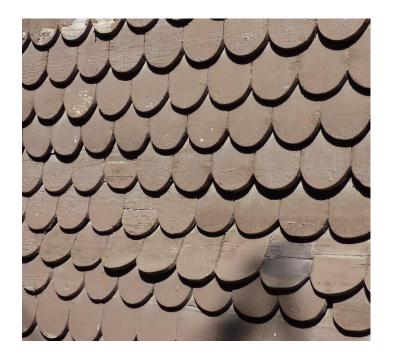
Left Elevation (3 of 3) - Siding:

4" wide

.375"thick

Existing painted wood

Dimensions of Existing

Smooth texture to be used (photo sample is textured for shape and size only)

.25" thick

Proposed: Hard shingle siding (photo courtesy: Hardiplank website)
