MILWAUKEE JUNCTION EAST GRAND + OAKLAND

HDC | NOVEMBER 2020

2857 & 2863 E GRAND BLVD SUMMARY

CLEANING PROCESS + EXISTING CONDITIONS

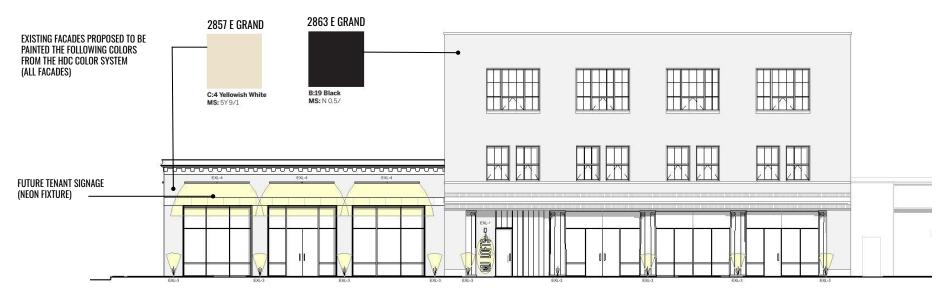
EAST GRAND BLVD - NORTH FACADE ORIGINAL PROPOSAL

- NEW WINDOWS IN EXISTING OPENINGS
- PAINT EXISTING BRICK
- NEW FACADE LIGHTING

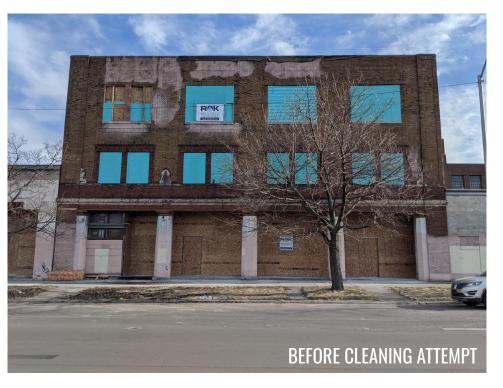
2857 & 2863 E GRAND BLVD NORTH ELEVATION

Contractor attempted to clean the graffiti from the brick facade on the upper levels of 2863 East Grand. He used HDC's Guidelines for Cleaning Masonry.

- CitriStrip paint stripper (no harsh fumes or NMP) was applied to a small test patch, in an area where brick had been painted with graffiti. After sitting for 15 minutes, the contractor used a power washer to attempt to remove the paint. **None of the graffiti or paint came off.**
- Muriatic Acid was applied to a small test patch of existing brick that had graffiti. After sitting for 15 minutes and power washing, no paint or graffiti were removed. See videos <u>here</u> and <u>here</u> of this process.

Conclusion: There is extensive damage and graffiti to the brickwork across both 2857 and 2863. Levels 2 and 3 of 2863 are also covered with extensive graffiti. Efforts to clean and remove this graffiti have shown no progress in rectifying this damage. It is our conclusion therefore that **the brick cannot be restored to its original condition**. We propose that the building be painted in its entirety in order to resolve the inconsistencies and damages caused by graffiti.

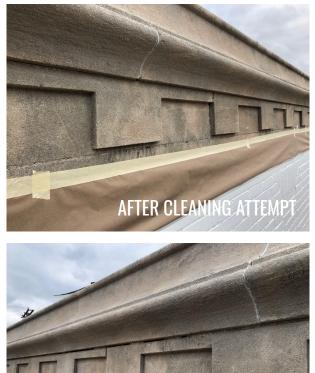
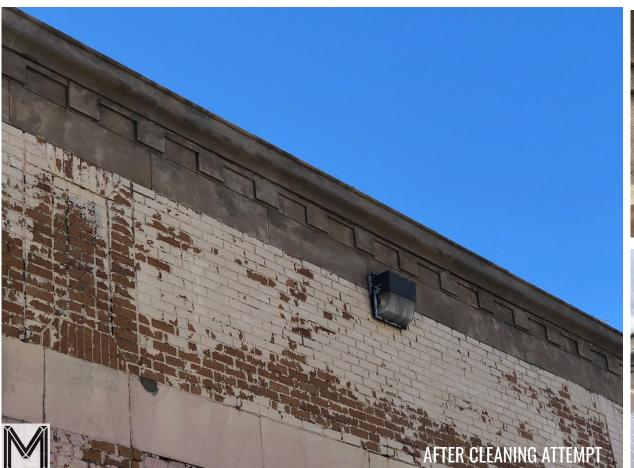
2857 E GRAND BLVD Cornice

The cornice on 2857 is also in poor condition, despite extensive efforts to clean and repair. Paint and stains remain and have a negative visual effect on the finished look of this rehabbed building. It is our opinion that the cornice should be painted to match the look of the rest of the building - the historical character, texture, and profile will remain, but without the staining and inconsistencies.

AFTER CLEANING ATTEMPT

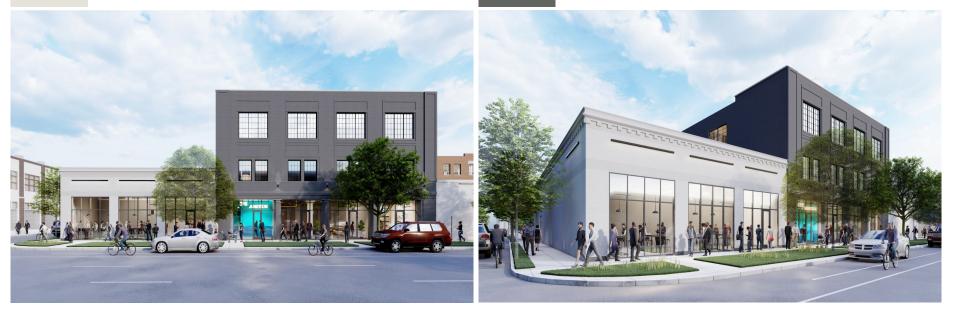
2857 & 2863 E GRAND BLVD PROPOSED COLORS

2857 - Sherwin Williams 7636 Origami White

2863 - Sherwin Williams 7068 Grizzle Gray
