## 1419 Seyburn Street: Scope of Work for Historic Approval

**Project Description:** Full gut rehabilitation of a single family home, previously abandoned and purchased off the tax auction. We are requesting approval to update the windows to aluminum clad wood, to repair the stucco, and repaint the exterior. Full mold mitigation and interior demolition was required due to excessive flooding that destroyed all interior hardwood and plaster, revealing a prior extension that was added to the kitchen on top of a porch. Because the porch didn't have the proper structure to support the kitchen, the back of the house where this extension exists is collapsing. In order to stabilize this, we need to reinforce the foundation in the back of the house. Within this newer extension over the former patio, there is a window we'd like to close over to add a kitchen pantry. We would also like to close an opening on the extension where we believe the oven ventilation once existed and add French doors to the existing patio. There is one pre-existing kitchen window that we'd like to raise to the height of the dining room windows to enable us to add a kitchen counter and create a consistent site line o

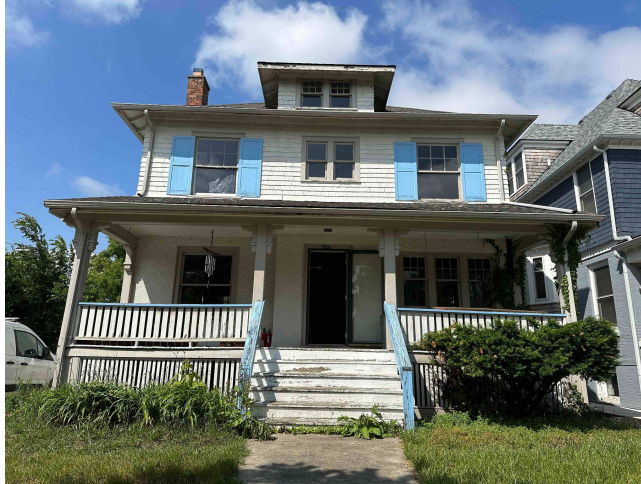
Current view:

- Replace windows with **Andersen 400 Series aluminum clad wood windows with E4 energy efficient glass**. Sandstone exterior and pine interior. Colonial grid on the top sash only for all front-facing windows EXCEPT the small central ones on the second floor, which will not have the Colonial grid.

- Repair stucco on first floor
- Stabilize wooden front porch
- Repaint house with greige trim, white stucco on the first floor, white shake on the second and third floors, and contrasting charcoal grey shutters on the second floor.

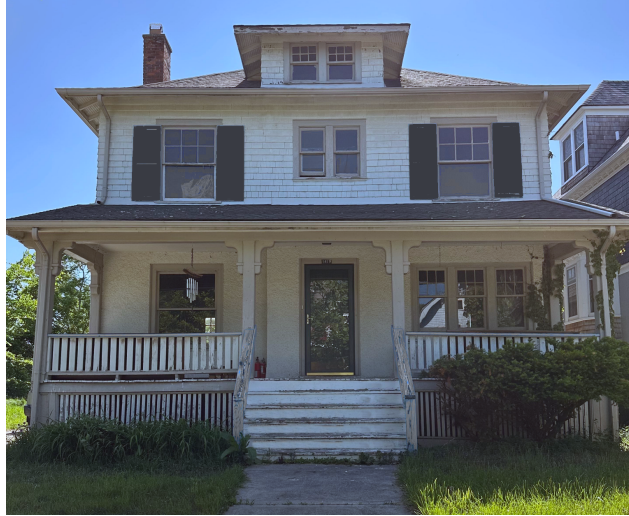
Proposed color scheme:

- Replace all blue paint, restoring the color scheme from the 1900s (see first photo)

**C:4 Yellowish  
White**

- Base color:

**MS: 5Y 9/1**

**A:2 Light Olive Gray**  
**MS: 10Y 6/1**

- Trim:

**A:8 Blackish Green**  
**MS: 2.5BG 2/2**

- Shutters:

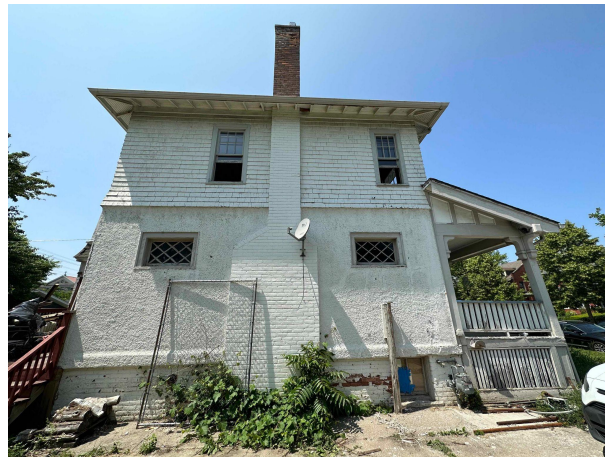
## Project Details: South Facade

- Restore diamond-muntin windows and add storm windows for protection and efficiency
- Repair stucco
- Repaint

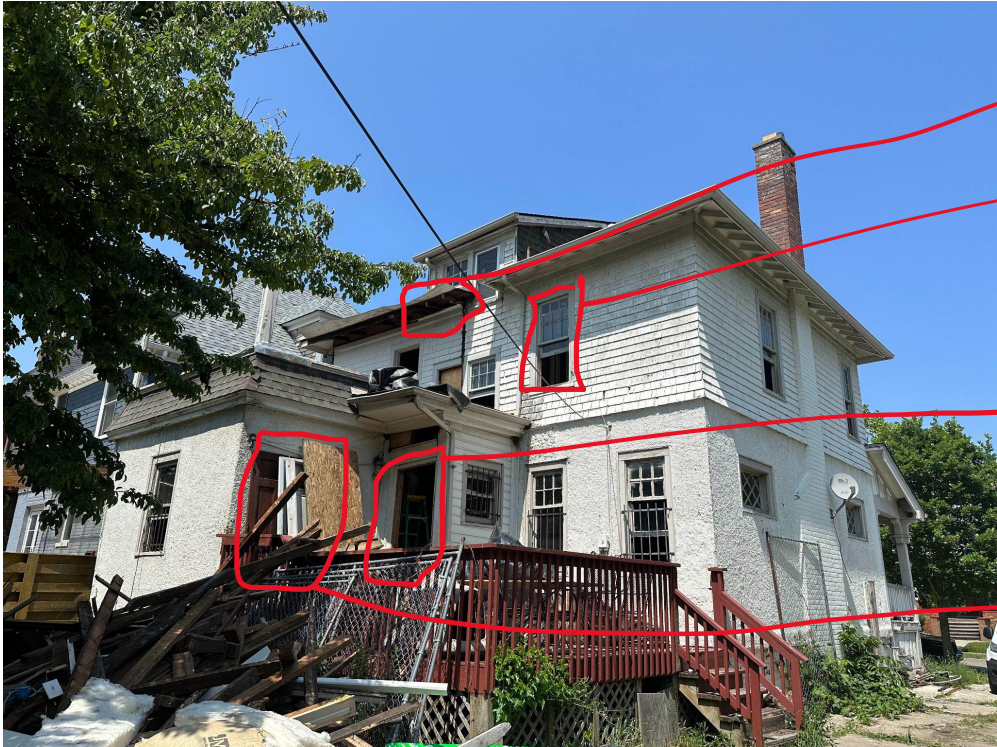
**Project Details: West/Rear Façade**

Remove roof extension that covers 3<sup>rd</sup> fl window

Replace window with fiberglass shower-proof window (see spec)

Replace door with small window

Add French doors leading to patio from kitchen/extension

- Replace second story double-hung window with fiberglass window and white-opaque glass (this window is in the new shower of the primary suite)
- Repair extension roof and deck above it
- Restore historic roof line (which was previously expanded beyond the patio door, over the third floor window)
- Replace the 36" window on the rear extension with a 60" window
- Replace the back door with a small window
- Add French doors from the extension onto the back patio
- Repair stucco
- Repaint

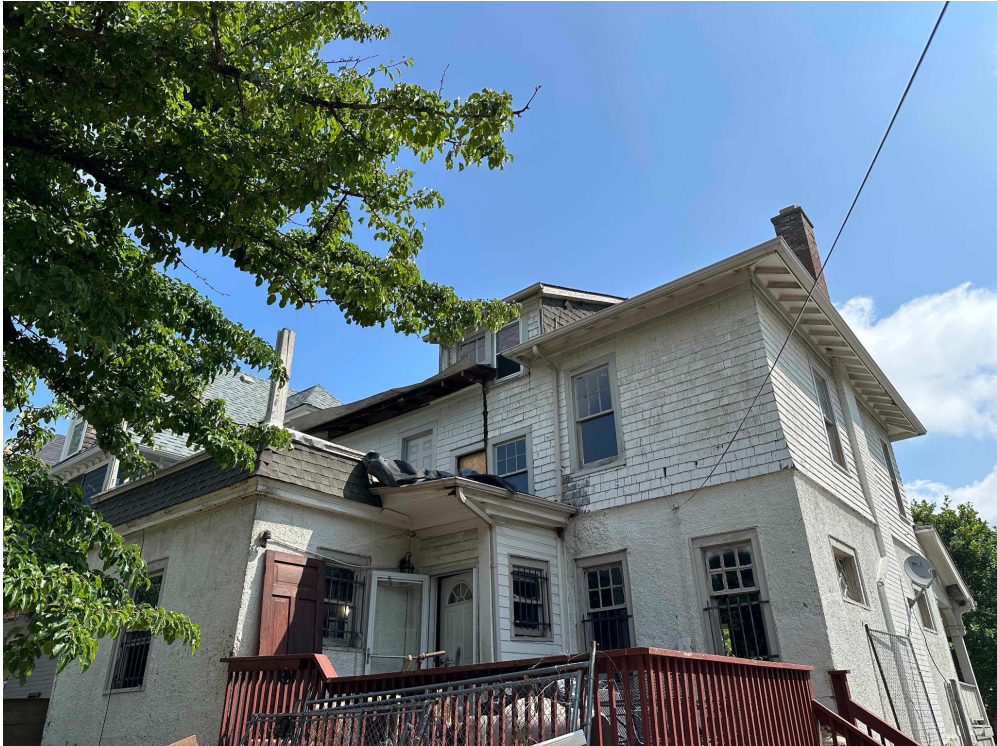
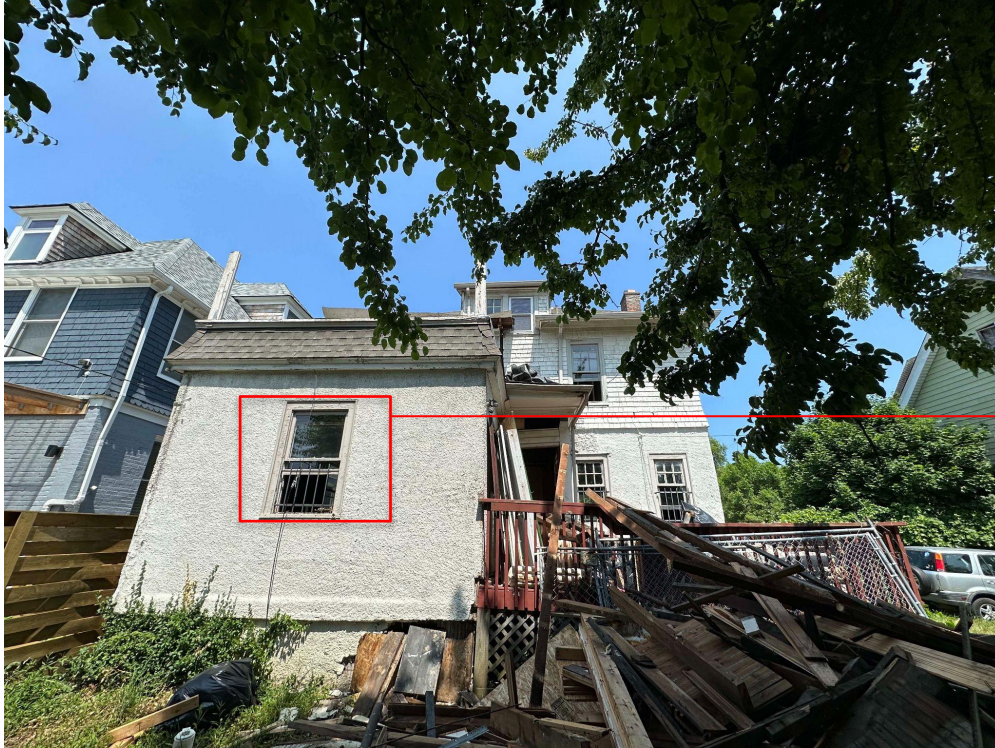
Replace 36" window  
with 60" window

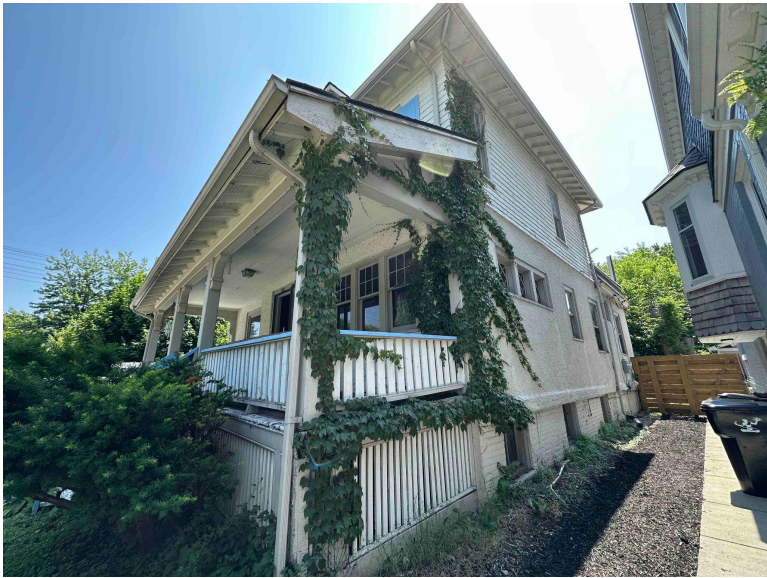
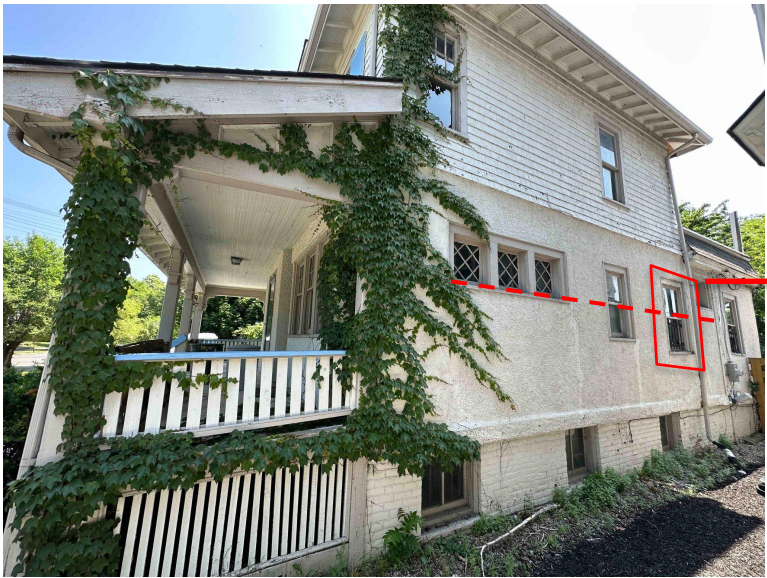
**Project Details: North Façade**

Reduce length of kitchen window to accommodate counter inside and match the site line of the historic dining room windows

- Close former oven ventilation “window” and full-sized window on the extension
- Shorten the window in the kitchen to accommodate a counter and match the architectural lines of the historic diamond windows in the dining room
- Repair historic diamond-muntin windows and add storm windows for protection and efficiency
- Repair stucco
- Repaint

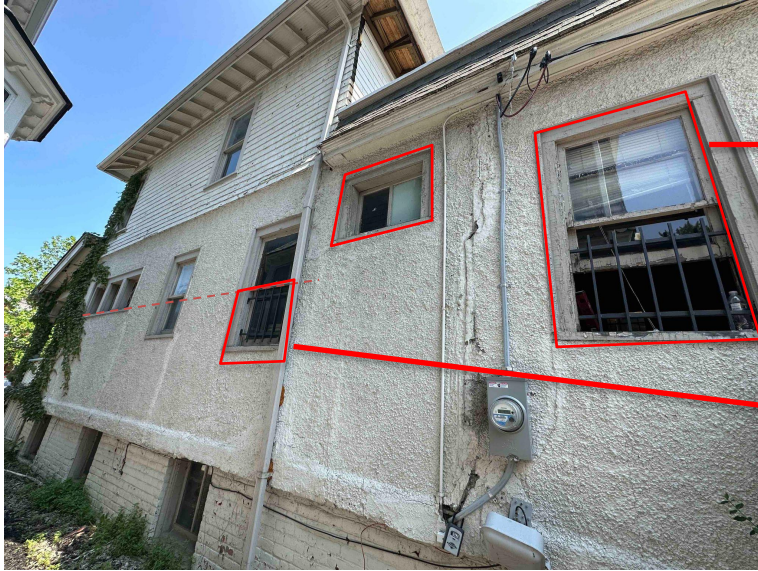
Close the ventilation opening and window that were added onto the extension to accommodate the kitchen build

Reduce length of kitchen window to accommodate kitchen counter inside and match site line of historic dining room windows

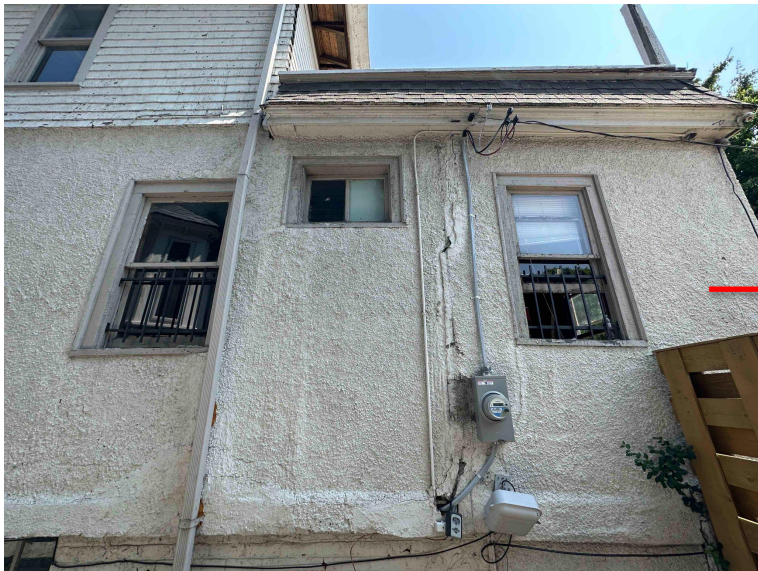
Repair/replace water damage to stucco and stabilize where the extension is tearing away
