Exhibit F - Schaap Center Flooding Risk Evaluation - Page 1 of 17

Schaap Center Flooding Risk Evaluation

September 17, 2021

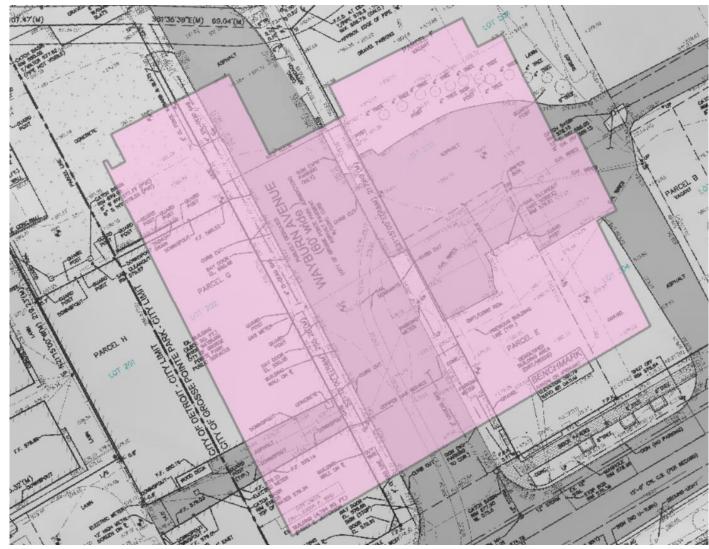
Spot Elevations Check

- LiDAR data was checked against surveyed spot elevations
- Elevation differences ranged from 0-ft to 0.5-ft
- LiDAR data trended higher than survey data

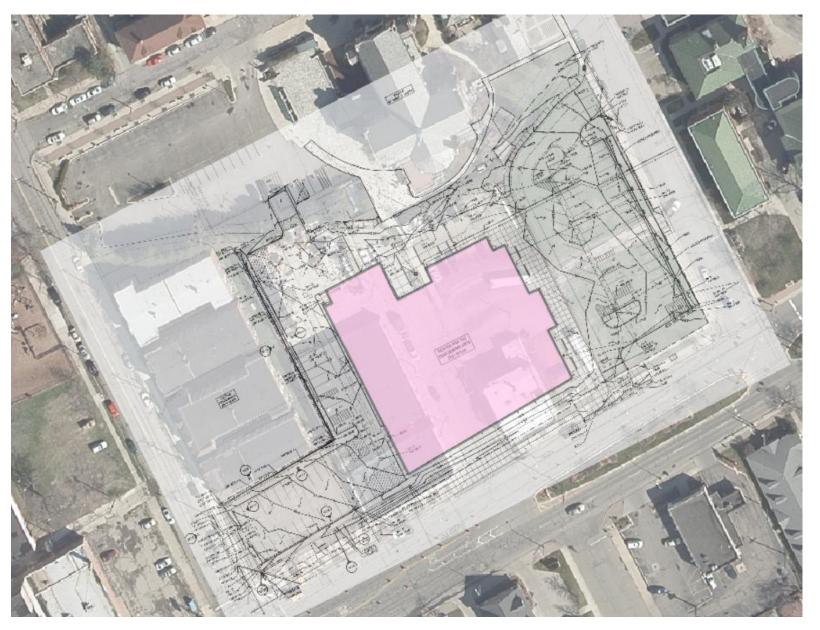
Building Footprint Location on Site

Location of proposed building footprint was developed using plans

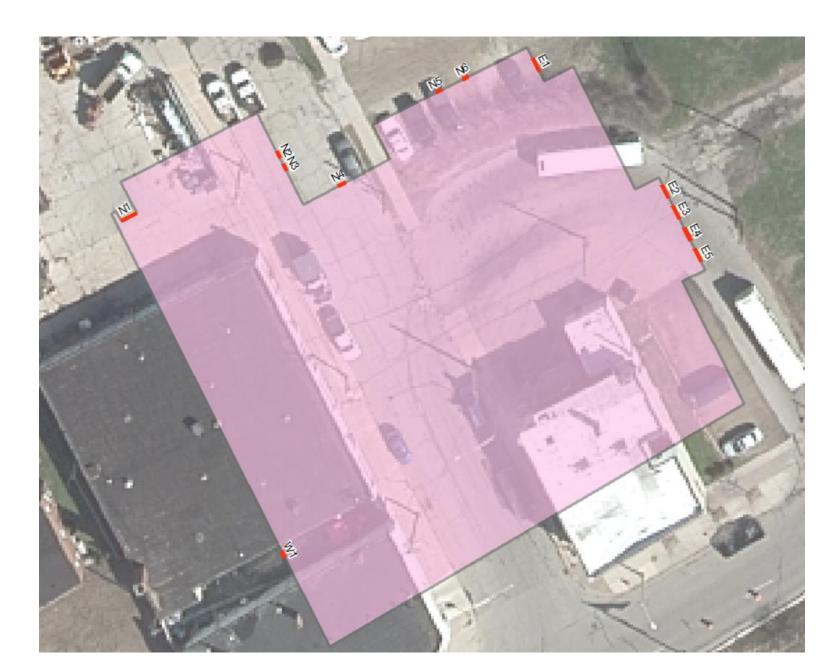
Door Locations

Entrances to building were identified based on plans

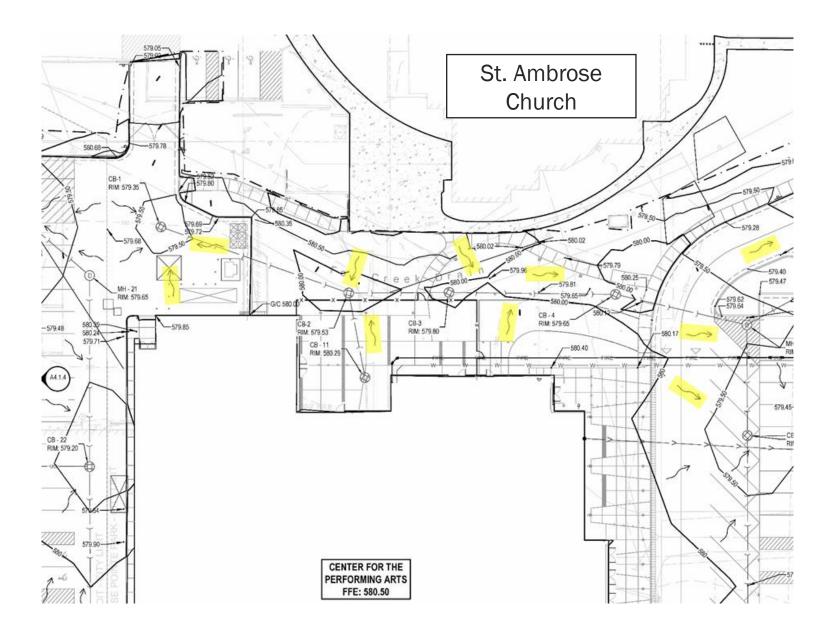
Surface Flow Directions (Proposed Grading)

- Proposed grading is lower than door thresholds
- Flow is directed toward proposed catch basins
- Surface grading does not increase flow toward St. Ambrose Church

- 1. Review design to verify capacity of sump pump
- 2. Investigate incorporating backflow prevention into the storm and sanitary connections
- 3. Verify grading plan on North side of building directs surface flow toward Maryland St. during extreme storm events
- 4. Verify grading plan diverts flow away from building at the Southwest door.

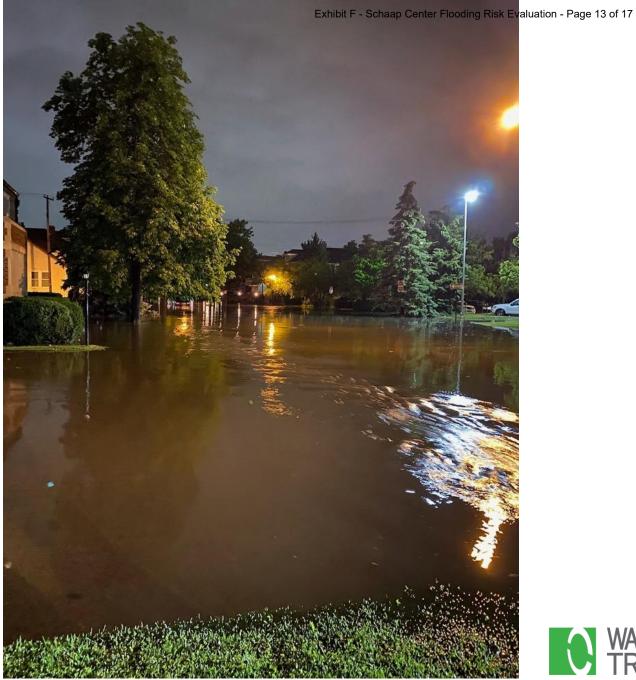
St. Ambrose Parish Photo Album: Flood – June 26, 2021

Photo used to estimate flood level and extent of flooding for June 25, 2021 event

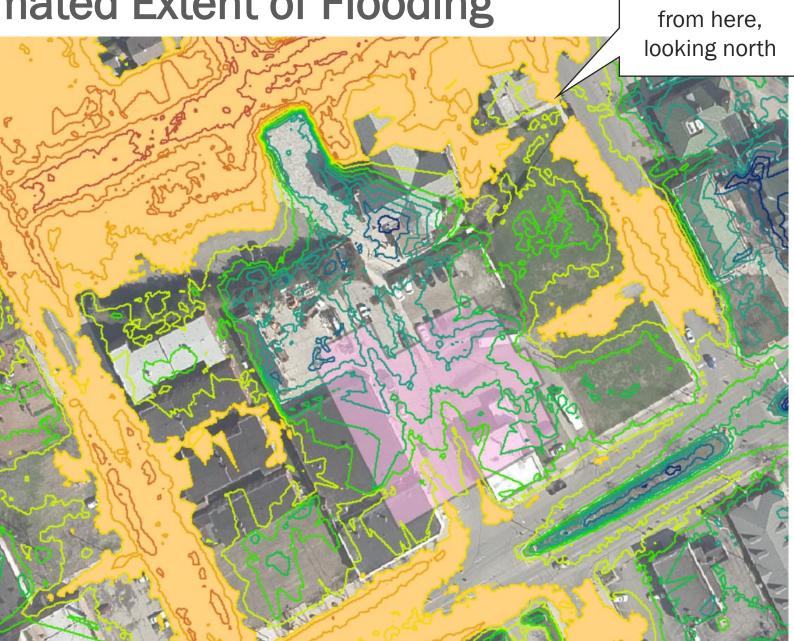
June 25, 2021 Estimated Extent of Flooding

- Flood elevation was determined to be 578.5' based on photo and LiDAR data
- Areas below 578.5' are shaded in orange
- Flooded area is not overlapping with Schaap Center footprint

- 1. The design protects floor drains from storm sewer backwater using a sump pump.
- 2. The design protects <u>footing drains</u> from storm sewer backwater using a sump pump
- 3. Sources of <u>sanitary flow</u> are above the ground surface and will be able to enter the combined sewer via gravity during sewer backwater conditions
- 4. Surface water generally flows away from the building
- 5. There may be some risk from surface flooding on the North side of the building and at the SW door.
- 6. The propose grading is not expected to increase the risk of flooding on the St. Ambrose Church property or adjacent properties.
