# M & N General Contracting LLC

Re: 637 Brewster, Brewster Wheeler Recreation Center  
Work in process before HDC approval

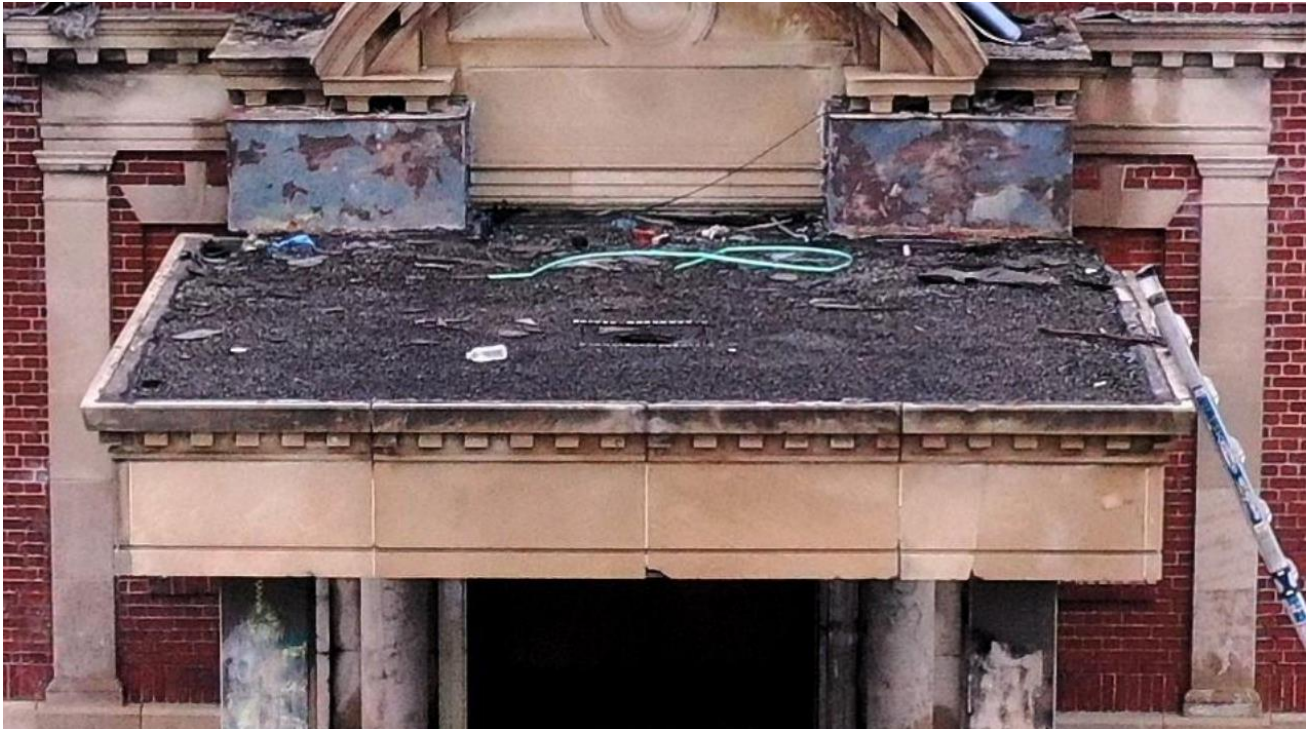
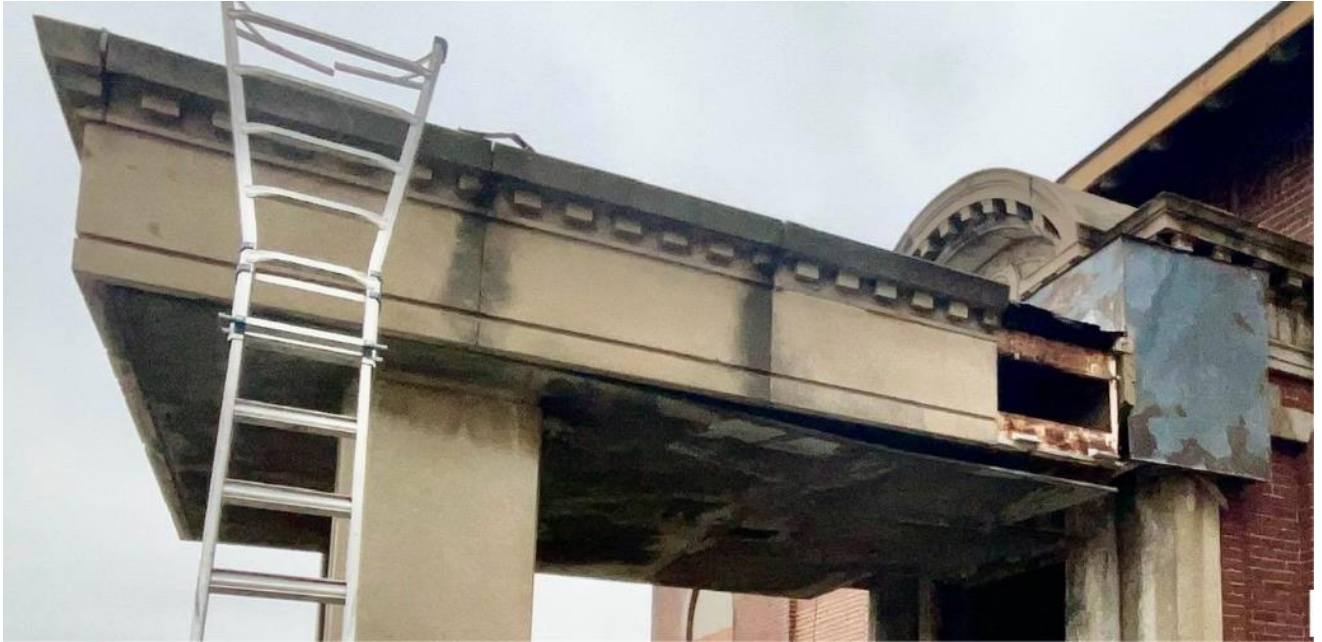
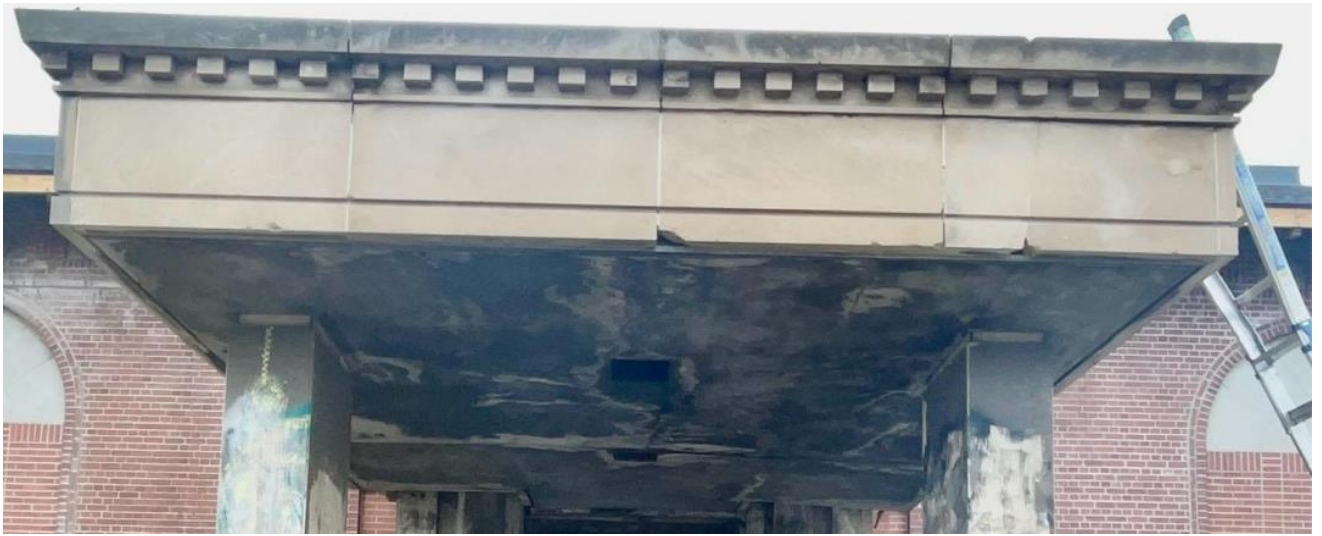
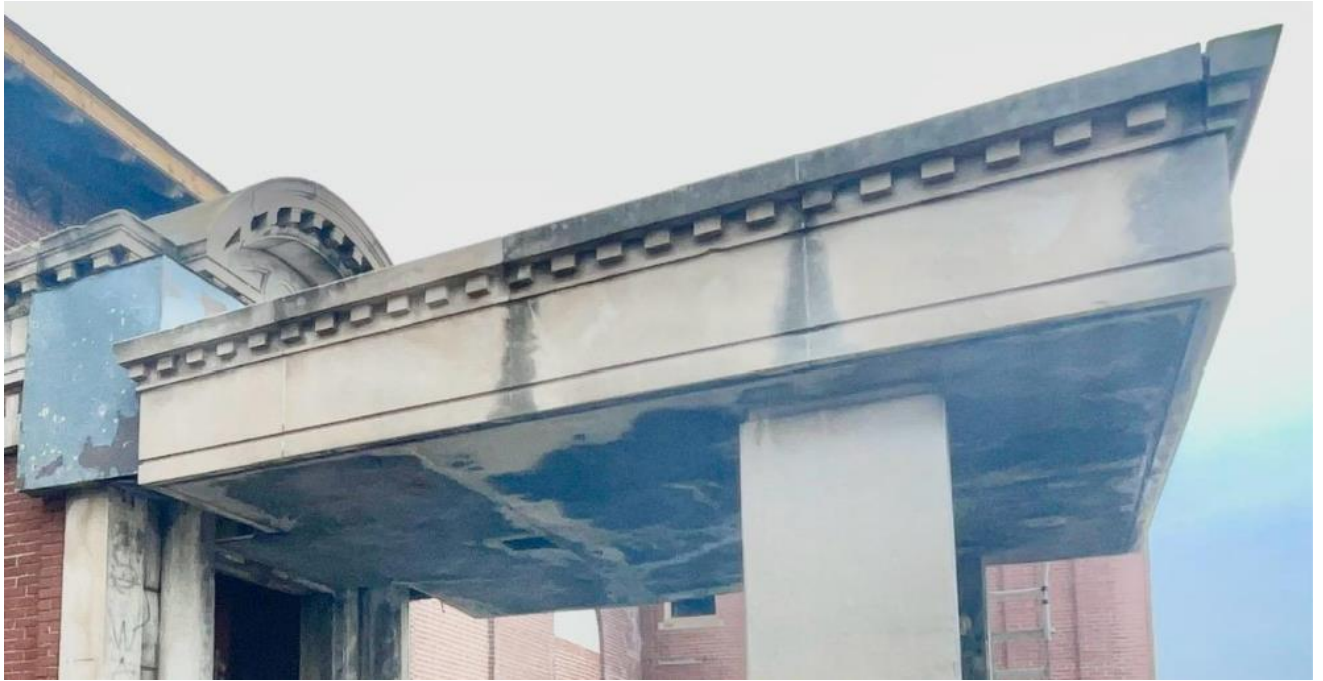
**Item #1: Existing canopy at the south elevation, west end- Library entry.**

The existing canopy stone items and suspended plaster-type ceiling were in disrepair and were in danger of falling on workers or visitors.

The roof was in disrepair and water was pouring through it. Some pieces of the stone fell from the structure.

At the direction of the owner M & N Construction LLC staff removed the outer items from the canopy as a safety precaution. (See pictures below)

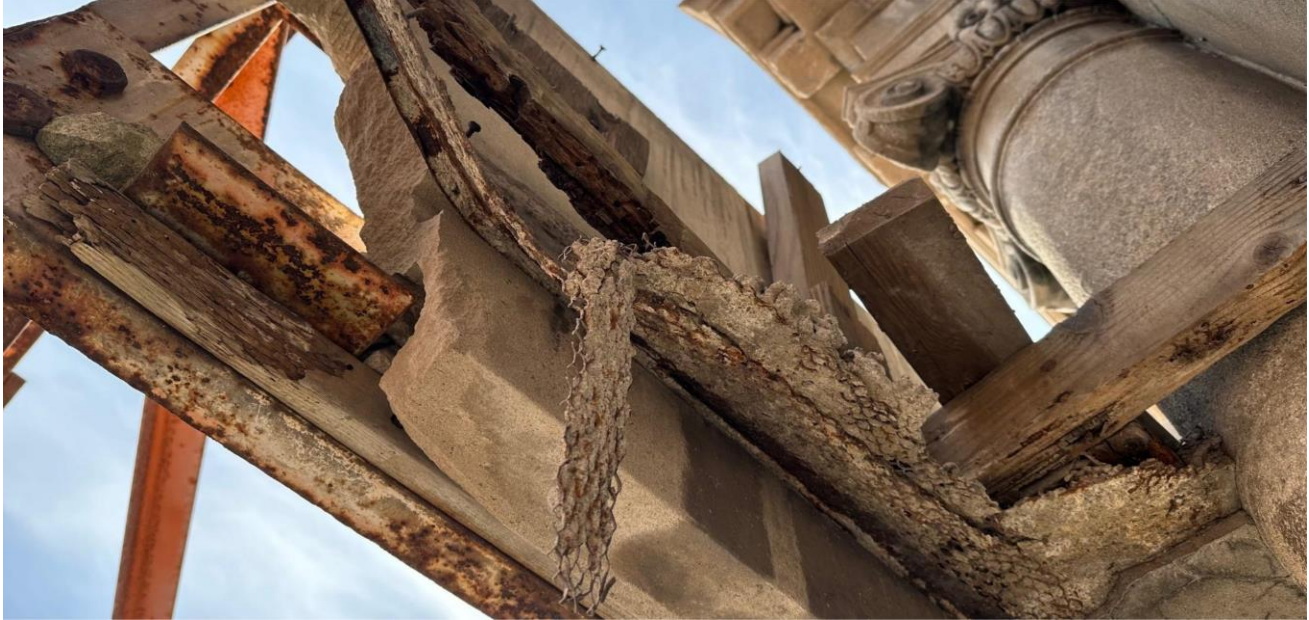
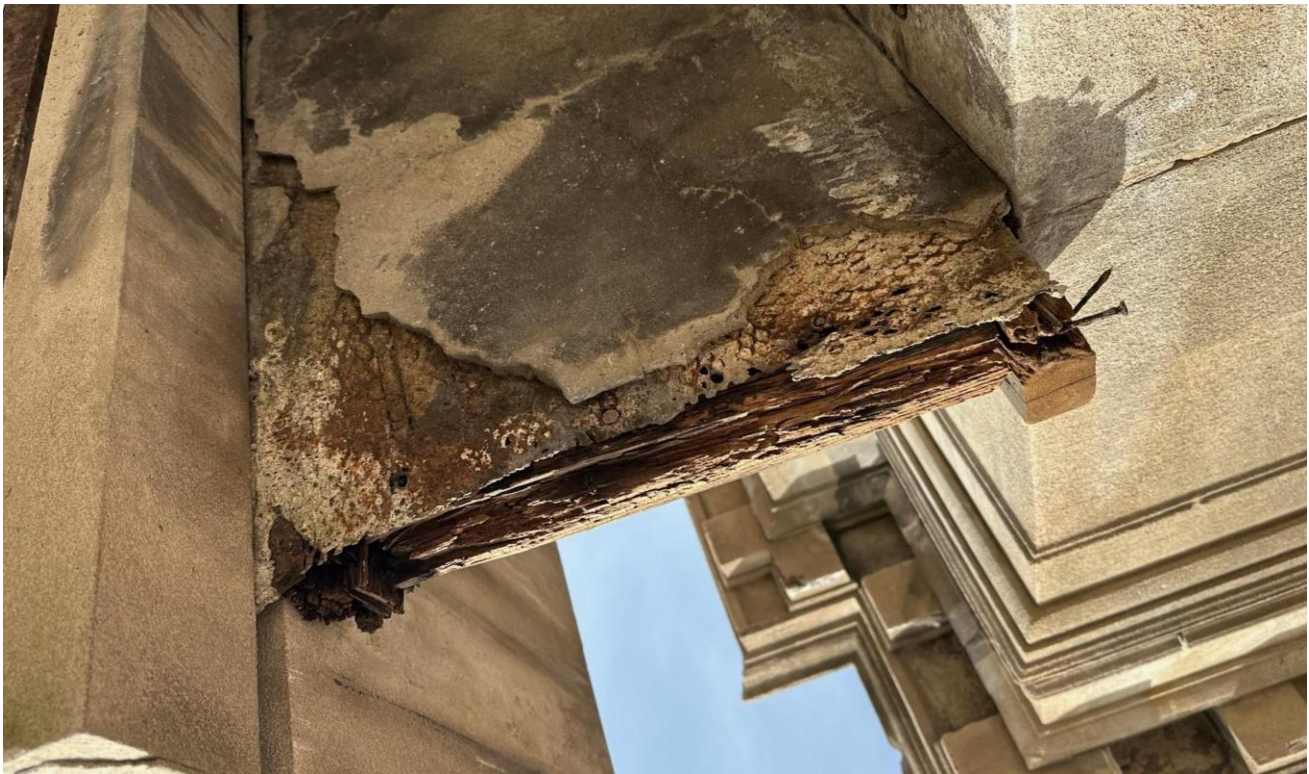
The following photos illustrate the rot of the substrates beneath the stone and roofing.

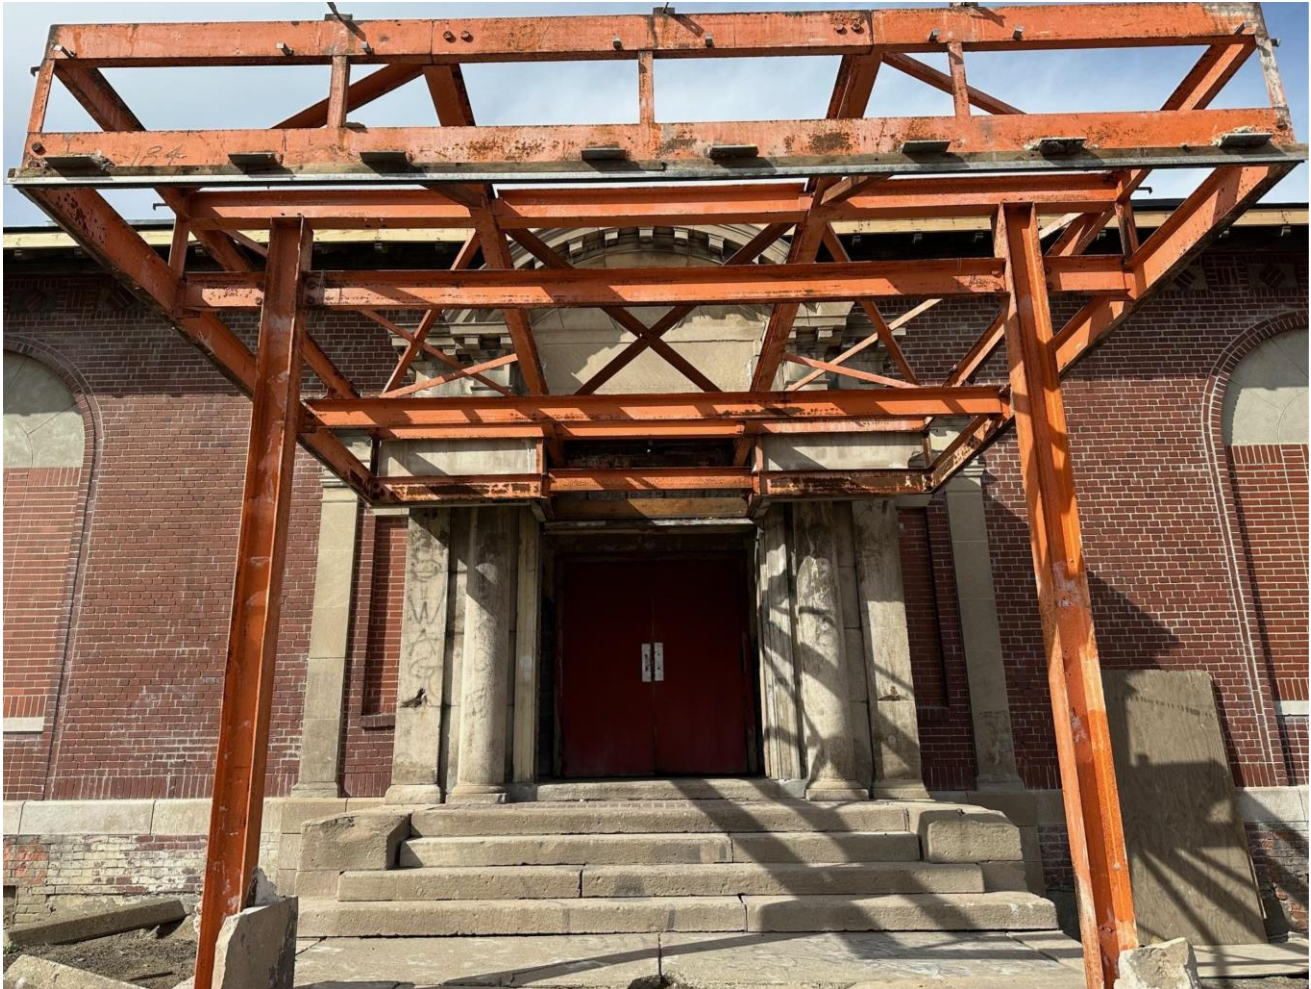
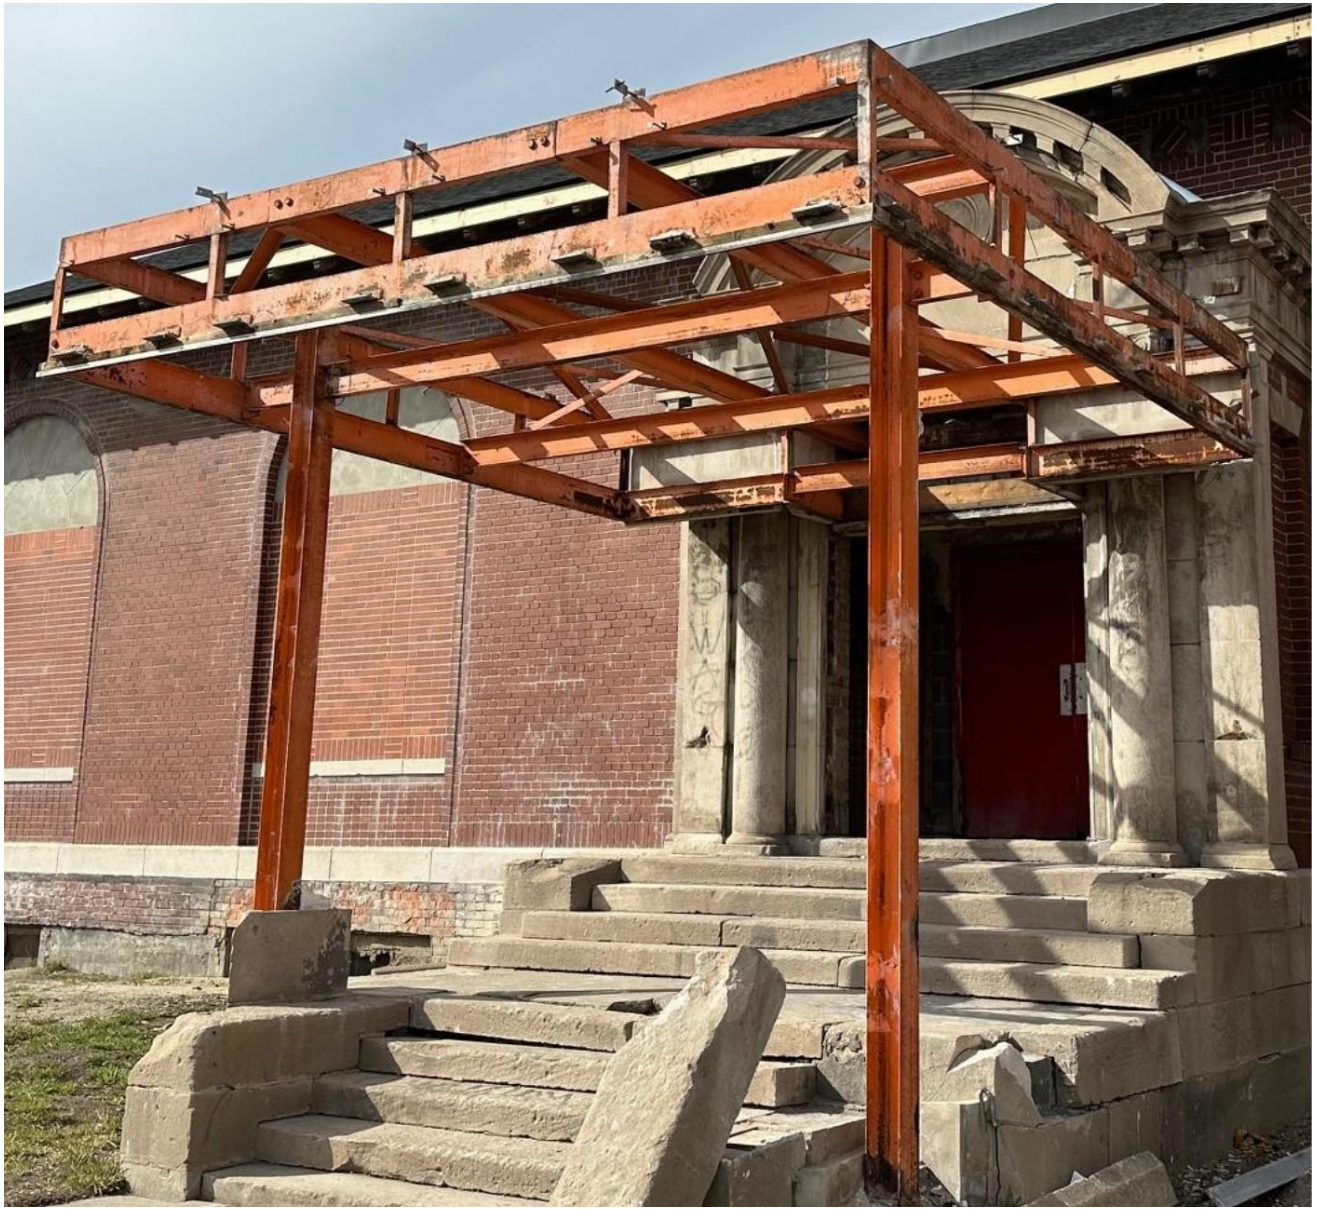
The following photos illustrate the structural steel for the canopy- still intact.

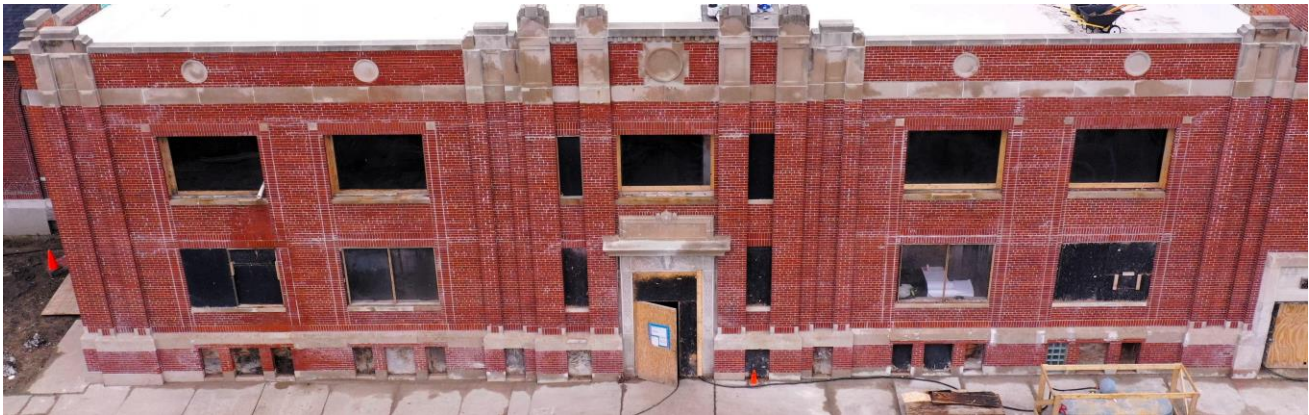
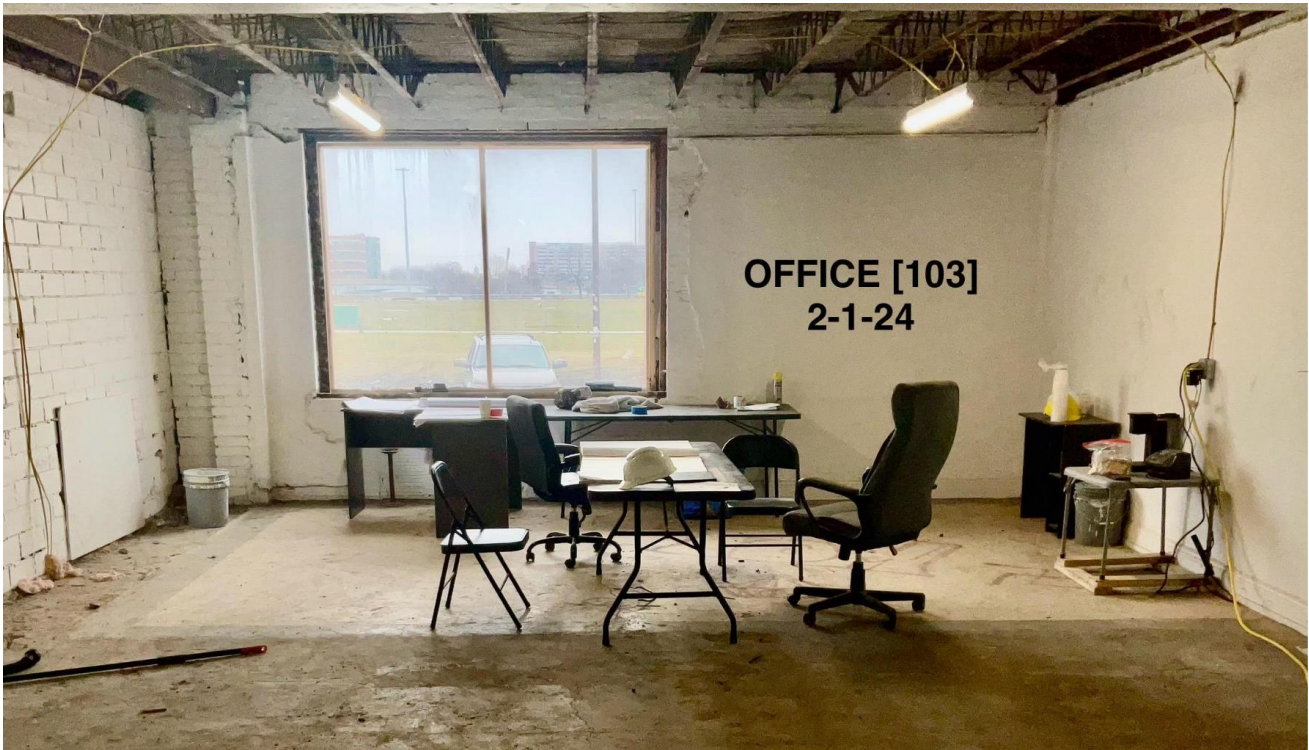
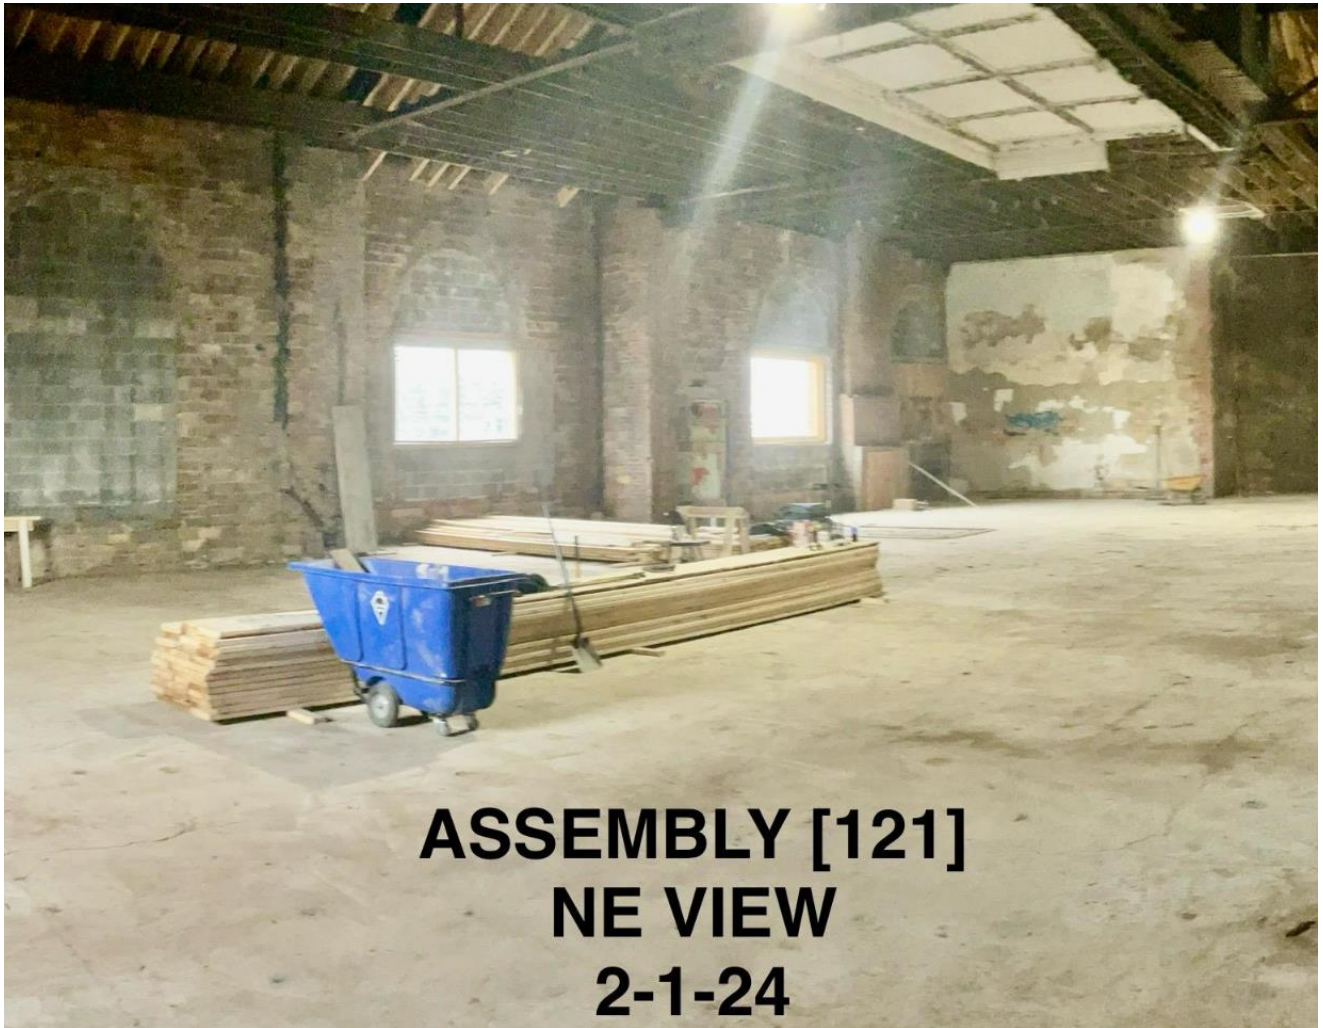
Item #2: Existing window openings- Install clear plexi-glass on them in-lieu of plywood.

The owner requested that the temporary plywood installed on the window openings to secure the building and protect it from outside elements be removed and replaced with clear plexi-glass to allow natural light inside the building and also allows potential partners to see the outside view from inside the building. This is only a temporary measure and the permanent windows will be ordered per and upon HDC approval of the construction documents submitted.
