677 W Canfield St – Historic District Commission

Exterior Changes Appropriateness Review: HDC2024-00343

Rear Construction – Overview

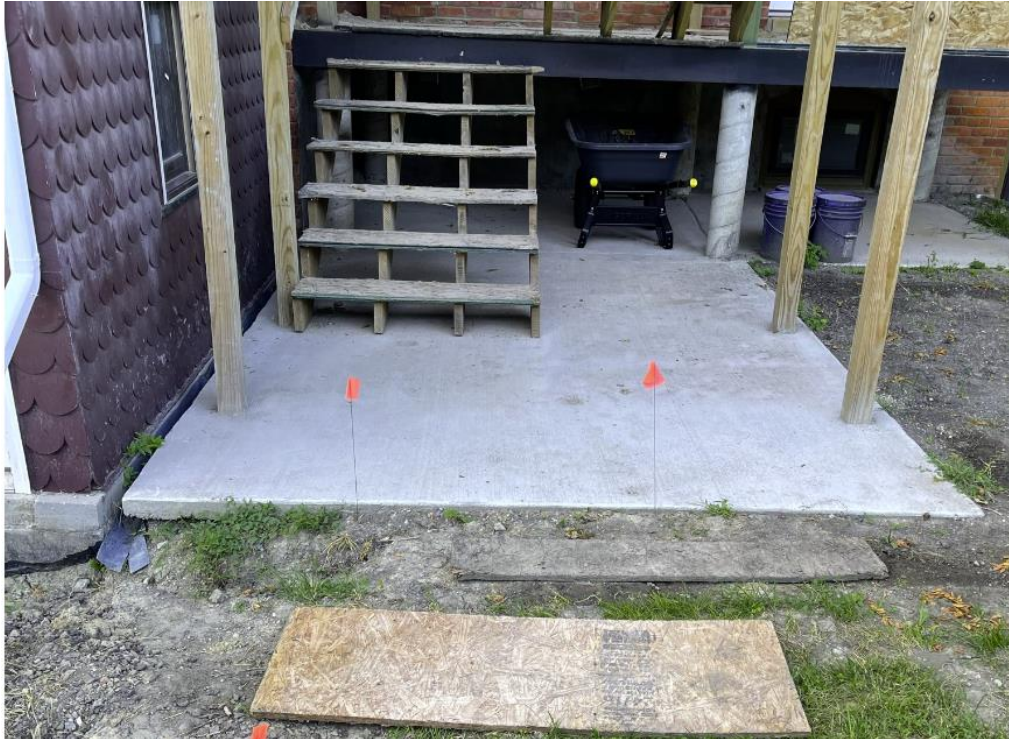
Paved Area #1

Gravel: 4" gravel base compacted with tamper

Mesh: Grade 40 galvanized wire mesh

Concrete: 4" of 4000 PSI concrete

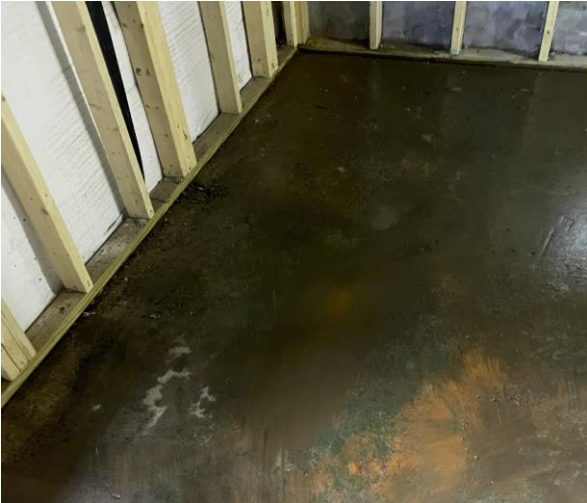
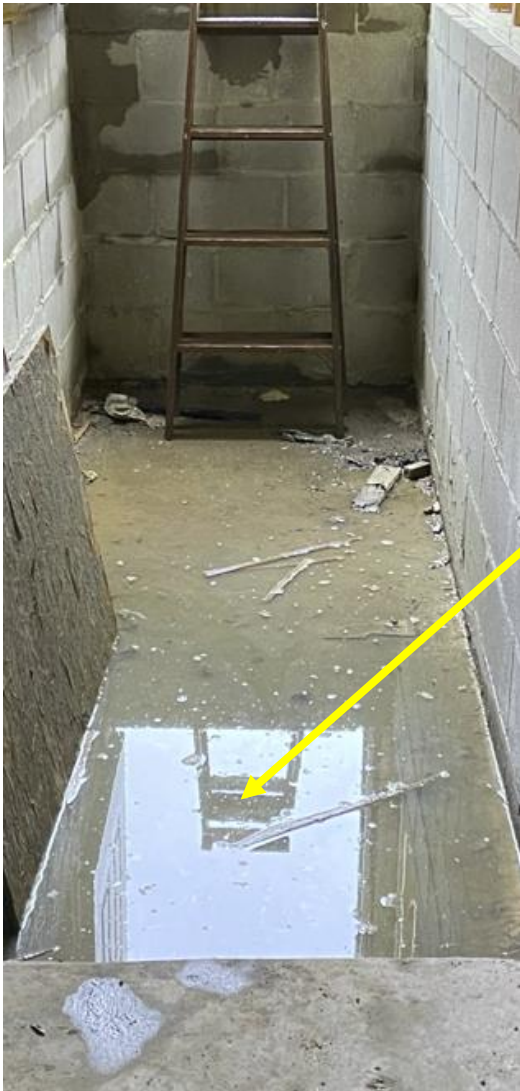
Pre-Rear Construction

Floor Drain
