# 677 W Canfield St – Historic District Commission

Appropriateness Review: HDC2024-00404 – COA Conditions Proposal

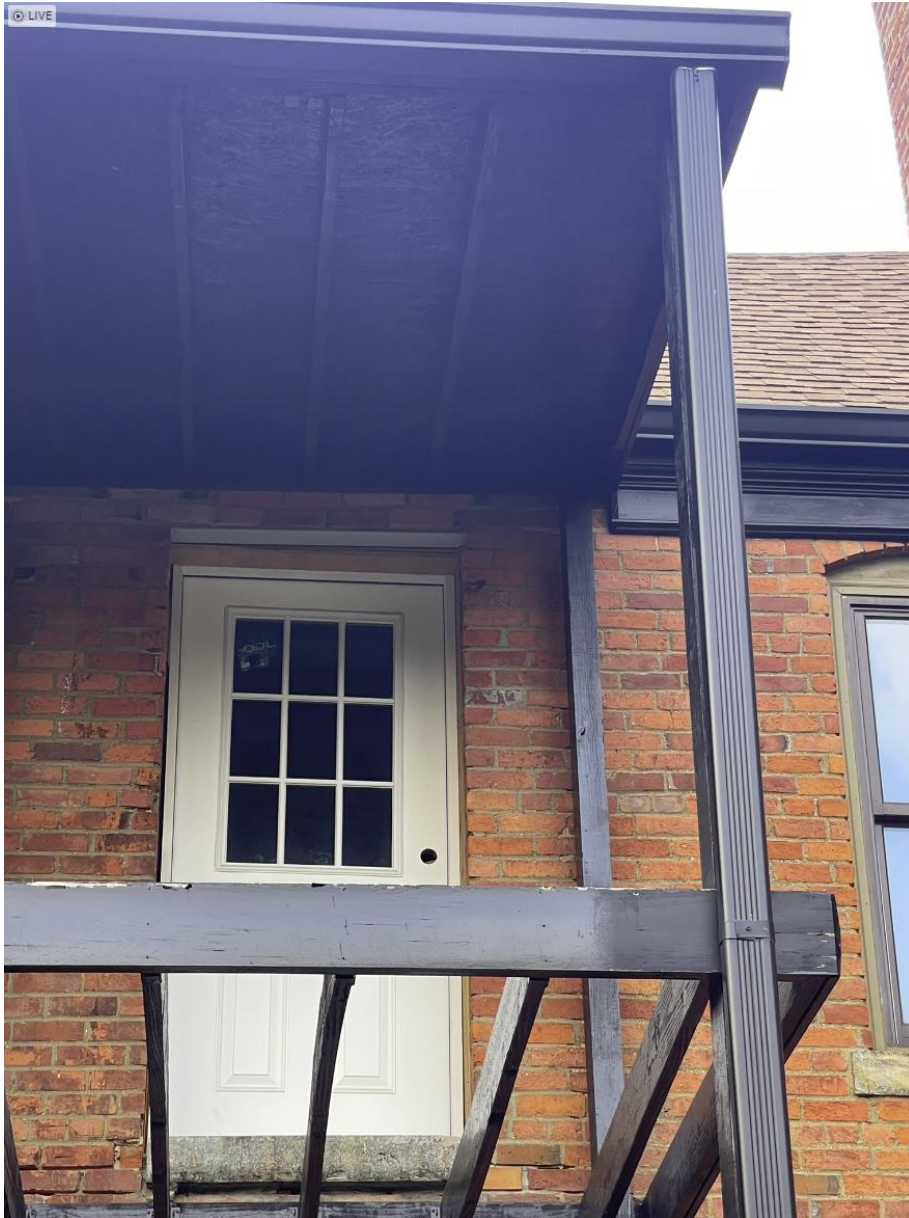
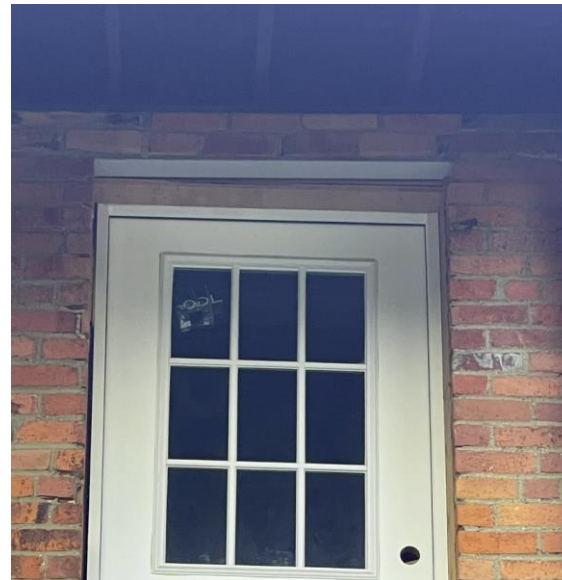
# Archway #1

- Original archway location is partially destroyed by door rough opening
- There is not much brick remaining above the door rough opening

## Proposal 1: Leave as is

**Alternative Proposal 2:** Attempt to install an archway ~2 brick widths higher than original location above current door rough opening

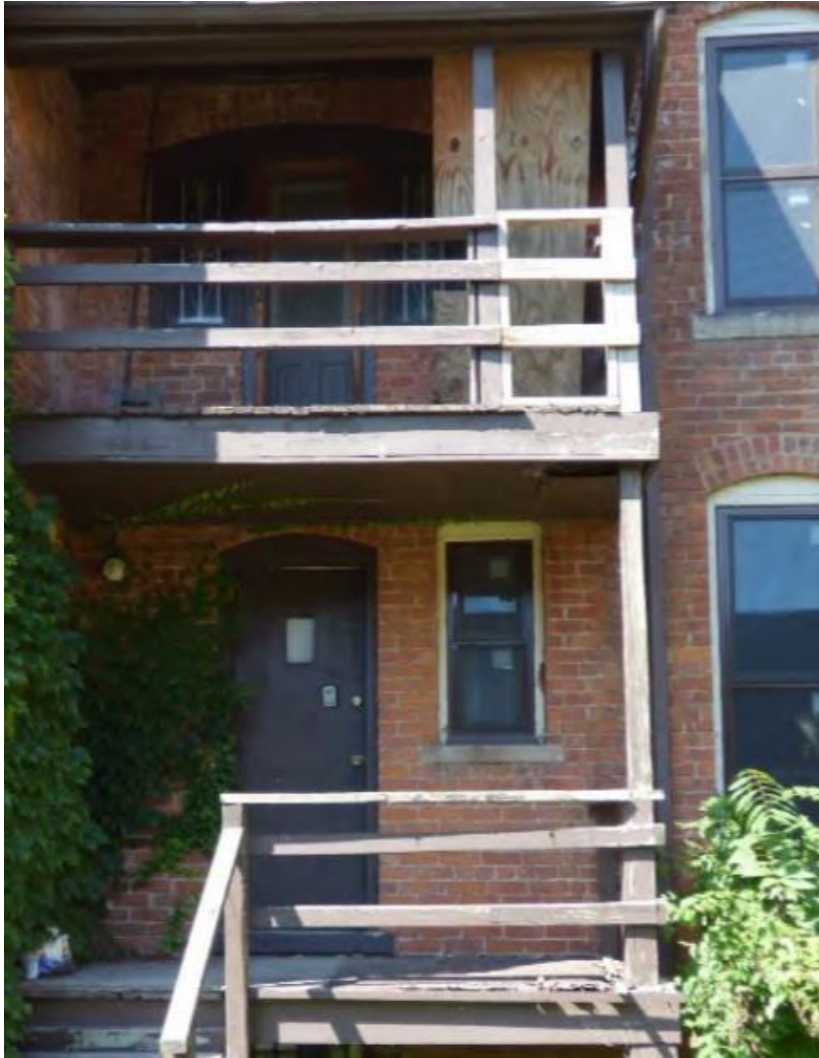
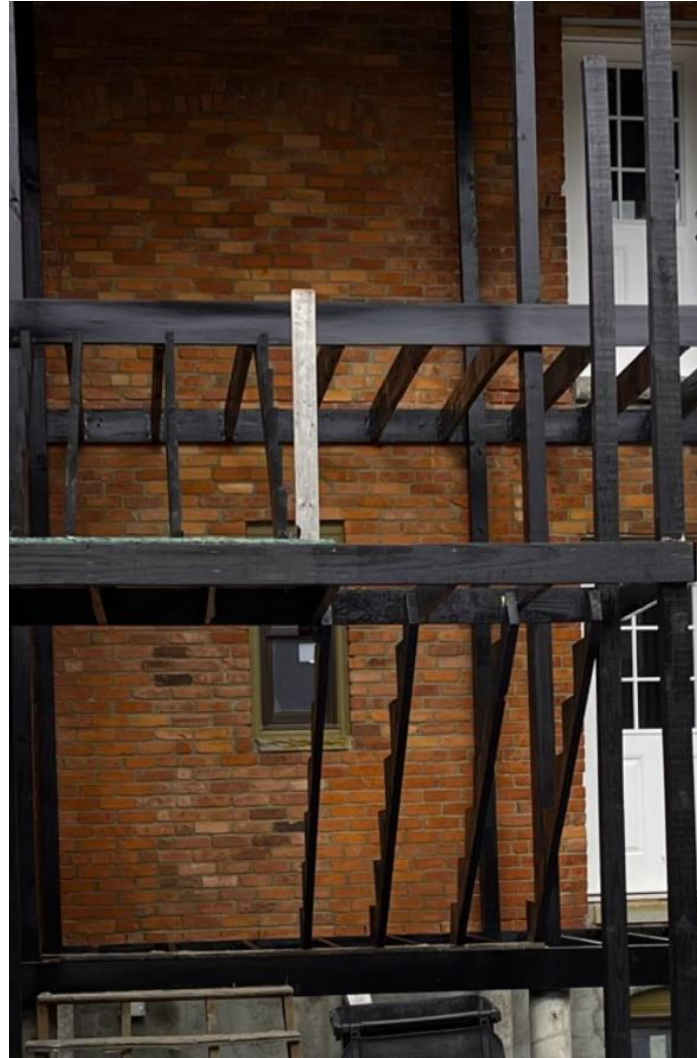
# Archway #4 & 3

- The window was preserved but moved to center over toilet in interior.
- Archway #3 original location is partially destroyed by current window rough opening
- Original window rough opening is covered by sink and vanity on interior

**Proposal 1:** Install an archway over current window rough opening

**Alternative Proposal 2:** Install an archway at original location of Archway #4 only
