**SUMMARY OF PETITIONER'S APPEAL AND REPSONSE TO DETROIT HISTORIC  
COMMISSION'S DENIAL**

RE: Existing Porch Condition

Please find attached a summary of the existing side porch located at 264 Watson Street, Detroit, Michigan. I have included a set of detailed photographs with identifying notes documenting the existing conditions of the present porch.

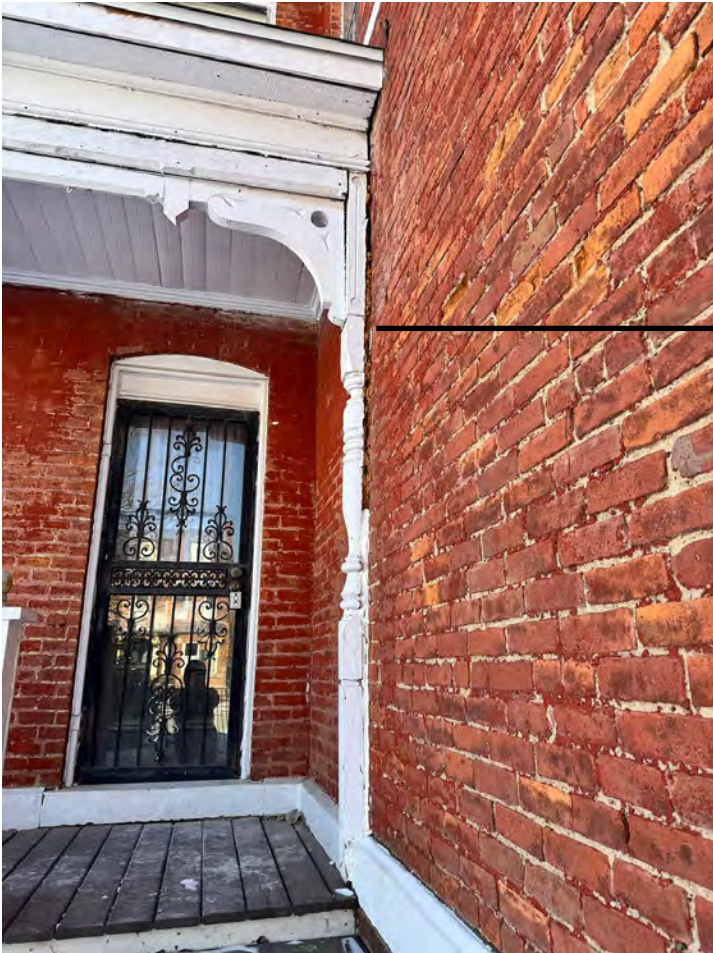
The pilaster is separating from the wall and is not attached properly to support the roof above

As a licensed architect, in my professional opinion, this structure has a number of major and minor deficiencies, when view together make the porch structurally unsound as a whole. To fix these deficiencies requires the entire porch to be disassembled and rebuilt to proper building codes.

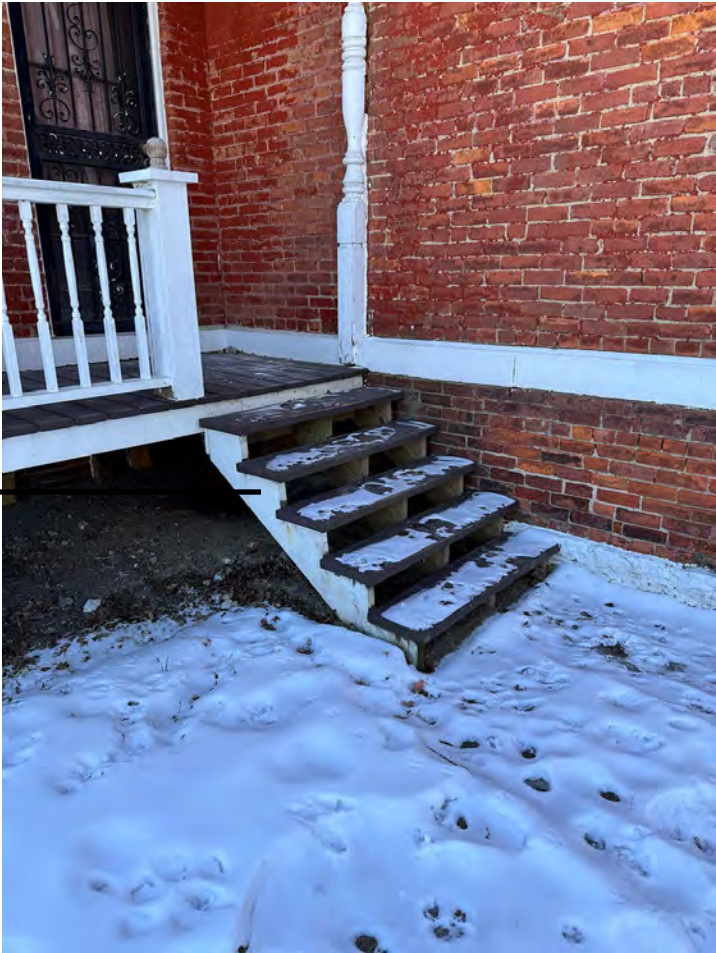
These steps are not original or historic. They are painted, pressure treated, exterior grade 2x members

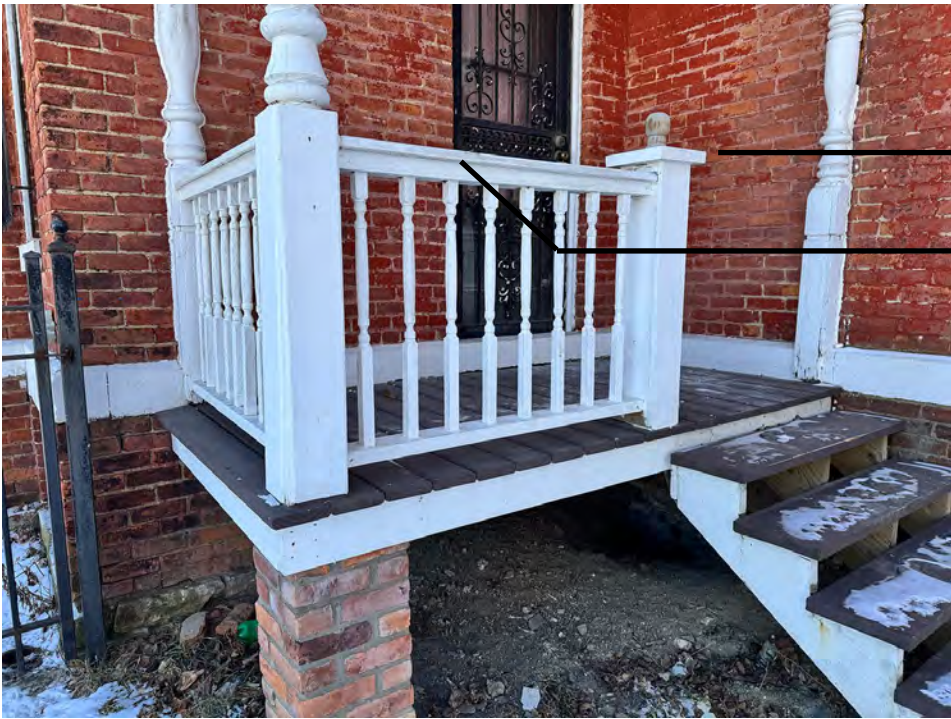
The new post cap and ornament are not original

The new top/cap rail of the porch rail is not original. These are standard 1x members

These bricks are not original to the house, these are standard common bricks available today. They are mortared together with high strength grout which is used in today's masonry construction.

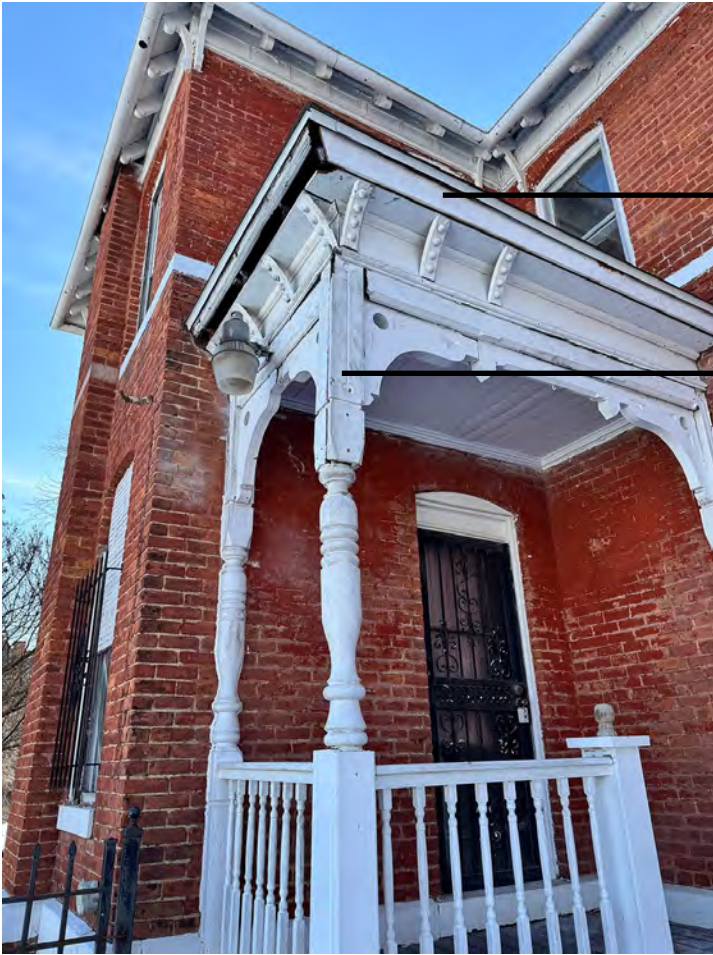
This fascia board is not original to the porch

The corner post has a number of wood pieces tacked together to create a "cover." We are unclear what is actually supporting the corner post beneath these applied

Some of the exposed tails on the roof members have decay and rot

The mercury vapor light is not original

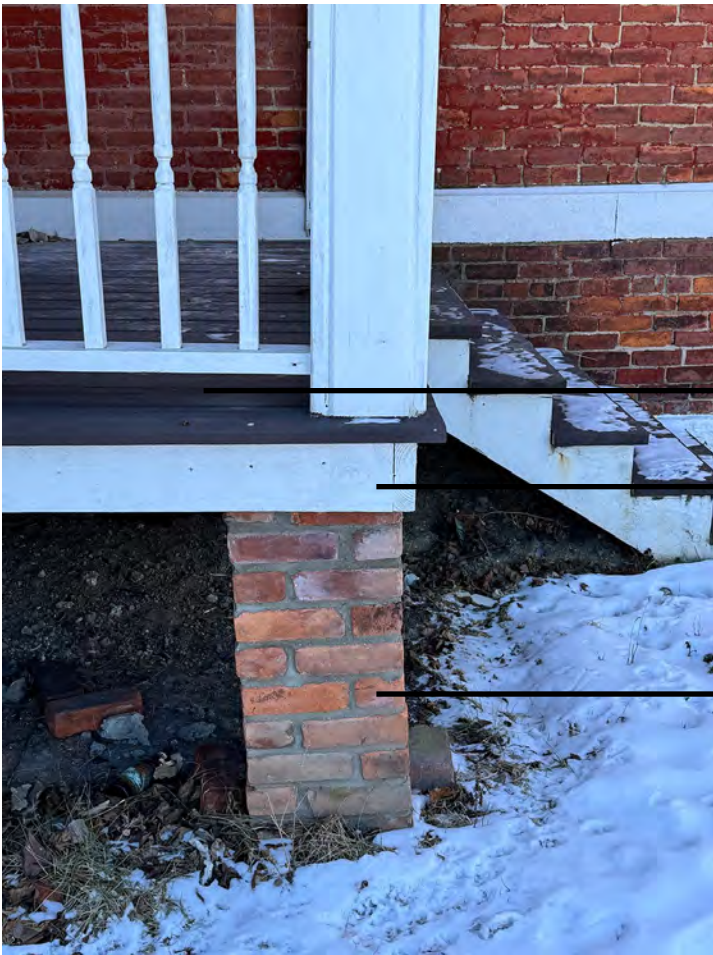
These are typical, modern 5/4 deck boards that have been painted, these are not original.

This is a modern, exterior grade 2x that has been painted white

The masonry pier, besides being constructed of new brick and using modern high-strength grout has a significant lean, it is not plumb. It is unclear if this has a proper frost depth foundation.

It is not clear if the spindles are original or new

The bottom portion of the corner post is made with modern 1x members nailed together. We are not clear on the structural soundness and integrity of the corner post

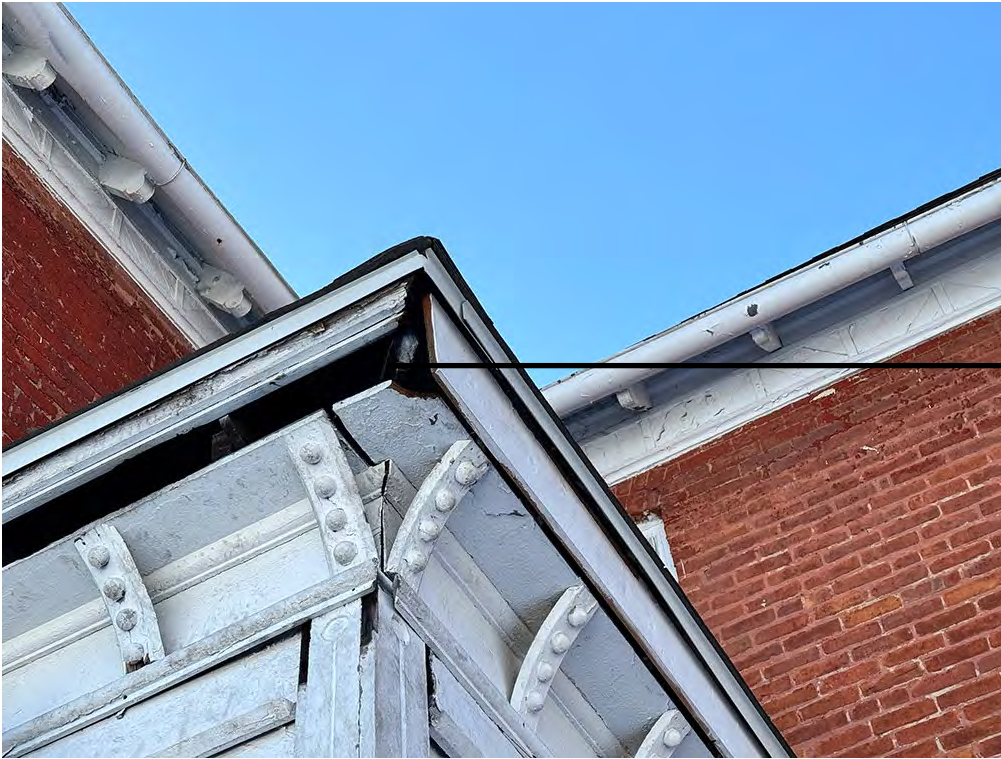
Separation and deterioration of the fascia boards remaining, some parts of the fascia are missing. Improper drip edge for the roof causing moisture to destroy the fascia board

The porch structure is modern, exterior grade 2x members. No joist hangers were used as required. It is unclear how the "rim board" is attached to the brick masonry.

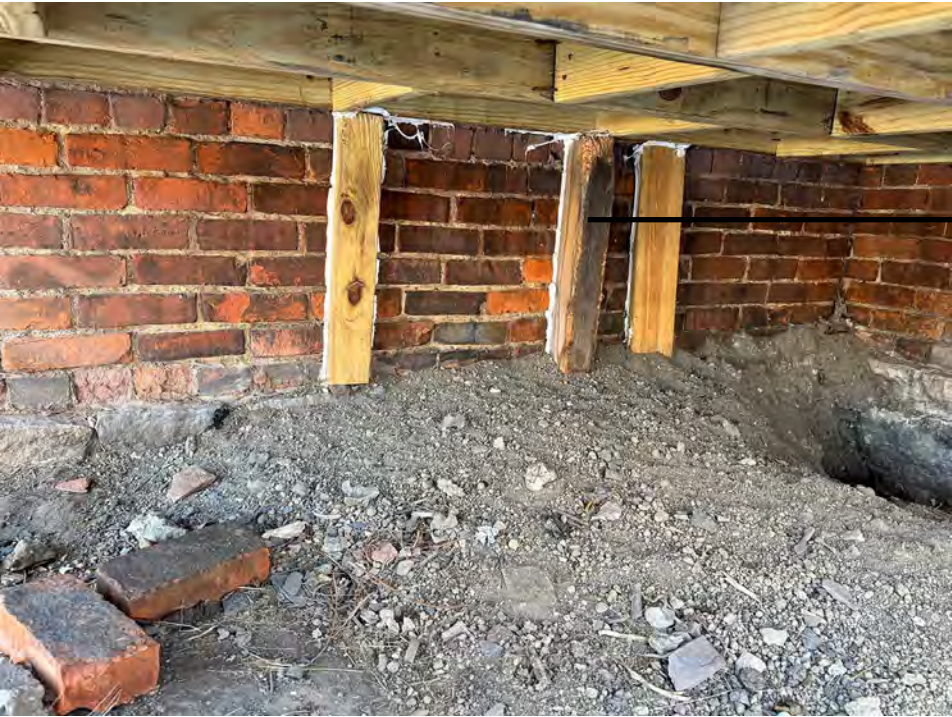
Structural “supports” have been “sil-  
iconed” or “construction adhesive”  
to the brick masonry. No where  
close to meeting simple structural  
requirements or building code.

Nails were “toe-nailed”, usually un-  
successfully with much of the nail  
exposed to the surface causing the  
rust shown.

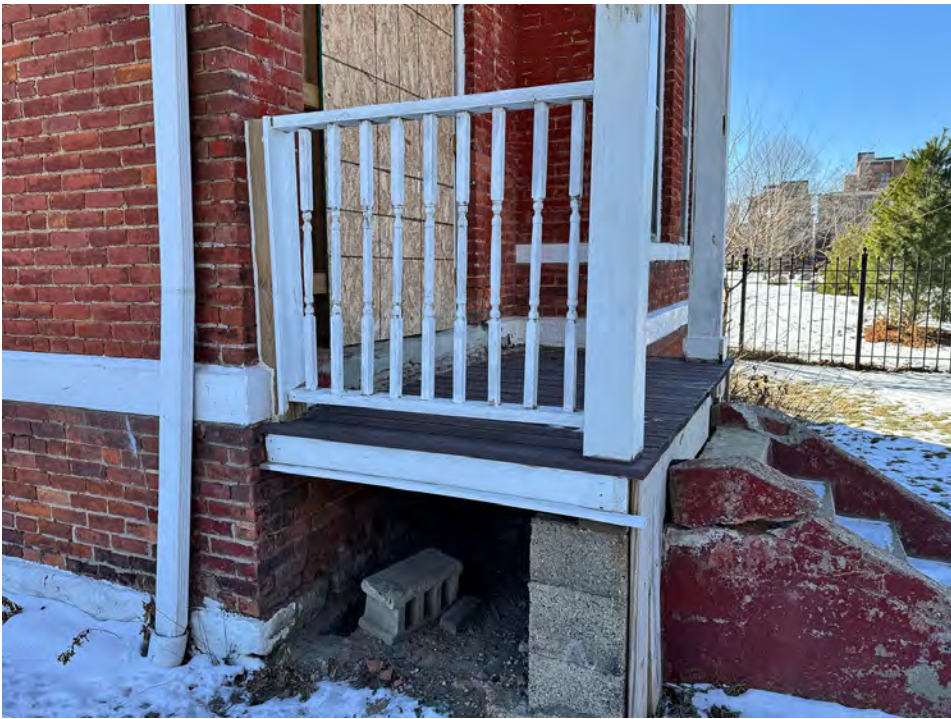
This is the front porch for reference, showing the same techniques used on the rebuilt side porch which is now in place, 2x structural members, 5/4 deck boards, 2x top cap rail

While there is some commonality between the front facade and the side porch, for example, the same brackets are used to support the protruding fascia, all of the structural construction and their individual structural members have been removed or altered significantly on both porches
