# HISTORIC DISTRICT COMMISSION ADDITIONAL INFORMATION REQUEST

**Application Number:** HDC2025-00493

**PROJECT ADDRESS:** 644, 656 Selden Street

**HISTORIC DISTRICT:** Willis-Selden

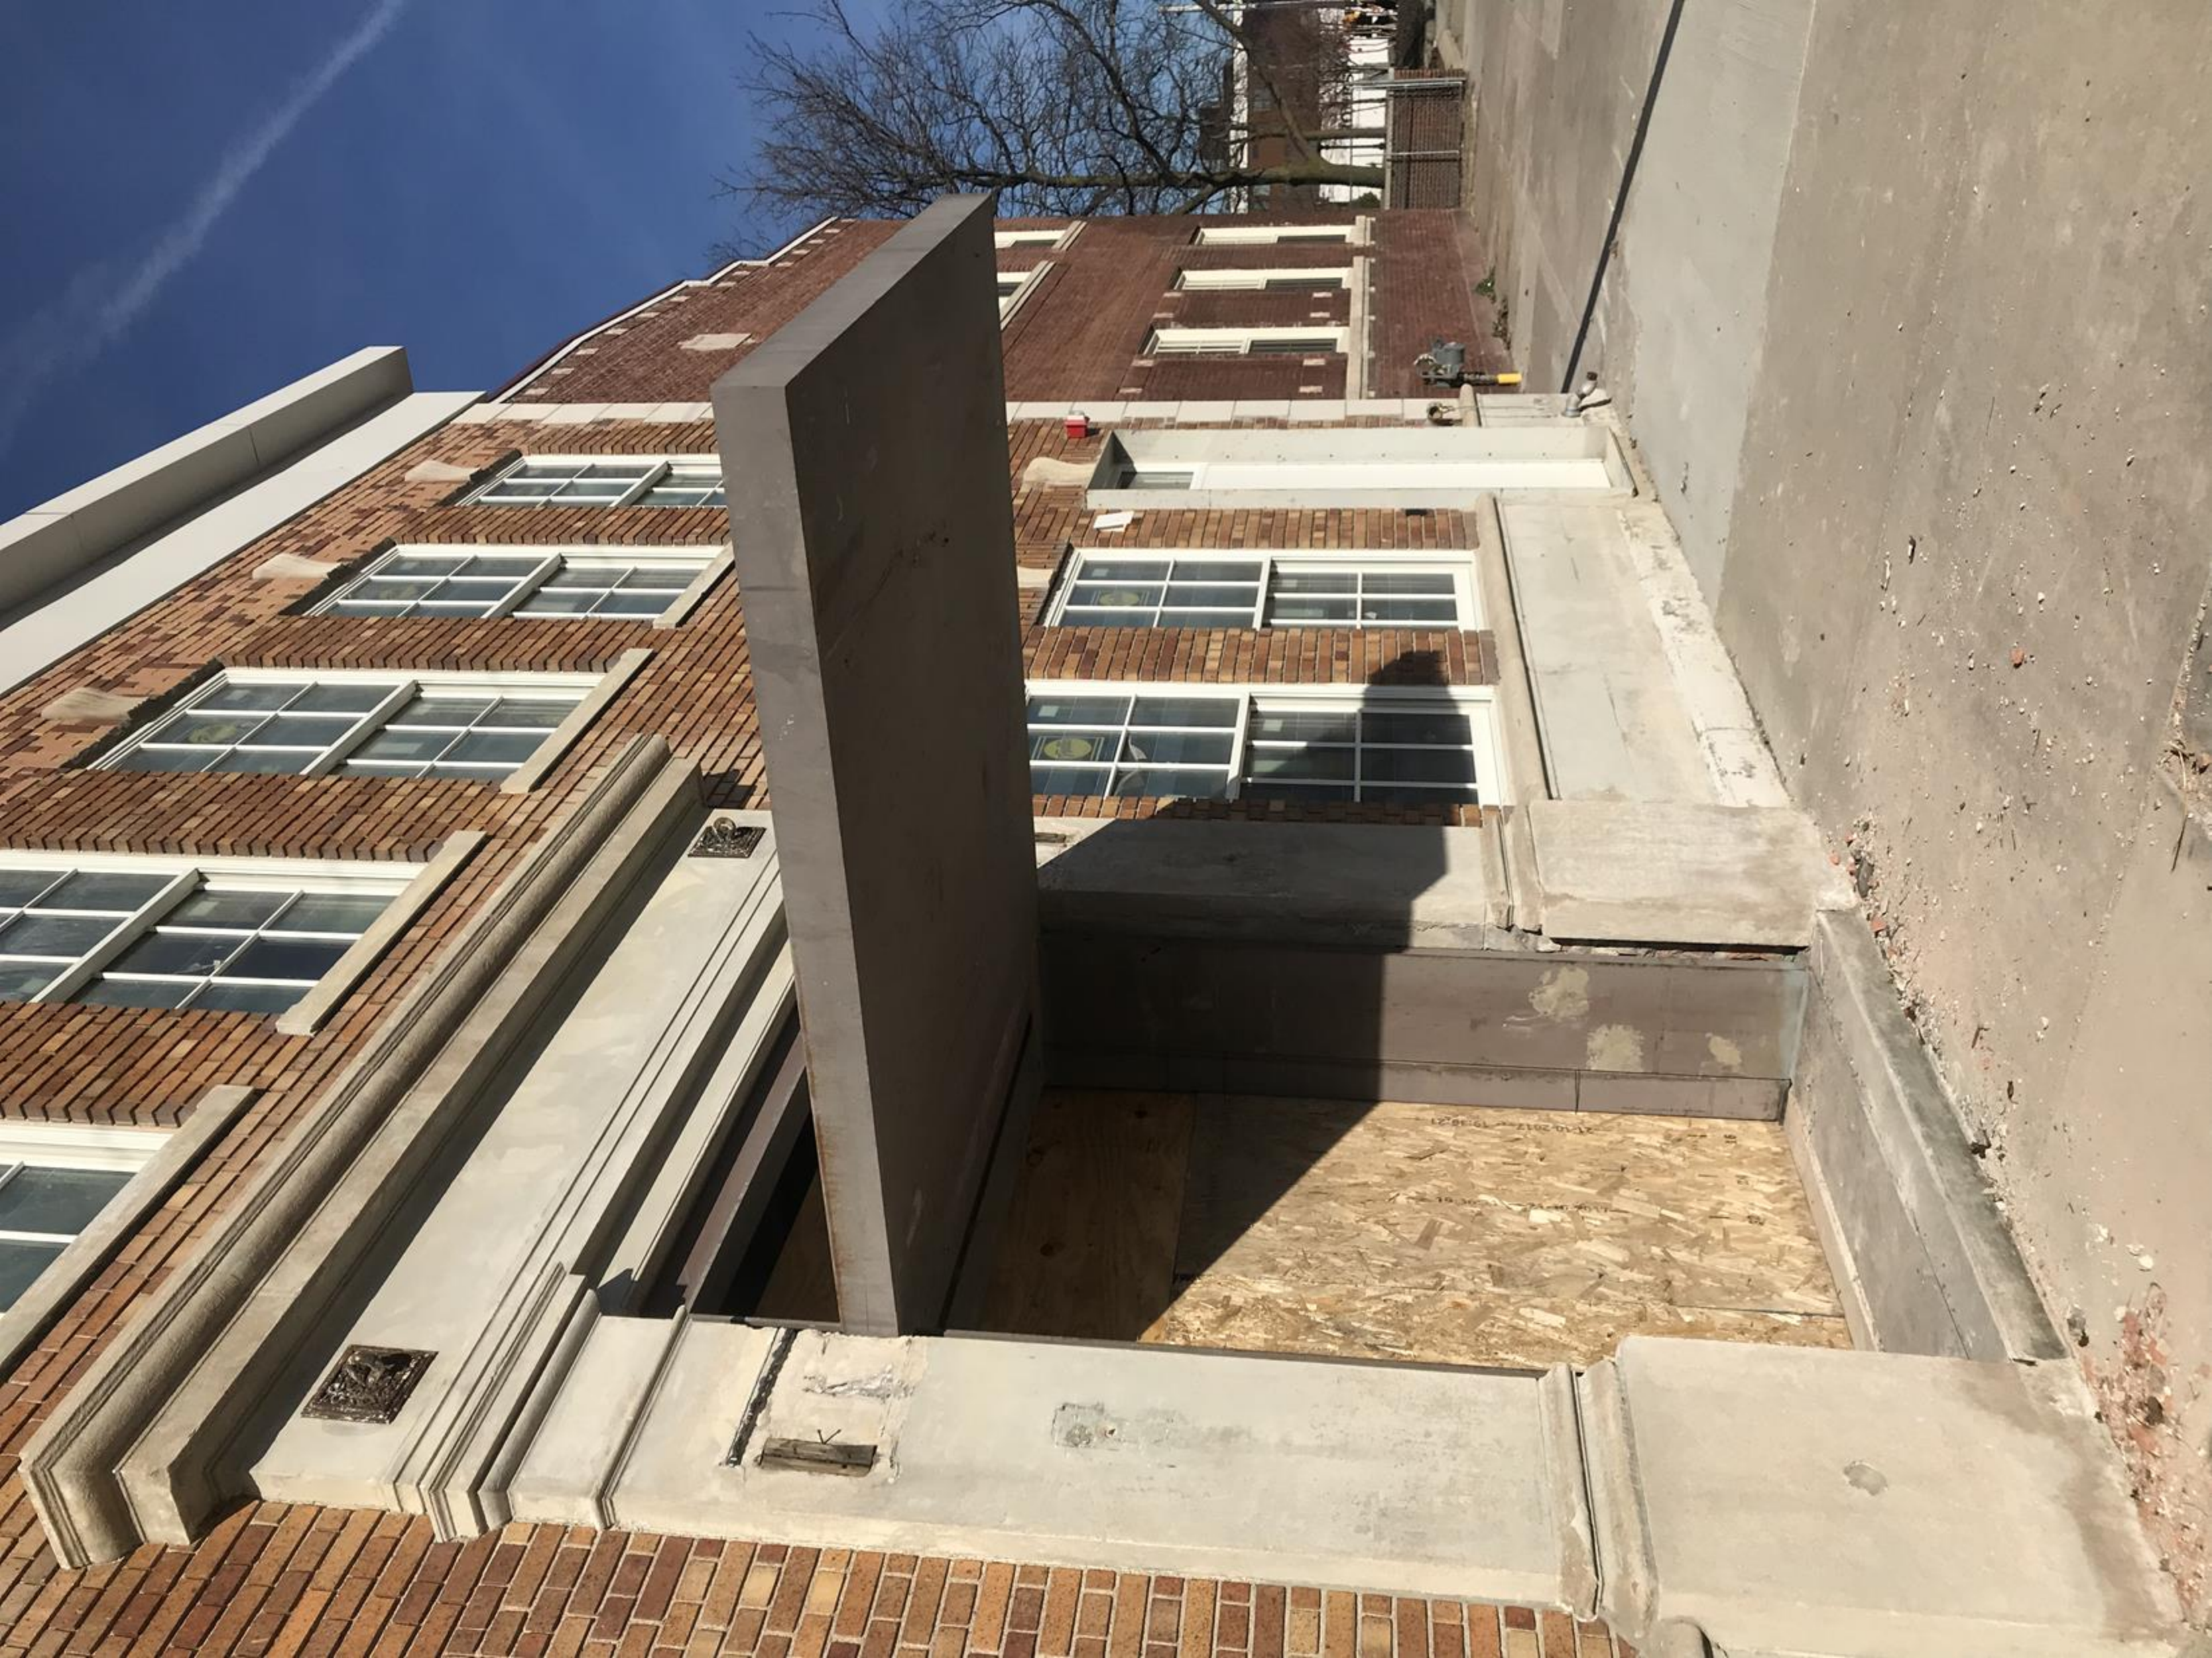
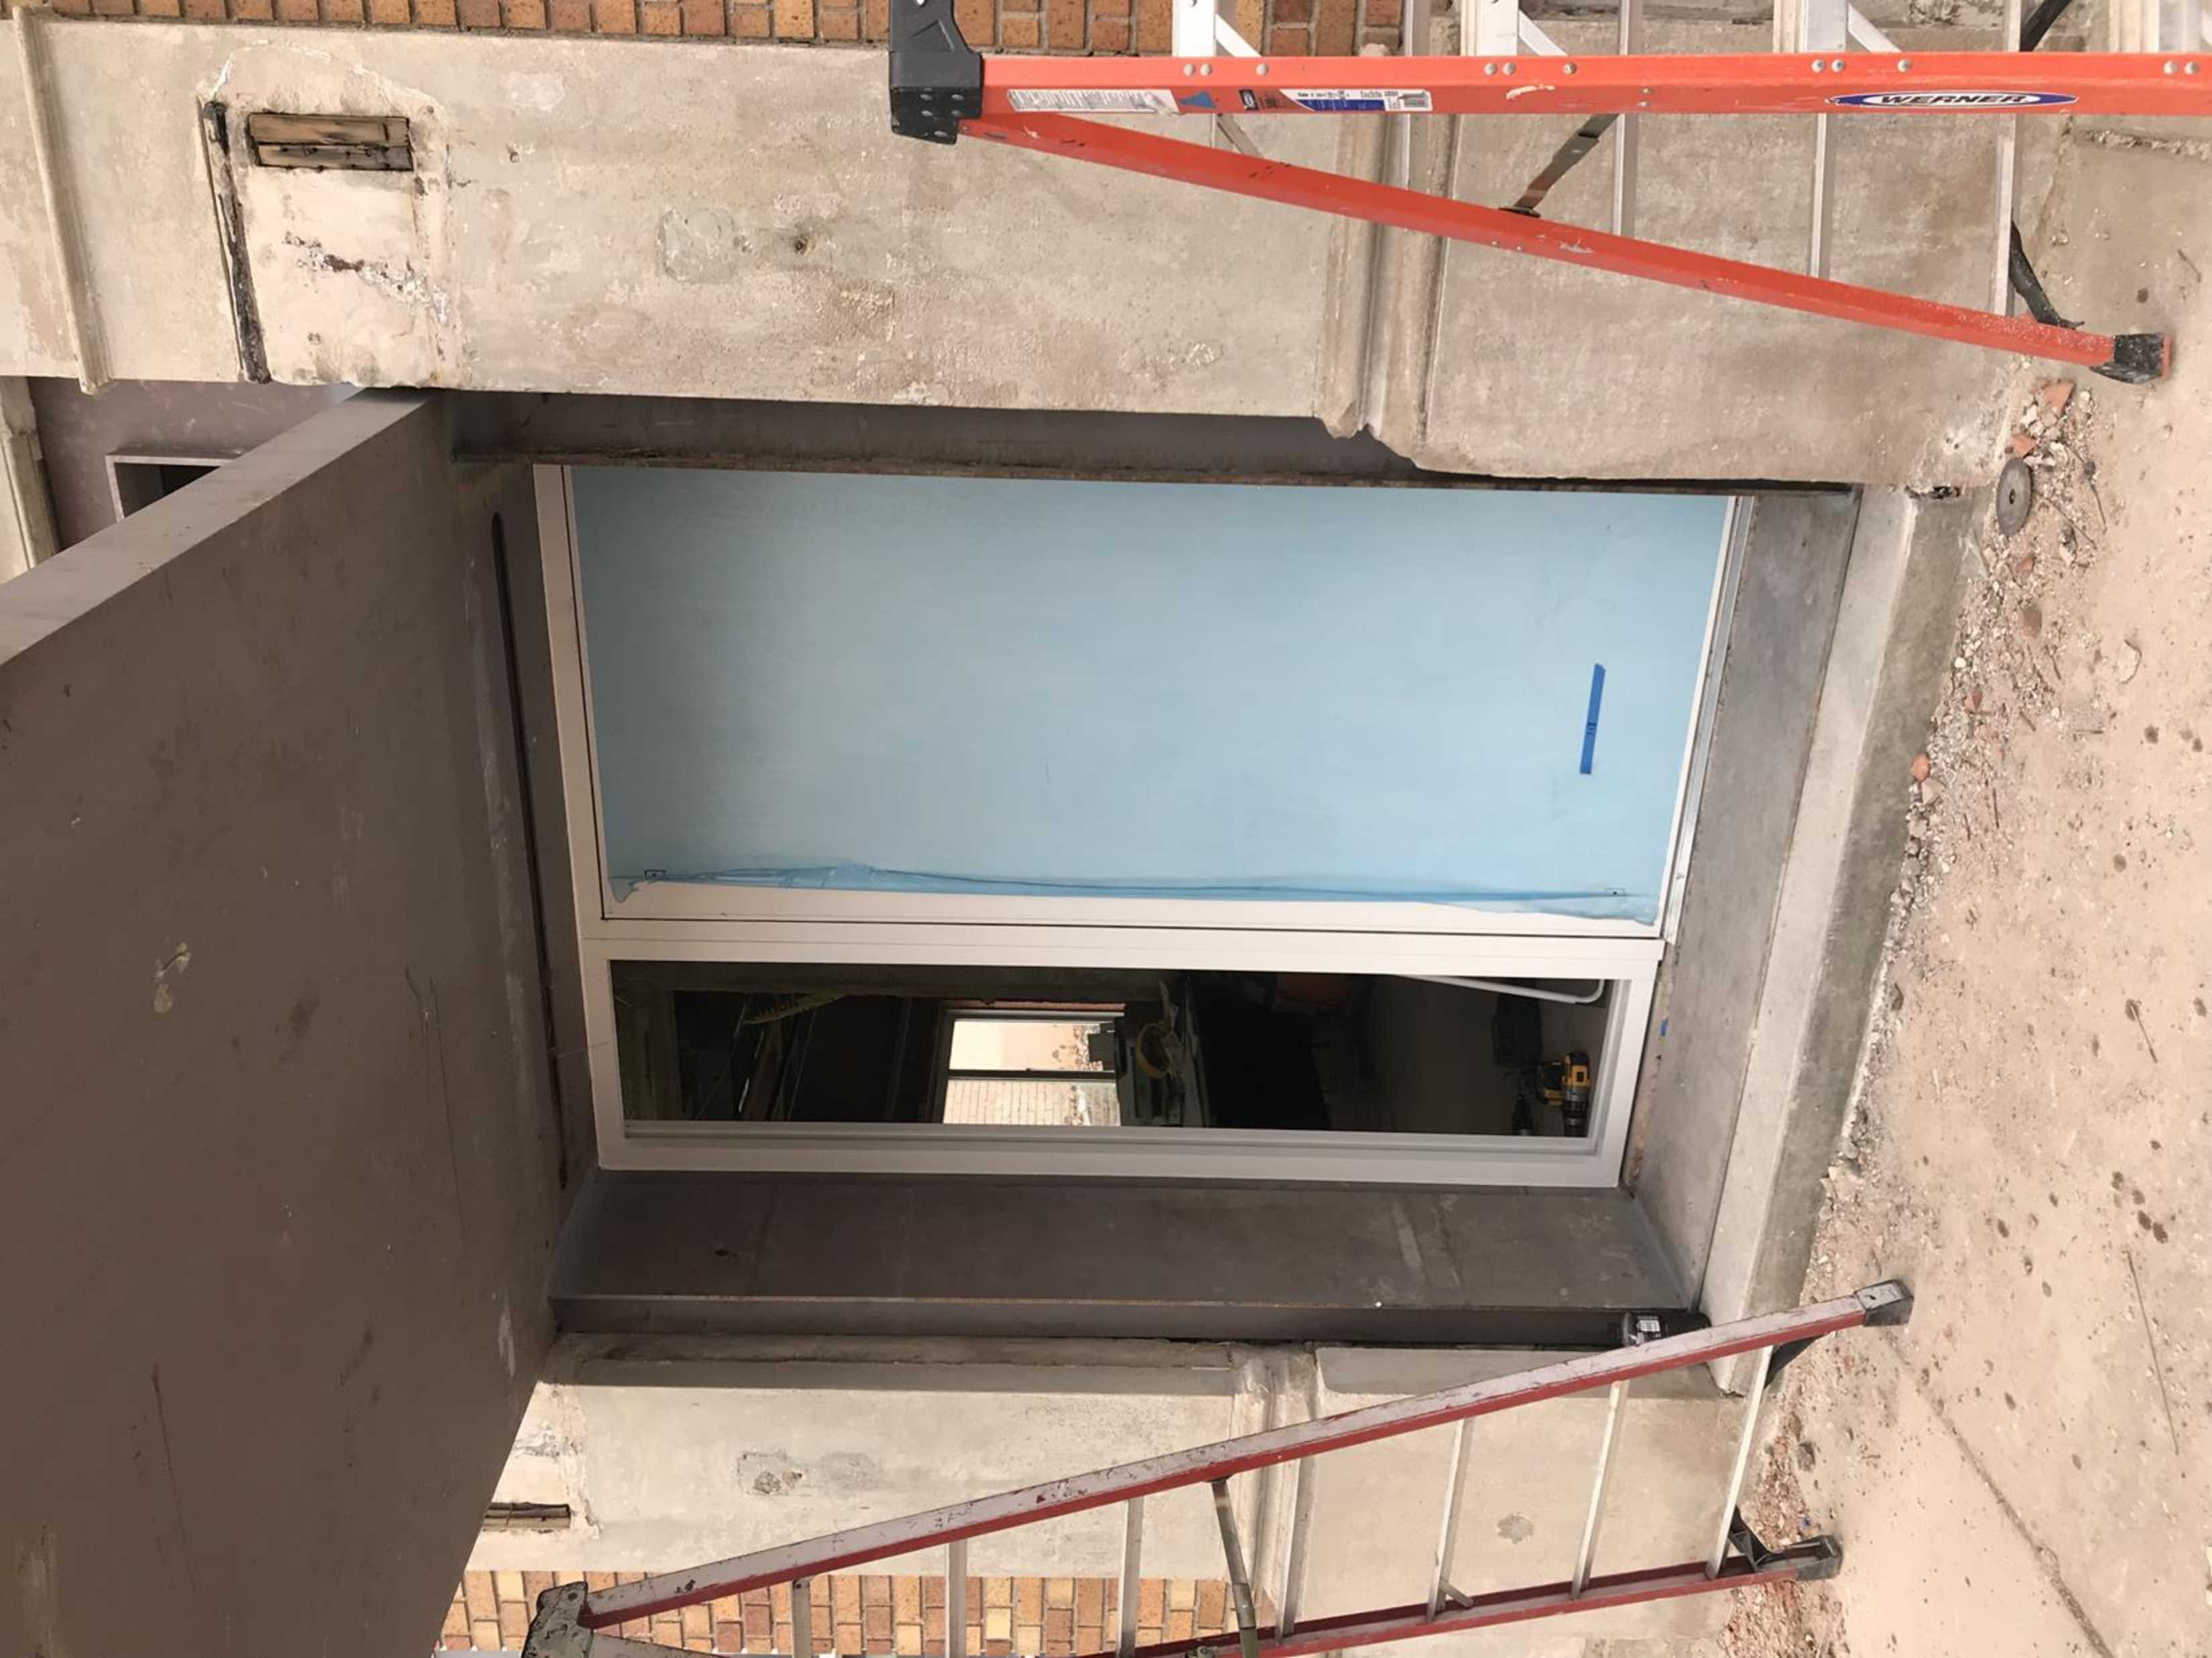
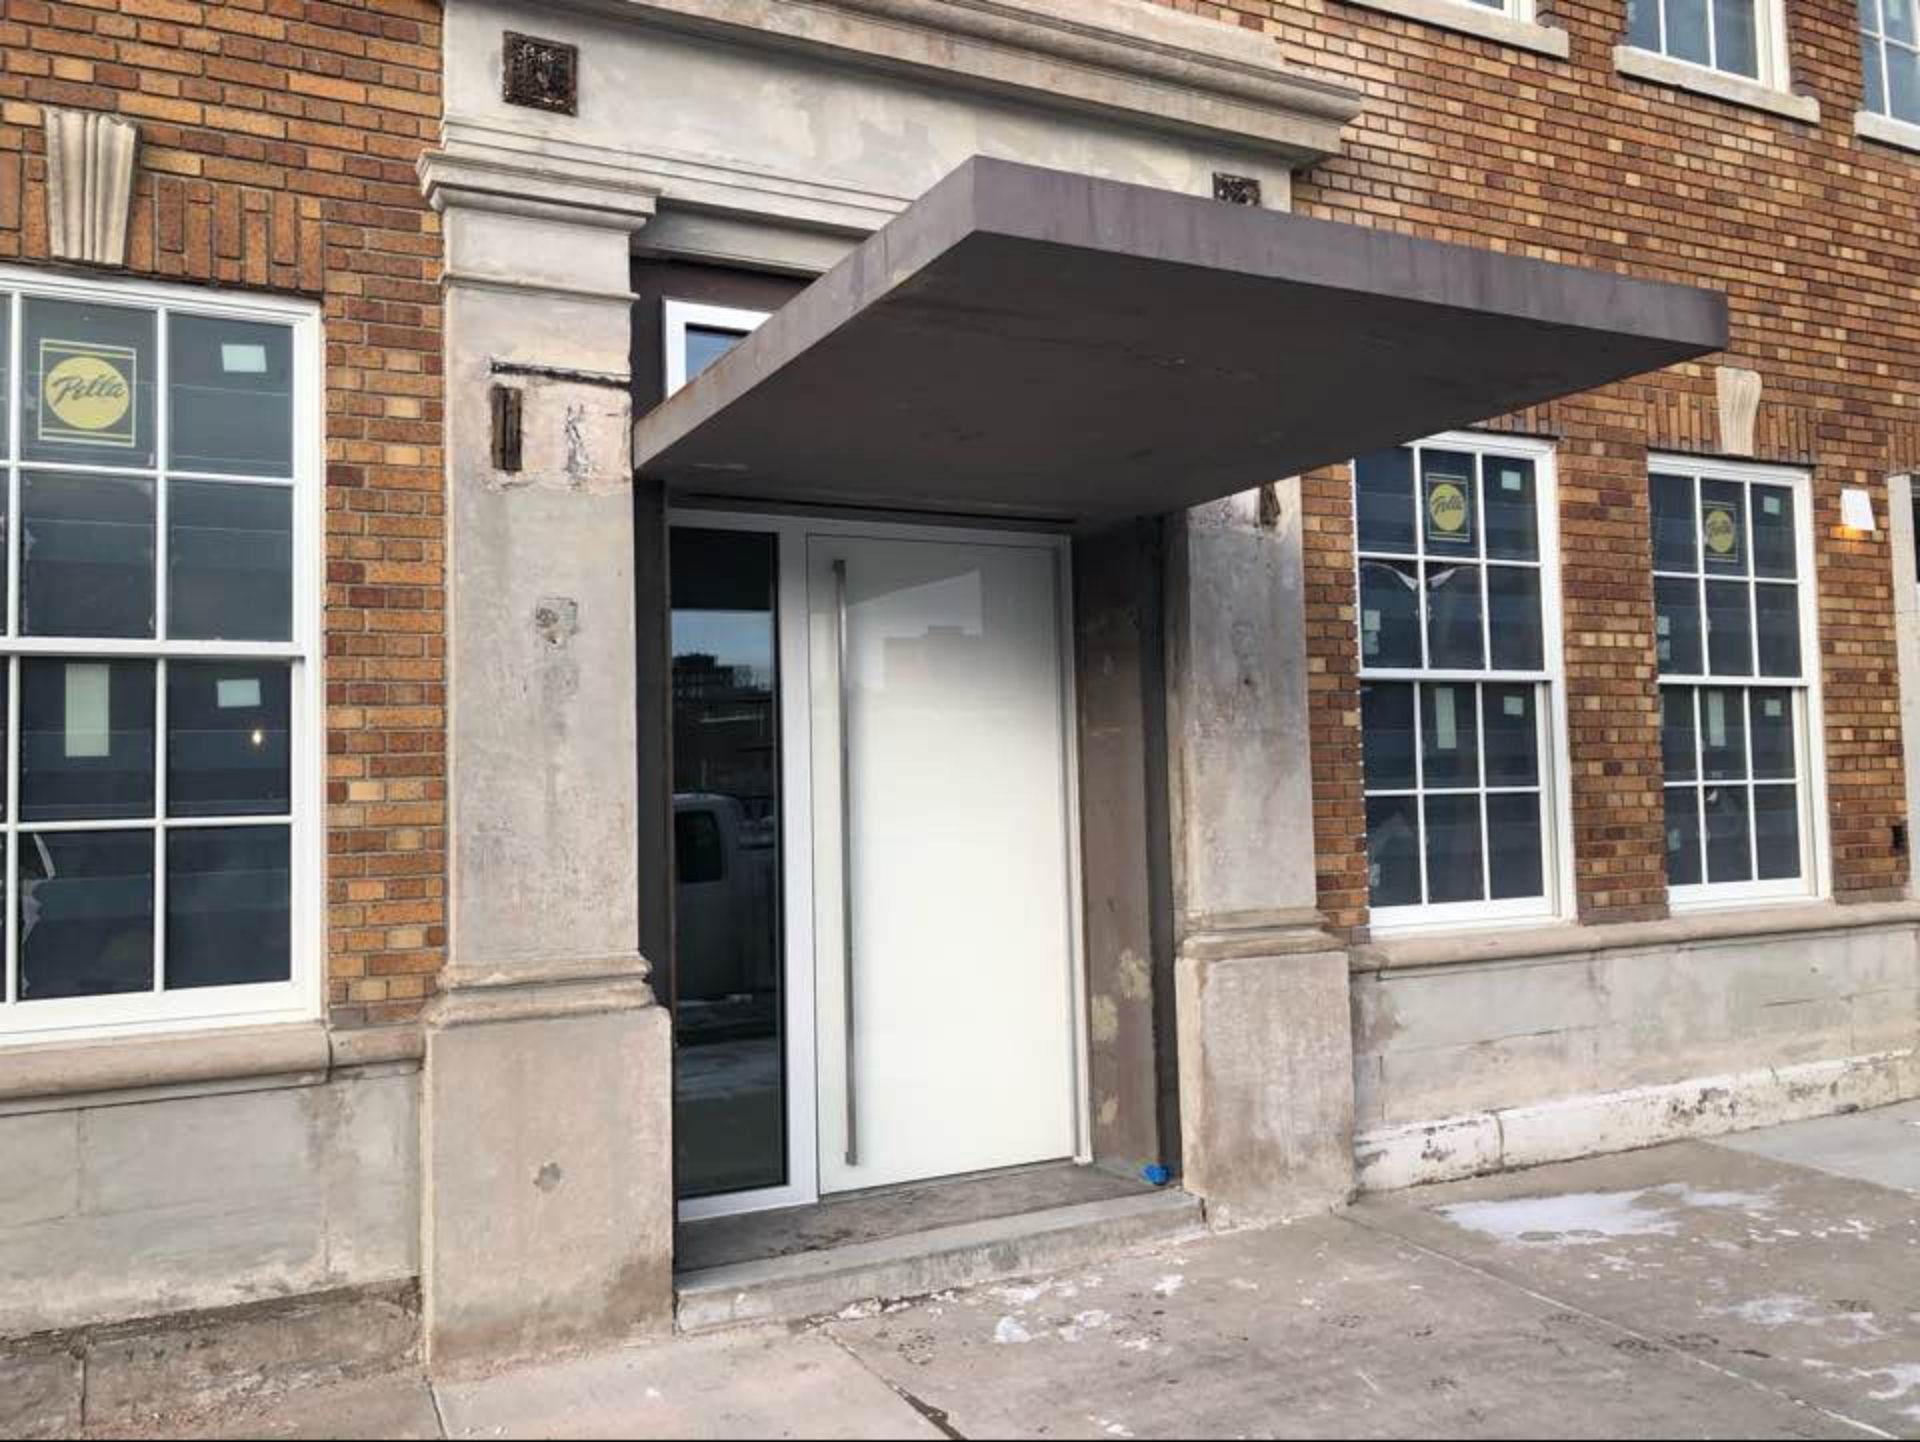
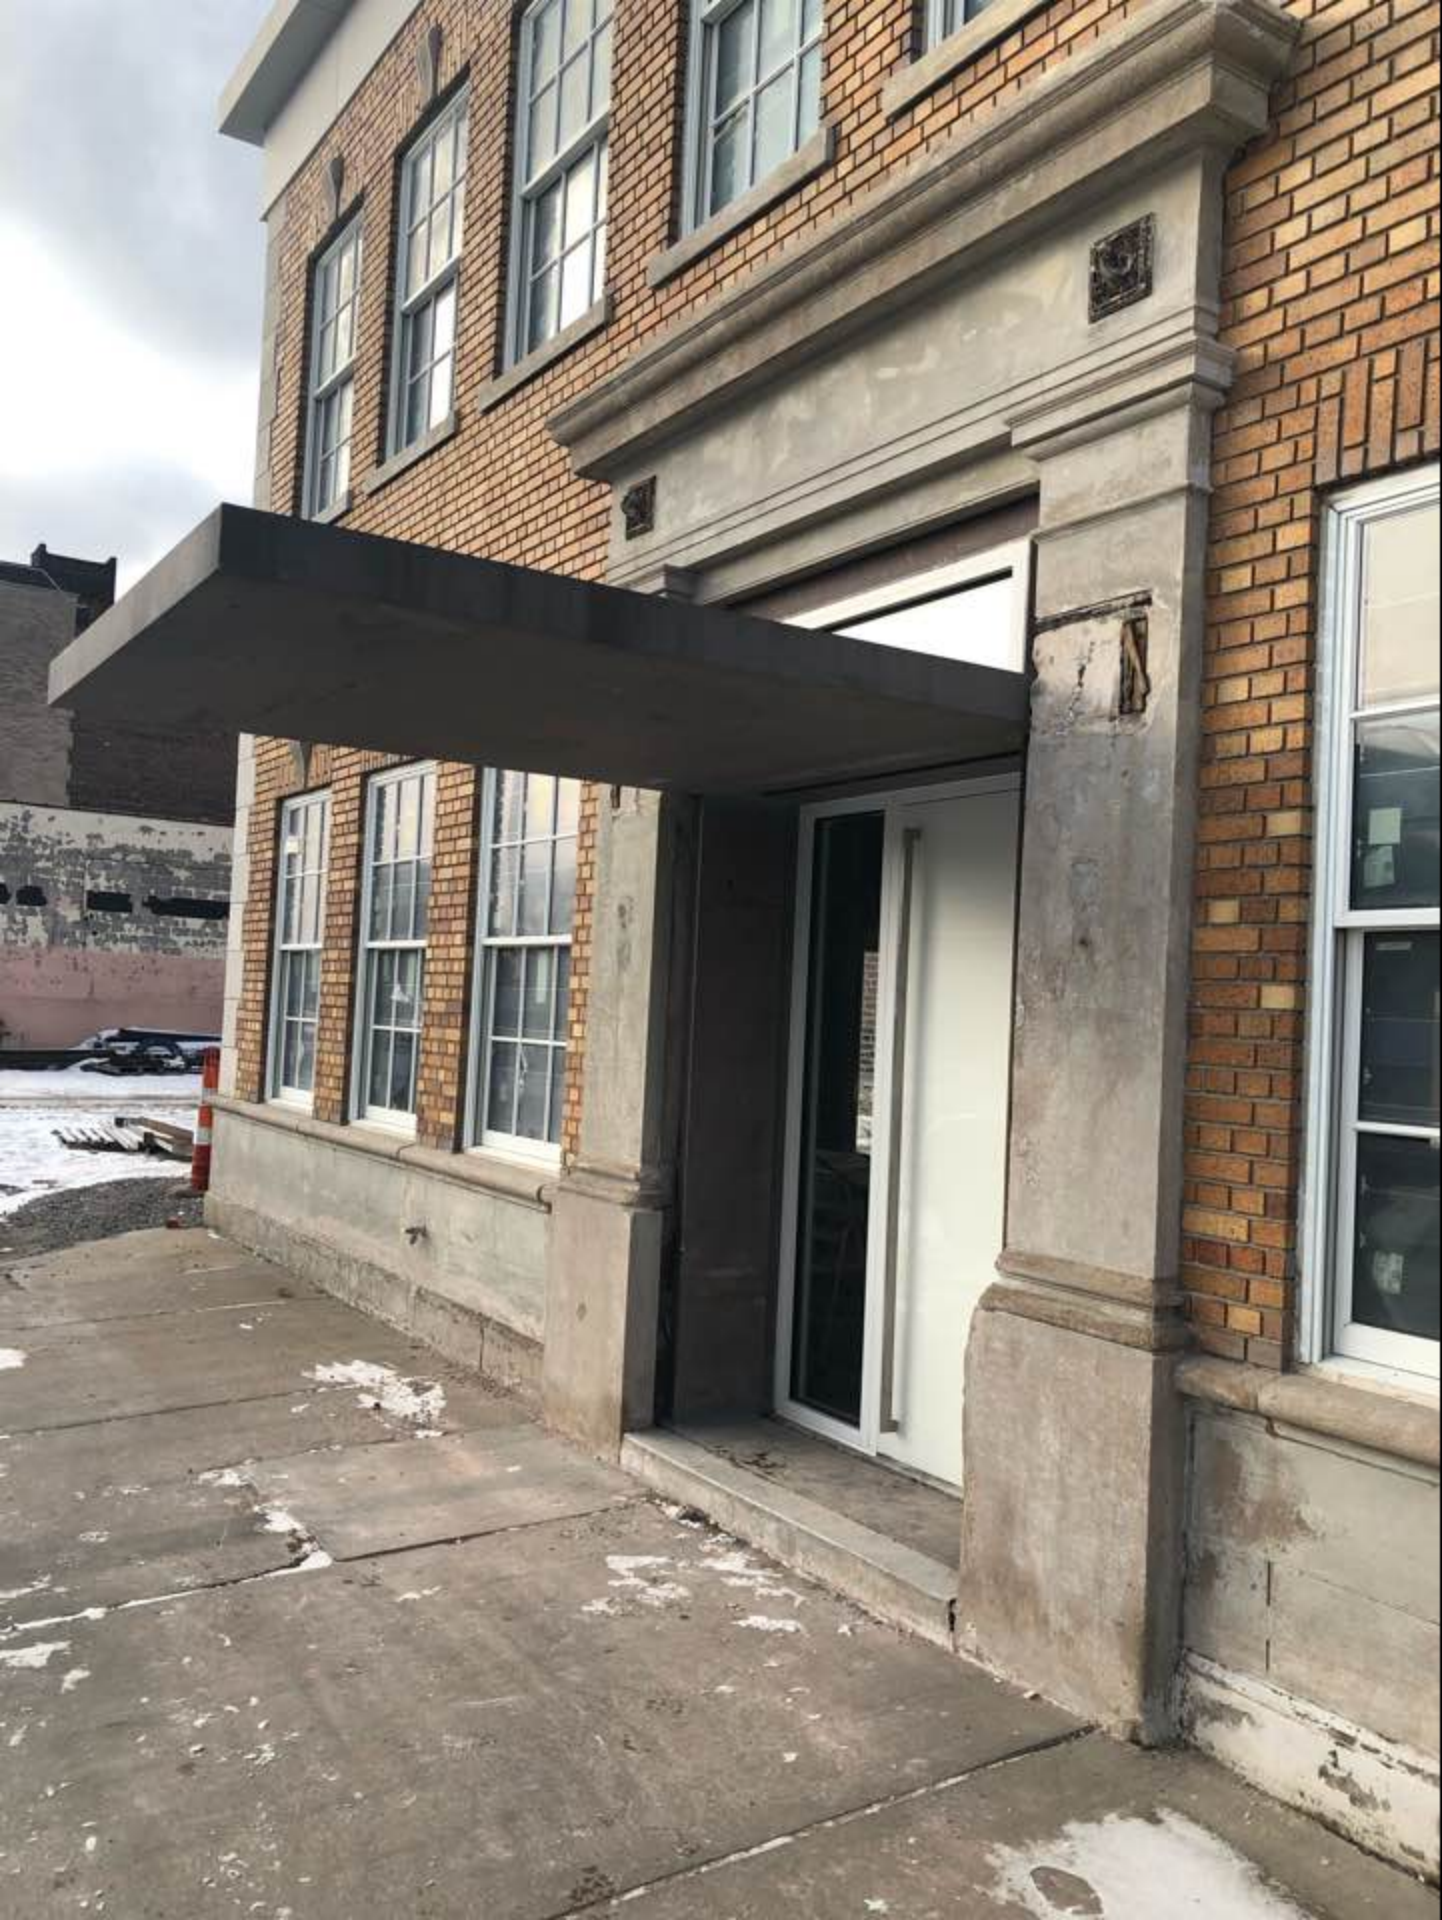
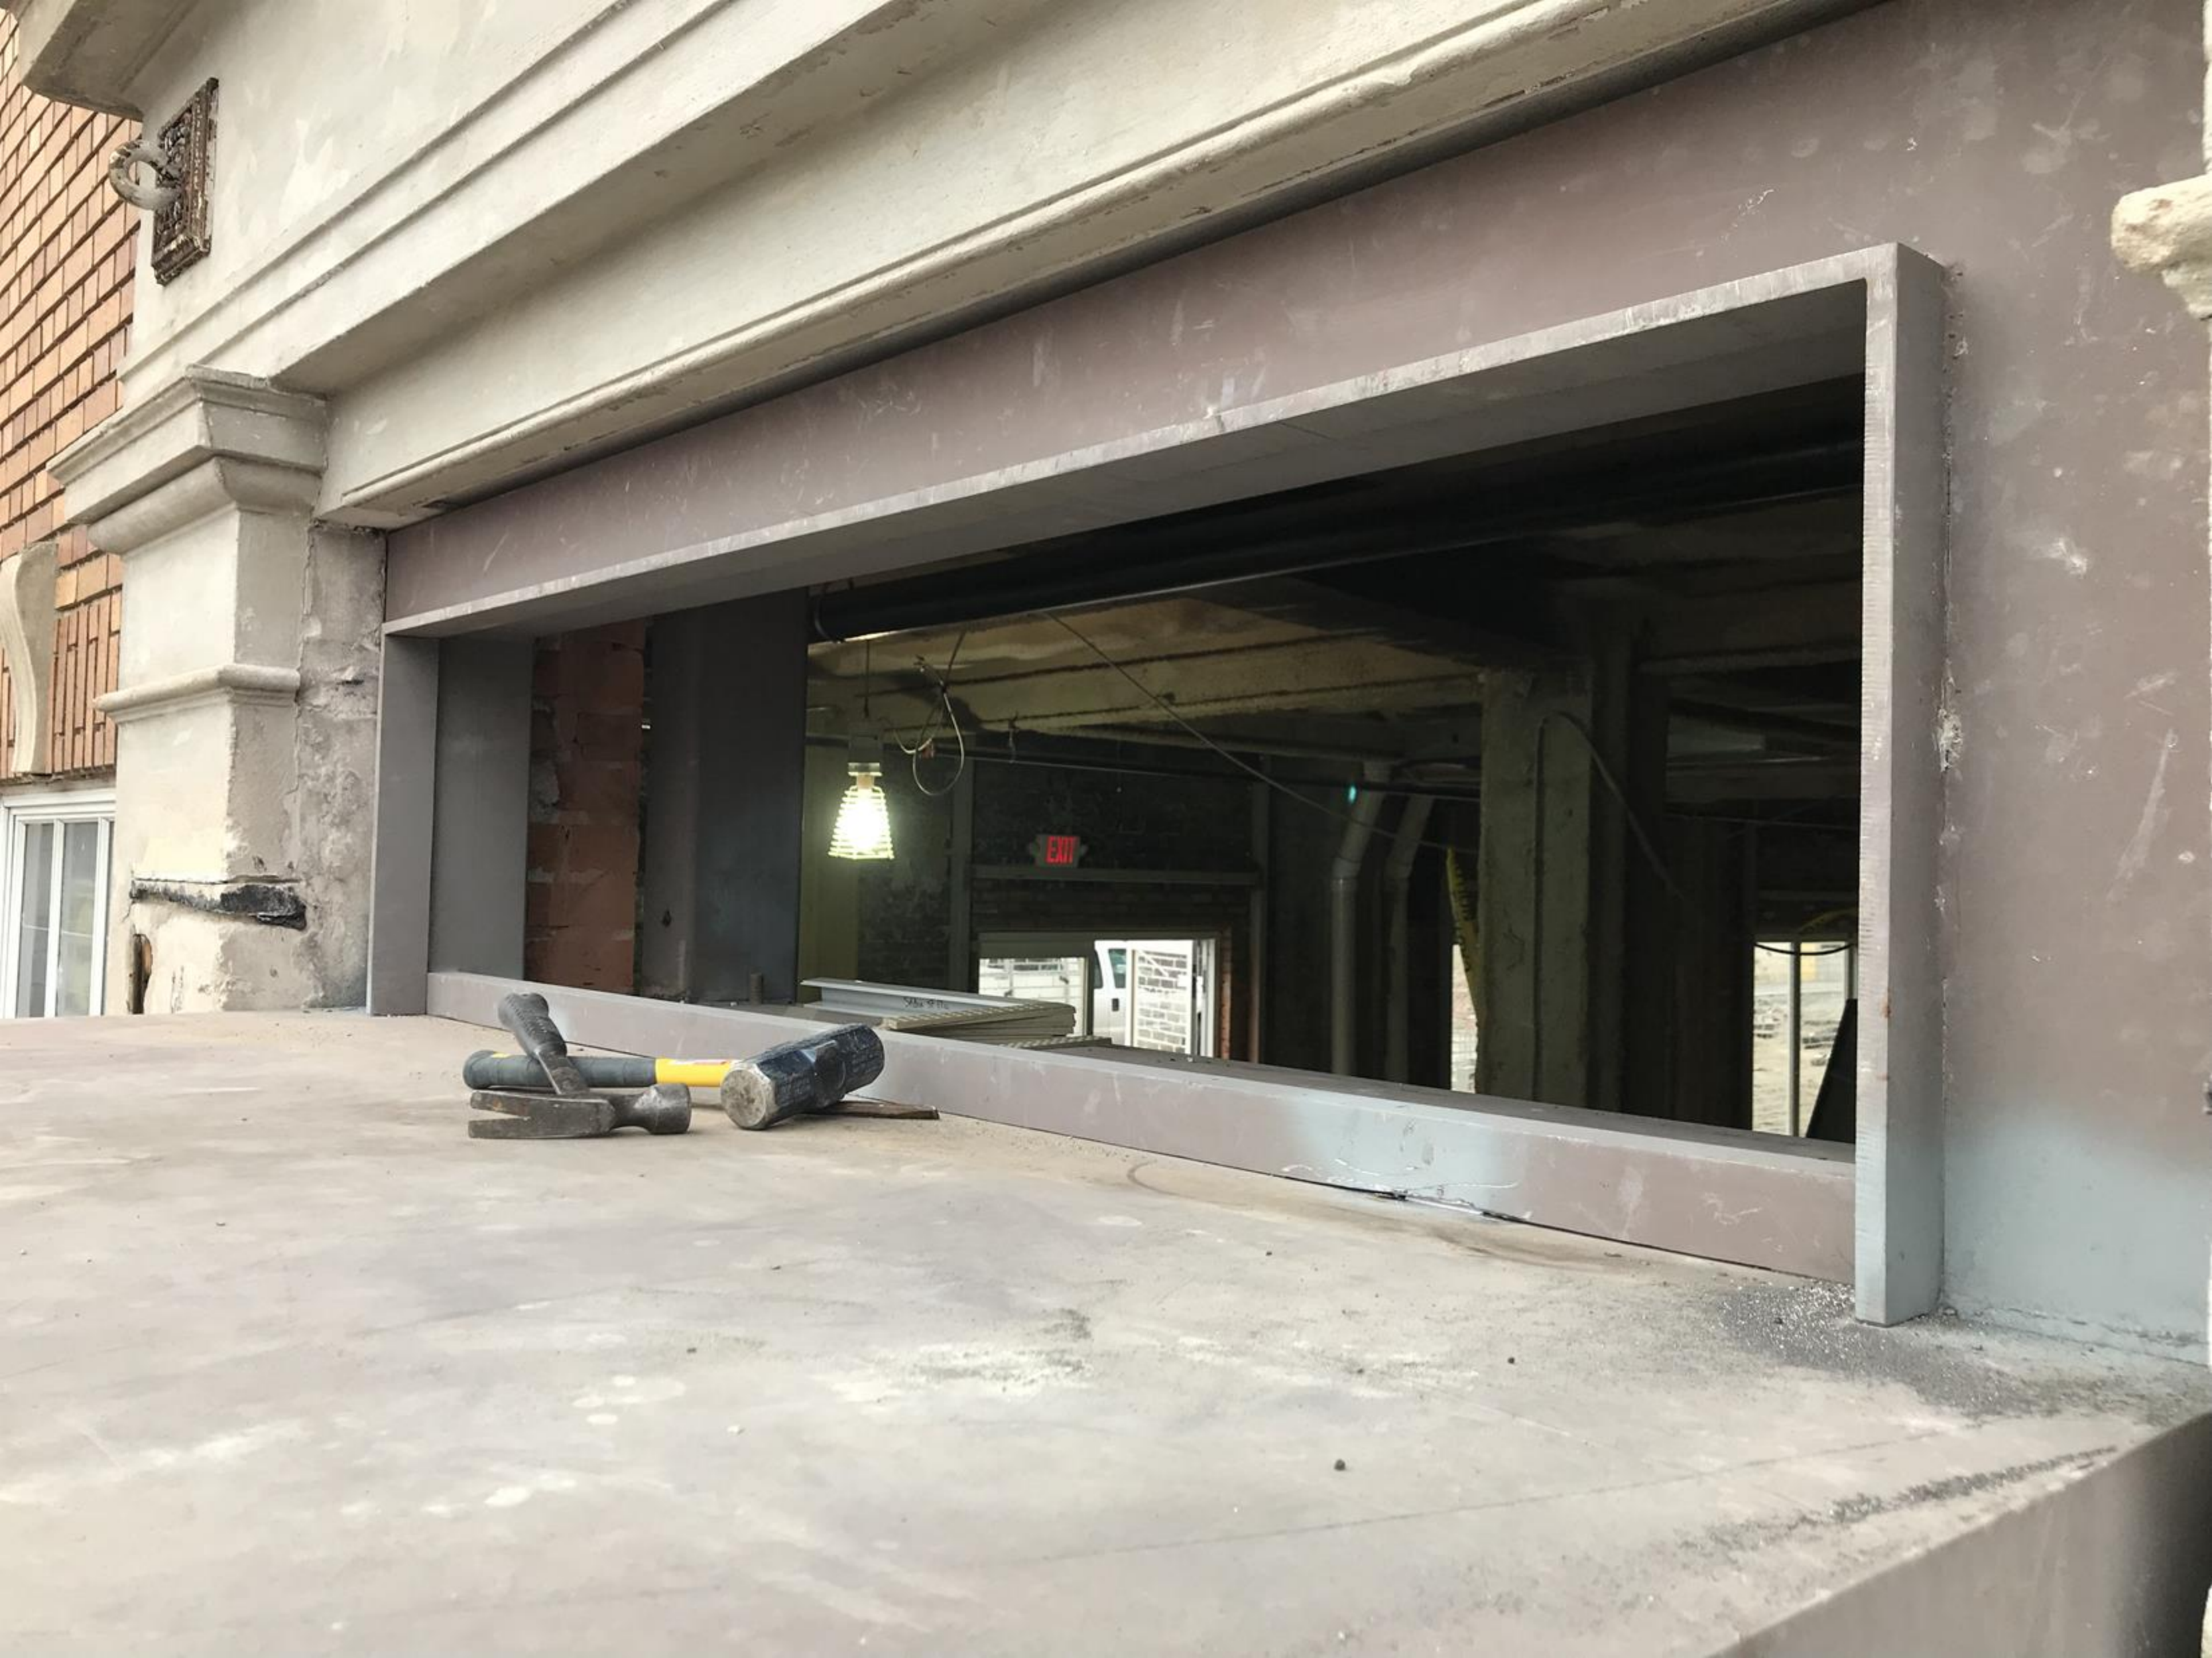
1. Painted limestone portal: The portal was painted after certain repairs were made by patching holes and chopped-off as well as eroded areas with a cement-lime based mortar, rather than replacing the limestone itself. We assume this decision was made by the owner due to cost. (All quoins on the corner of the façade were replaced, however). Please see the photos of the damaged areas attached (Site photo from January 2019)

2. We discussed the removal of the paint once more with the owner after your comment. We decided to follow THE SECRETARY OF THE INTERIOR'S STANDARDS FOR THE TREATMENT OF HISTORIC PROPERTIES WITH GUIDELINES FOR PRESERVING, REHABILITATING, RESTORING & RECONSTRUCTING HISTORIC BUILDINGS, Standard # 8. Chemical or physical treatments, if appropriate, will be undertaken using the gentlest means possible. Treatments that cause damage to historic materials will not be used.

Removing damaged or deteriorated paint only to the next sound layer using the gentlest method possible (e.g., hand scraping) prior to repainting.

Paint that is firmly adhered to the stone surfaces will not be aggressively removed. Any shiny or too smooth surfaces will be sanded over using sand or emery paper to create a good key.

The use of KEIM SOLDALIT Sol-silicate All Surface Mineral Finish can be applied to previously painted surfaces without primer. It is ideal for surfaces exposed to severe weather conditions. Tenacious adhesion is enhanced with Soldalit's nanoparticle technology that allows penetration of even the densest mineral or masonry substrates and provides a mechanical anchor to most existing organic, latex, or acrylic paints in sound condition. (<https://keim-usa.com/product-categories/exterior-paint/soldalit/>)
