# HISTORIC DISTRICT COMMISSION ADDITIONAL INFORMATION REQUEST

**Application Number:** HDC2025-00705

**PROJECT ADDRESS:** 1815 Seminole St

Re: Condition Assessment and Recommendation for Window Restoration + Replacement –  
1815 Seminole

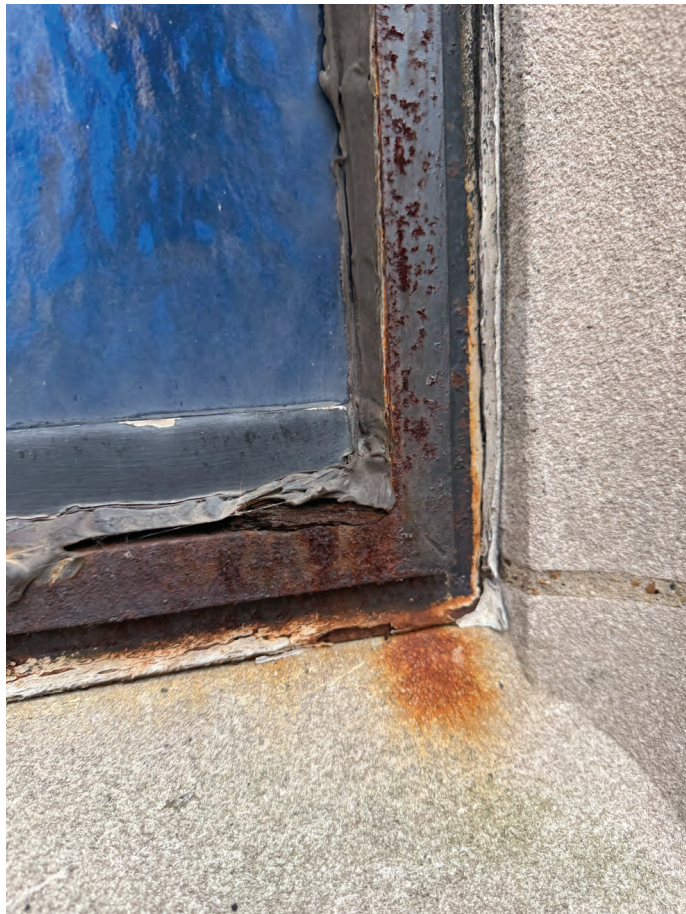
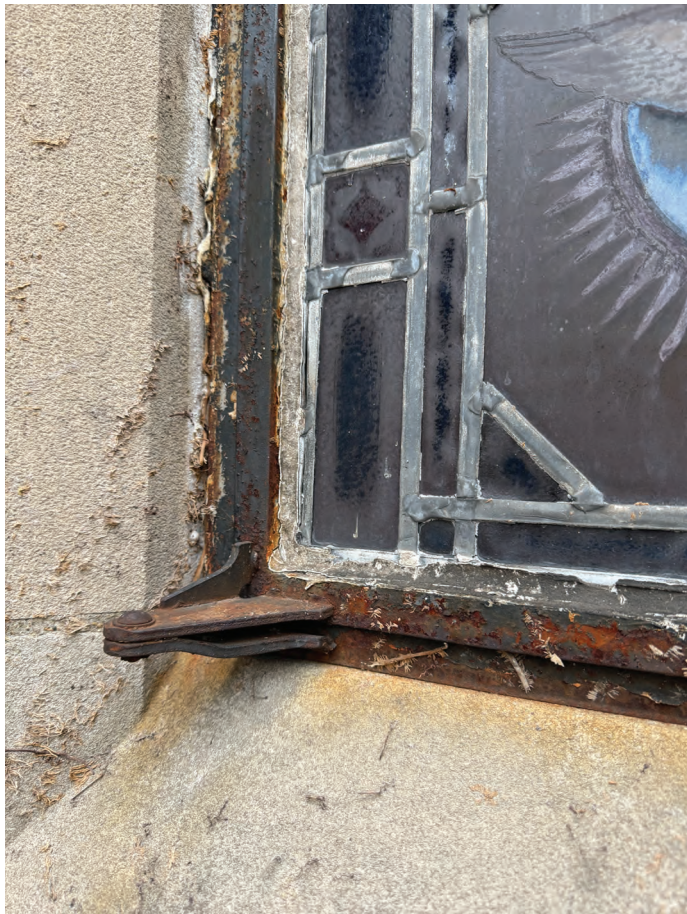
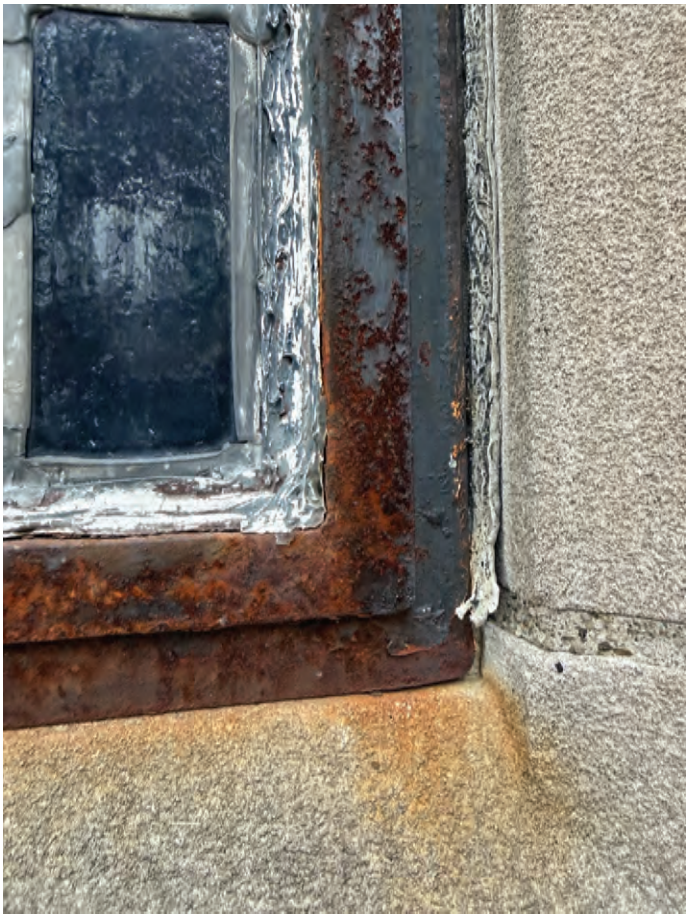
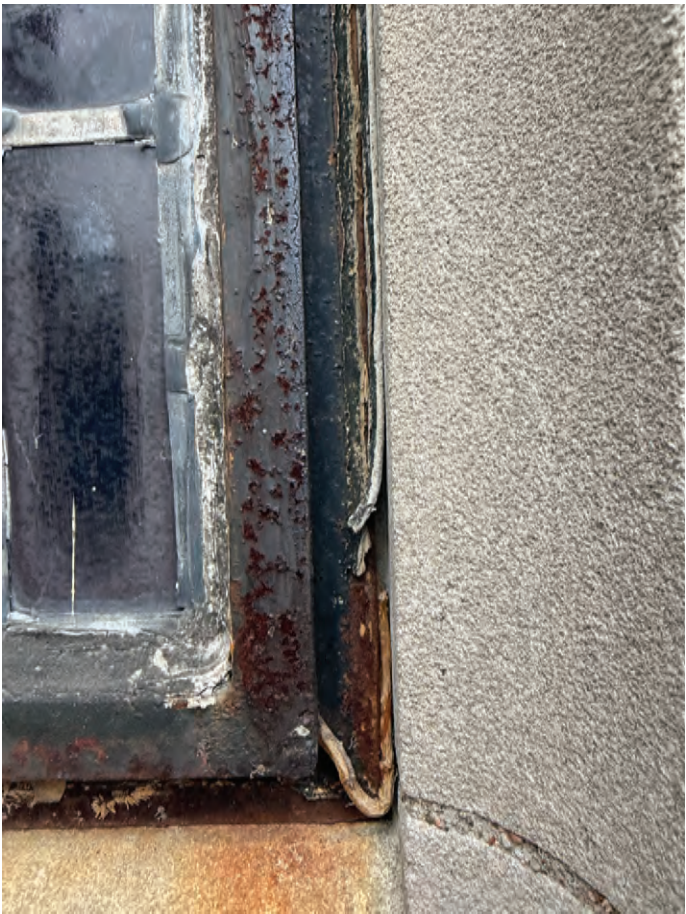
EXISTING EXTERIOR FRAME/CAULK CONDITIONS (TYP.)

The property was abandoned for approximately 15 years without maintenance. During this period, exposure to moisture, temperature swings, and lack of protection allowed the steel window frames to rust beyond repair. The extent of corrosion and material degradation precludes any meaningful restoration or stabilization of the existing units. One of the window units is missing its steel frame entirely, eliminating any structural integrity and making restoration impossible. Other windows exhibit severe corrosion and metal loss, compromising their function and rendering them structurally unsalvageable. The original operating hardware and mechanisms are completely inoperable. Due to rust, metal fatigue, and long-term neglect, these components cannot be restored to safe or functional condition.

Given these conditions, repair efforts would not only be impractical for the operation sides but would also fail to meet modern environmental, structural, and safety standards. Replacement is the only viable option that ensures safety while maintaining the architectural character of the structure. The homeowner has remained steadfast in their commitment to keeping the original leaded glass where they are fixed in place.

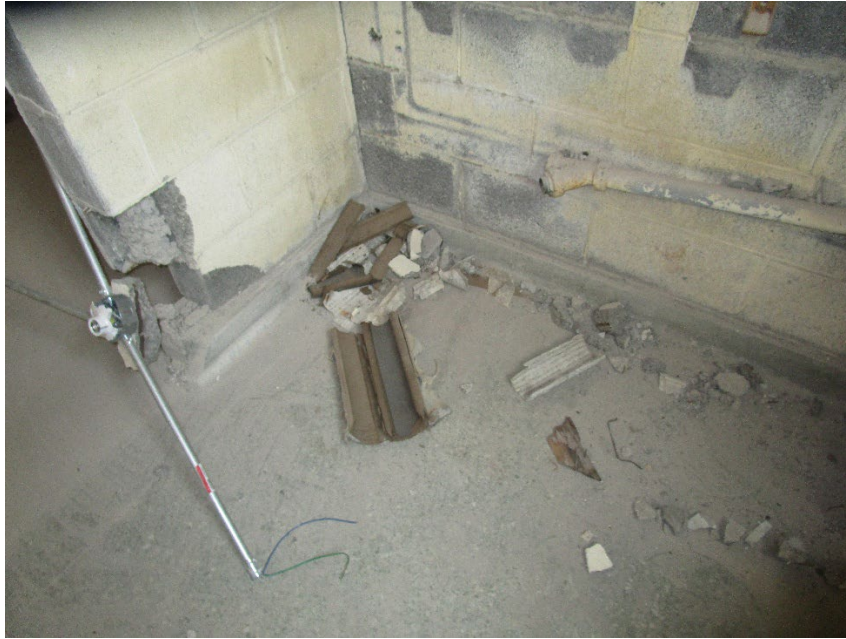
**Asbestos-containing pipe insulation.**

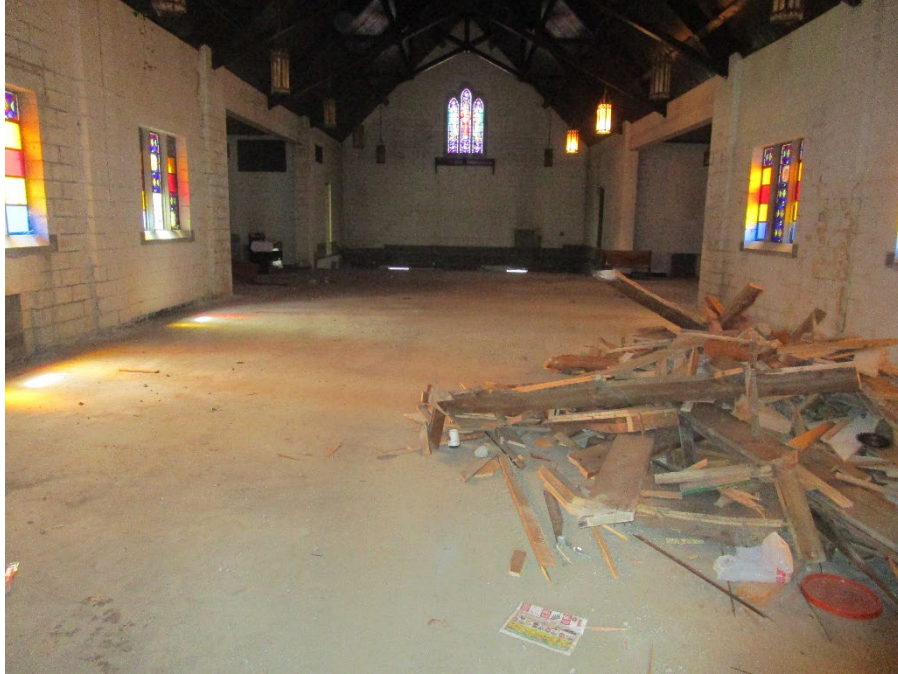
| 8 | Window glazing SE-stained glass | Brown | Chrysotile-10%<br>Other-90% | Yes<br>Chrysotile-10% |

**Windows, including the stained glasses, have both caulk and glazing that tested positive for asbestos.**
