470 MLK

PROJECT SUBMITTAL OF DOCUMENTS

FOR PRESENTATION TO THE
DETROIT HISTORICAL COMMISSION

470 MARTIN LUTHER KING JR. BLVD.
DETROIT, MICHIGAN

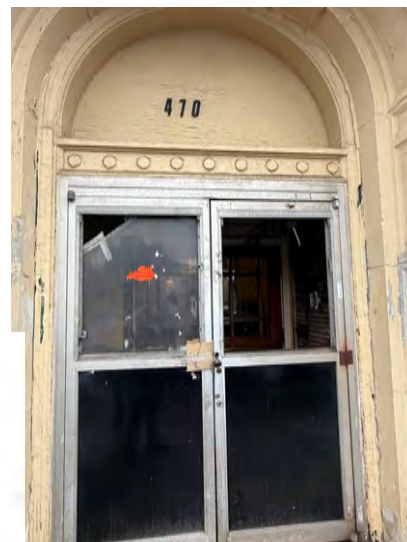
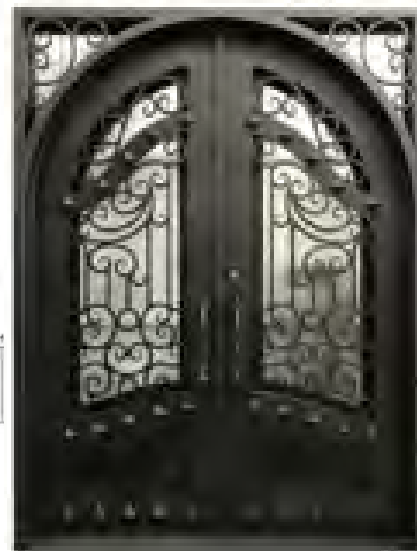
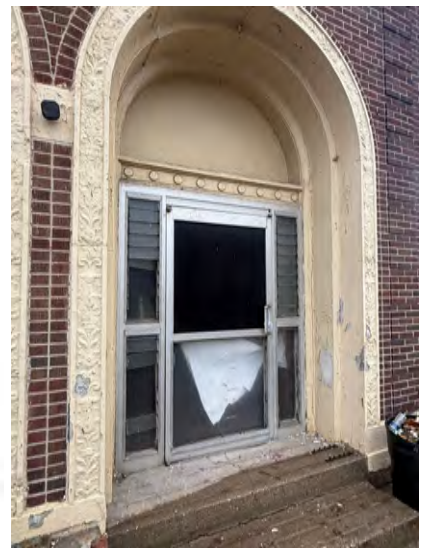
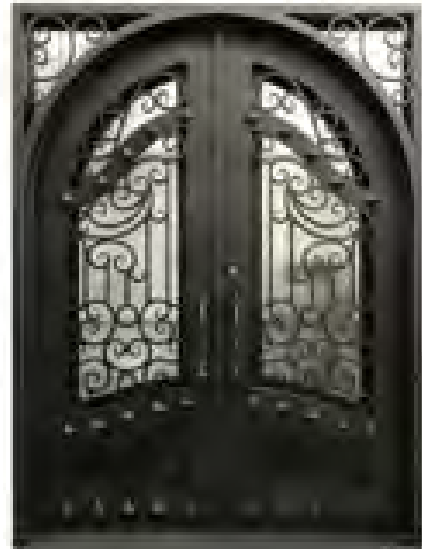
470 Project Production drawing (Drawing from Interior view)

Item	W1	Products	83 series single hung window	Item	W1	Products	Wood
QTY	127	color	black Chinese brand	QTY	127	color	
Grids	YES	Hardware	5mm+9A+5mm+argon gas	Grids	NO	Hardware	
Flyscreen	NONE	Glass		Flyscreen	NONE	Glass	
Remarks	Customize 6"*1" aluminum frame, NFRC certificate			Remarks	NOT REPAIRABLE

Bedrooms - Front Facing MLK to Have exterior Muntins (detail page 11)

existing window- 38"x 70" (small variation per window)

Brick molding to removed not salvageable.

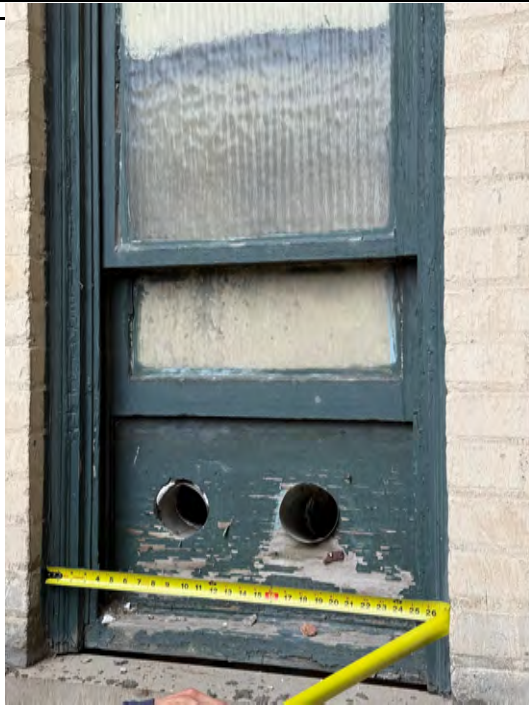
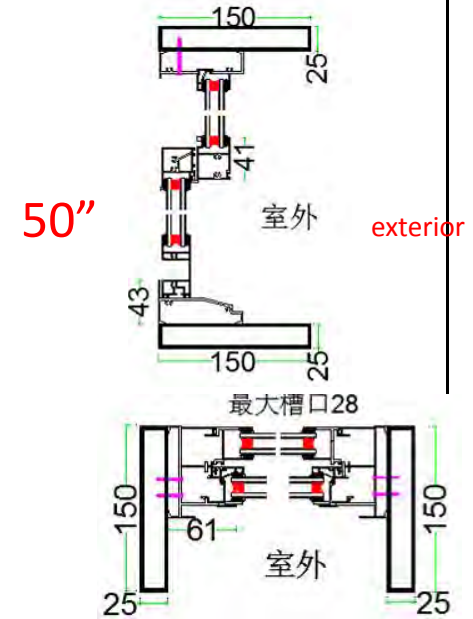
470 Project Production drawing (Drawing from Interior view)

Item	W2	Products	Existing Wood window	Item	W2	Products	83 series single hung window
QTY	127			QTY	127	color	black Chinese brand
Grids	NO	Hardware		Grids	YES	Hardware	5mm+9A+5mm+argon gas
Flyscreen	NONE	Glass		Flyscreen	NONE	Glass	
Remarks	NOT REPAIRABLE			Remarks	Customize 6"*1" aluminum frame, NFRC certificate

Bathrooms- Front Facing MLK to Have exterior Muntins (detail page 11)

existing window- 27.5"x 50" (small variation per window)

Brick molding to removed not salvageable.

- Top sash: Wood-1.5 Steel-1.535
- Meeting Rail Wood-1.5 Steel-1.535
- Sash Bottom Rail Wood-2.5 Steel-2.4"
- Muntin Wood-N/A Steel-.59"
- Stile Wood-N/A Steel-N/A
- Perimeter Frame Wood-N/A Steel-1.53

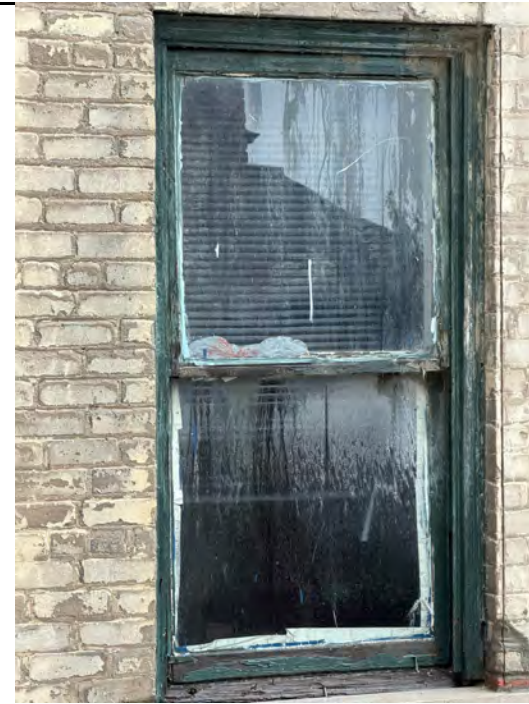
64.5"

23.5"

Item	W3	Products	83 series single hung window	Item	W4	Products	Existing Wood Window
QTY	4	color	black	QTY	3		
Grids	YES	Hardware	Chinese brand	Grids	NO		
Flyscreen	NONE	Glass	5mm+9A+5mm+argon gas	Flyscreen	NONE	Glass	
Remarks	'aluminum frame, NFRC certificate			Remarks	NOT REPAIRABLE

Basemet Various-existing window- 23.5"x 64.5" (small variation per window)

Brick molding to removed not salvageable.

Top sash: Wood-1.5 Steel-1.535

Meeting Rail Wood-1.5 Steel-1.535

Sash Bottom Rail Wood-2.5 Steel-2.4"

Muntin Wood-N/A Steel-.59"

Stile Wood-N/A Steel-N/A

Perimeter Frame Wood-N/A Steel-1.53

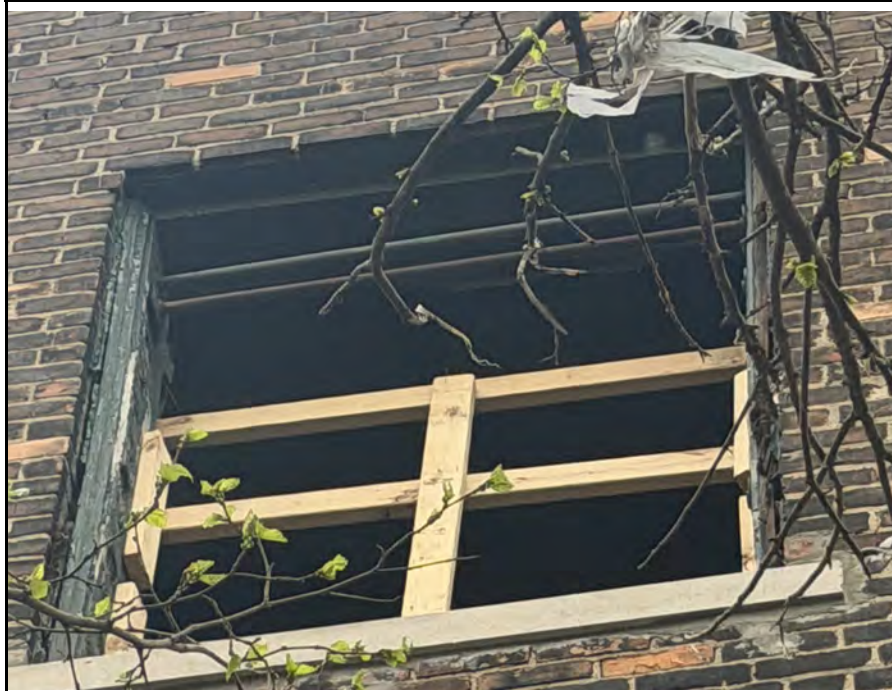
W6 E2 Series s Fixed window, Black powder coating. QTY: 3Set

Item	W6	Products	Existing Window	Item	W6	Products	E2 series thermal break fixed window
QTY	3	color		QTY	3	color	black
Grids	NO	Hardware		Grids	NO	Hardware	Chinese brand
Flyscreen	NONE	Glass		Flyscreen	NONE	Glass	6mm+20A+6mm+argon gas
Remarks	NOT REPAIRABLE			Remarks	NFRC certificate

Alley Side Stairwells-

existing Opening Size- 55.5" x 78.5"

Brick molding to be removed cannot not be salvaged

Top sash: Wood-1.5 Steel-1.535

Meeting Rail Wood-N/A Steel-N/A

Sash Bottom Rail Wood-N/A Steel-1.535"

Muntin Wood-N/A Steel-.59"

Stile Wood-N/A Steel-N/A

Perimeter Frame Wood-N/A Steel-1.53

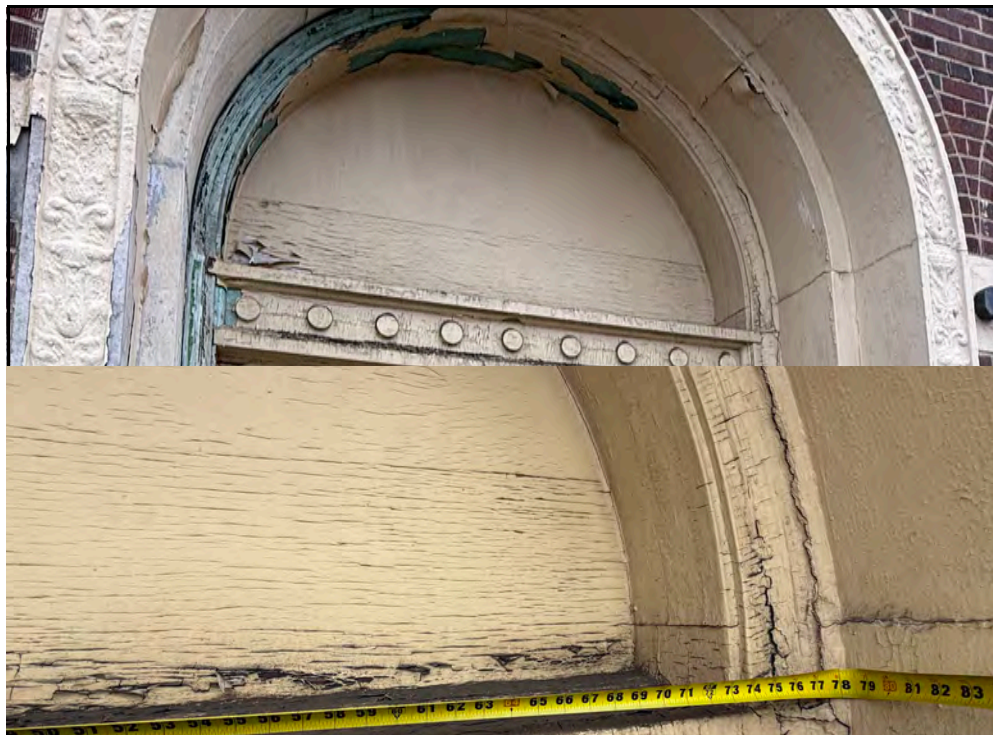
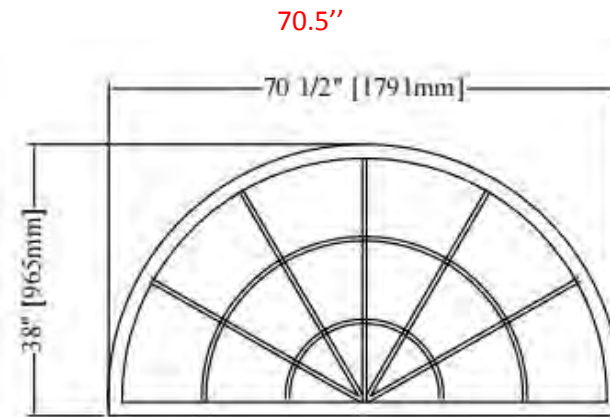
Item	W5-upper	Products	65 series thermal break fixed window
				QTY	5	color	black
				Grids	YES	Hardware	Chinese brand hardware
				Flyscreen	NONE	Glass	5mm+20A+5mmLOWE+argon gas
				Remarks	NFRC certificate

Front windows Arches-
 existing wood plaser sized- 70.5"x38" (small variation per window)
 Brick molding to remain and be restored -3" on all sides.

Top sash: Wood-N/A Steel-N/A
 Meeting Rail Wood-N/A Steel-N/A
 Sash Bottom Rail Wood-N/A Steel-1.535"
 Muntin Wood-N/A Steel-.59"
 Stile Wood-N/A Steel-N/A
 Perimeter Frame Wood-N/A Steel-1.53

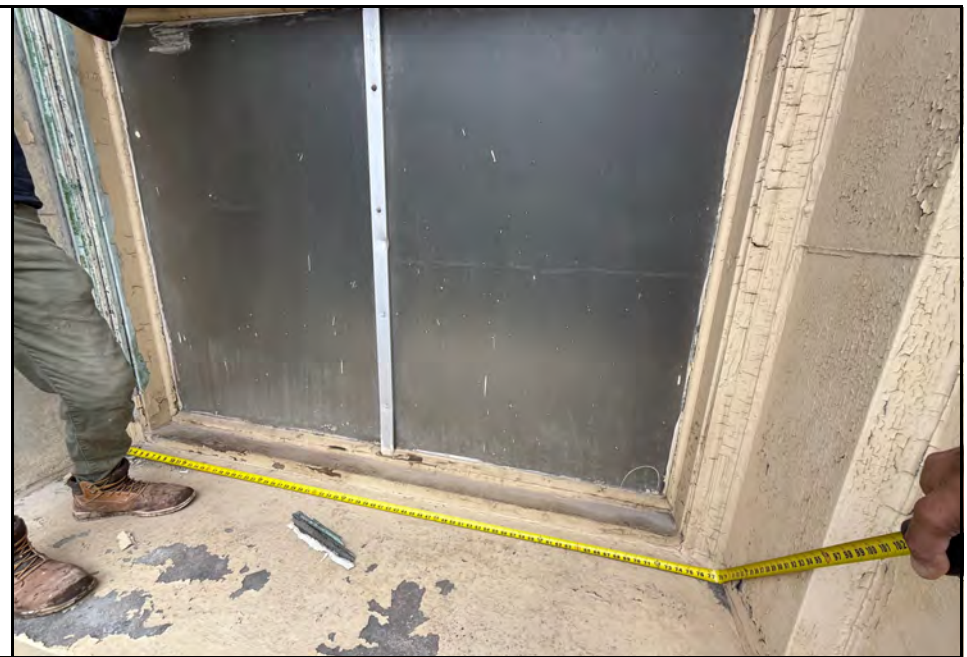
Item	W5-lower	Products	65 series thermal break fixed window				
QTY	3	color	black				
Grids	YES	Hardware	Chinese brand hardware				
Flyscreen	NONE	Glass	5mm+20A+5mmLOWE+argon gas				
Remarks	NFRC certificate

Front Picture windows below Arches-
 Existing window size 70.5"x 52"
 Brick molding to remain and be restored -3" on all sides.

Top sash: Wood-1.5" Steel-N/A
 Meeting Rail Wood-N/A Steel-N/A
 Sash Bottom Rail Wood-1.5" Steel-1.535"
 Muntin Wood-N/A Steel-.59"
 Stile Wood-N/A Steel-N/A
 Perimeter Frame Wood-N/A Steel-1.53

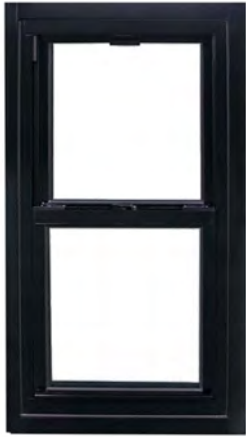
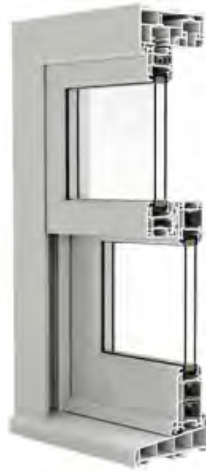
- PROFILE 6063-T5 ALUMINUM ALLOY
- 2.0MM THICKNESS
- BLACK COLOR
- BLACK COLOR STRIP BETWEEN GLAZE
- HIDDEN WATER DRAINAGE SYSTEM
- INTEGRATED HARDWARE
- NFRC STANDARD
- DOUBLE TEMPERED SAFETY GLASS
- LOW E COATING -DOUBLE PANE INSULATED
- 8MM+15A+8MM+LOW E+ARGON GLASS

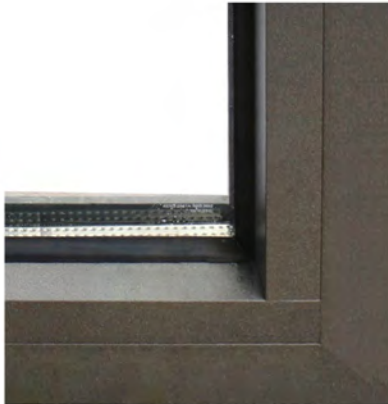
National Fenestration Rating Council® CERTIFIED	FOSHAN REALGRES BUILDING MATERIALS CO., LTD	
	ALUMINUM WINDOW AND DOOR DoubleLayer Glazed • Argon Fill • Low E FRG-N-1 00001-00001	
ENERGY PERFORMANCE RATINGS		
U-Factor (U.S./I-P)	Solar Heat Gain Coefficient	
0.29	0.23	
ADDITIONAL PERFORMANCE RATINGS		
Visible Transmittance	Air Leakage (U.S./I-P)	
0.34	≤0.3	
<small>Manufacturer stipulates that these ratings conform to applicable NFRC procedures for determining white product performance. NFRC ratings are determined for a fixed set of environmental conditions and a specific product size. NFRC does not recommend any product and does not warrant the suitability of any product for any specific use. Consult manufacturer's literature for other product performance information. www.nfrc.org</small>

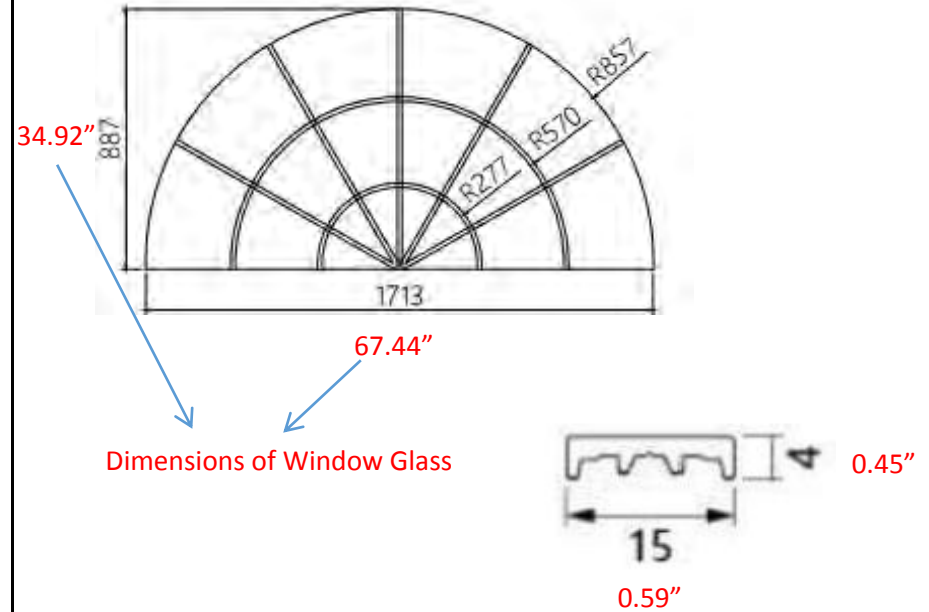
Item	G2	Products	Exterior grids only just on exterior side
QTY	16 sets	color	black

Item	G3	Products	Exterior grids only just on exterior side
QTY	5 sets	color	black

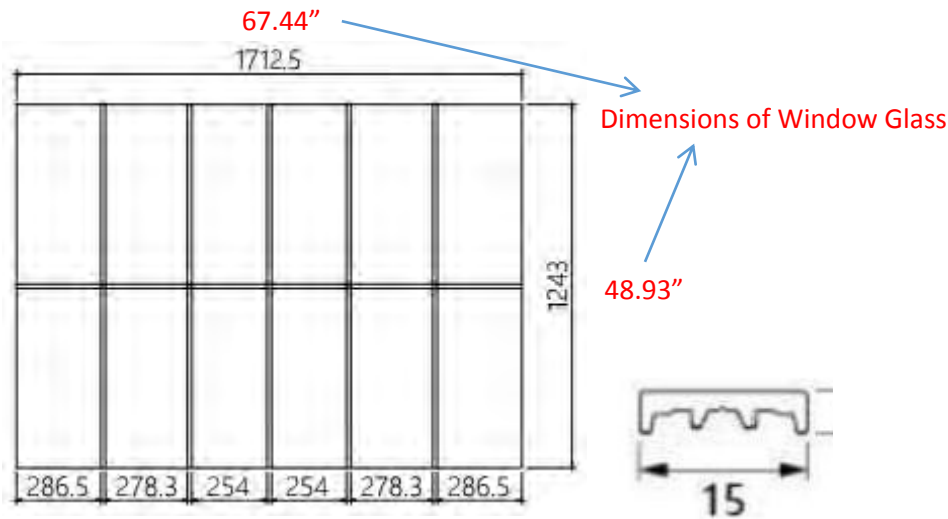
Item	G4	Products	Exterior grids only just on exterior side
QTY	3 sets	color	black

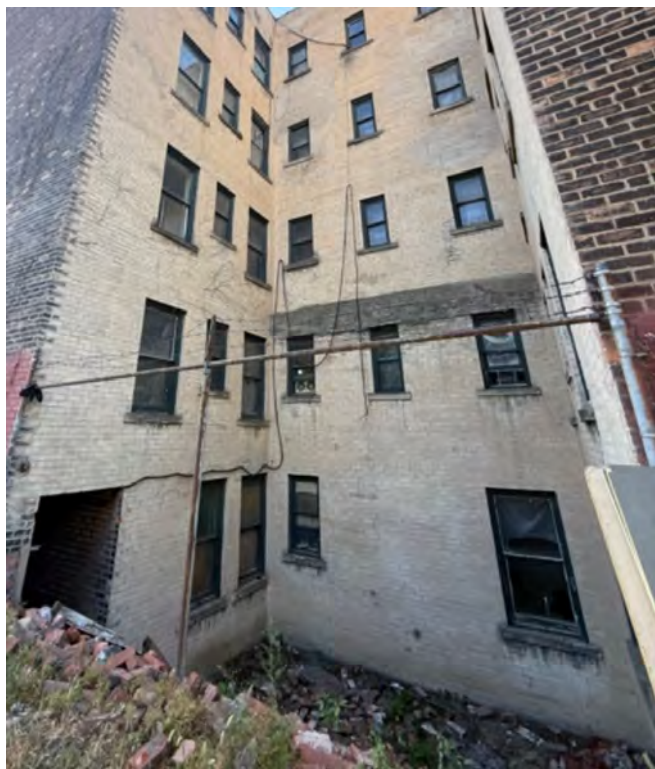
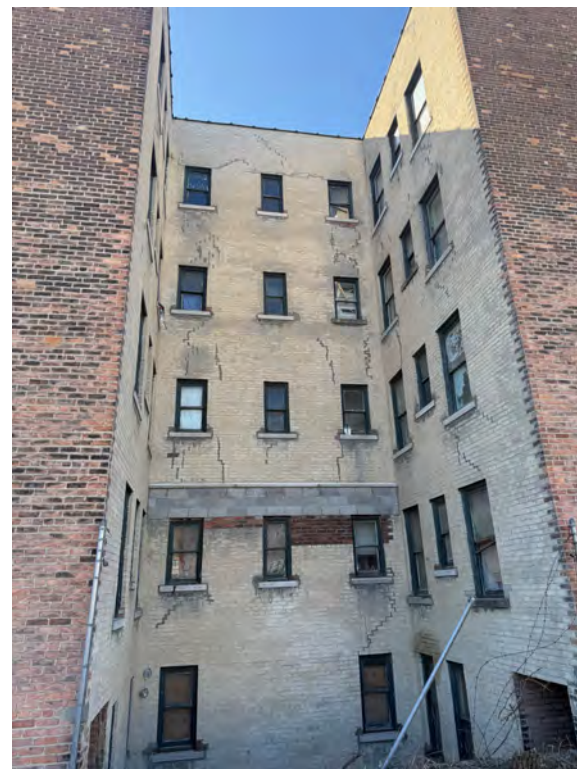
Weathered brick was surface coated in mortar and not salvageable. Repaired with CMU block for durability. Entire interior area to be painted and hide CMU block.

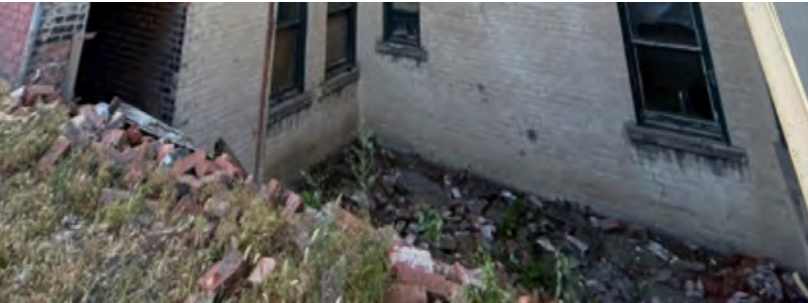
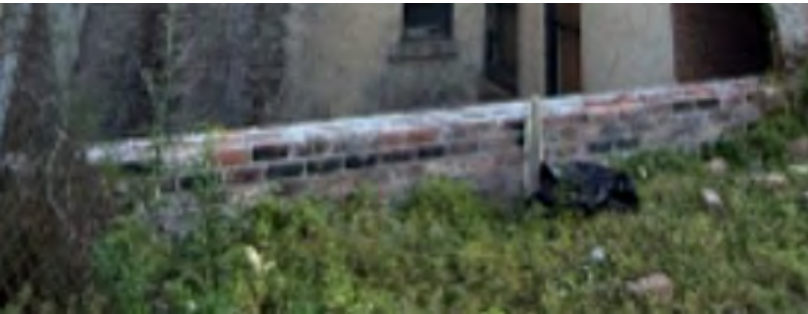
2 images below Showing original retaining wall

Retaining Wall was deteriorated and required repair. Bricks salvaged and repurposed on on building.

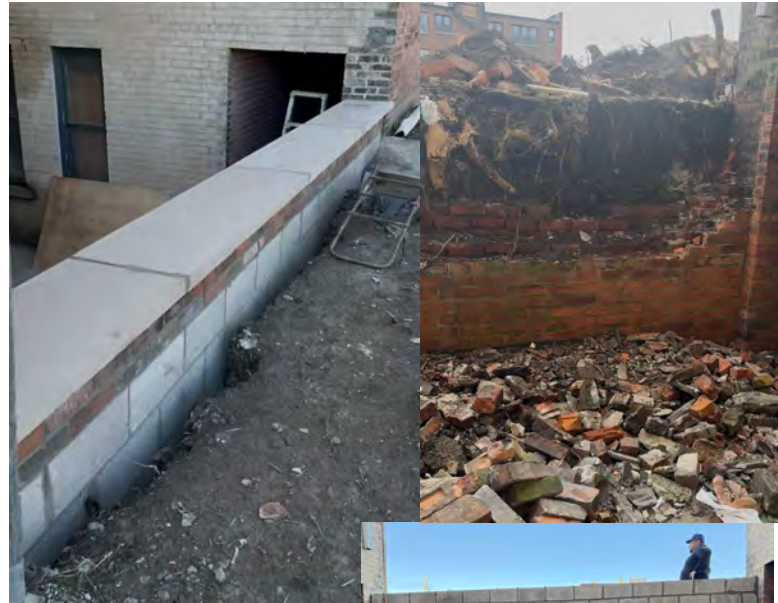
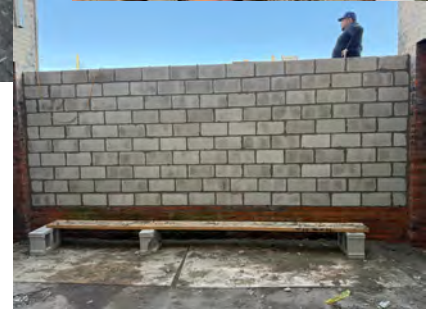
3 images below showing repaired wall and New limestone cap

CMU currently exposed, will be below grade once backfilled and parking lot poured on neighboring property. Limestone cap installed for weather proofing wall and for base to install new safety rail per city requirement.
