# Lead-Based Paint Inspection & Risk Assessment
# CCSEM St. Matthew
# 6021 Whittier Avenue
# Detroit, Michigan

LBP Inspection & Risk Assessment Dates:
September 20-24, 2022
Report Date: November 10, 2022

**ASTI Project No.: 4-11685**

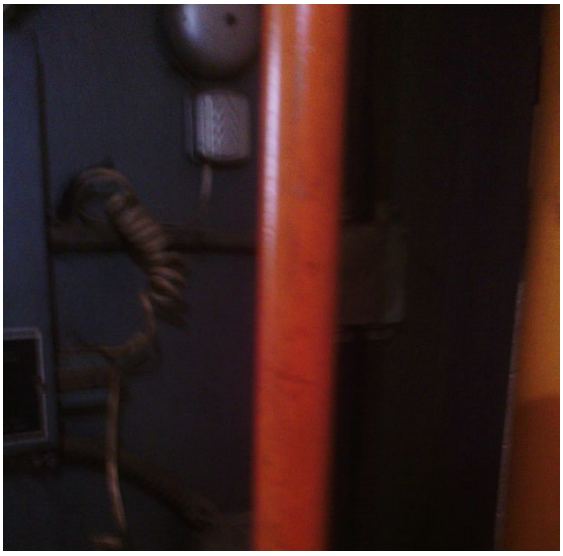
| | **Photo 13.** View of XRF Reading #4368, LBP positive pipe in 5959 Whittier |
