STAFF REPORT 05-08-2024 REGULAR MEETING

APPLICATION NUMBER: HDC2024-00183

ADDRESS: 64 EDMUND PLACE

SCOPE: ERECT REAR ADDITION AND ROOF DECKS, RESTORE FULL-WIDTH FRONT PORCH, INSTALL WINDOWS

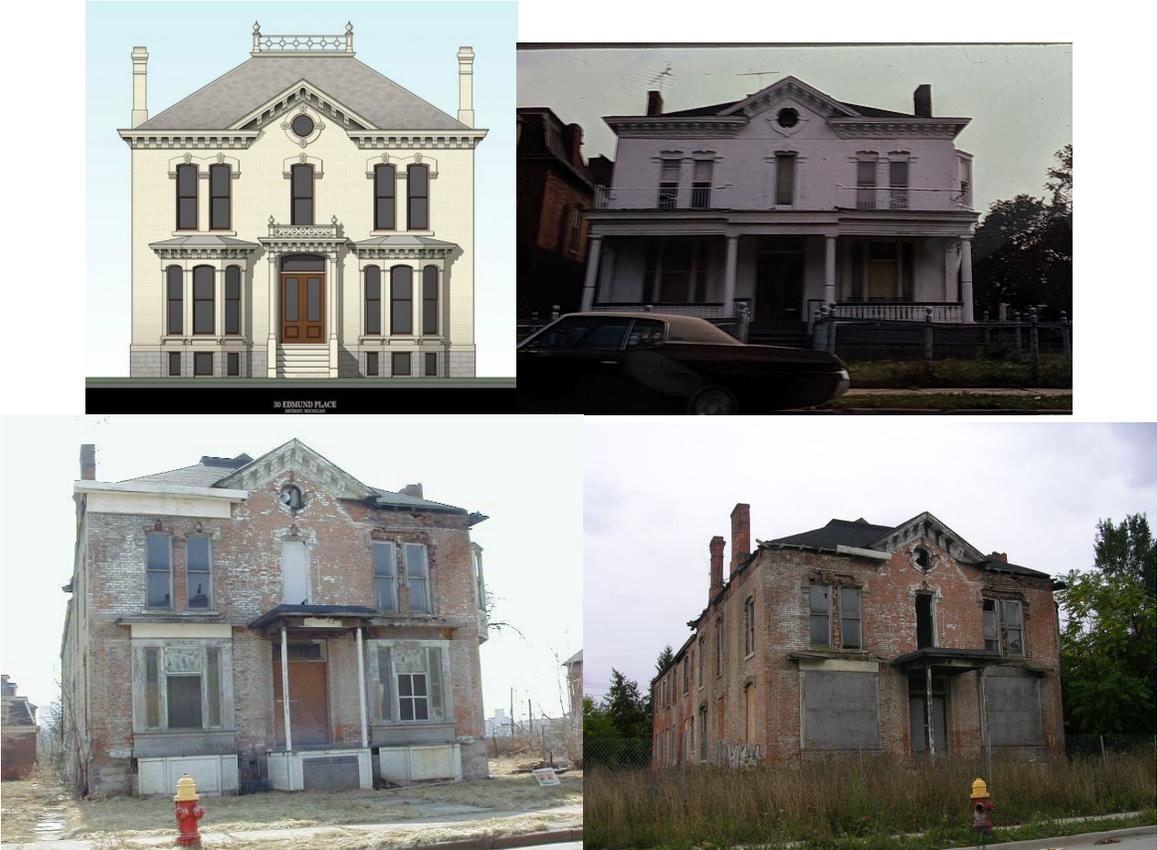
Multiple iterations of 64 Edmund Place. The first image, created by user “uyinla” and shared on Flickr, is a speculative rendering of its original appearance, which staff judges to be a reasonable guess. The second image, upper right, is the appearance of the building when it entered the historic district in 1980, long stripped of its Victorian bay windows and porch, replaced by a full-width Colonial Revival porch, consistent with architectural fashions in the early 20th Century. The two bottom images are from more recent decades.

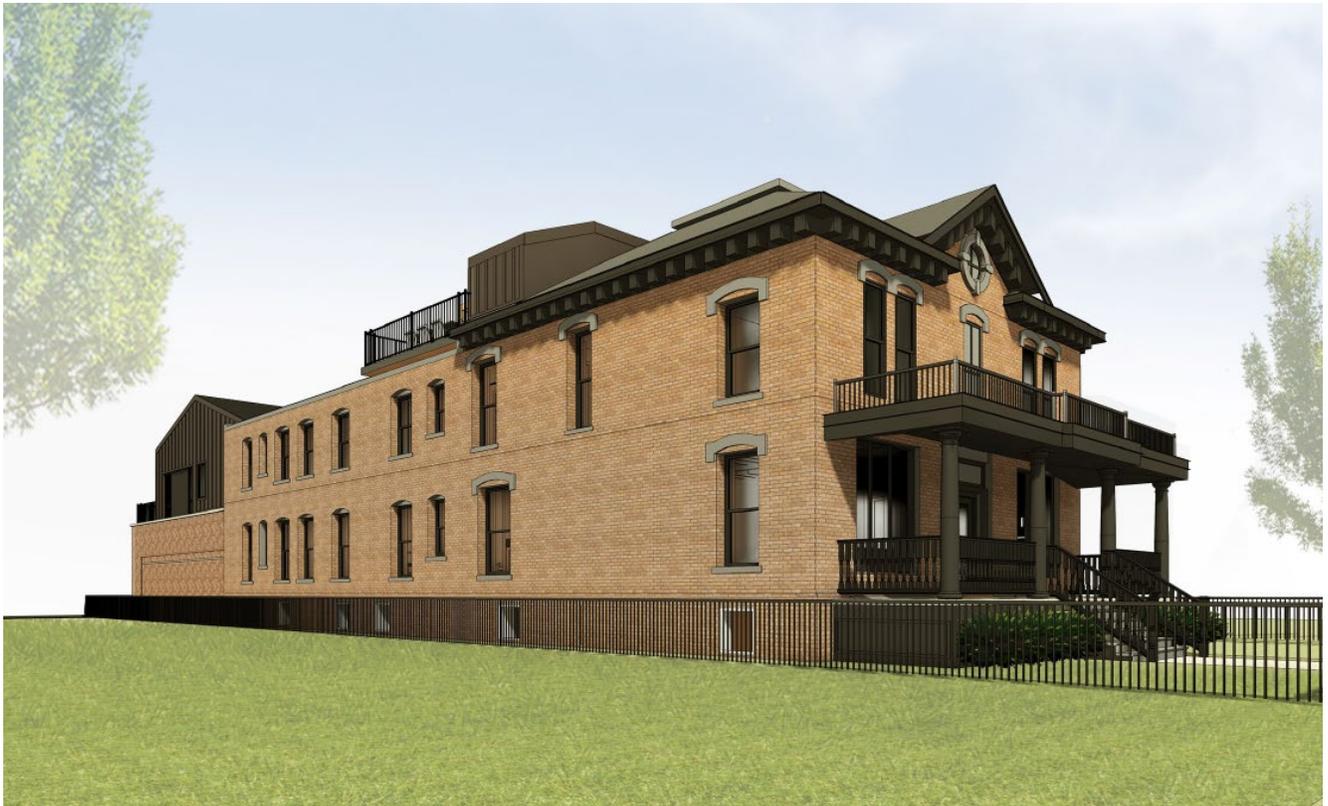
Rendering of view from Edmund Place, east side of building, showing rooftop deck alterations and new addition visible at far left.

- A rooftop “doghouse” and deck addition is proposed at the juncture between the original 1870s house and the 1910s rooming addition. The architect has attempted to limit the visible impact of the modern elements enclosing the stair (the board and batten clad shapes) by sloping their rooflines consistent with the historic slope. While preferable to an initial design presented to staff, staff recommends that further revision of the design be pursued to make these elements less visible. Along with retaining the four historic chimneys, described in the previous bullet point, this might be accomplished in one or more of the following ways:

- Reconfiguring the interior stairs by combining two stairs into one, reorienting the runs to be on the building’s long axis, or similar moves
 - Changing the materiality of some planes of the proposed “doghouse” elements from opaque to transparent, lessening their impact within the overall expression of the roof. This could involve adding glass walls to one or more of the vertical sides, allowing views through the elements.

- Restoring the long lost rooftop balustrade (also visible in the 1963 photo above), which would restore another authentic historic element to the roof (along with retaining the chimneys) that might reduce the impact of the “doghouse” elements.

- The four chimneys on the main house be repaired and preserved
- The "doghouse" elements housing the new stairs to the mid-building roof deck be redesigned to be less obtrusive, via internal reconfiguration of the stairs, the introduction of glass planes to allow greater transparency through the elements, and/or reintroduction of a rooftop balustrade as seen in historic photographs
- Window product selection and configuration throughout the rehabilitated areas of the building will be true wood or aluminum-clad wood units, with vertically-oriented double-hung configuration compatible with Italianate or Colonial Revival examples. A new front elevation depicting revisions to the first floor front-facing windows shall be submitted.

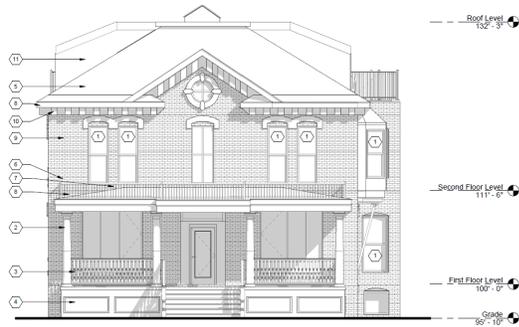
1 NORTH ELEVATION
SCALE: 3/16" = 1'-0"

Architectural elevations from applicant materials (left image – front, right image – rear, below- side elevation). Not to scale.

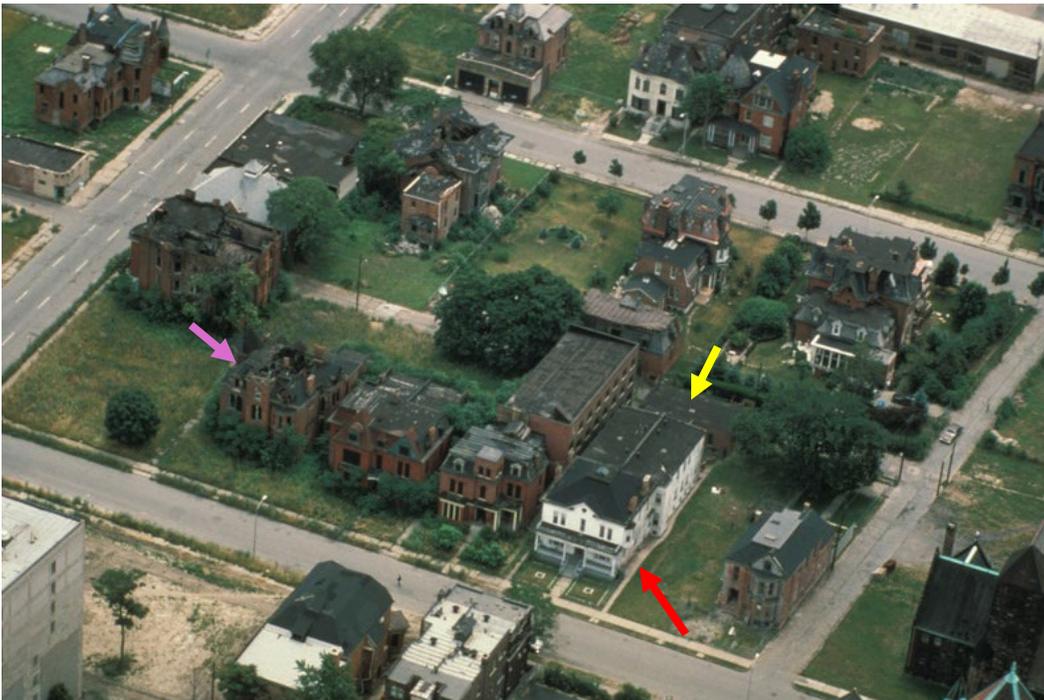
In this undated (likely c. 1990s) aerial view of the block, the subject building is seen in white (red arrow points at original house). Note that the one story garage structure at the rear of the lot is still extant in this image (yellow arrow), as well as a massive 3-story addition at the mansion next door, now gone. Note also the ruined condition of the Lucien Moore house (104 Edmund Place), with no roof, now restored (purple arrow). The ruined Ransom-Gillis House is just visible at the upper left. From Detroit Urbex website.
