7 Parkman

Address: 15000 Mackenzie
 Parcel: 22044630
 District: 7
 SNF Area: n/a
 Owner: City of Detroit
 Site Area: 3.75 ac
 Gross Floor Area: 40,800 sf
 Floors: 2
 Plan Type: U
 School Type: Elementary
 Year Built: 1940, 1947, 1953
 Zoned: R1
 Base Rehab Cost (est): \$1.3M
 Total Rehab Cost (est): \$9.9M

Building Overview

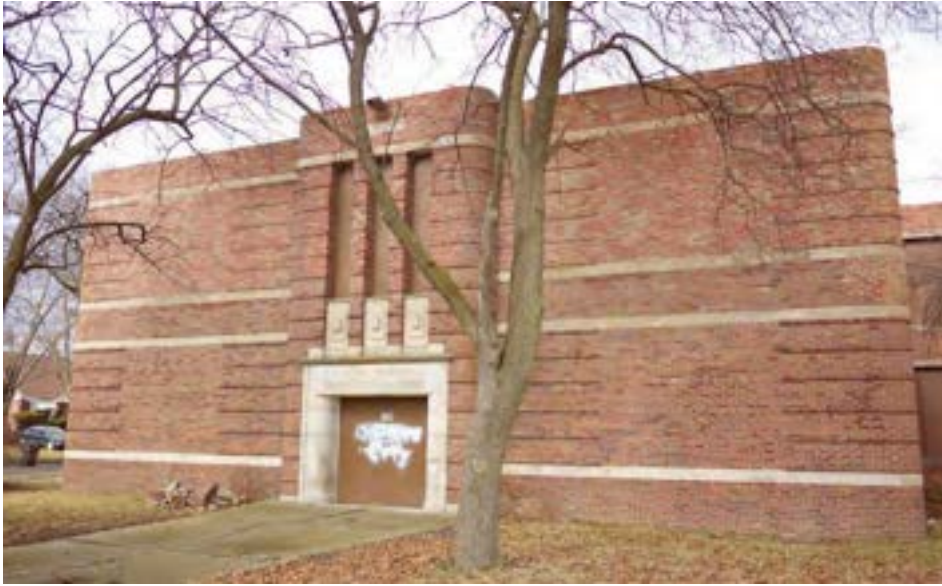
Parkman's original southwest unit, completed in 1940. The rest of the school was completed in 1948-1952. This image shows the school's streamlined moderne style of architecture, with unique rounded corners, horizontal bands of stone and brick details, and striking vertical slit windows at the entrances.

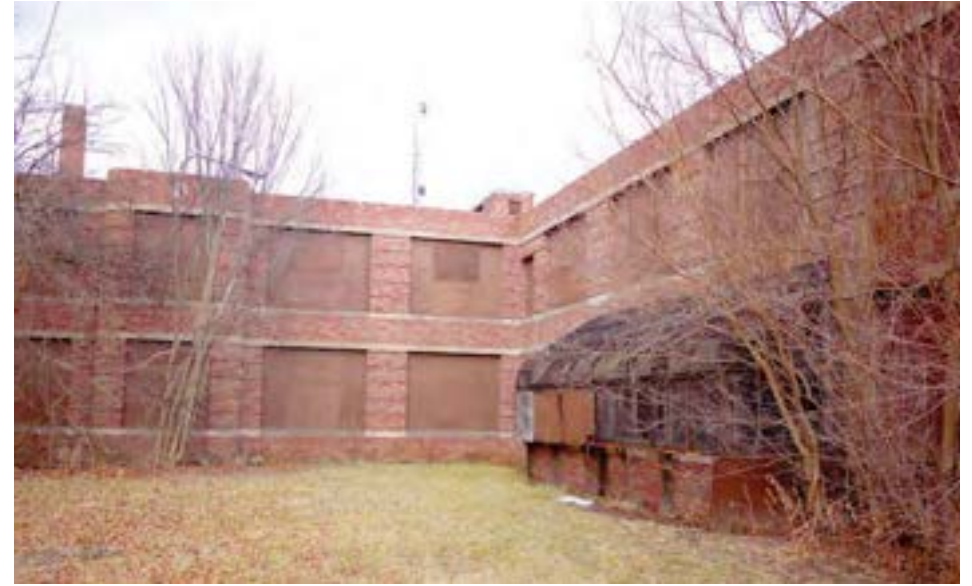
The three wings of the school wrap around a south-facing grassy courtyard with small trees. There is no direct access to the courtyard from inside the school, but the courtyard is open to the primary street frontage and flanked by the two main entrances.

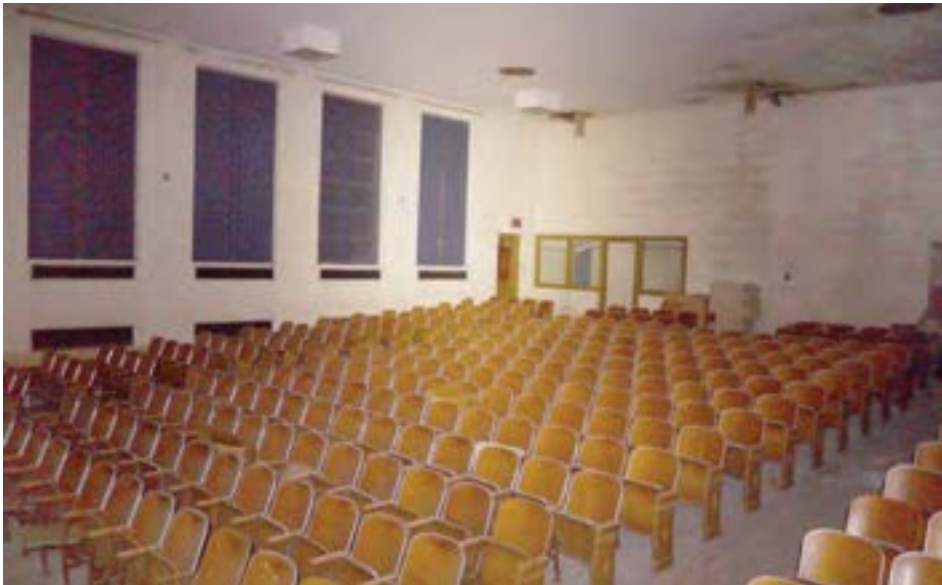
The auditorium, added in 1952, is a simple CMU box. Original wood seating and steel-frame windows are still intact.

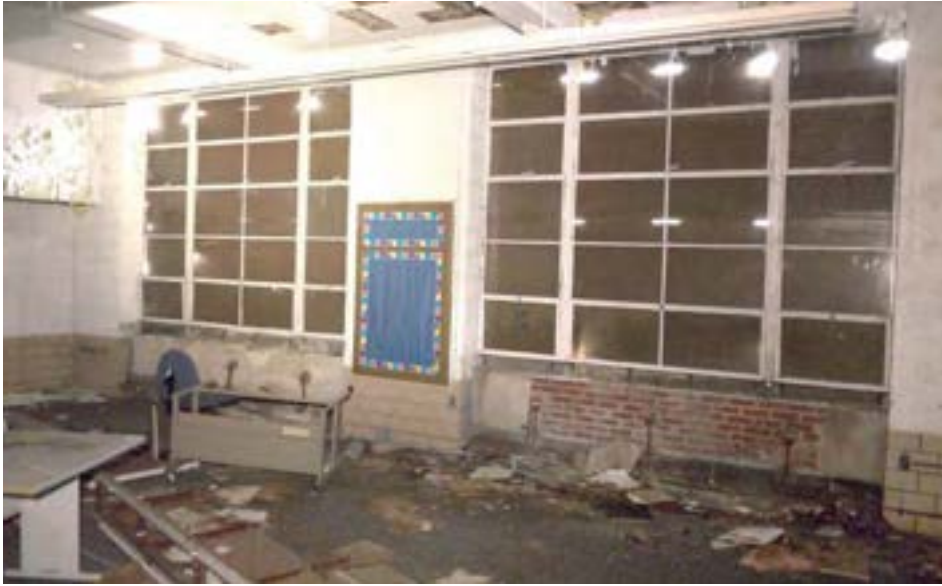
Classrooms feature large double windows consisting of a 4x5 steel-frame grid. Most of the original windows at Parkman remain intact.

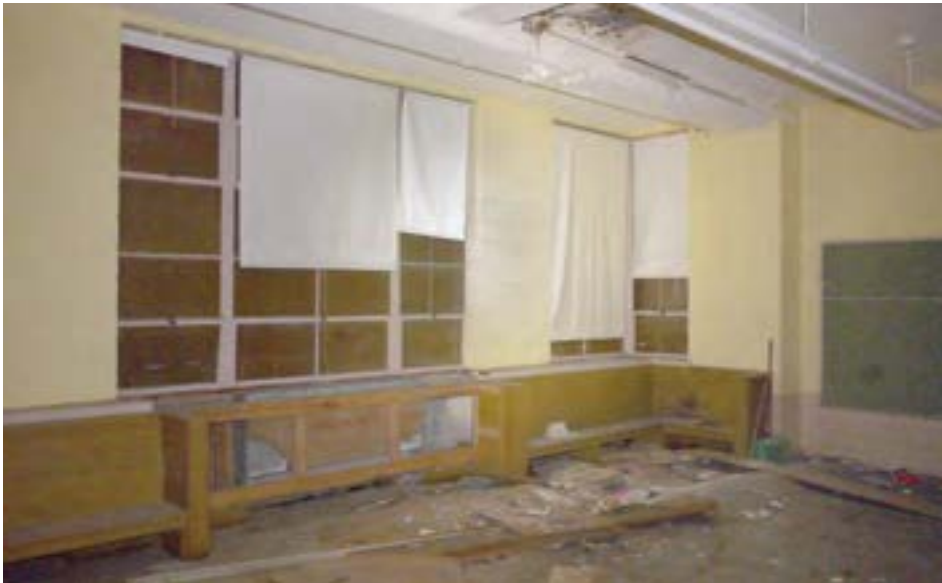
The kindergarten space dispenses with the deep 5-sided bay window that is a hallmark of Detroit elementary schools constructed during the 1920s and 30s. Instead, there is a rectangular alcove with a large central window and wrap-around corner windows.

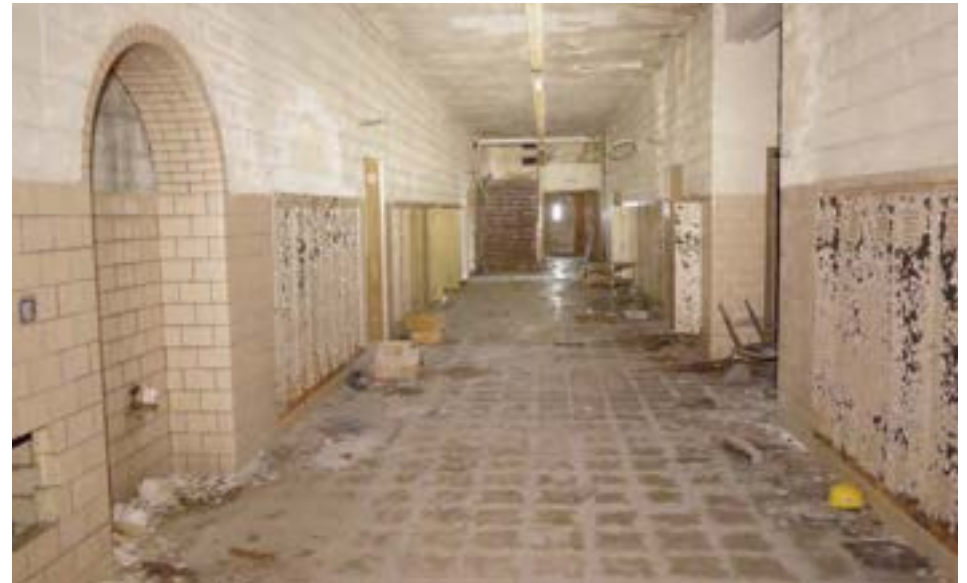
Interiors are simple and sturdy masonry construction, with glazed block accents. Arched alcoves once housed drinking fountains, which have been taken. The corridors do not receive much natural light; the only sources are narrow slit windows in the stairwells at the ends of each corridor.

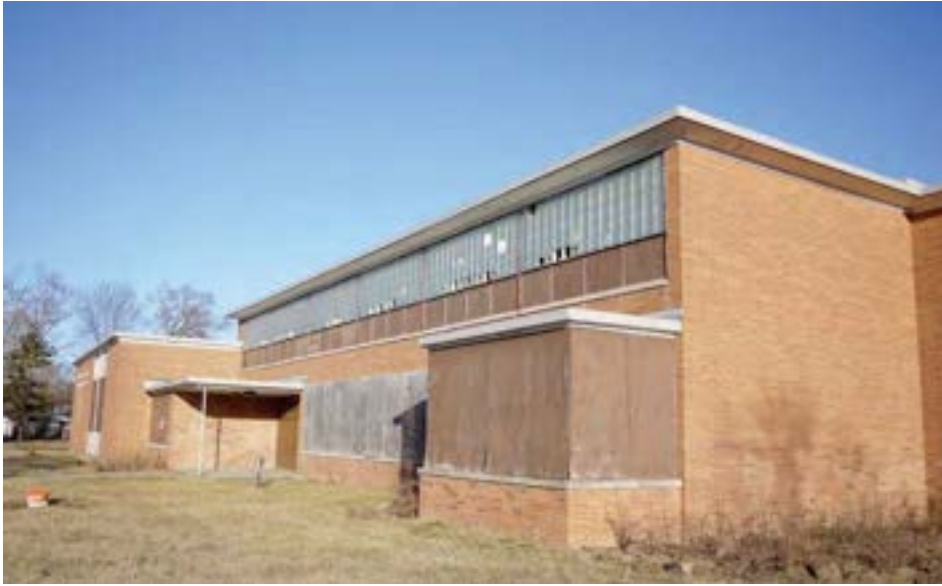
The main (south) facade of the school, showing continuous bands of glass block extending along the entire classroom wing. The windows are largely intact.

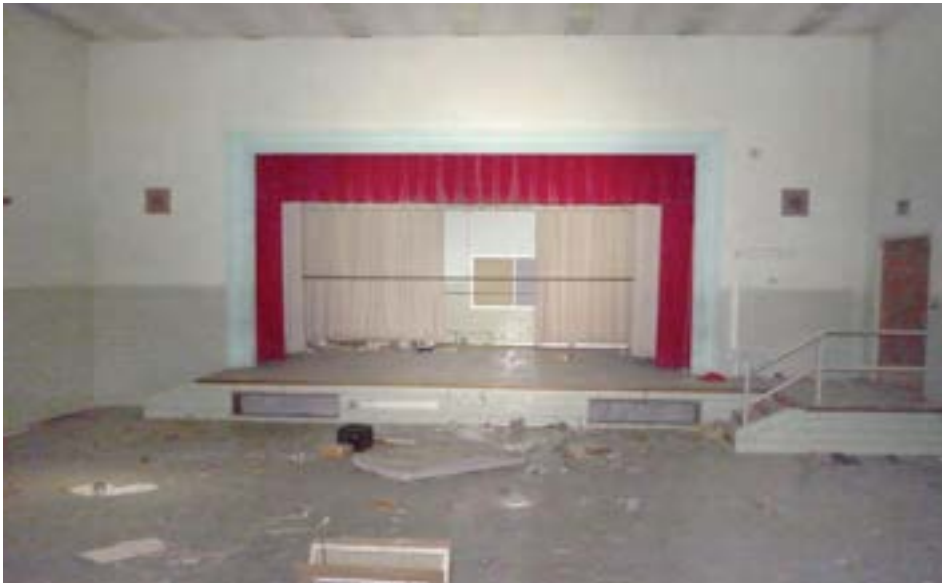
The auditorium is small, with a low stage and a flat sunken floor. The space is a simple box with painted CMU and green glazed tile matching the corridors.

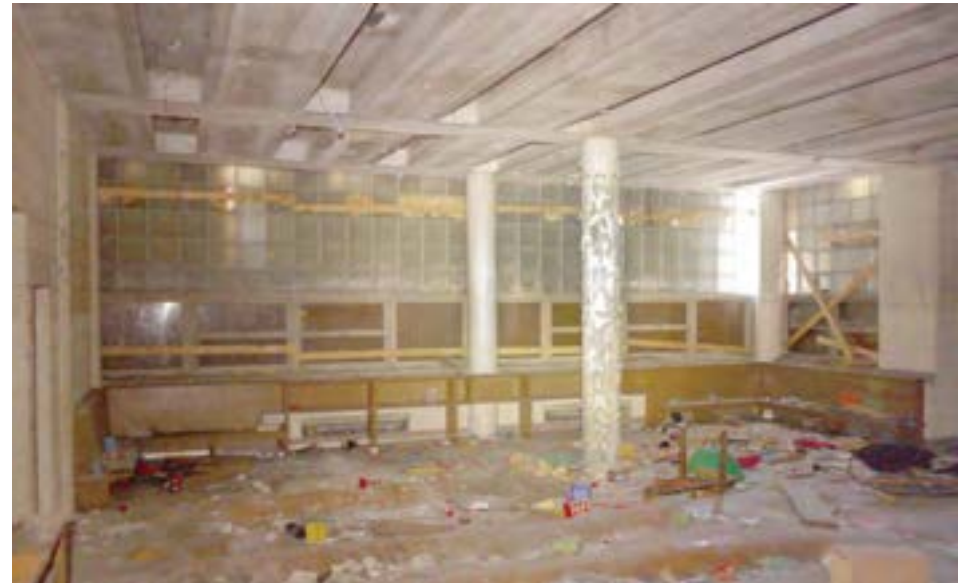
The kindergarten is a large space that features a wide bump-out with windows on three sides.

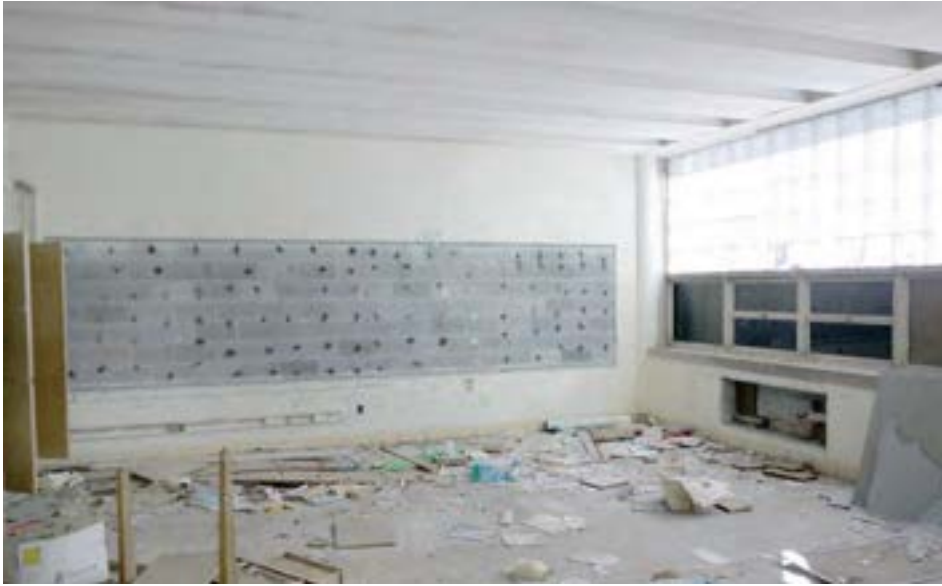
Classrooms are typical of 1950s-era schools, with concrete block construction, and wall-to-wall ribbon windows comprised of glass block over steel-framed operable lites.

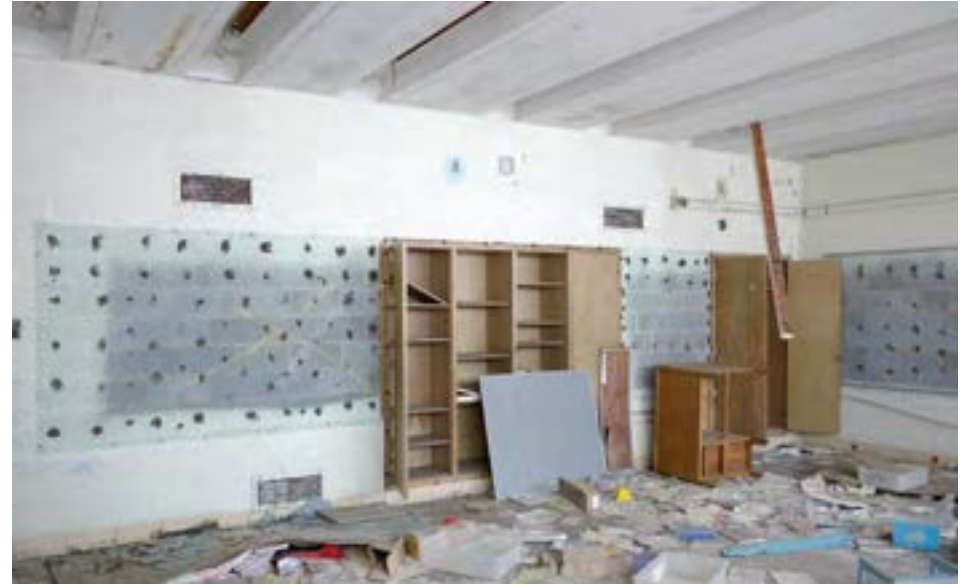
Classroom finishes are simple, including simple wood cabinetry, VCT floors, and an exposed-structure ceiling that incorporates fluorescent tube lights in between the joists.

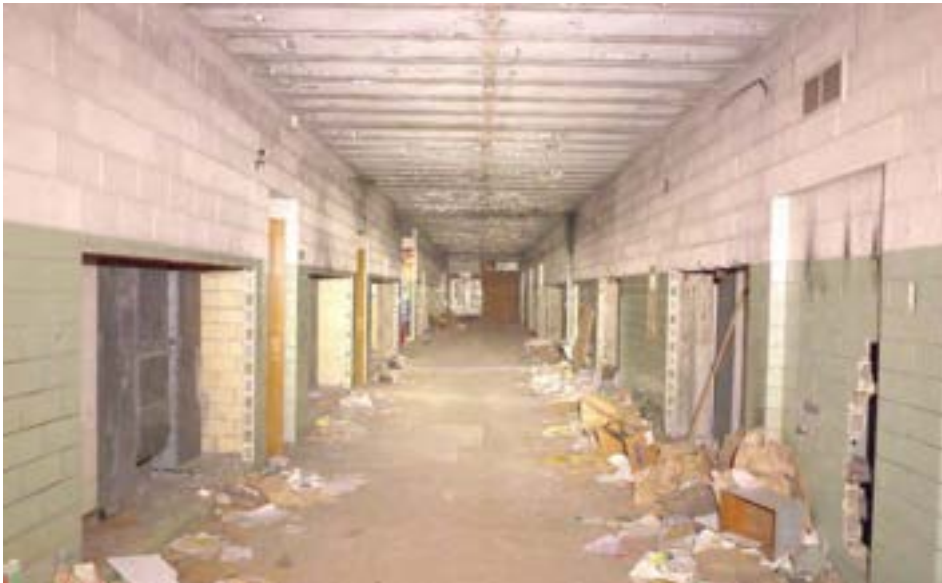
The building has been extensively scrapped, but finishes and structure remain in relatively good condition. The school's corridors feature glazed block finishes with a unique shade of jade green.

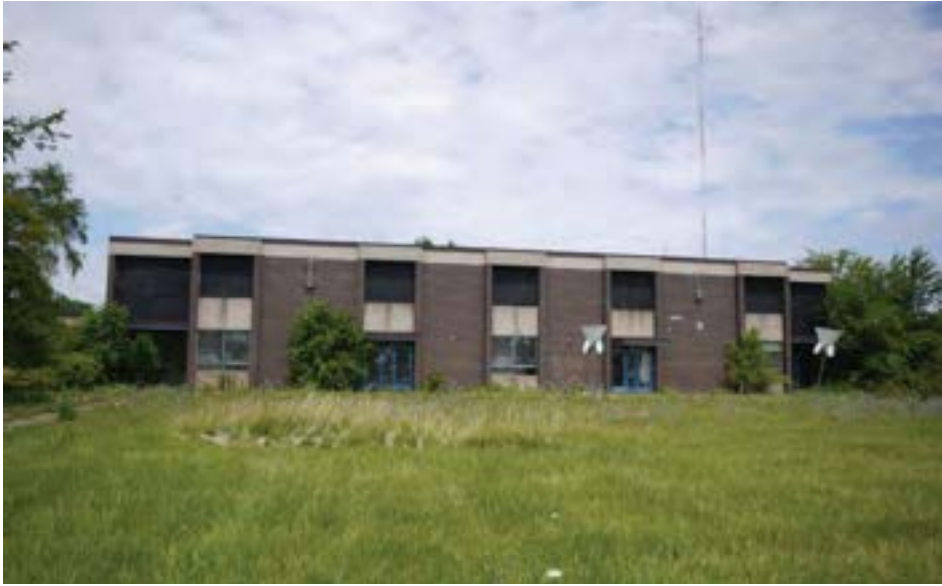
South elevation with small play field in foreground, showing a 2-story classroom wing.

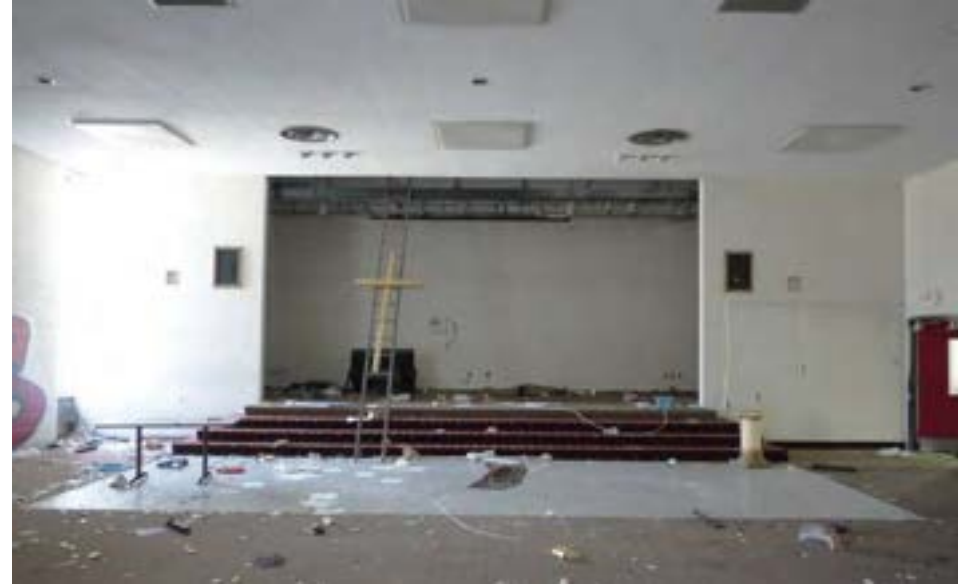
The auditorium is a large square space measuring 45x45' not including the stage area. There is a flat carpeted floor and no fixed seating.

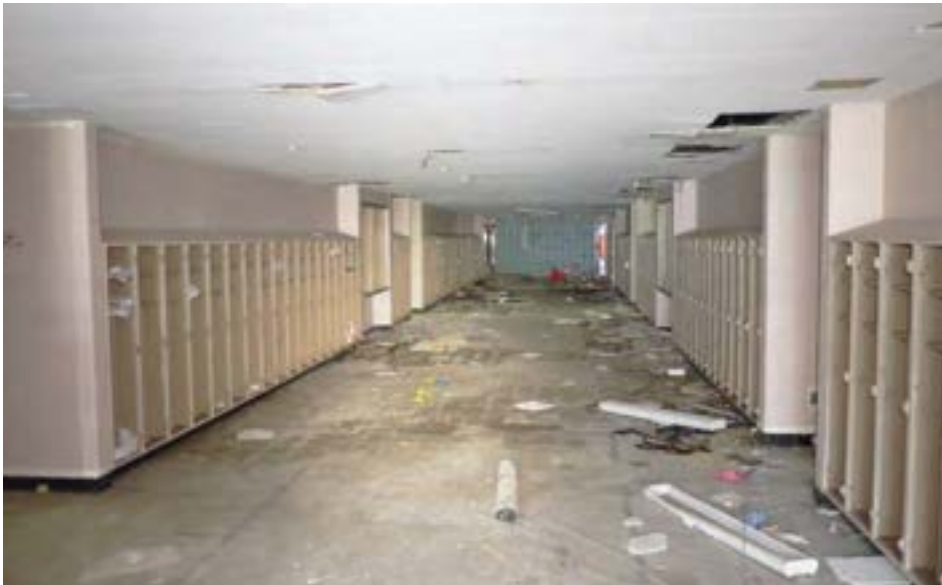
The main hallway is 17' wide with 8' ceilings and lockers lining the wall. The corridor forms a central axis between the main entrance and a decorative glazed tile art wall at the opposite end.

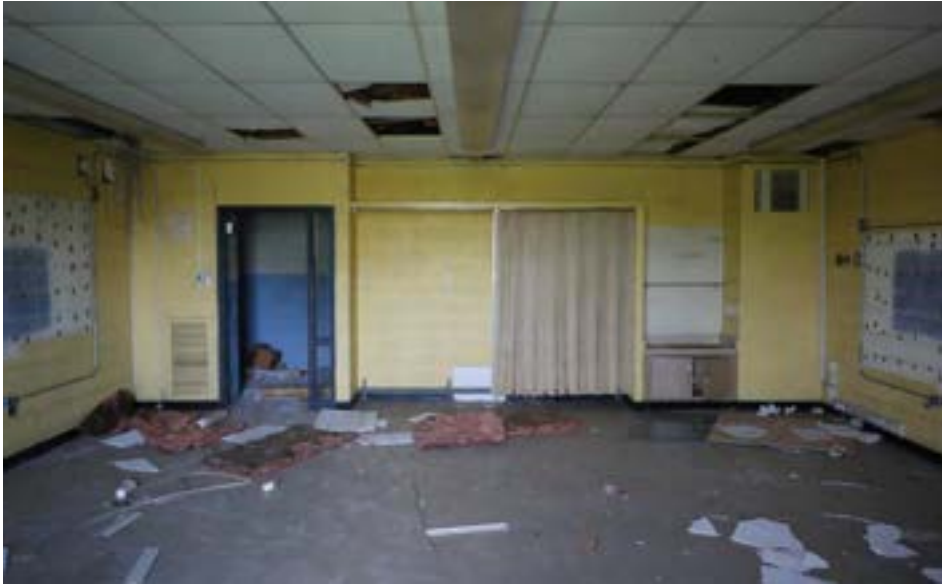
A typical 2nd classroom on the south wing. Instead of the wood built-in storage units found in most other schools, this school has a folding plastic curtain concealing a storage alcove.

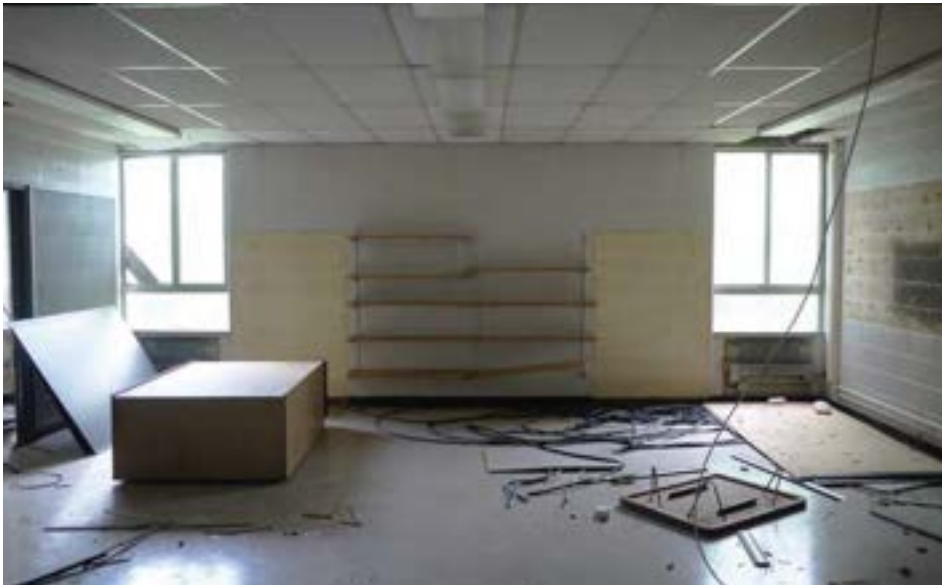
A typical first-floor classroom with aluminum frame windows in each corner.

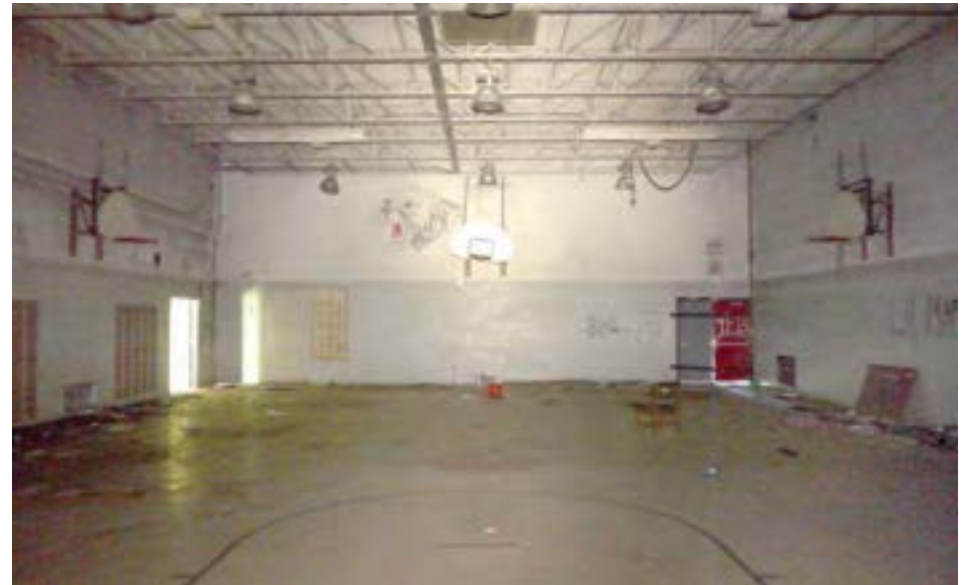
The gym is a windowless space with painted CMU walls and an open-web steel joist ceiling. The space is 45x70' with 20' ceilings.

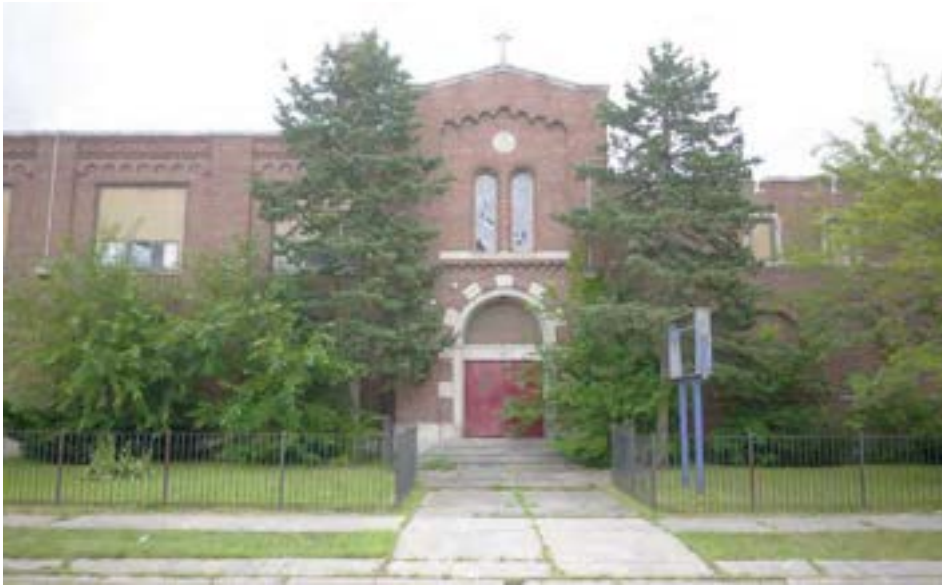
West (front) elevation with main entrance. This school's design give away its origins as a Catholic school, from the cross ardoning the rooftop to the use of Romanesque arch motifs and stained glass windows.

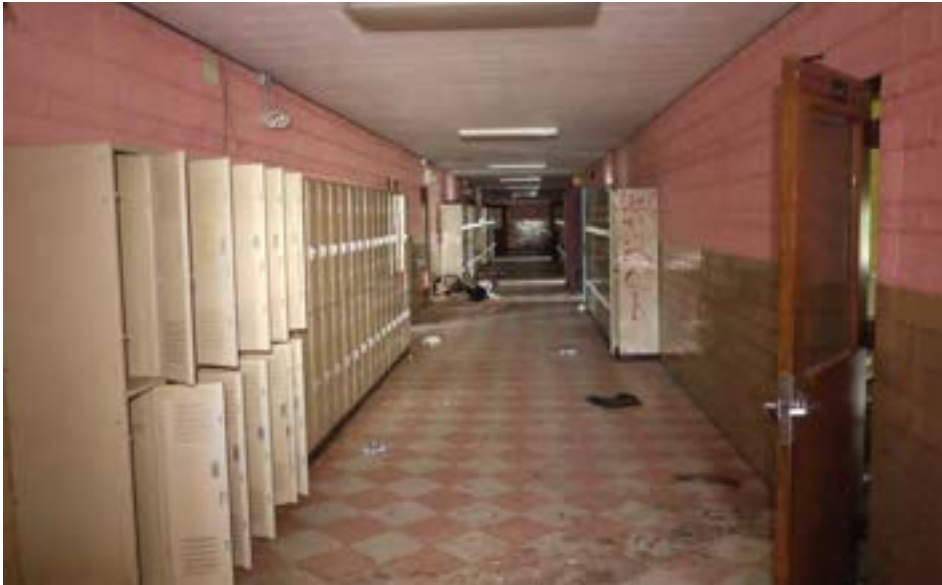
The second floor main corridor is a simple double-loaded hallway with painted CMU and glazed block walls. This hallway did not originally contain lockers; instead, students stored their coats and belongings inside the classrooms.

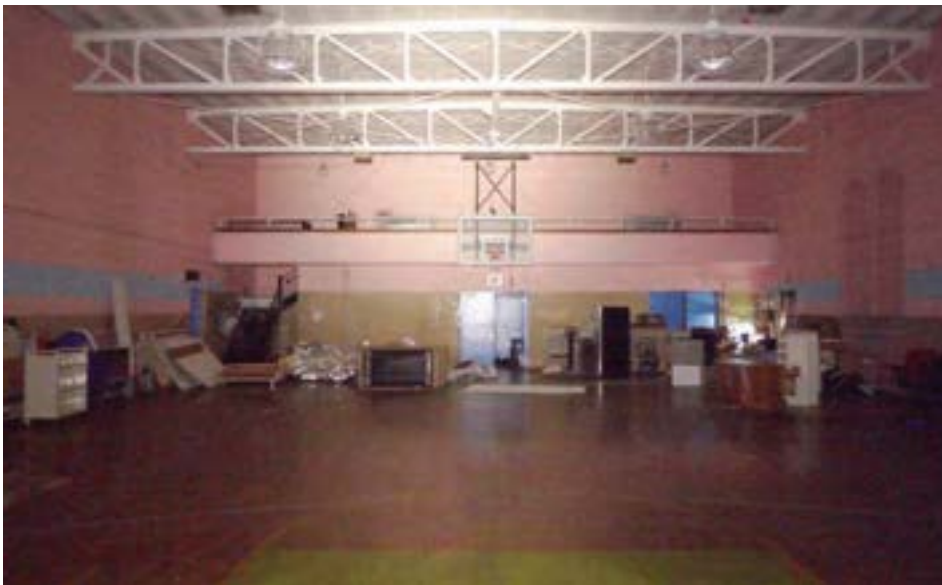
Gymnasium viewed from stage, showing balcony seating area (behind basketball hoop) with kitchen and storage areas below.

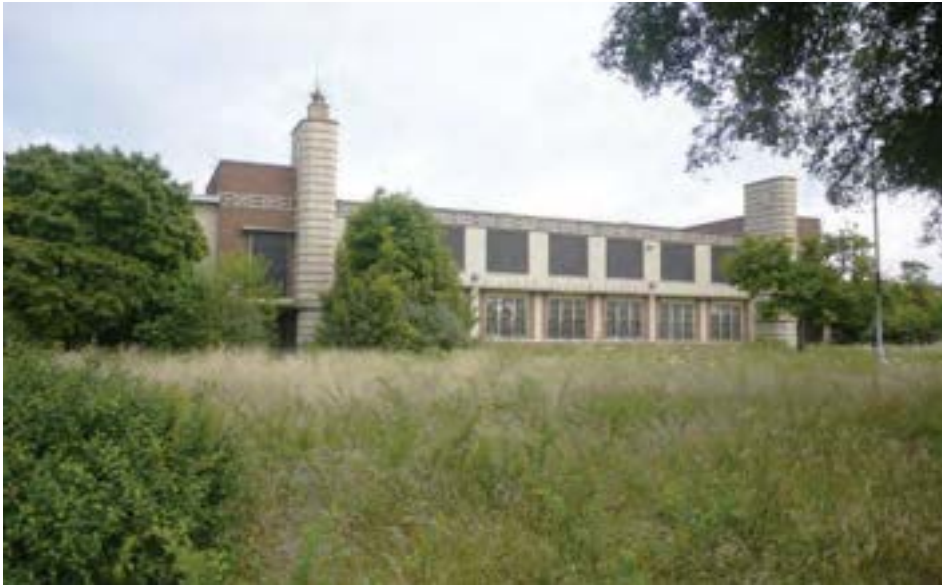
Front facade (southeast elevation) and main entrance towers, showcasing Herman's unusual geometric detailing. The school is set back at an angle from the intersection of Tireman and Asbury Park, creating a large field in front of the school.

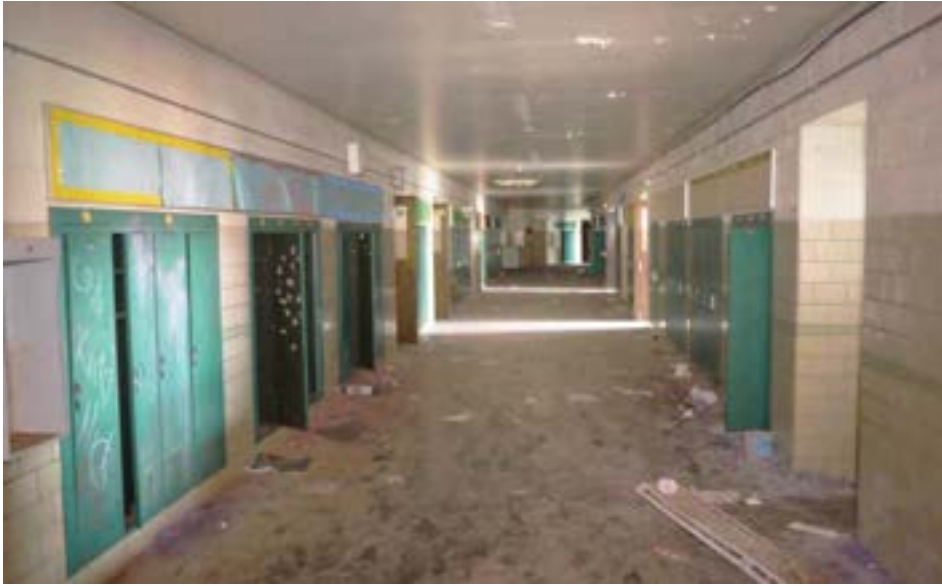
Second floor main corridor. showing finishes in relatively good condition.

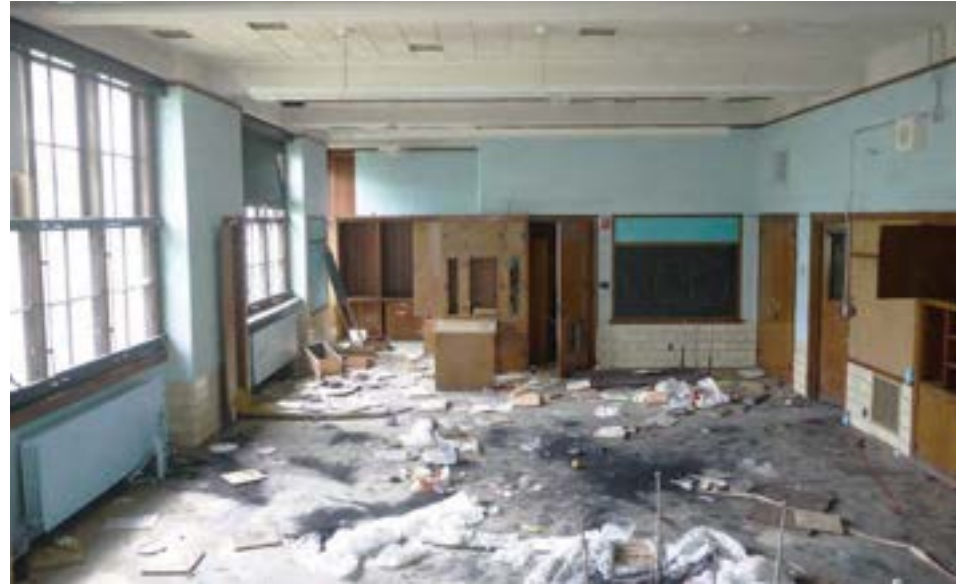
First floor "practical arts" classroom with intact windows and wood cabinetry.

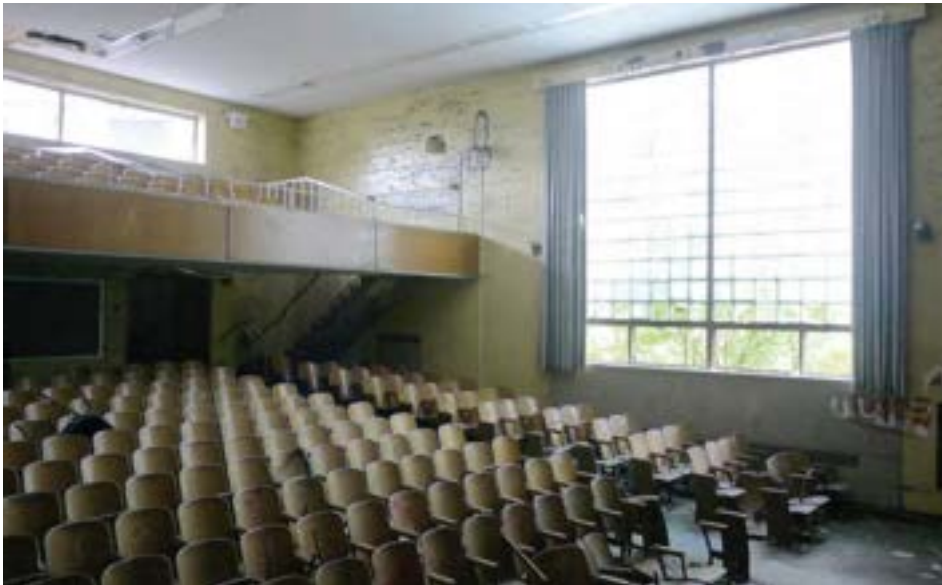
Auditorium main floor and balcony viewed from stage. The space receives most of its light from one large glass block window.

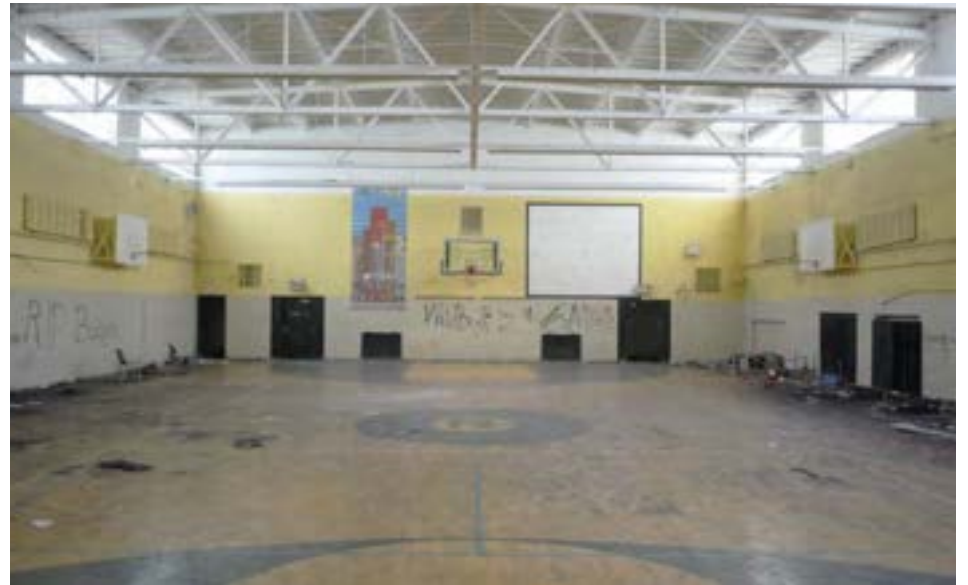
The 60x90' gymnasium is in relatively good condition. It is lit by glass block clerestory windows on the northwest and southeast elevations.

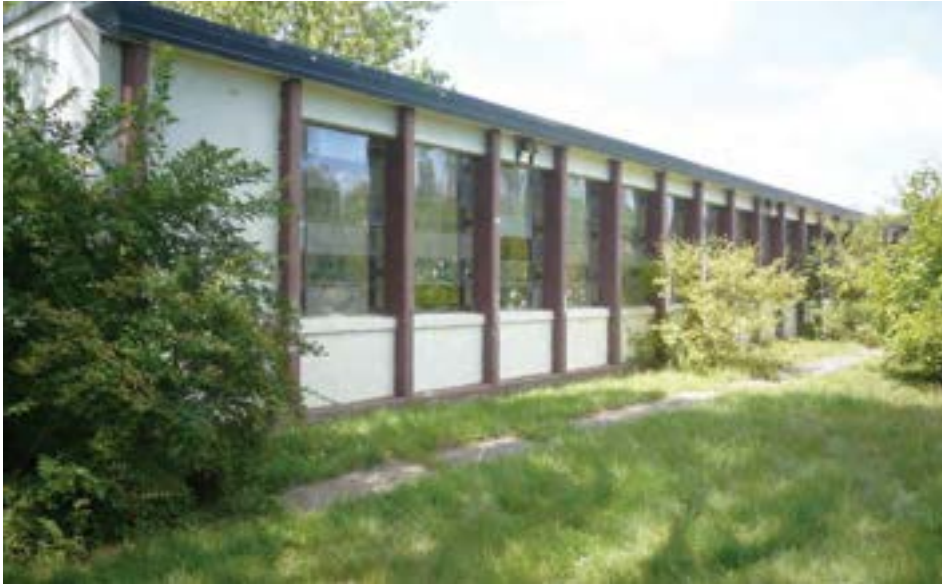
East elevation showing repeating steel-frame grid windows and concrete columns. The school's modern style is quite different from other schools built in Detroit, even others in same era. This school appears to barely predate the shift to International Style architecture circa 1950.

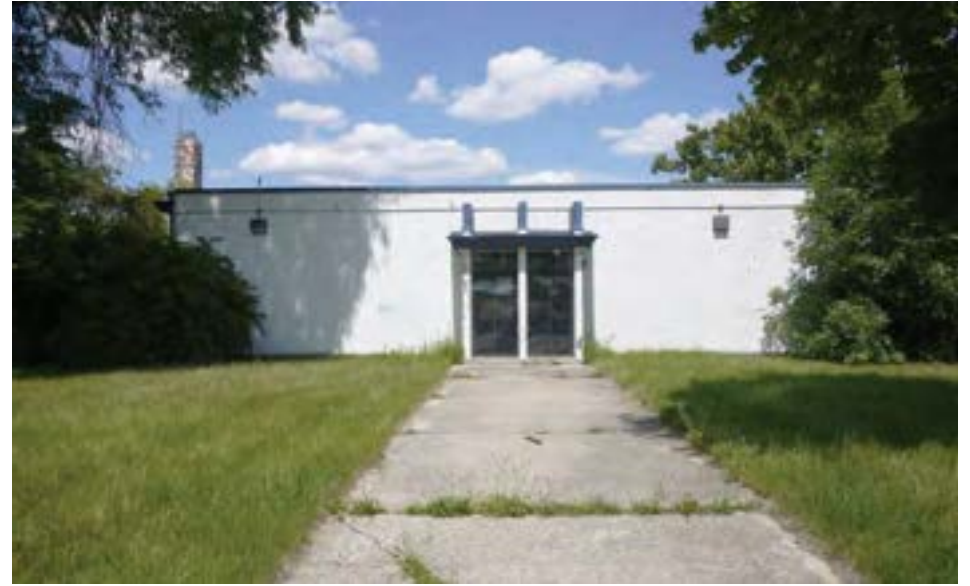
The southeast entrance facing Cathedral Street is a non-descript door with no embellishment. The single-story school is built on grade and has all accessible entrances.

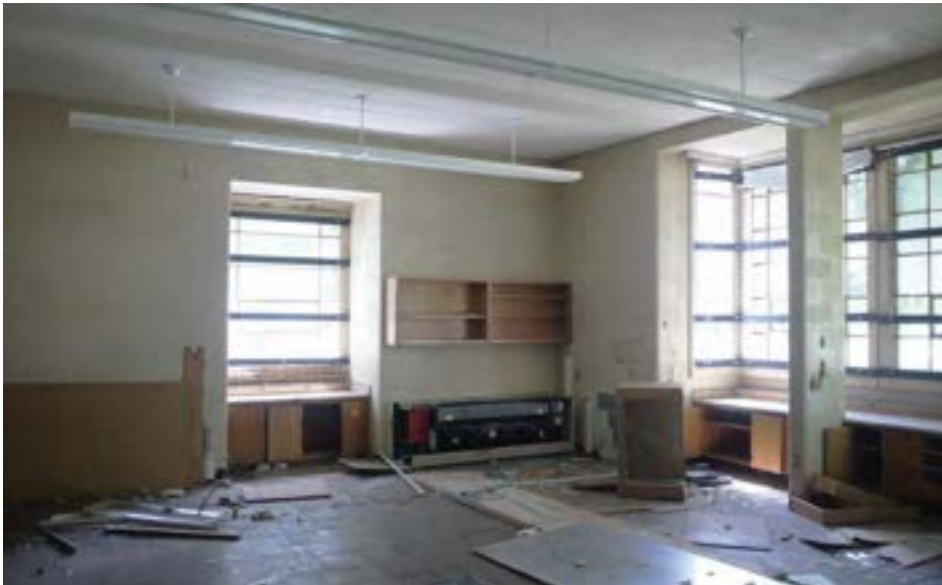
The science room includes a shallow bay with windows on three sides, in lieu of the full conservatory commonly found at other schools.

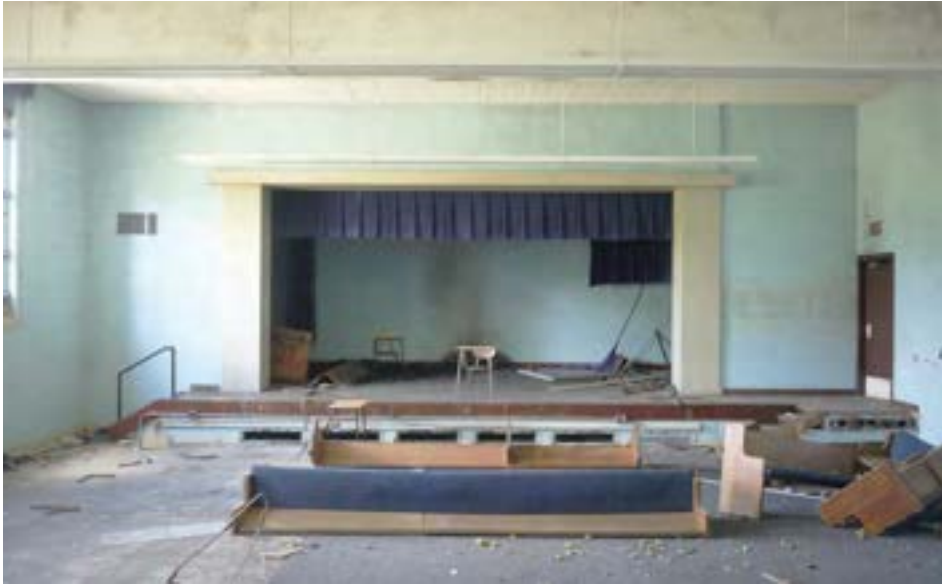
The small auditorium has a low and wide stage area and a flat floor. Its finishes are simple painted concrete.

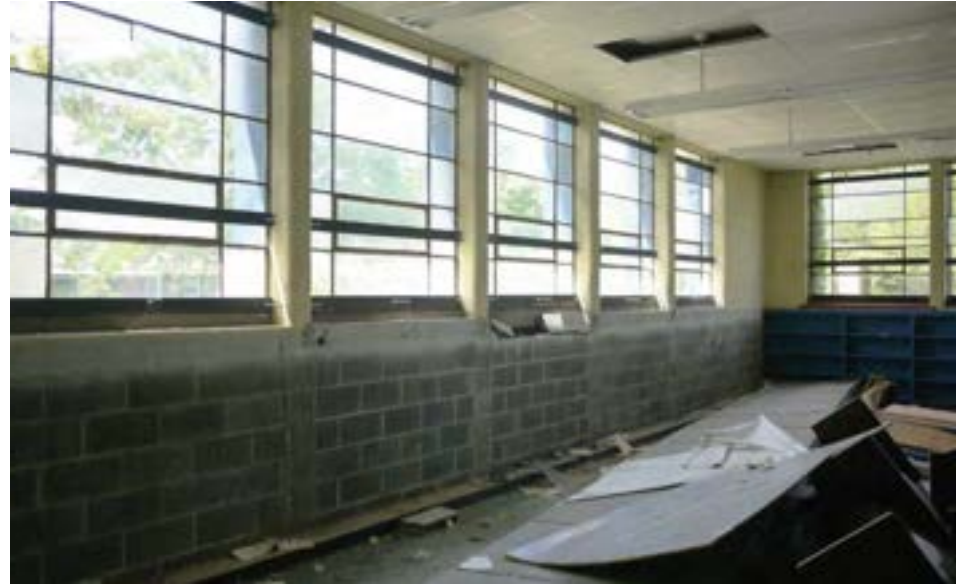
The library features the same steel-frame grid windows as the rest of the school, but they have been shifted higher to accommodate bookshelves below. The shelving in the foreground has been tipped over, but some standing units are visible at far right.

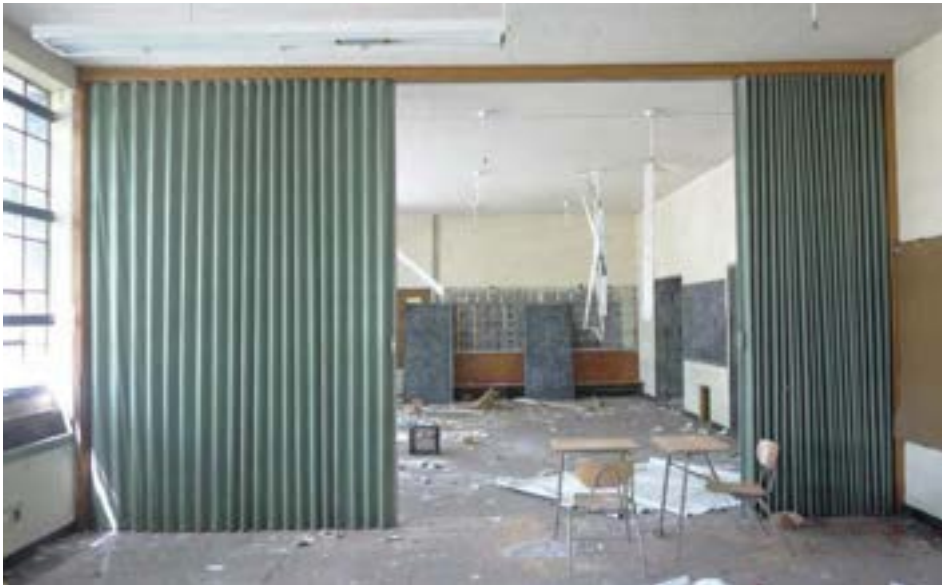
The main kindergarten space consists of two conjoined classrooms separated by a folding partition. There is no bay window, a common kindergarten feature in other historic elementary schools.

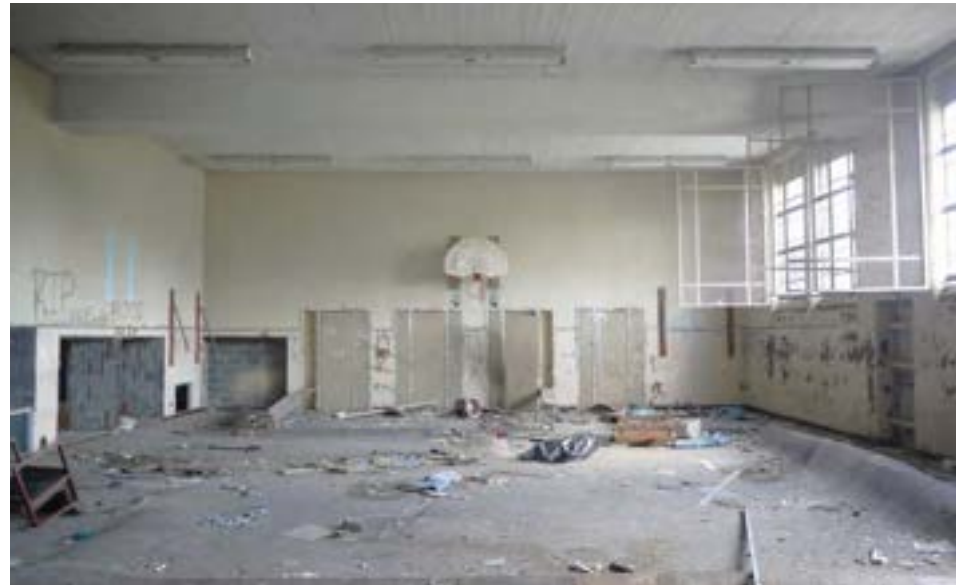
The gym is a simple concrete box with large steel-frame windows. Although there are lunch tables built into the walls, indicating the space's use as a cafeteria, the school does not have a kitchen or food serving area.

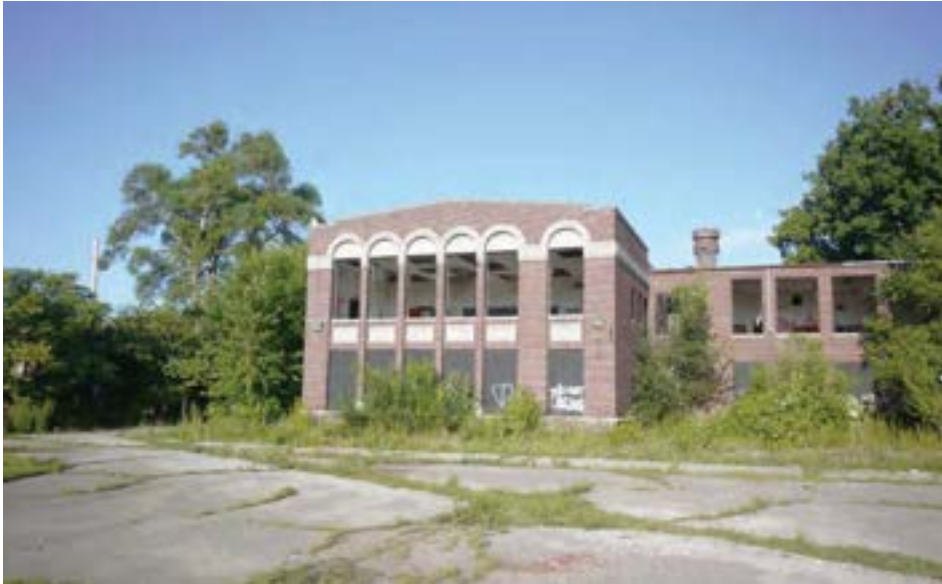
East (rear) elevation of original 1924 unit viewed from parking lot. Two large classrooms occupy the east wing. The front elevation has a similar appearance, with repeating window openings and arch accents.

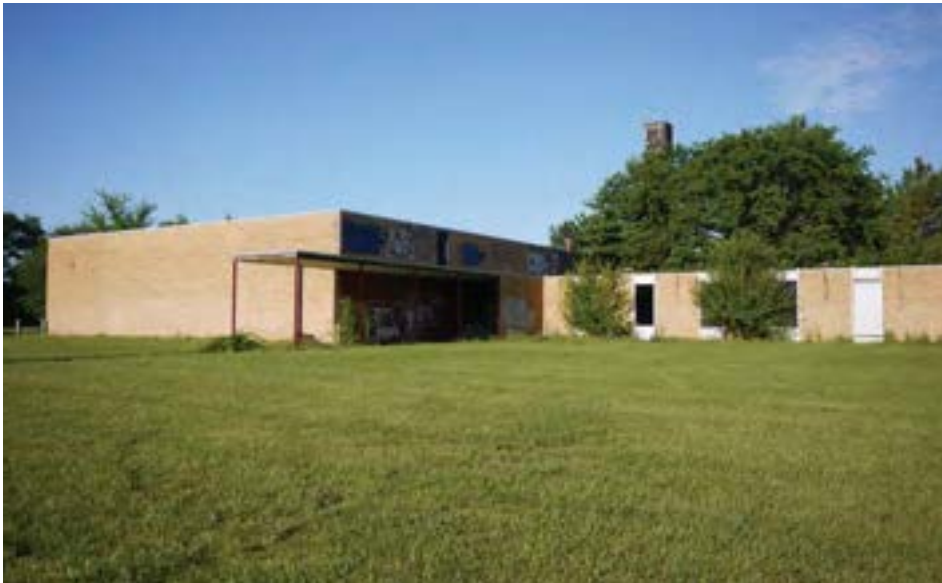
East elevation of 1963 unit viewed from Simanek Playfield. Large volume on left is the multipurpose cafeteria. Low volume to right is a connector corridor which provides a link to the workshop spaces and frames an interior courtyard.

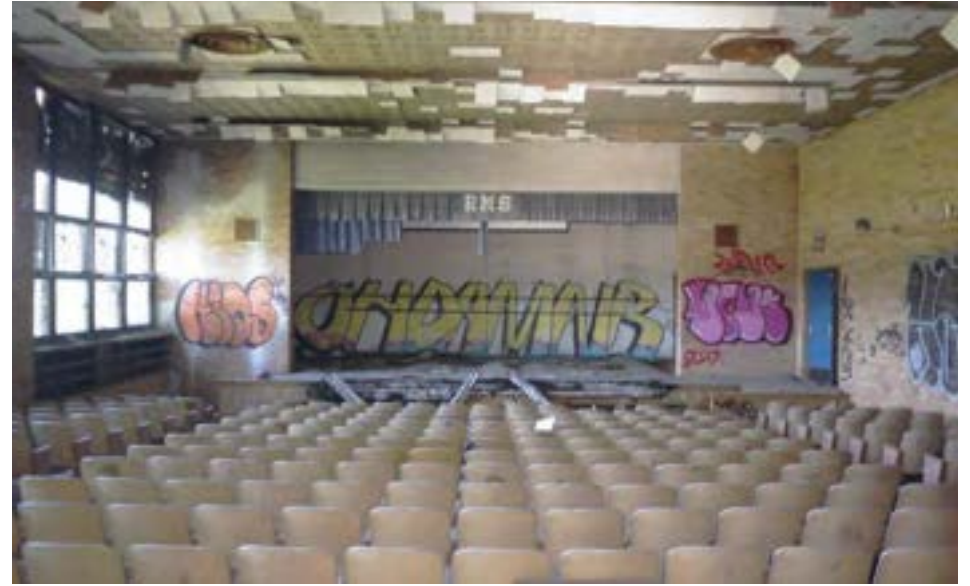
Brick auditorium in 1955 unit is in serviceable condition. Large grid of aluminum windows provides views to park; original design was presumably glass block.

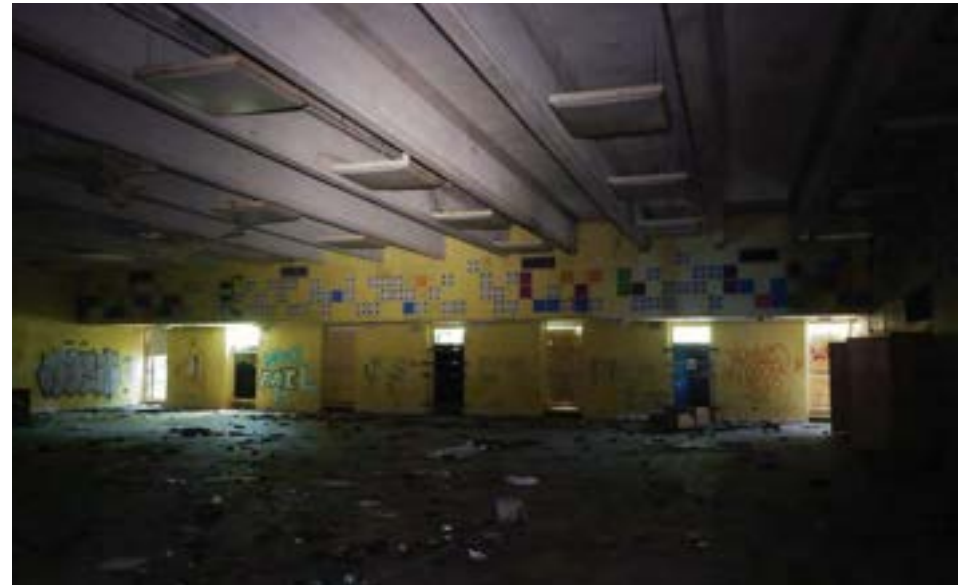
Cafeteria in 1963 unit is a spacious column-free area with long-span concrete roof.
