Comprehensive Conditions Assessment

part of the East Riverfront Asset Study

EAST RIVERFRONT ASSET STUDY

CONDITION ASSESSMENT & SEAWALL SHORELINE INVESTIGATION

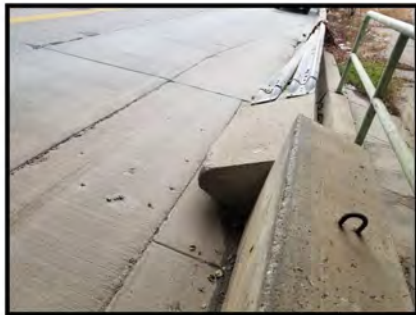
Cast In Place Concrete Barrier	AT2	Spalling and horizontal cracking through	Structural

Wall with Rail		length of wall on EB traffic side	
Steel Frame Work	AT2, AT4, AT5, AT6	Oxidized surfaces present throughout	Structural
Steel Frame Work	AT2, AT4, AT5, AT7	Paint system in poor condition	Structural
Concrete Panels	AT8	Very few hairline cracks present, with minor evidence of moisture and efflorescence in these areas	Structural
Hand Rails	AT7	Damaged section of hand rail	Structural
Bricks Pavers	UL33, UL33A	minor settlement, 10% bricks need replacing, all pavers need to be re-grouted	Civil
Brick pavers	UL45, UL46, UL47	brick pavers need to be re-grouted	Civil
Brick pavers	UL42	brick pavers need to be re-grouted	Civil
Brick pavers	UL67, UL68, UL69	brick pavers need to be re-grouted	Civil
Brick pavers	UL71, UL72	Brick pavers need to be re-grouted	Civil

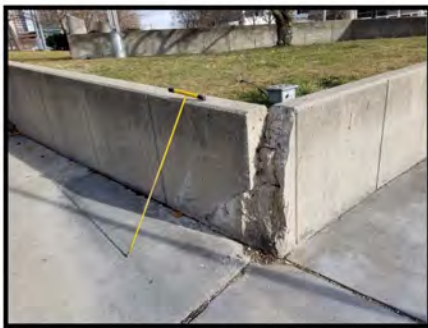
3 - NECESSARY, NOT YET CRITICAL			
Conditions where routine maintenance is needed to avoid potential downtime in operations.			
STRUCTURE AND COMPONENT TYPE	PHOTO LOG ID #	NOTES	STRUCTURAL OR CIVIL
Stone and Concrete Wall	UL6, UL7, UL8	18" wall section cracked and spalled, Masonry Materials in need of maintenance	Structural
Reinforced Concrete Wall		Minor cracking noted- 40 LF	Structural
Reinforced Concrete Wall	UL13	Integral concrete wall and bench with cracking at end of wall	Structural
Reinforced Concrete Wall	UL15	Spalling 5' of wall section and damage at inserted railing	Structural
Reinforced Concrete Wall	UL18	Vertical cracks in wall sections	Structural
Reinforced Concrete Wall	UL19	Spalled concrete at corner of wall and bench sections exposing steel reinforcement	Structural
Reinforced Concrete Wall with Rail	UL24, UL25, UL26, UL27	Minor settlement, shifting, and cracking of precast wall sections with some loss of expansion sealants	Structural

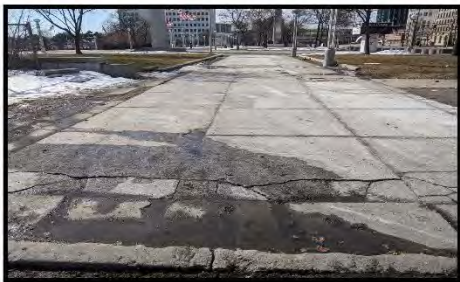
Reinforced Concrete Wall with Rail	UL28, UI29	Minor settlement, shifting, and cracking of precast wall sections with some loss of expansion sealants	Structural
Reinforced Concrete Wall with Rail	UL30, UL31	Slope repairs along precast wall sections	Structural
Reinforced Concrete Wall	LL1	5'x4' section of damaged concrete wall dividing wall	Structural
Reinforced Concrete Wall	LL2	40' of wall with delamination of concrete surface	Structural
Reinforced Concrete Curbing	LL2	40' of 6"x18" protective curbing damaged at wall base	Structural
Reinforced Concrete Wall	LL3	Approximately 5' of horizontal cracking at base of stairwell	Structural
Reinforced Concrete Wall	LL5, LL6	Random cracking in cast in place wall and overhead panel sections with minor evidence of moisture and efflorescence- 20 LF	Structural
Reinforced Concrete Wall	LL7, LL8	Delamination of concrete beam and wall surface exposing rebar and exhibiting rust- 240 SF	Structural

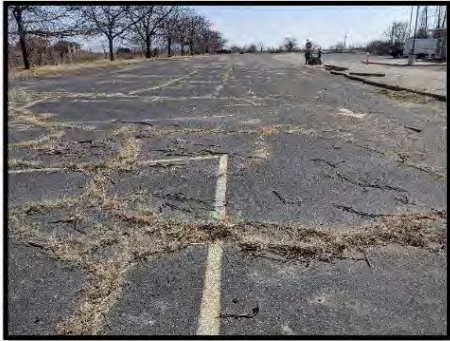
SJBL7

ST. JEAN BOAT LAUNCH PHOTO LOG			
1 - CURRENTLY CRITICAL Conditions in need of immediate improvement to address safety hazards, stop accelerated deterioration to return asset to operation.			
STRUCTURE AND COMPONENT TYPE	PHOTO LOG ID #	NOTES	STRUCTURAL OR CIVIL
Asphalt Pavement	SJBL-7 to SJBL-10, JBBL-13	Fair condition, needs joints sealed and 15% replacement	Civil
Fence and Gate	SJBL-14 to SJBL-15	Fair condition, needs joints sealed and 20% replacement	Civil
2 - POTENTIALLY CRITICAL Conditions that if not corrected expeditiously, will become critical within a year and could impact operations.			
STRUCTURE AND COMPONENT TYPE	PHOTO LOG ID #	NOTES	STRUCTURAL OR CIVIL
Concrete Pavement	SJBL-8, SJBL-11	Fair condition, needs joints sealed and 20% replacement	Civil
3 - NECESSARY, NOT YET CRITICAL Conditions where routine maintenance is needed to avoid potential downtime in operations.			
STRUCTURE AND COMPONENT TYPE	PHOTO LOG ID #	NOTES	STRUCTURAL OR CIVIL

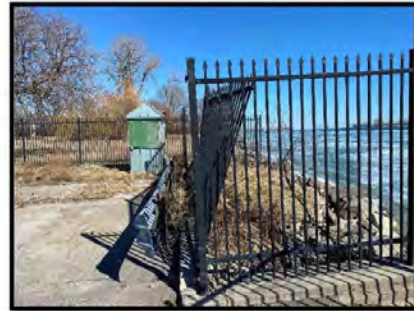
ERMA HENDERSON MARINA PHOTO LOG			
1 - CURRENTLY CRITICAL Conditions in need of immediate improvement to address safety hazards, stop accelerated deterioration to return asset to operation.			
STRUCTURE AND COMPONENT TYPE	PHOTO LOG ID #	NOTES	STRUCTURAL OR CIVIL
Fence	EHM-35	Replace section of fence that has been damaged.	Civil
Storm Sewer	EHM-38 to EHM-45	Storm sewer to be removed and replaced. Concrete gutter valley needs to be replaced	Civil
Storm Sewer, Concrete Gutter	EHM-46, EHM-47	Storm sewer to be removed and replaced. Concrete gutter valley needs to be replaced	Civil
Concrete Paving	EHM-48	Concrete gutter valley needs to be replaced, asphalt pavement to be joint sealed.	Civil
2 - POTENTIALLY CRITICAL Conditions that if not corrected expeditiously, will become critical within a year and could impact operations.			
STRUCTURE AND COMPONENT TYPE	PHOTO LOG ID #	NOTES	STRUCTURAL OR CIVIL
Shoreline	EHM-36	New shoreline protection recommended	Civil

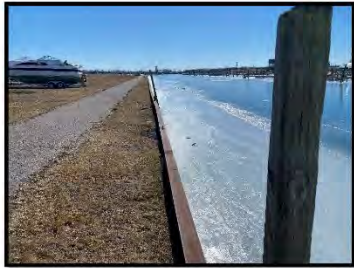
RM40

Steel Sheet Pile Seawall	RM-40	Steel Sheet Pile Seawall in good condition. Tie back locations appear to be in good condition.
Steel Sheet Pile Seawall	RM-41	Steel Sheet Pile Seawall in good condition. Tie back locations appear to be in good condition.
Drainage Structure	RM-42	Structure in need of repair.
Steel Sheet Pile Seawall	RM-43	Steel Sheet Pile Seawall in good condition. Tie back locations appear to be in good condition.
Steel Sheet Pile Seawall	RM-44	Steel Sheet Pile Seawall in good condition. Tie back locations appear to be in good condition.
Steel Sheet Pile Seawall	RM-45	Steel Sheet Pile Seawall in good condition. Tie back locations appear to be in good condition.
Steel Sheet Pile Seawall	RM-46	Steel Sheet Pile Seawall in good condition. Tie back locations

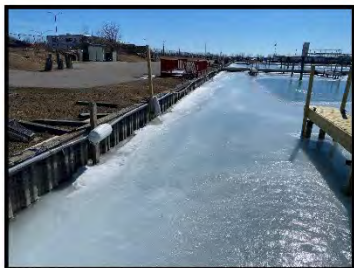
RM46

appear to be in good condition.
Steel Sheet Pile Seawall	RM-47	Steel Sheet Pile Seawall in good condition. Tie back locations appear to be in good condition.
Steel Sheet Pile Seawall	RM-48	Steel Sheet Pile Seawall in good condition. Tie back locations appear to be in good condition.
Steel Sheet Pile Seawall	RM-49	Steel Sheet Pile Seawall in good condition. Tie back locations appear to be in good condition.
Steel Sheet Pile Seawall	RM-50	Steel Sheet Pile Seawall in good condition. Tie back locations appear to be in good condition.
Steel Sheet Pile Seawall	RM-51	Steel Sheet Pile Seawall in good condition. Tie back locations appear to be in good condition.
Steel Sheet Pile Seawall	RM-52	Steel Sheet Pile Seawall in good condition. Tie back locations appear to be in good condition.
Steel Sheet Pile Seawall	RM-53	Steel Sheet Pile Seawall in good condition. Tie back locations appear to be in good condition.

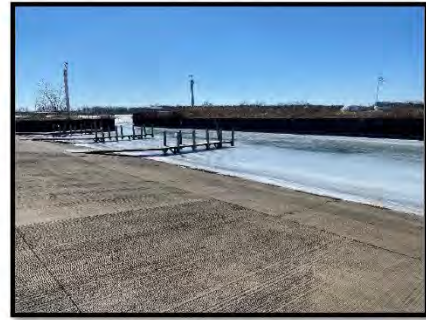
SJBL1

STRUCTURE AND COMPONENT TYPE	PHOTO LOG ID #	NOTES
Steel Sheet Pile Seawall	SJBL-1	Steel Sheet Pile Seawall in good condition. Tie back locations appear to be in good condition. Metal top-rail in good condition.
Steel Sheet Pile Seawall	SJBL-2	Steel Sheet Pile Seawall in good condition. Tie back locations appear to be in good condition.
Steel Sheet Pile Seawall	SJBL-3	Steel Sheet Pile Seawall in good condition. Tie back locations appear to be in good condition.
Steel Sheet Pile Seawall	SJBL-4	Steel Sheet Pile Seawall in good condition. Tie back locations appear to be in good condition.
Steel Sheet Pile Seawall	SJBL-5	Steel Sheet Pile Seawall in good condition. Tie back locations appear to be in good condition.
Steel Sheet Pile Seawall	SJBL-6	Steel Sheet Pile Seawall in good condition. Tie back locations appear to be in good condition. Monument sign in good condition.

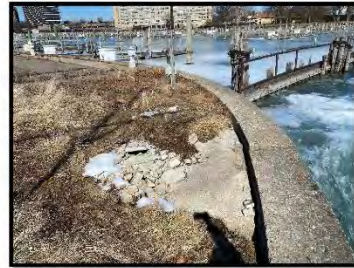
STRUCTURE AND COMPONENT TYPE	PHOTO LOG ID #	NOTES
Reinforced Concrete Seawall	EHM-1	Concrete seawall in fair condition.
Reinforced Concrete Seawall	EHM-2	Concrete seawall in fair condition. Noted separation in wall segments causing material loss from behind wall.
Reinforced Concrete Seawall	EHM-3	Concrete seawall in fair condition. Noted separation in wall segments causing material loss from behind wall.
Wood and Steel Constructed Breakwall	EHM-4	Timber pile and steel components noted to be in poor condition for breakwall at riverside entrance.
Wood and Steel Constructed Breakwall	EHM-5	Timber pile and steel components noted to be in poor condition for breakwall at riverside entrance.
Reinforced Concrete Seawall	EHM-6	Concrete seawall in fair condition.
Reinforced Concrete Seawall	EHM-7	Concrete seawall in fair condition.
Reinforced Concrete Seawall	EHM-8	Concrete seawall in fair condition.
Reinforced Concrete Seawall	EHM-9	Concrete seawall in fair condition.

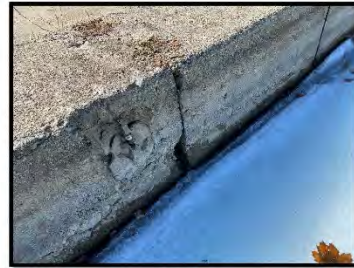
Reinforced Concrete Seawall	EHM-10	Concrete seawall in fair condition. Noted deterioration to top of wall section requiring maintenance.
Reinforced Concrete Seawall	EHM-11	Concrete seawall in fair condition. Noted deterioration to top of wall section requiring maintenance.
Reinforced Concrete Seawall	EHM-12	Concrete seawall in fair condition. Noted deterioration to top of wall section requiring maintenance.
Reinforced Concrete Retaining Wall	EHM-13	Concrete retaining wall in good condition.
Reinforced Concrete Seawall	EHM-14	Concrete seawall in fair condition. Noted deterioration to top of wall section requiring maintenance.

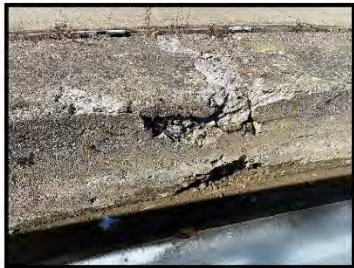
Reinforced Concrete Seawall	EHM-15	Concrete seawall in fair condition. Noted deterioration to top of wall section requiring maintenance.
Reinforced Concrete Seawall	EHM-16	Concrete seawall in fair condition. Noted deterioration to top of wall section requiring maintenance.
Reinforced Concrete Seawall	EHM-17	Concrete seawall in fair condition. Noted deterioration to top of wall section requiring maintenance.
Reinforced Concrete Seawall	EHM-18	Concrete seawall in fair condition. Noted separation between wall and concrete walk creating potential trip hazard.
Reinforced Concrete Seawall	EHM-19	Concrete seawall in fair condition.
Reinforced Concrete Seawall	EHM-20	Concrete seawall in fair condition.
Reinforced Concrete Seawall	EHM-21	Significant settlement behind wall causing concrete walk to be very uneven and creating potential hazards.
Reinforced Concrete Seawall	EHM-22	Significant settlement behind wall causing concrete walk to be very uneven and creating potential hazards.

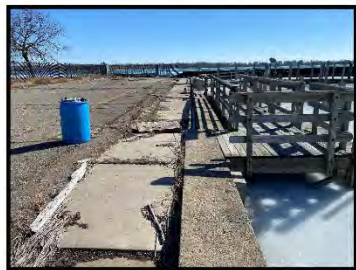
Reinforced Concrete Seawall	EHM-23	Significant settlement behind wall causing concrete walk to be very uneven and creating potential hazards.
Reinforced Concrete Seawall	EHM-24	Significant settlement behind wall causing concrete walk to be very uneven and creating potential hazards.
Reinforced Concrete Seawall	EHM-25	Concrete Seawall appears to be failing. Approximately 180' of wall moving significantly toward waterside. Failure is also causing significant issues with pavement surfaces behind wall.
Reinforced Concrete Seawall	EHM-26	Concrete Seawall appears to be failing. Approximately 180' of wall moving significantly toward waterside. Failure is also causing significant issues with pavement surfaces behind wall.
Reinforced Concrete Seawall	EHM-27	Concrete Seawall appears to be failing. Approximately 180' of wall moving significantly toward waterside. Failure is also causing significant issues with pavement surfaces behind wall.

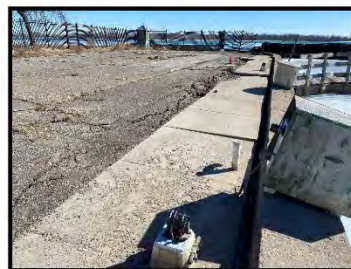
Reinforced Concrete Seawall	EHM-28	Concrete Seawall appears to be failing. Approximately 180' of wall moving significantly toward waterside. Failure is also causing significant issues with pavement surfaces behind wall.
Reinforced Concrete Seawall	EHM-29	Concrete Seawall appears to be failing. Approximately 180' of wall moving significantly toward waterside. Failure is also causing significant issues with pavement surfaces behind wall.
Reinforced Concrete Seawall	EHM-30	Concrete Seawall appears to be failing. Approximately 180' of wall moving significantly toward waterside. Failure is also causing significant issues with pavement surfaces behind wall.
Reinforced Concrete Seawall	EHM-31	Concrete Seawall appears to be failing. Approximately 180' of wall moving significantly toward waterside. Failure is also causing significant issues with pavement surfaces behind wall.
Reinforced Concrete Seawall	EHM-32	Concrete Seawall appears to be failing. Approximately 180' of wall moving significantly toward waterside. Failure is also causing significant issues with pavement surfaces behind wall.

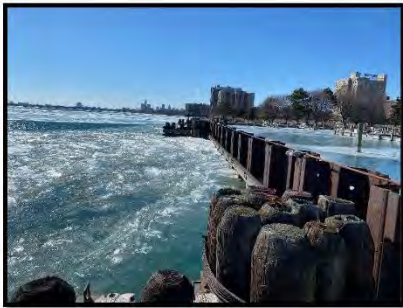
Reinforced Concrete Seawall	EHM-33	Concrete Seawall appears to be failing. Approximately 180' of wall moving significantly toward waterside. Failure is also causing significant issues with pavement surfaces behind wall.
Steel Sheet Pile Breakwall	EHM-34	Steel Sheet Pile Breakwall in fair condition.
Perimeter Fencing	EHM-35	Damage noted to fence section. Approximately 40' of fence to be repaired.
8 – ERMA HENDERSON PARK PHOTO LOG		
STRUCTURE AND COMPONENT TYPE	PHOTO LOG ID #	NOTES
Seawall and Shoreline	EH-1	Existing concrete and steel sheet pile wall, leaning railing sections and flooding noted
Seawall and Shoreline	EH-2	Existing concrete and steel sheet pile wall, leaning railing sections and flooding noted
Seawall and Shoreline	EH-3	Water level at same elevation as top of wall

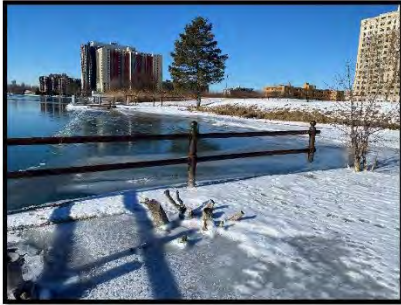
Seawall and Shoreline	EH-4	Damaged and missing light pole
Seawall and Shoreline	EH-5	Flooded area and eroision at berm
Seawall and Shoreline	EH-6	Broken post at railing
Seawall and Shoreline	EH-7	Broken post at railing
Seawall and Shoreline	EH-8	Noted erosion at berm section
Seawall and Shoreline	EH-9	Area from seawall to berm flooding
Seawall and Shoreline	EH-10	Approximately 70' of mission railing and damaged posts
