CERTIFICATE OF APPROPRIATENESS

RE: Application Number 20-6968; 691 W. Alexandrine Street, Willis – Selden Historic District

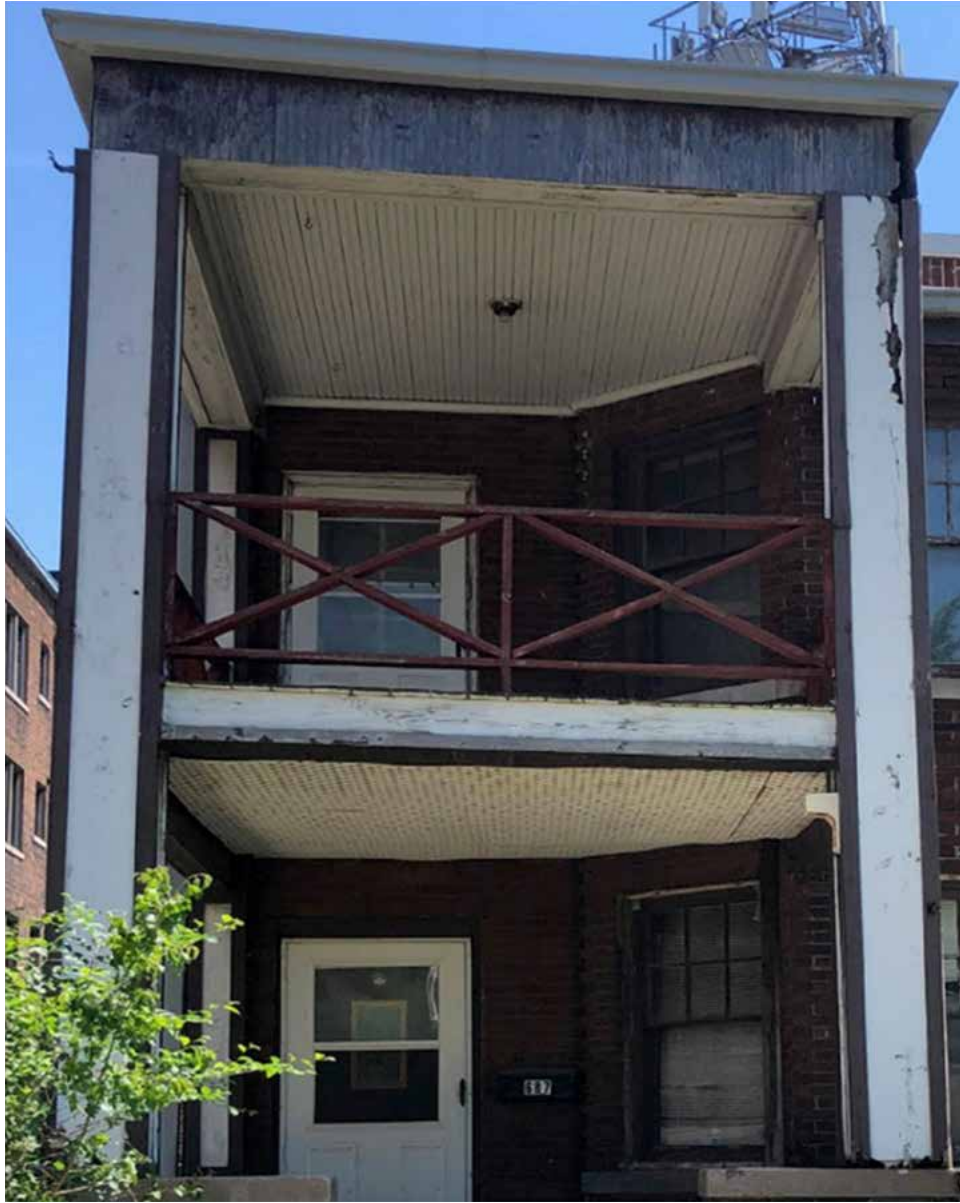
- COLUMNS HAVE SEVERE ROT AND DECAY
- TRIM BOARDS ARE MISSING

IT IS OUR OPINION THAT THE WOOD ON THE PORCH HAS SEVER ROT AND IS IN DISARRAY. THE UPPER PORCH IS DANGEROUS AND SHOULD NOT BE USE. THE WOOD ON THE PORCH NEEDS TO BE DISASSEMBLED WHILE SUPPORTING THE ROOF. THE PORCH TO BE REBUILT USING NEW WOOD AND SUPPORT COLUMNS. TRIM BOARD TO BE INSTALLED TO MATCH EXISTING AND PAINTED TO REDUCE THE CHANCE OF ROT.

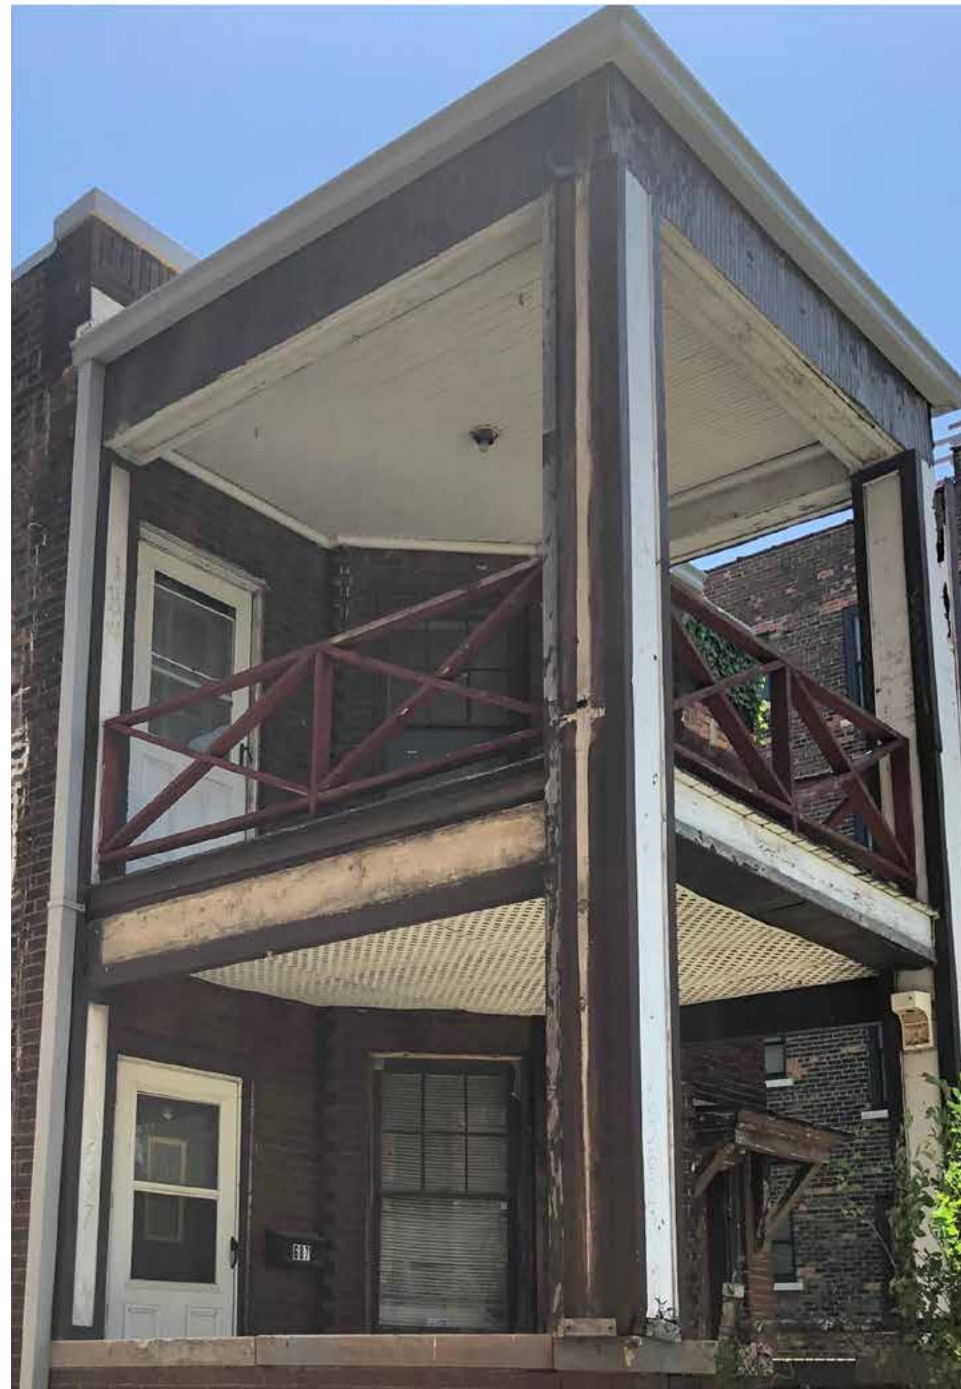
- BOARDS HAVE BEEN REPLACED
- COLUMNS HAVE SEVERE ROT AND DECAY
- SUPPORT FOR THE UPPER PORCH IS IN RISK

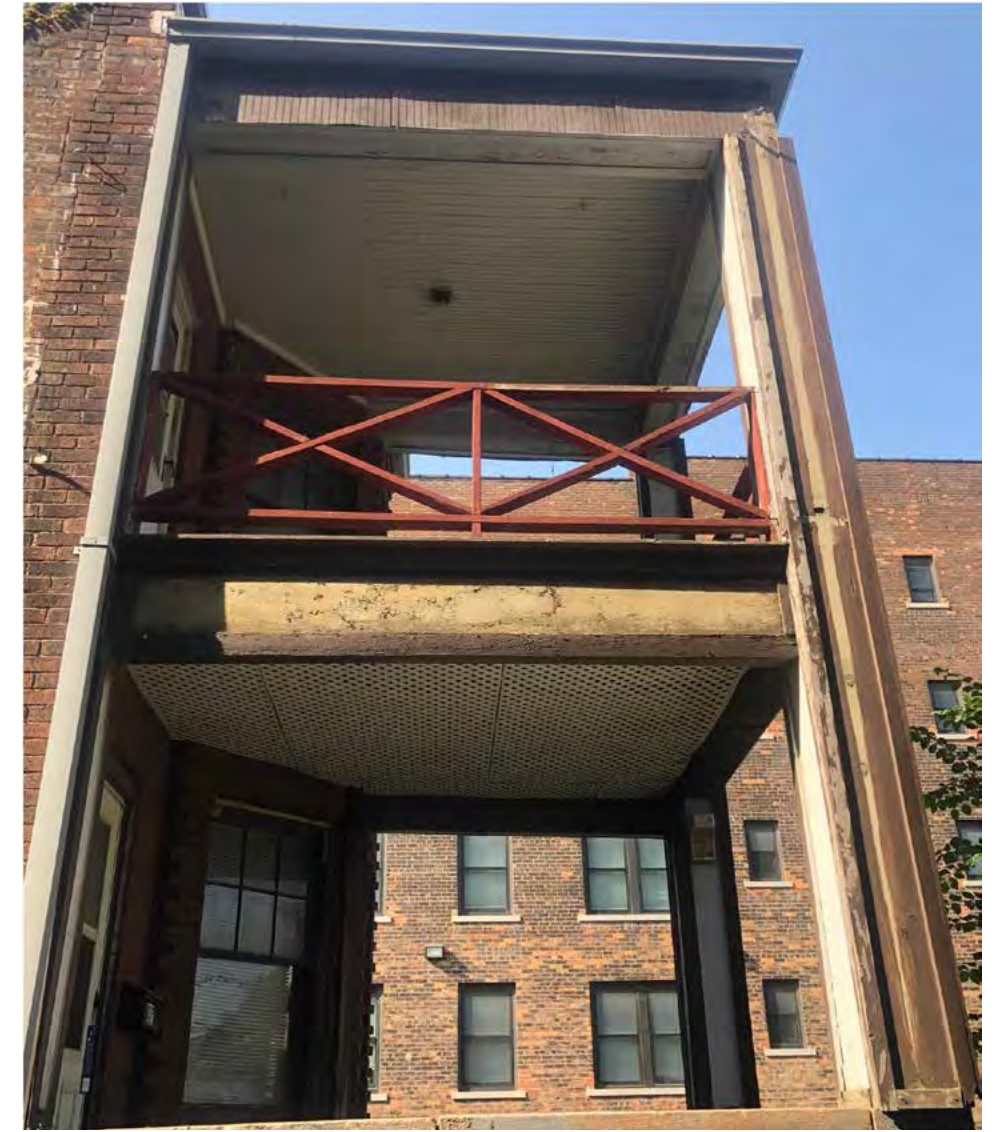
- BOARDS HAVE BEEN REPLACED
- TRIM BOARDS ARE MISSING
- COLUMNS HAVE SEVERE ROT AND DECAY COULD COLLAPSE CAUSING THE UPPER PORCH TO COLLAPSE.
- FACIA BOARDS HAVE ROTTED AWAY

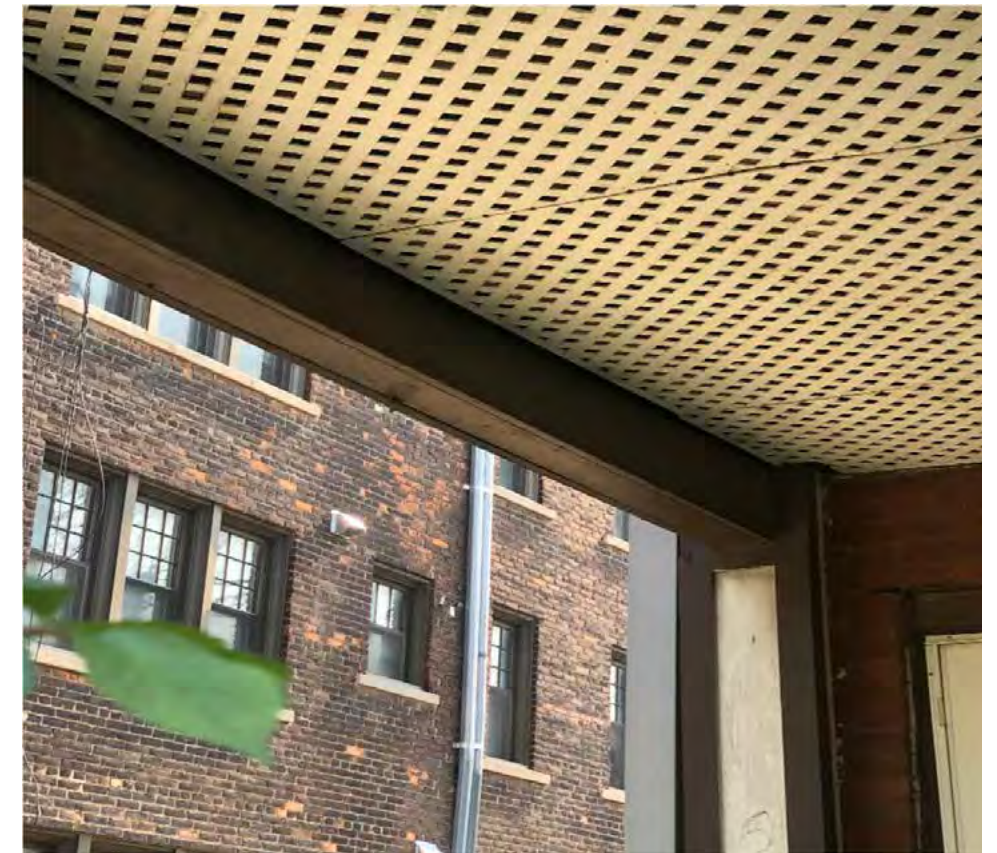
- UPPER PORCH HAS SOME ROT IN THE SUPPORTS
- THE FLOORING HAS A LOT OF ROT (WOULD NOT RECOMMEND ANYONE VENTURE ONTO THE PORCH)
- THE CEILING OF THE LOWER DECK HAS BEEN REPLACED WITH VINYL LATTICE.

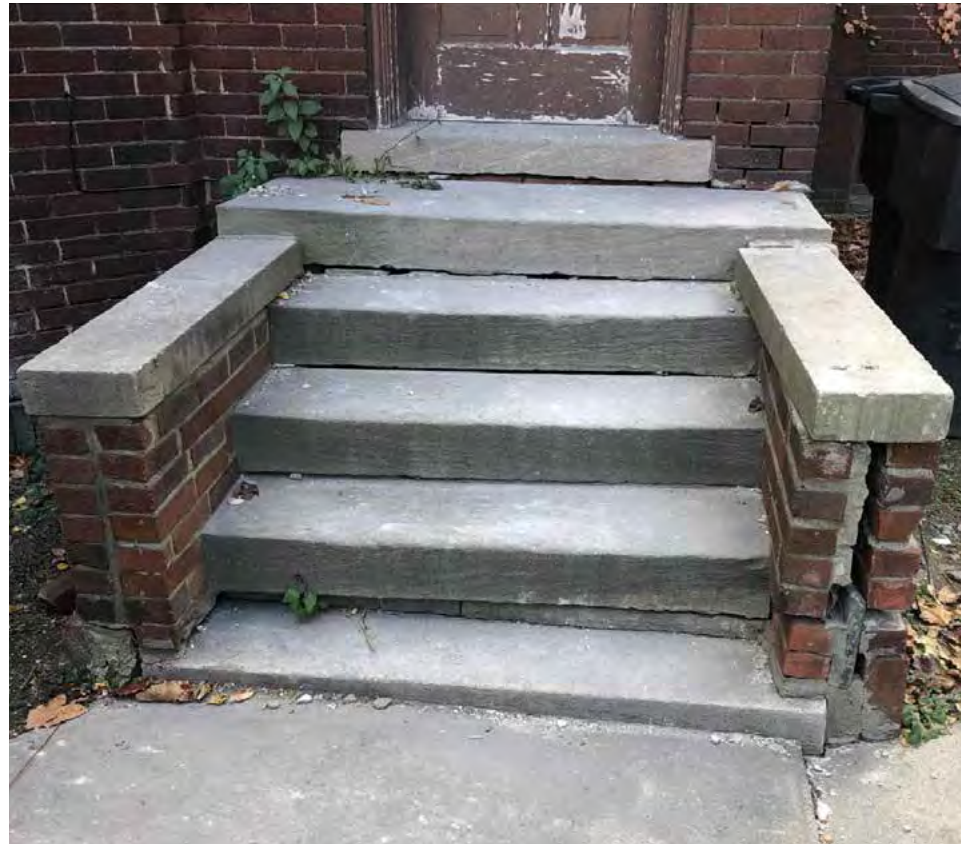
- STEPS HAVE PULLED AWAY FROM THE PORCH AND WAS IMPROPERLY FILLED
- STEP WALL HAS PULLED AWAY FROM ITSELF AND WAS IMPROPERLY FILLED
- STEPS ARE NOT TO CODE OR ADA COMPLIANCE.
- THERE ARE GAPS BETWEEN THE STEPS AND HAVE BEEN FILLED

IT IS OUR OPINION THAT THE PORCHES ARE IN SERVER DISARRAY. THE PORCHES ARE DANGEROUS AND NEEDS TO BE DISASSEMBLED, AND THE BRICK BE CLEANED OF OLD MORTAR, THE LIMESTONE STEPS, AND CAPS TO BE REMOVED AND CLEANED. THE PORCH TO HAVE A CONCRETE FOOTING AND THE PORCH TO BE REBUILT USING THE EXISTING BRICK AND LIMESTONE STEPS AND CAPS.

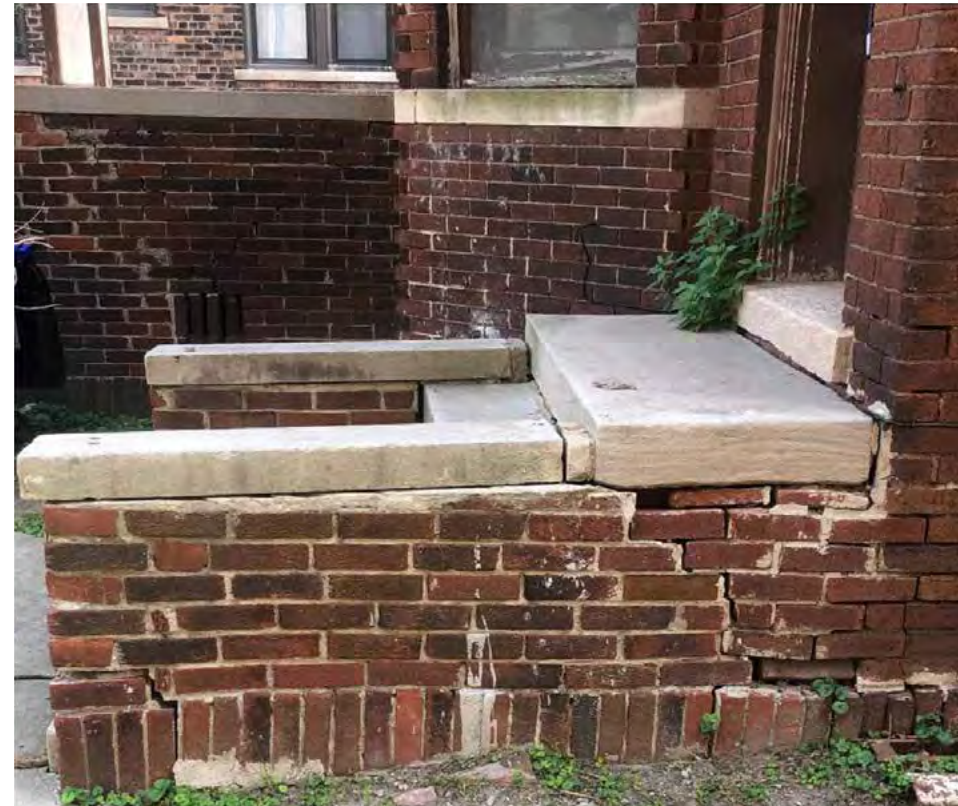
- THE GAPS IN THE BRICK HAVE BEEN IMPROPERLY FILLED AND LOOK BAD.
- BRICKS ARE LOOSE AND FALLING OUT
- THERE ARE SEVERE CRACKS IN THE PORCH WALL
- WALL IS FALLING APART AND IS UNSAFE. WILL NEED TO BE TORN DOWN AND REBUILT TO BE CORRECTED.
- SOME BRICKS HAVE BEEN REPLACED WITH NON-MATCHING BRICKS

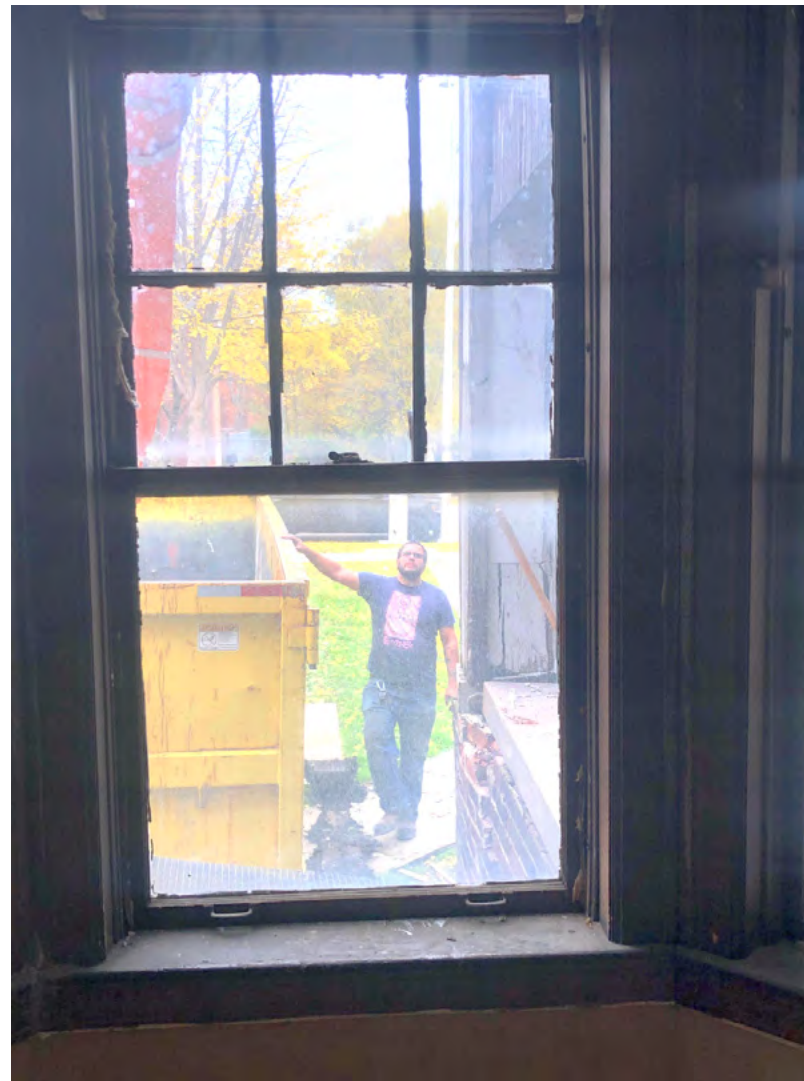
Window F-2

- Window opens but the lead counterweights are missing
- Interior sill is rotten
- One stop is missing, and the other stop is missing all but one of the screws
- Window needs to be re-putted
- Weather stripping missing
- Jamb on right side has rot

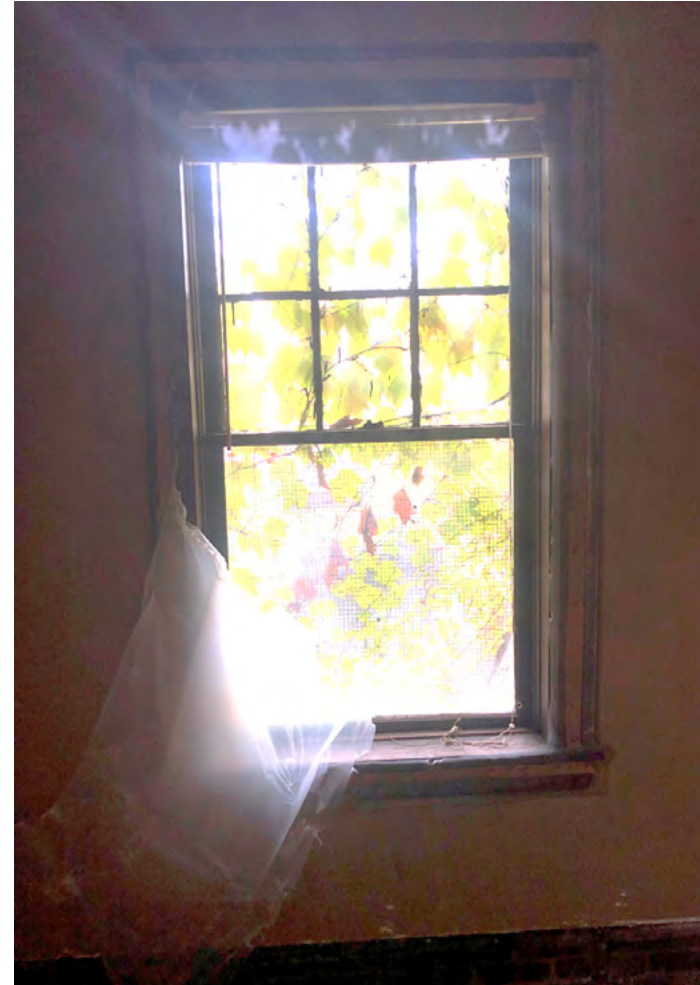
Window F-4

- Window will not open
- Missing Handles
- Both of the lead weights are missing
- Upper Sash has extensive rot on bottom
- Window interior sill had some replacement
- Exterior brickmold extensive rot on bottom
- Exterior sill has extensive rot
- Weather stripping missing
- Window needs to be re-putted
- Window will not lock

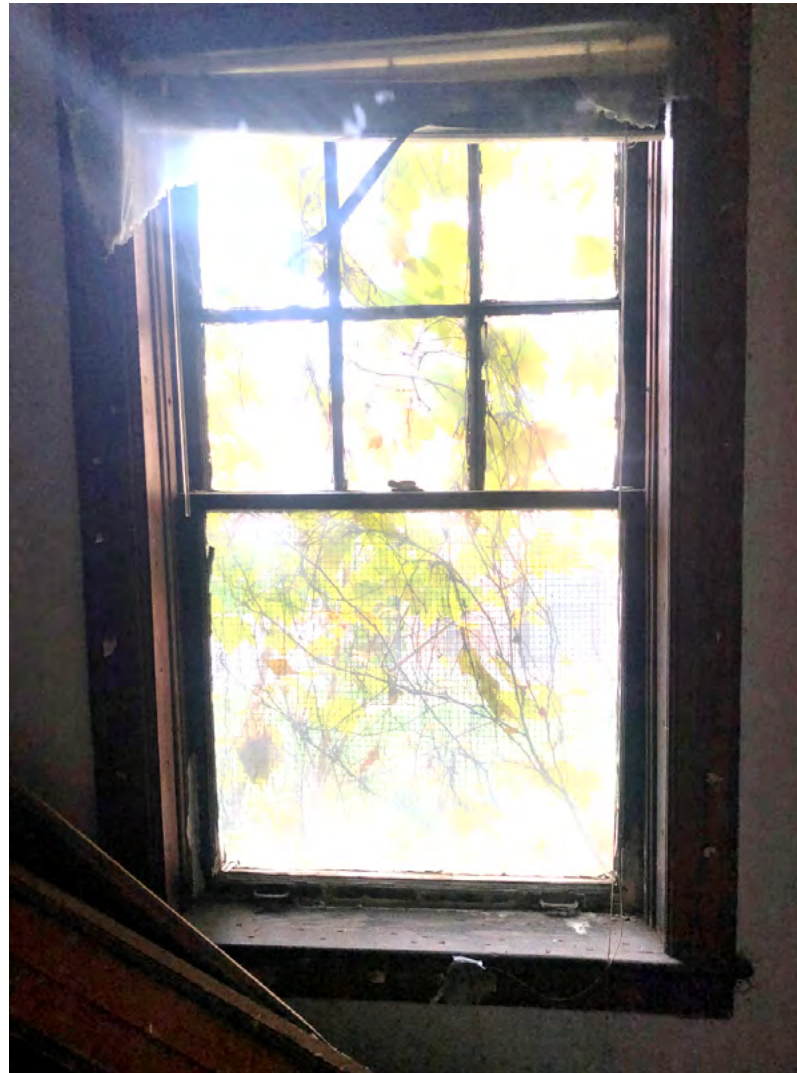
Window F-6

- Window will not open
- Bottom sash has extensive rot
- Window needs to be re-putted
- Both lead weights are missing
- Interior sill is rotten and broken
- Exterior sill has extensive rot, and the sash is pushed out
- Stops are missing
- Weather stripping missing

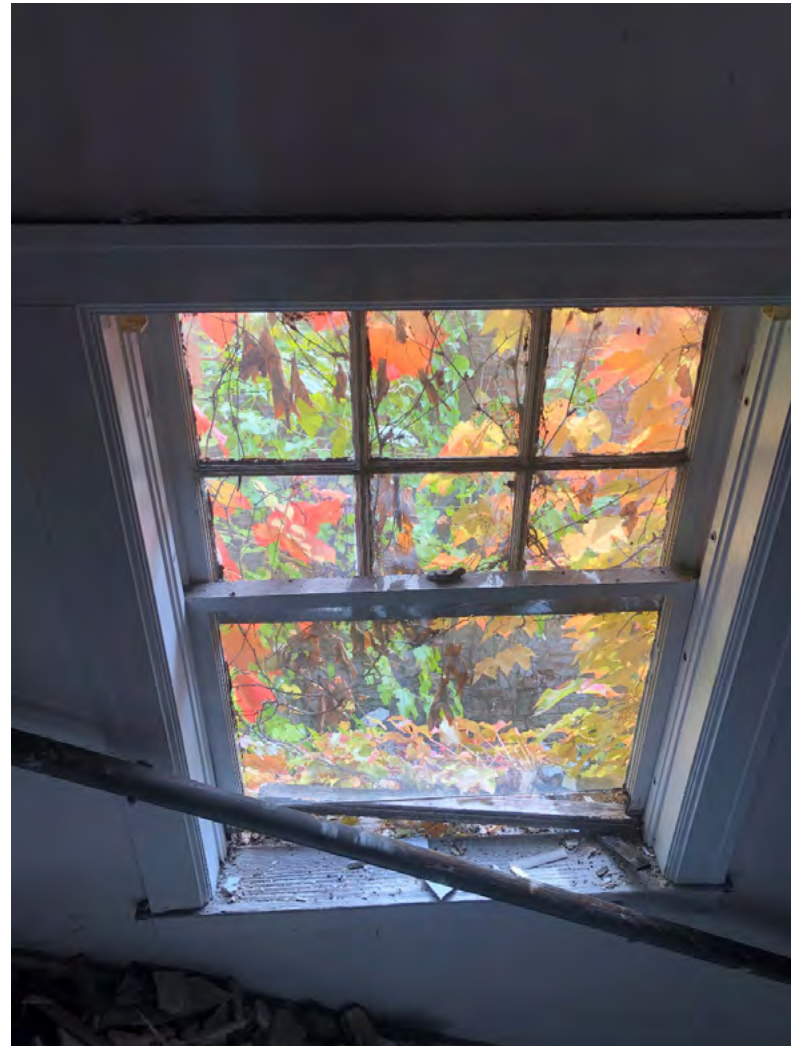
Window S-12

- Window will not open
- Window is three over one
- Bottom sash has extensive rot and is broken
- Glass in upper sash is broken on right side
- Interior sill has massive rot
- Weather stripping missing
- Window needs to be re-putted
- Exterior sill has massive rot
- Lead weights are missing

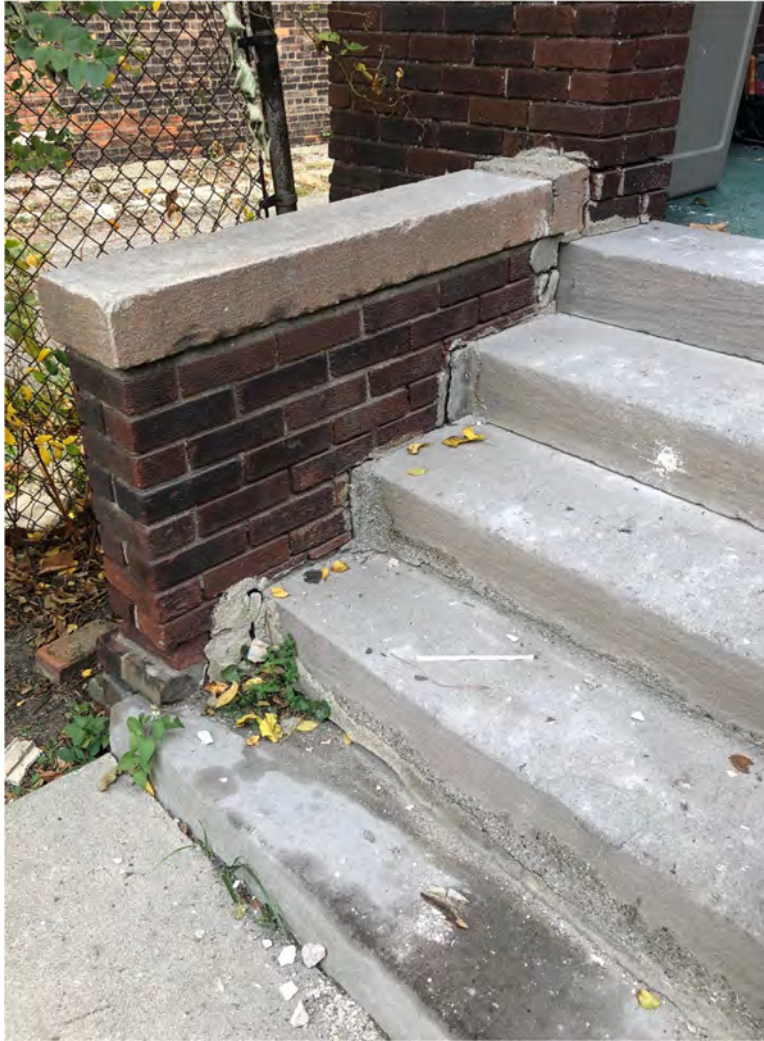
STEP and STEP WALLS

- Steps have pulled away from the porch and was improperly filled
- Wall has pulled away from the porch and was improperly filled
- Steps are not to code or ADA compliance.
- There are gaps between the steps and have been filled

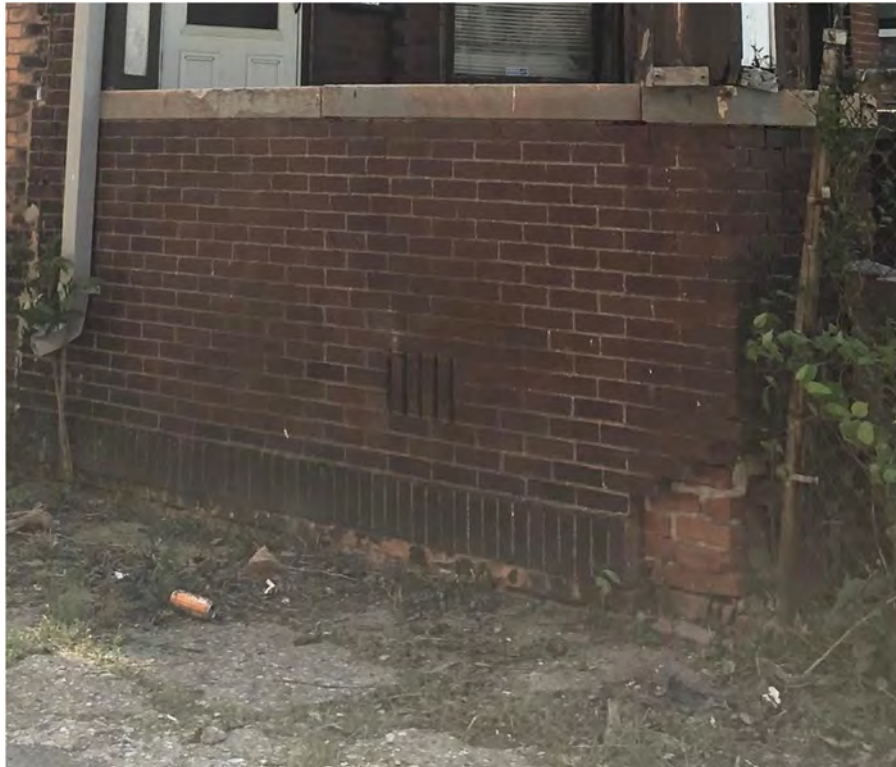
- Bricks on corner are missing.
- The rest of the porch walls is in good condition. Bricks need to be cleaned.

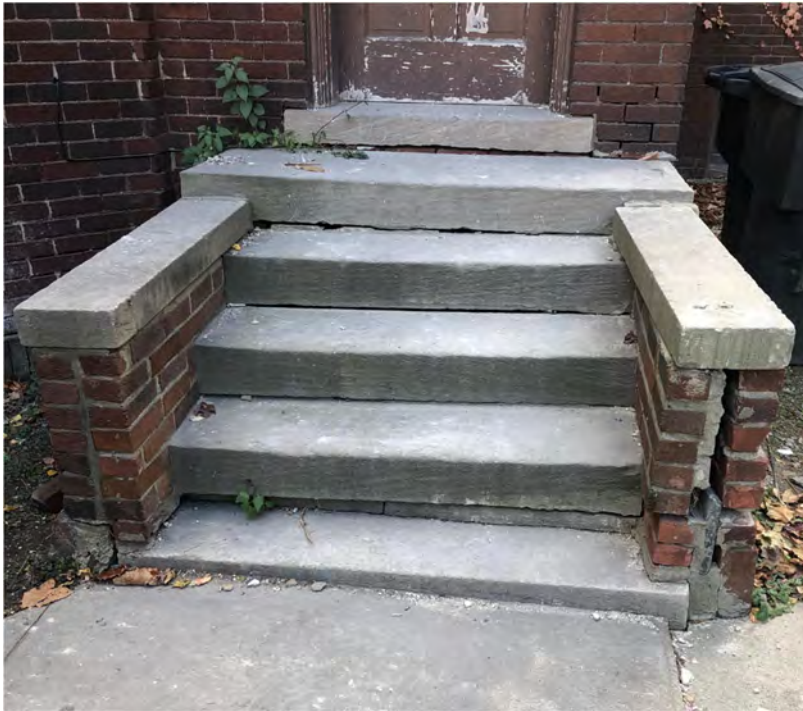
SECOND PORCH

- Steps have pulled away from the porch and was improperly filled
- Step Wall has pulled away from itself and was improperly filled
- Steps are not to code or ADA compliance.
- There are gaps between the steps and have been filled

It is our opinion that the porches are in server disarray. The porches are dangerous and needs to be disassembled, and the brick be cleaned of old mortar, the limestone steps, and caps to be removed and cleaned. The porch to have a concrete footing and the porch to be rebuilt using the existing brick and limestone steps and caps.

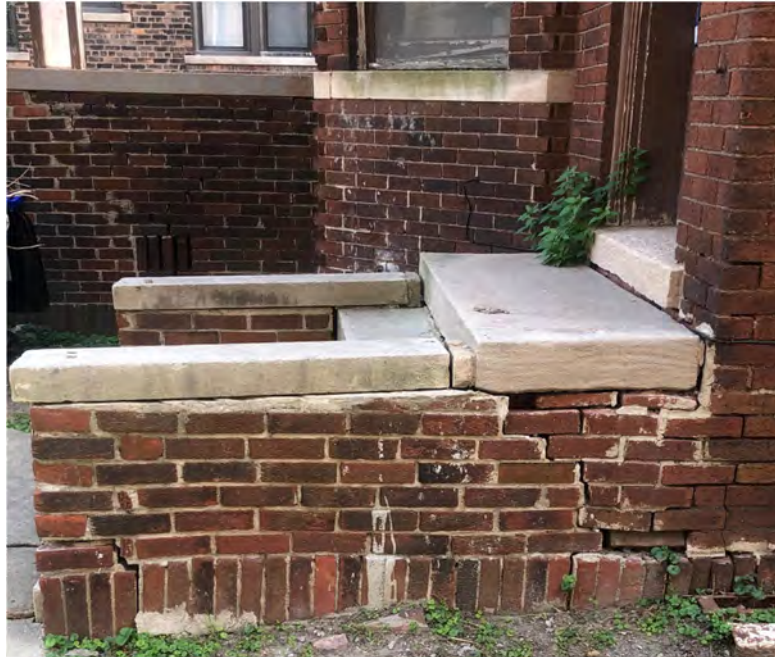
- The gaps in the brick have been improperly filled and look bad.
- Bricks are loose and falling out
- There are severe cracks in the porch wall
- Wall is falling apart and is unsafe. Will need to be torn down and rebuilt to be corrected.
- Some bricks have been replaced with non-matching bricks

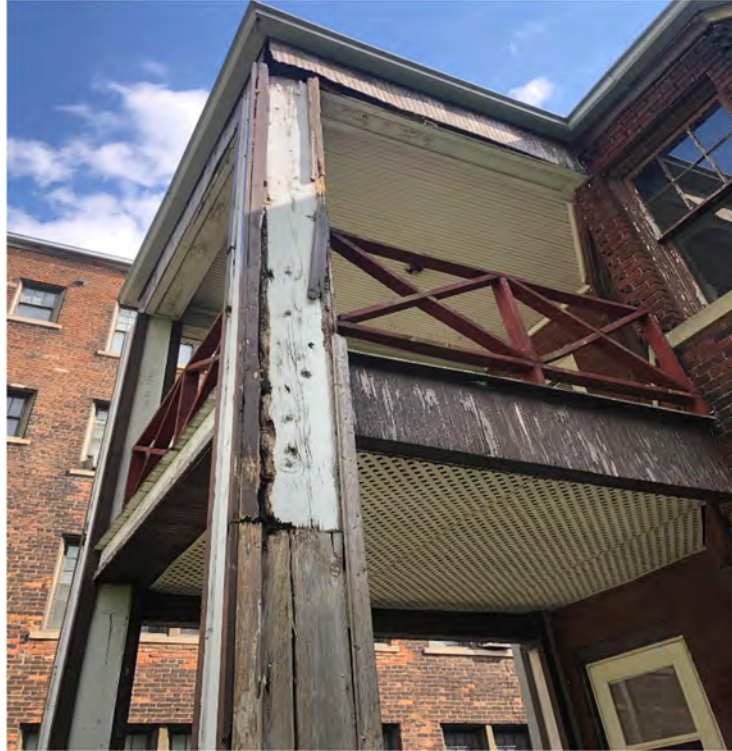
- Column has shifted from support on the upper roof.
- Railing has rot.
- Railing does not meet code.

It is our opinion that the wood on the porch has sever rot and is in disarray. The upper porch is dangerous and should not be use. The wood on the porch needs to be disassembled while supporting the roof. The porch to be rebuilt using new wood and support columns. Trim board to be installed to match existing and painted to reduce the chance of rot.
