HISTORIC DISTRICT COMMISSION NOTICE OF DENIAL

Application Number: HDC2025-00014

NAME: Alexander Belilovsky		COMPANY NAME: Alexandria Home Solutions	
ADDRESS: 24293 Telegraph Road	CITY: Southfield	STATE: MI	ZIP: 48033
PROJECT ADDRESS: 4071 Leslie			
HISTORIC DISTRICT: Russell Woods-Sullivan

Replace historic steel windows and associated wood trim with new aluminum-clad wood windows

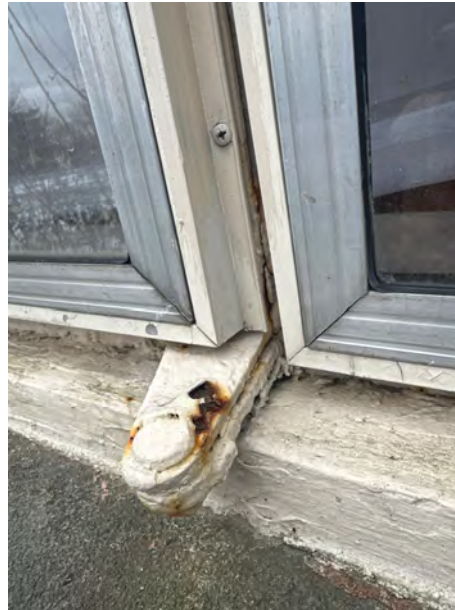
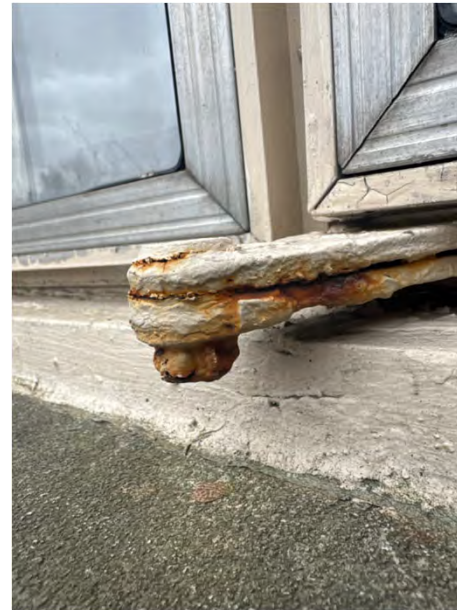
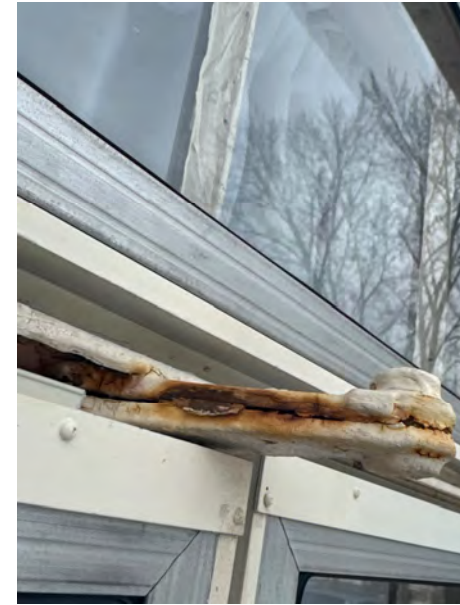
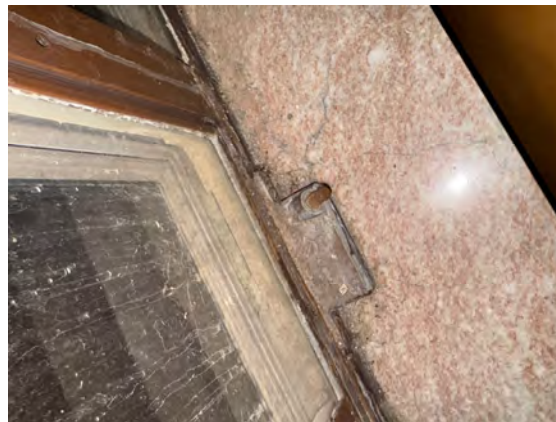
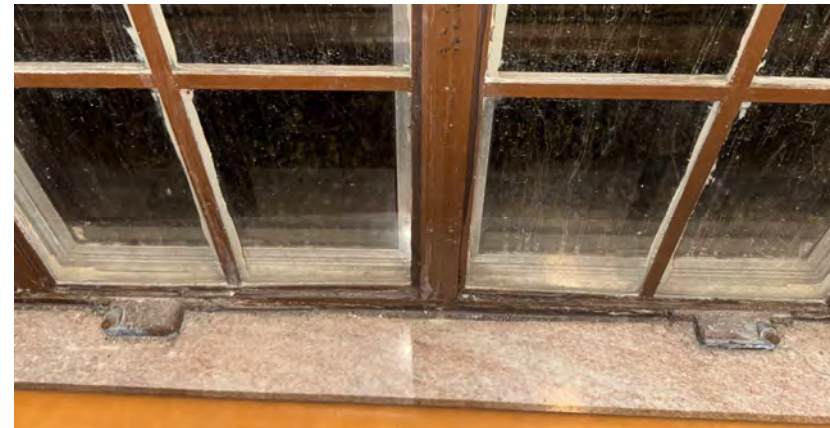
1- hardware and window rusted shut, inoperable. Fails to meet egress/code

- Deteriorated wood in window frame compromising structural integrity
- Rusty gears in casement windows
- Inoperability: Window is sealed shut. Non-functioning windows exacerbate the non-compliance, as they cannot serve as emergency exits or provide adequate ventilation. Repair is not a feasible solution when operability cannot be restored due to structural and mechanical issues.
- Non code compliance: Failure to Meet Egress Standards: The windows do not meet egress requirements, making them unsafe and non-compliant with current building codes. This is particularly problematic for emergency escape routes.

1. Rusted Gear in Casement Window:

•**Functional Obsolescence:** A rusted gear in a casement window has lost its mechanical integrity, preventing smooth or reliable operation. Rust compromises the precise movement required for opening and closing, and repairs (e.g., lubrication or partial component replacement) often fail to restore full functionality due to corrosion spread across interconnected parts.

•**Safety Concerns:** A malfunctioning gear could lead to sudden failure, making the window unsafe for operation. As per guidelines, operability is essential to preserve the historic character of windows

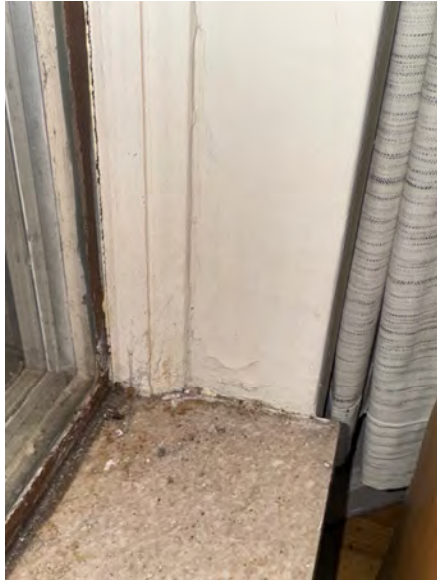
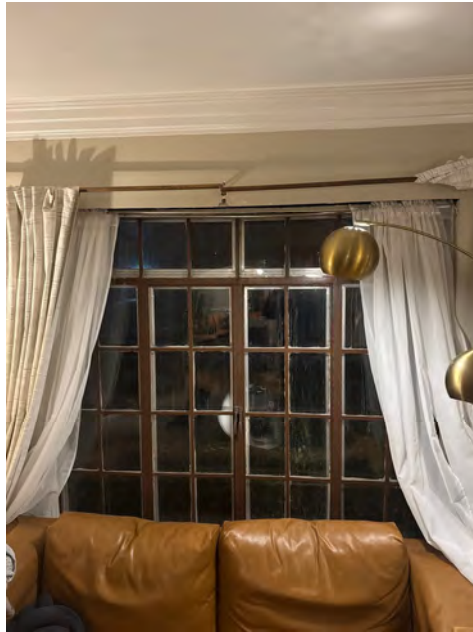
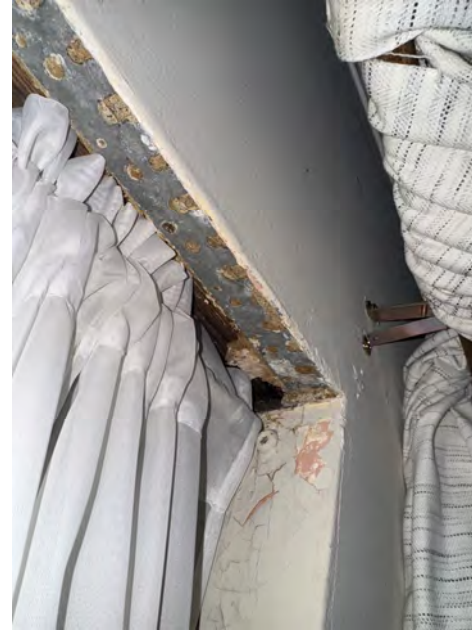
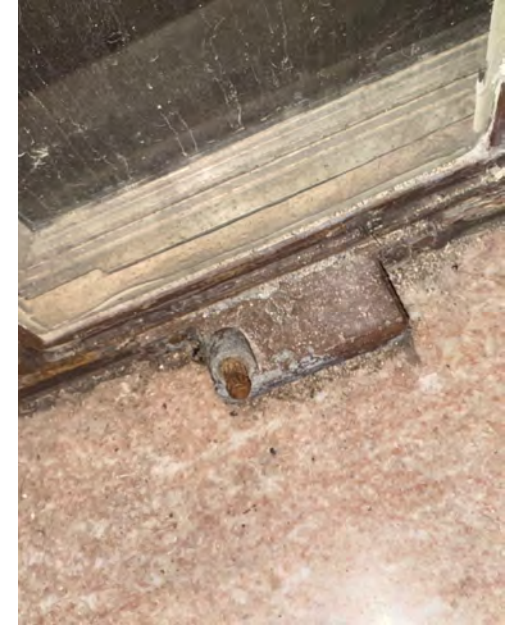
Window 1: (Continued)

- Deteriorated wood in window frame compromising structural integrity
- Extensive water damage shows extreme deterioration, compromising structural integrity of the window and weatherproofing ability

Water Damage to Interior Walls:

- **Evidence of Intrusion:** Photographs demonstrate water infiltration through the windows, leading to damage such as stained walls, mold growth, and potential weakening of wall structures. This evidence underscores the windows' failure to provide a proper seal against weather.
- **Health and Safety Issues:** Mold and water damage present serious health risks to occupants, violating modern building codes that require healthy and habitable living conditions.

Deteriorated Wood on exterior:

• **Loss of Structural Integrity:** Wood that has deteriorated due to moisture, mold, or rot no longer provides adequate support for the window assembly. This compromises the entire frame's stability and may pose a safety hazard.

Full Replacement Justification:

- Holistic Solution:** Full replacement with wood windows featuring aluminum cladding ensures compliance with historic guidelines while addressing durability, functionality, and weatherproofing.
- Long-Term Preservation:** The new windows will match the original design while incorporating modern materials that prevent recurrence of these issues. Proper water grading, operability, and protection against further deterioration are integral to preserving the building's structural and historical integrity

Replacement is necessary when repair is not technically feasible or when deterioration affects the window's ability to retain its shape, support glass, and maintain weatherproofing. Aluminum-clad wrapping further ensures long-term durability by protecting against future moisture and weather-related damage

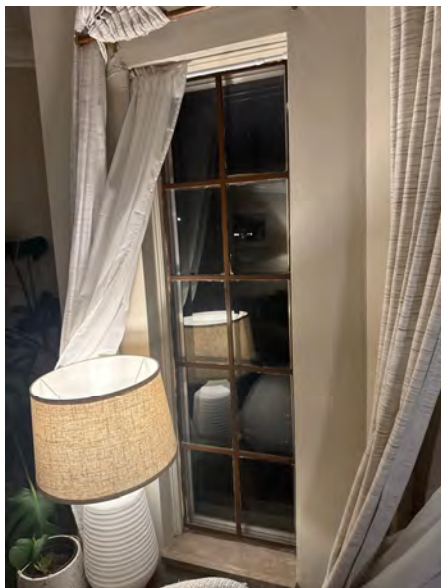
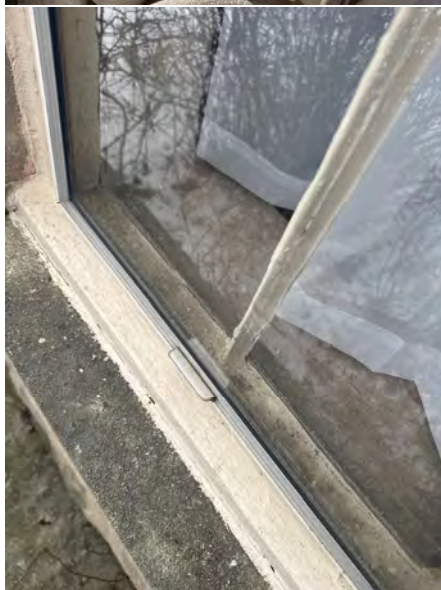
Window 3:

- Evidence of exterior wood frame rot
- Evidence of mold between storm window and original window

- **Deteriorated Wood on exterior:**
- **Loss of Structural Integrity:** Wood that has deteriorated due to moisture, mold, or rot no longer provides adequate support for the window assembly. This compromises the entire frame's stability and may pose a safety hazard.
- **Guideline Requirements:** Replacement is necessary when repair is not technically feasible or when deterioration affects the window's ability to retain its shape, support glass, and maintain weatherproofing. Aluminum-clad wrapping further ensures long-term durability by protecting against future moisture and weather-related damage

- **Compromised Integrity:** Mold indicates prolonged moisture exposure, often leading to weakened or deteriorated materials that cannot be effectively repaired, necessitating full replacement.
- **Health Hazards:** Mold poses significant health risks (e.g., respiratory issues) and can persist in porous materials, making replacement essential to fully eliminate the issue and prevent recurrence.
- **Underlying Moisture Issues:** Mold is often caused by structural defects like improper grading or seals, which require replacement to correct and ensure future moisture resistance.
- **Code and Safety Compliance:** Replacement ensures compliance with modern building codes and health standards, providing a safe, mold-free environment while preventing further damage.

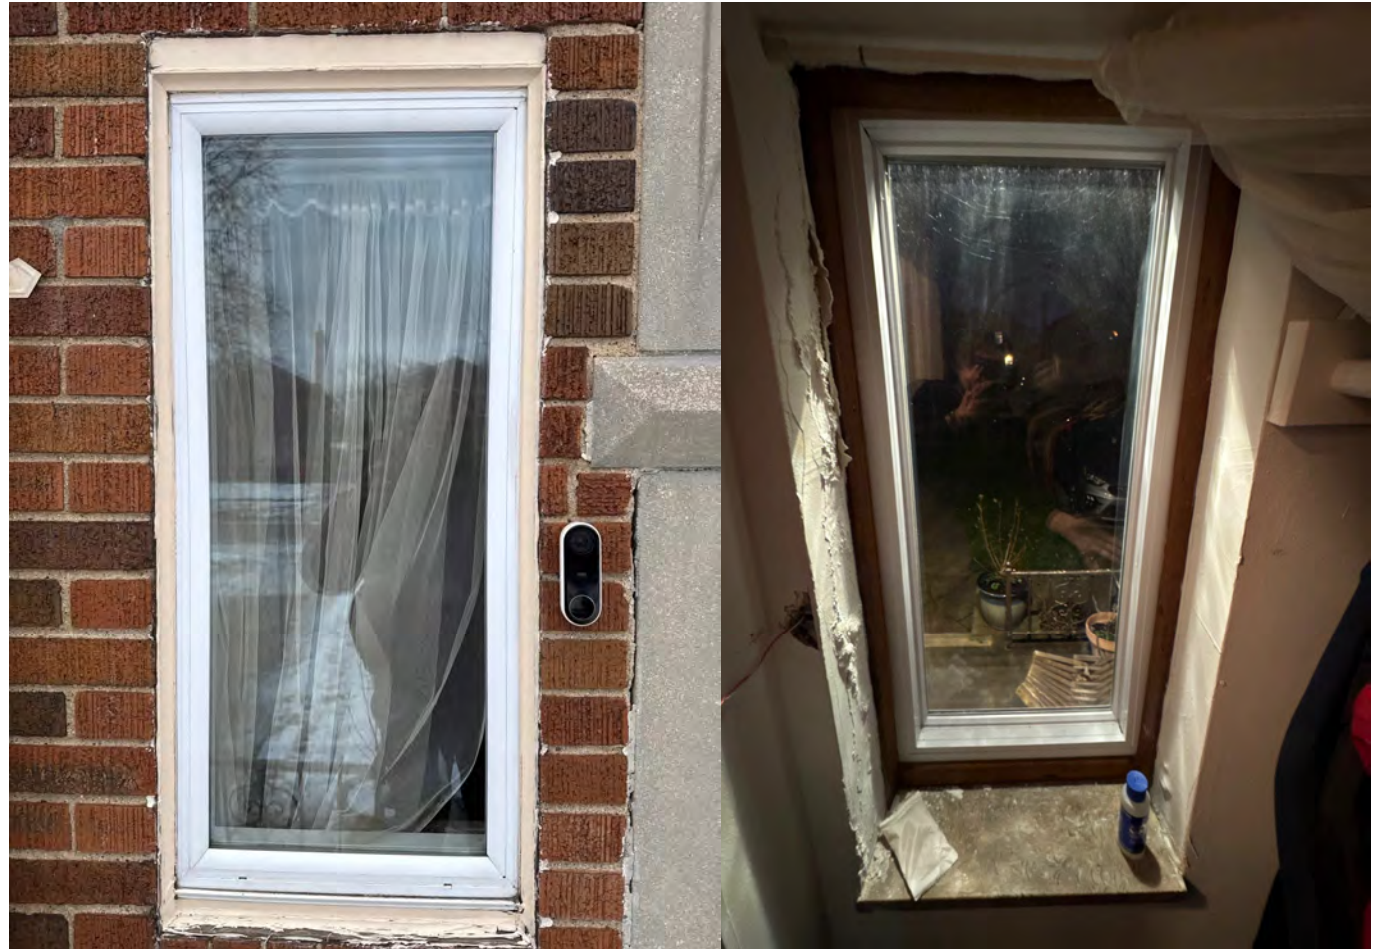
Window 13:

- Vinyl
- Marble sill will be preserved to maintain historical correctness

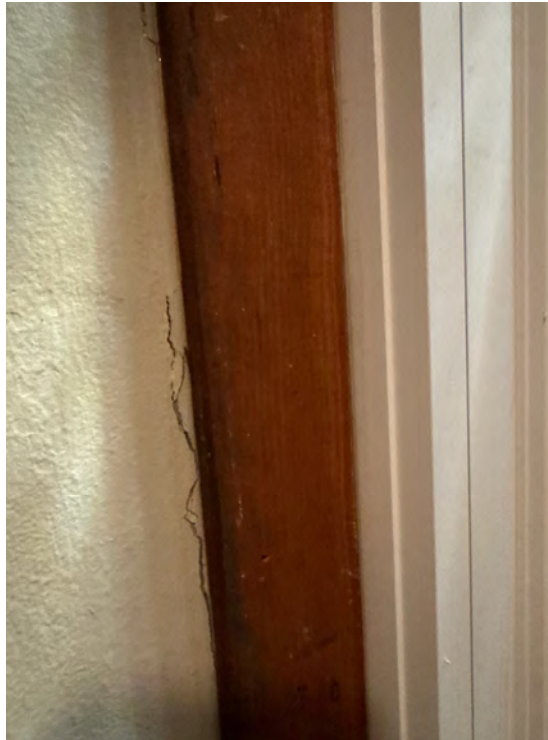
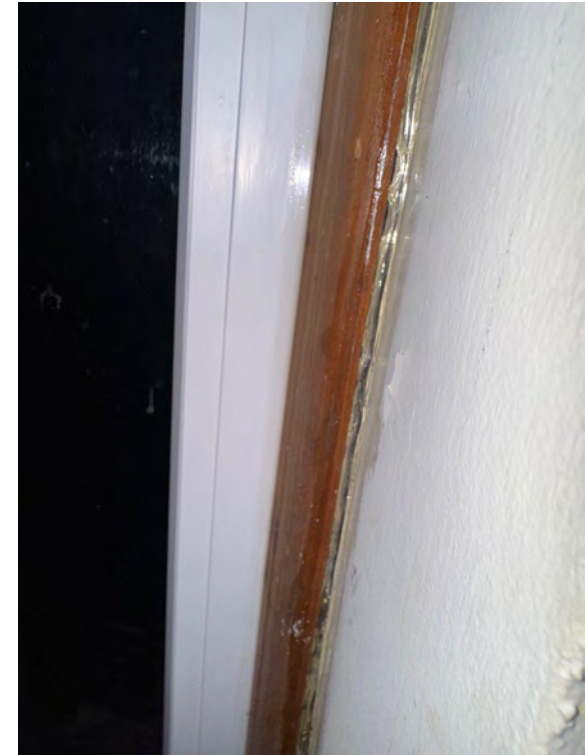
Window 14:

- Repairs with clear silicone calk were attempted
- vinyl

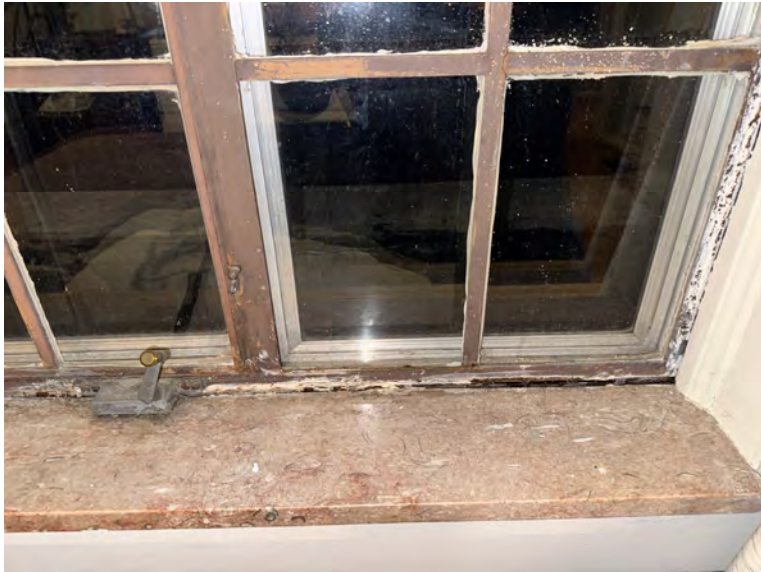
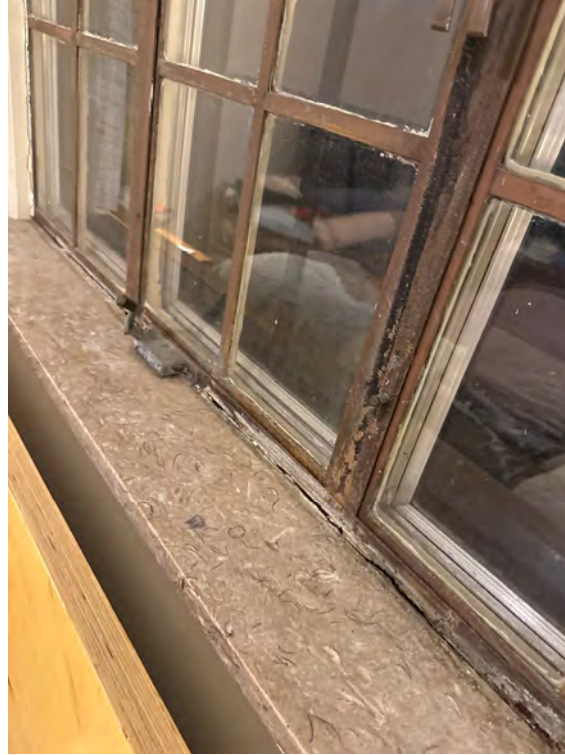
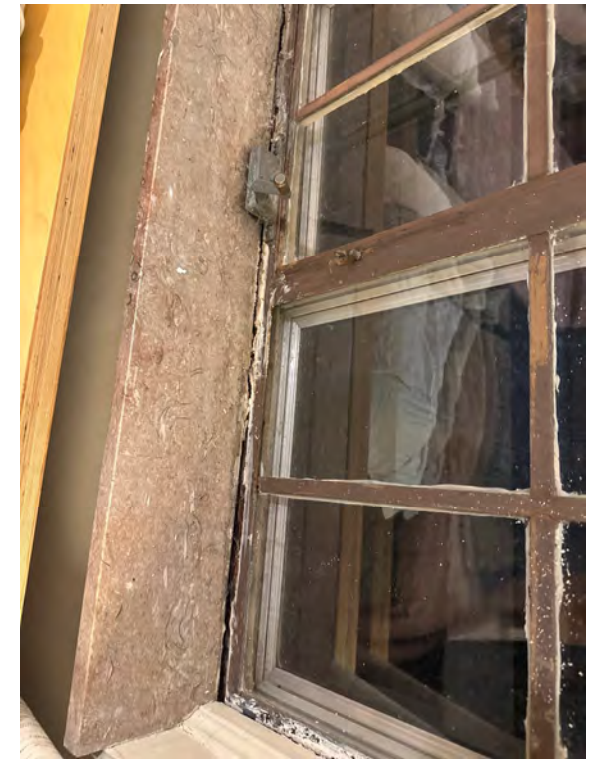
Window 16 (continued)

16- Master bedroom: substantial gaps in weather proofing, only one casement window opens due to hardware rusted shut, fails to meet egress/code

- substantial gaps in weather proofing,
- only one casement window opens due to hardware rusted shut,
- fails to meet egress/code

- Substantial gaps
- Substantial rusting

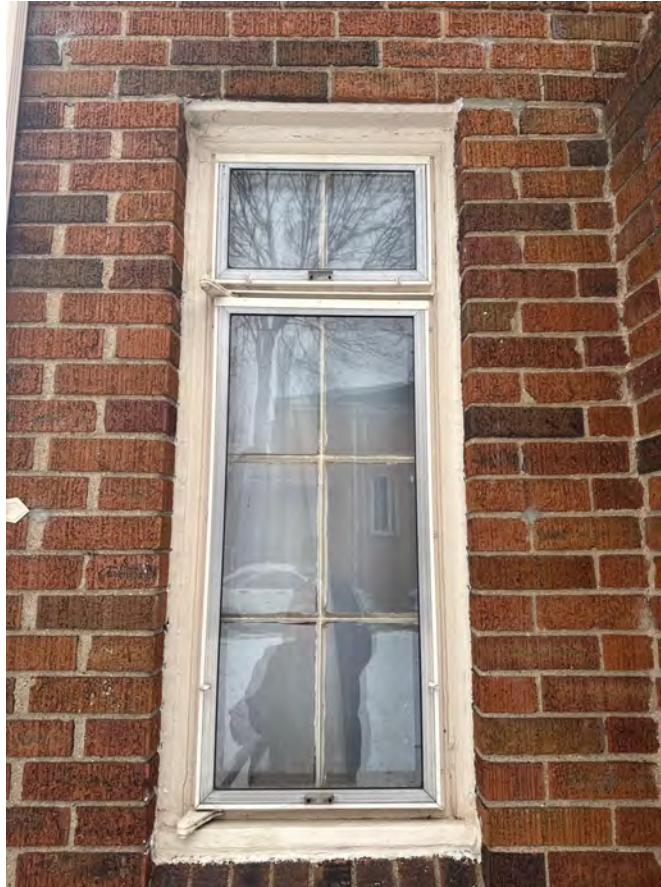
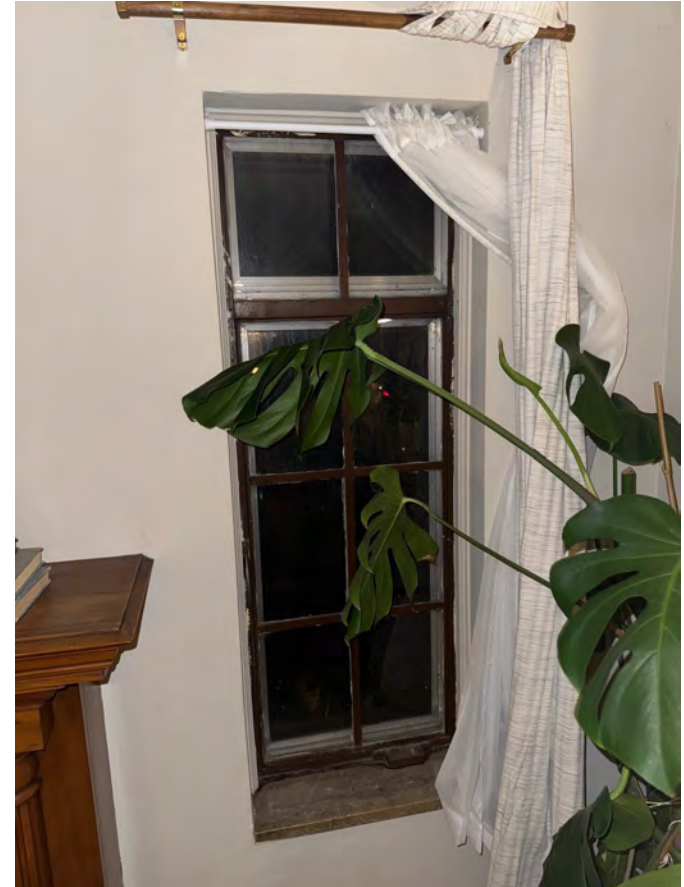
Window 4

- Sealed shut, does not meet egress/code

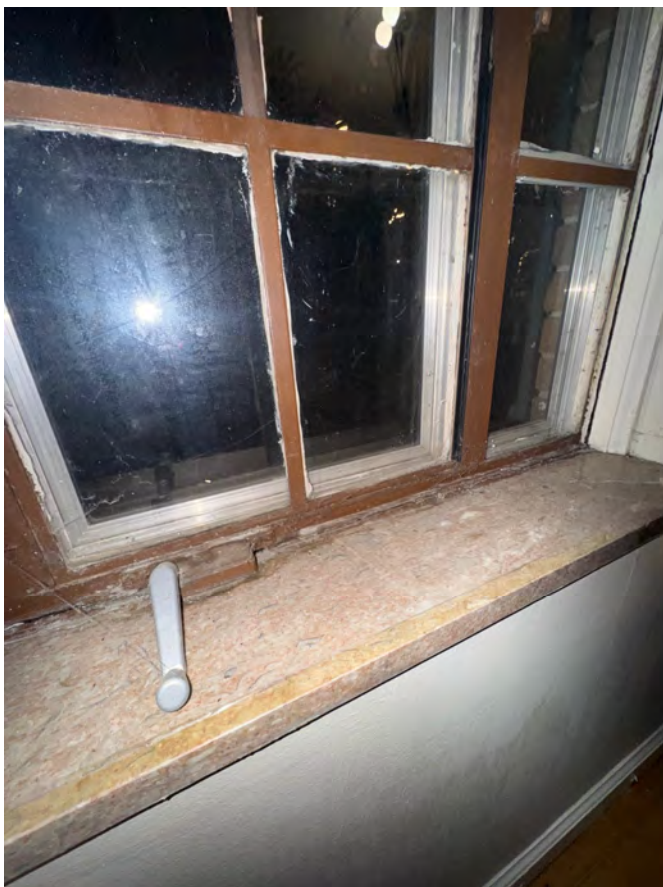
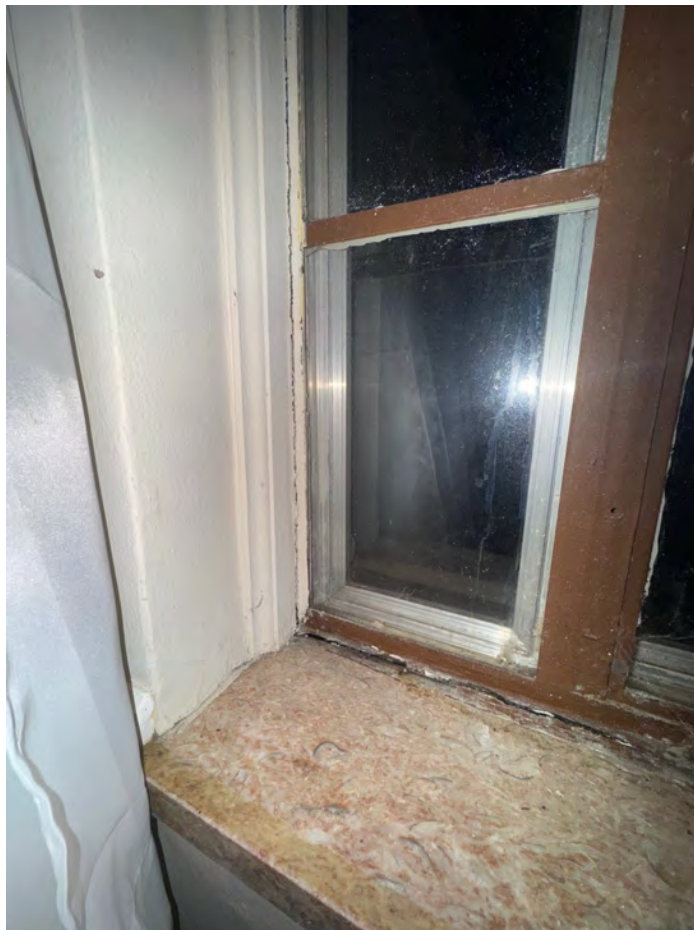
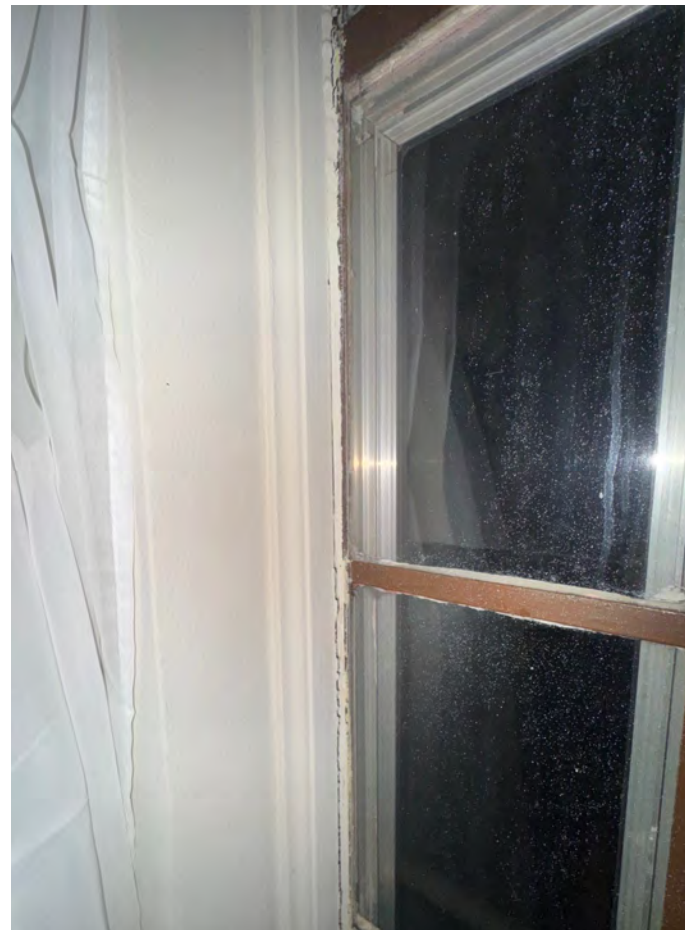
Window 7 (Continued)

- Handle no longer works, gears rusted shut

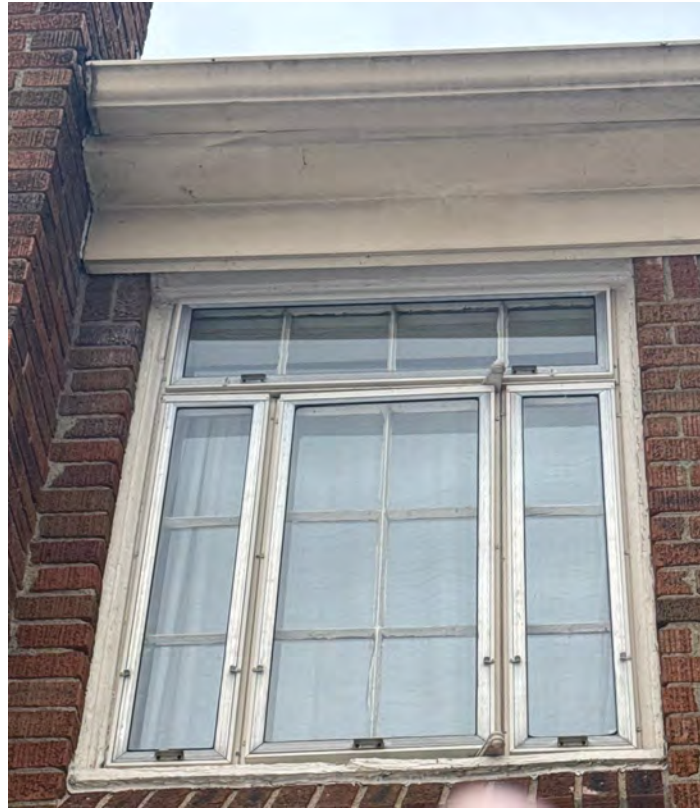
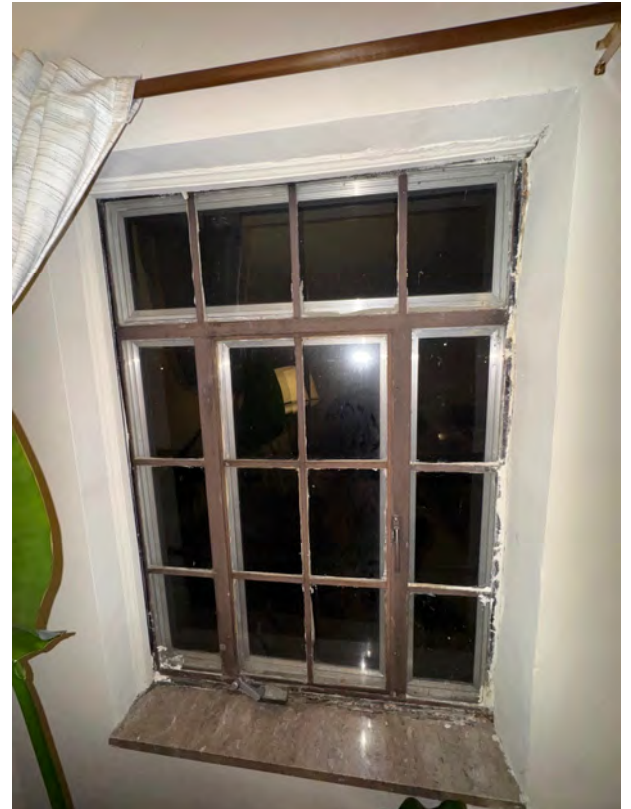
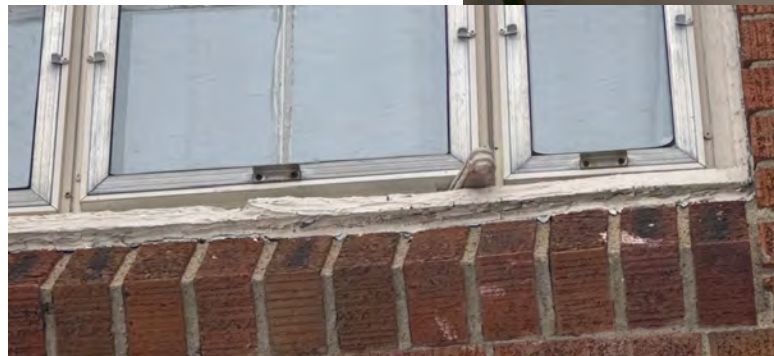
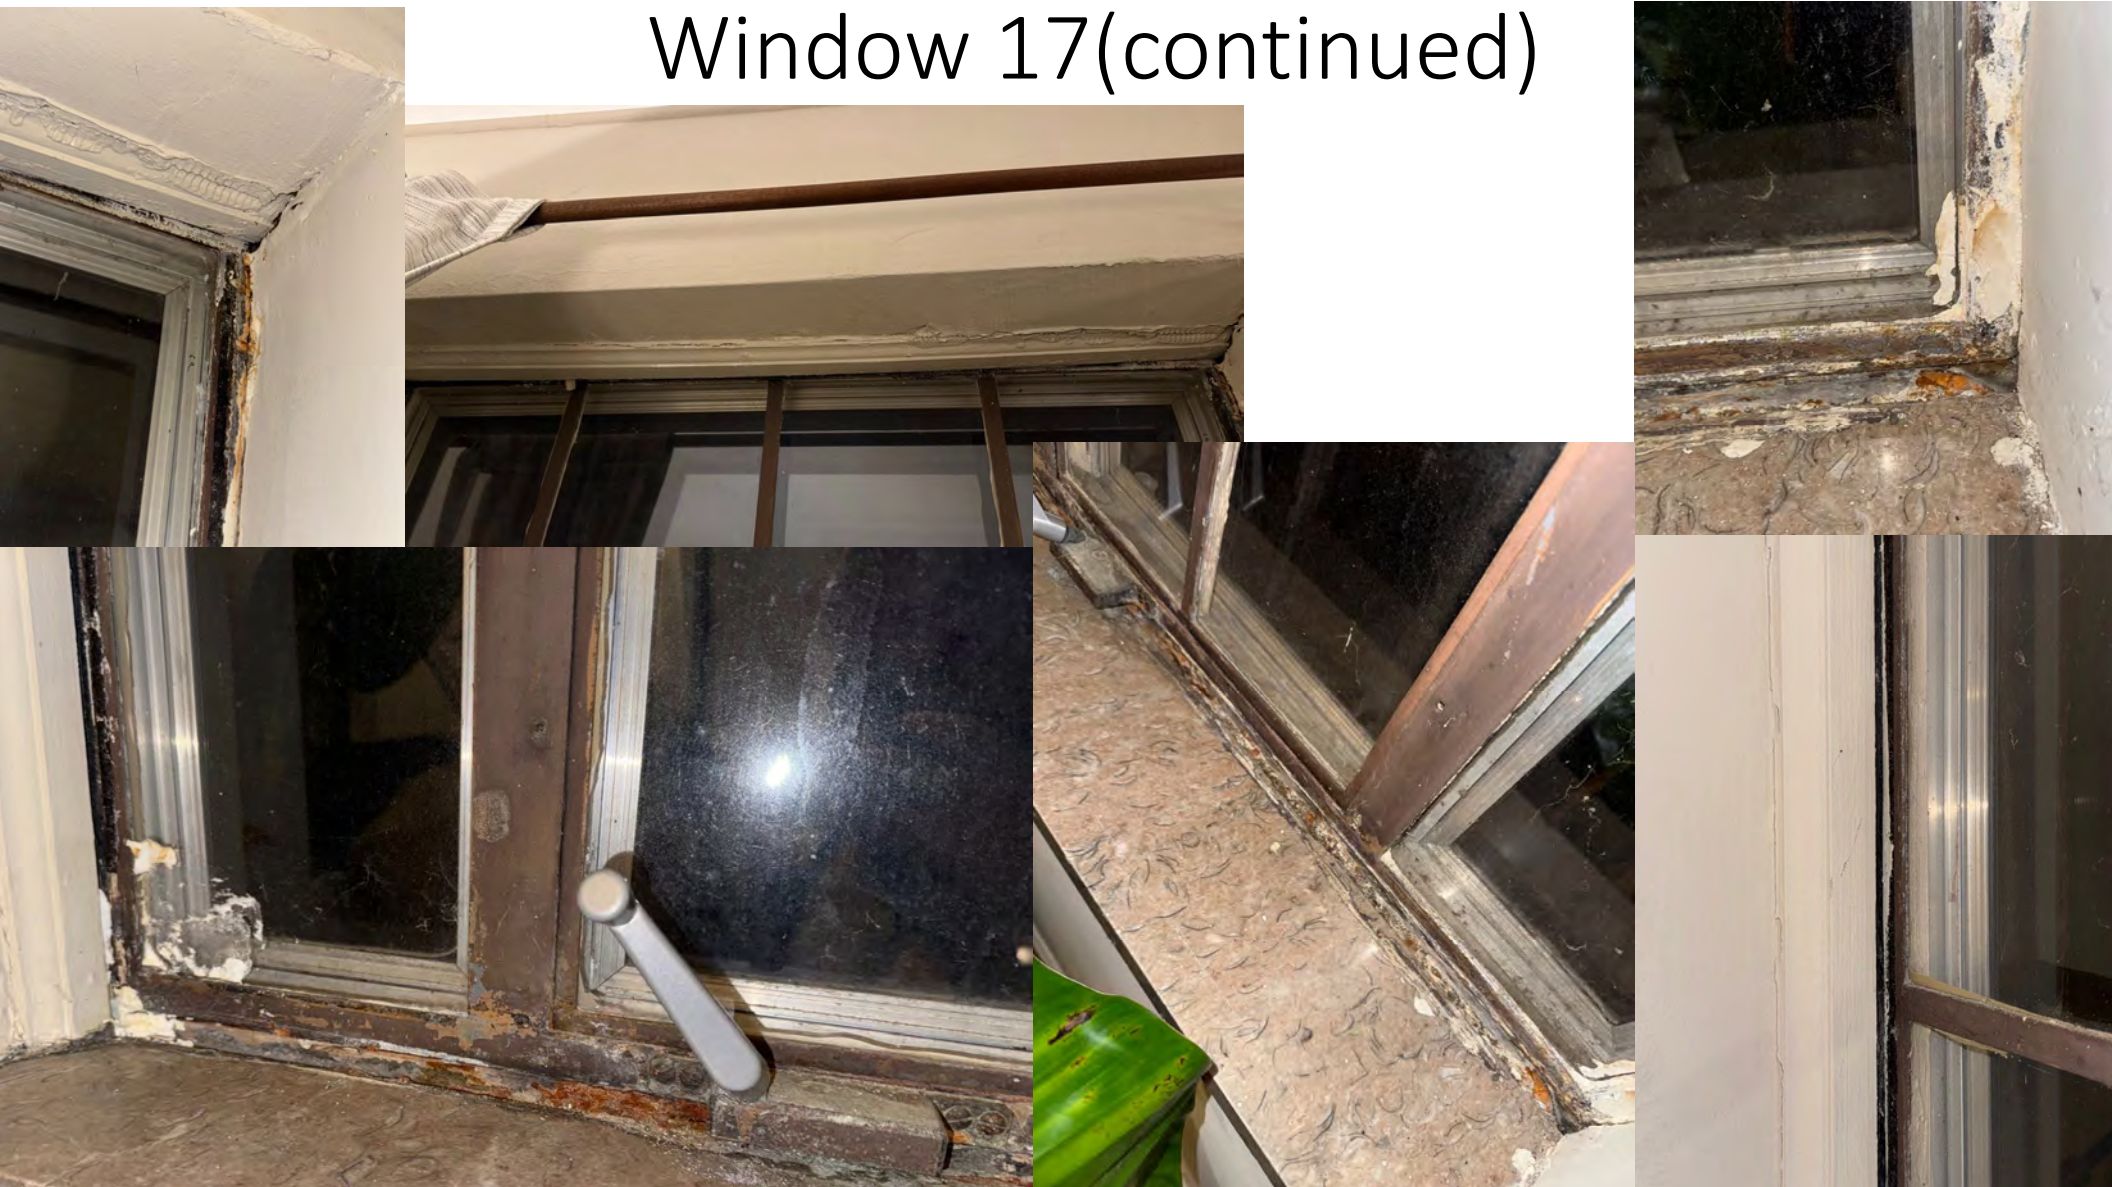
Window 17

- 4- sealed shut
- 5- sealed/rusted shut
- 6- structural rust, evidence of water damage
- 7- sealed/rusted shut
- 17- Worst Condition on entire floor
- 18- sealed/rusted shut
- 19- vinyl; not historically correct

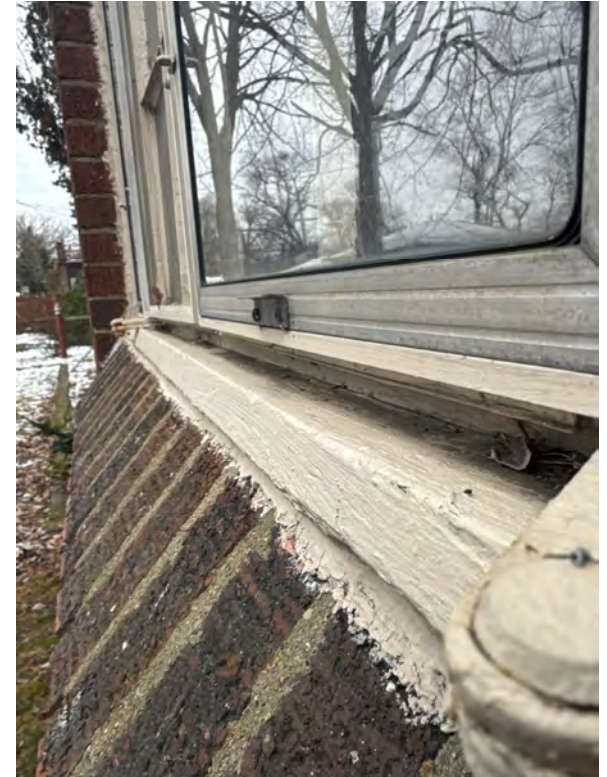
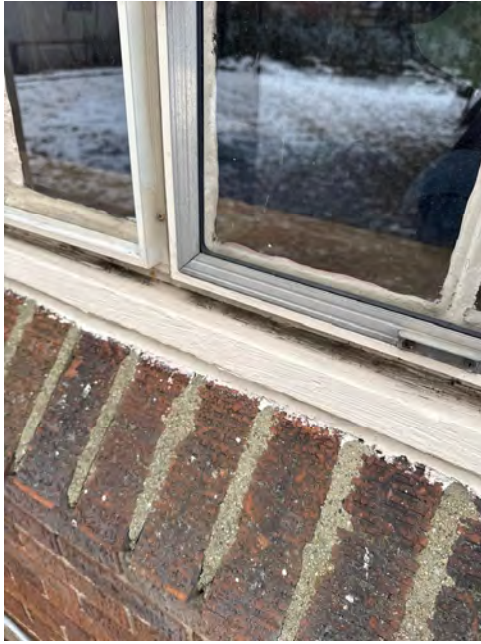
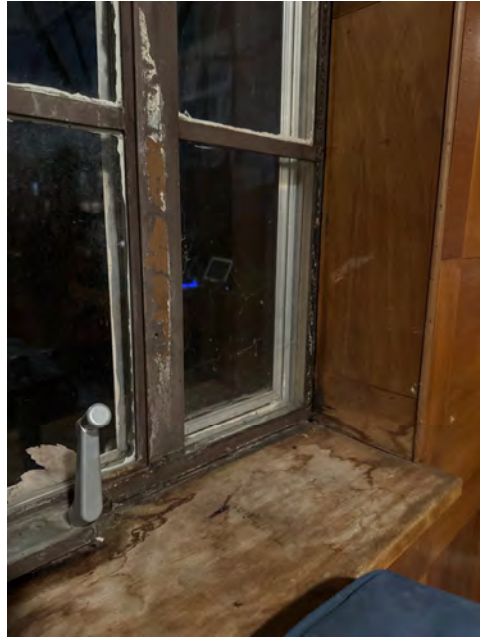
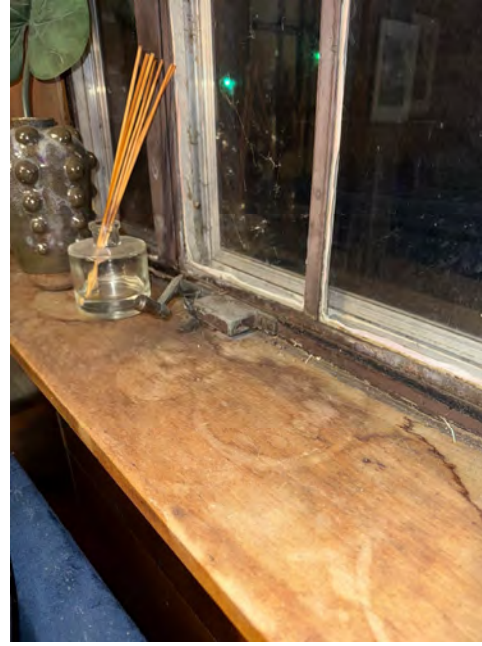
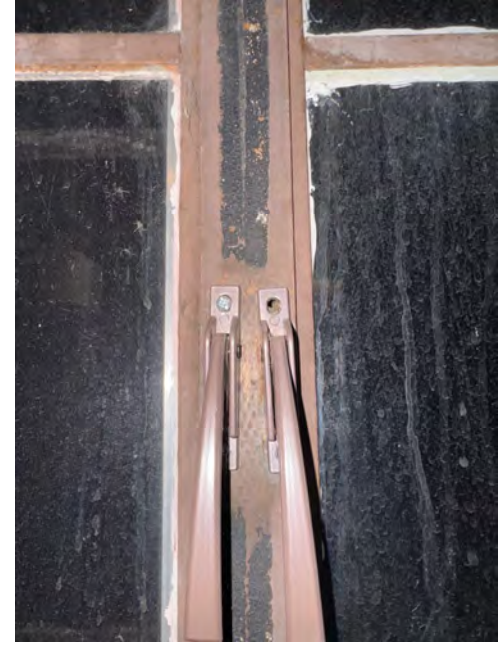
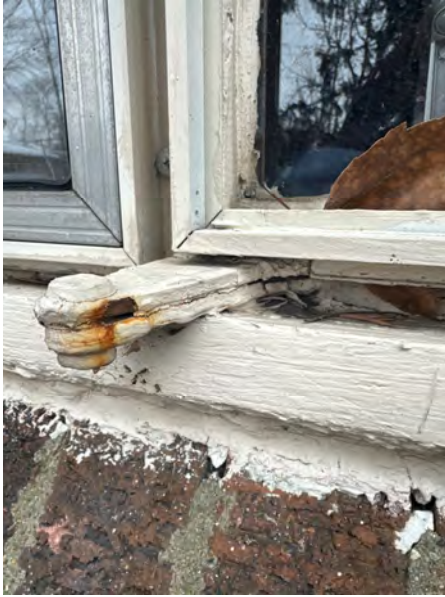
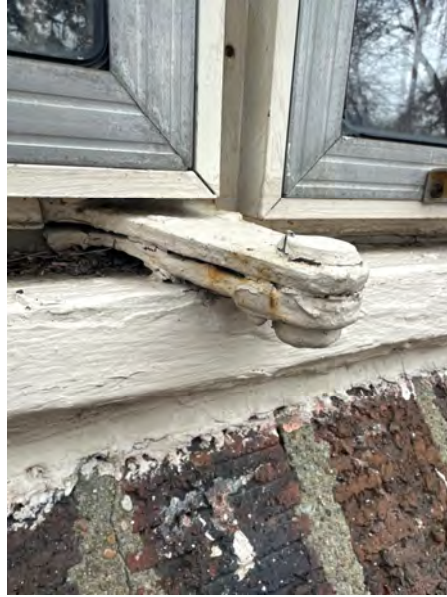
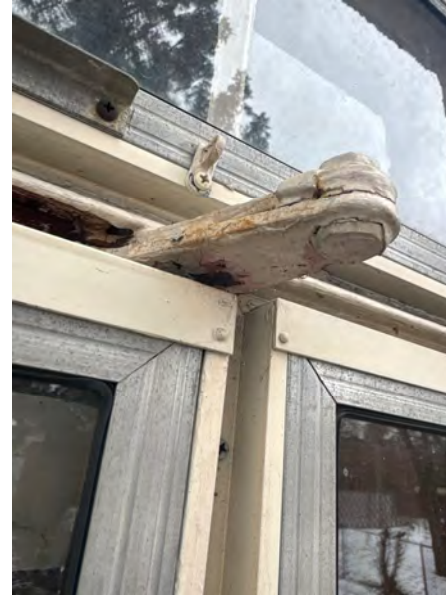
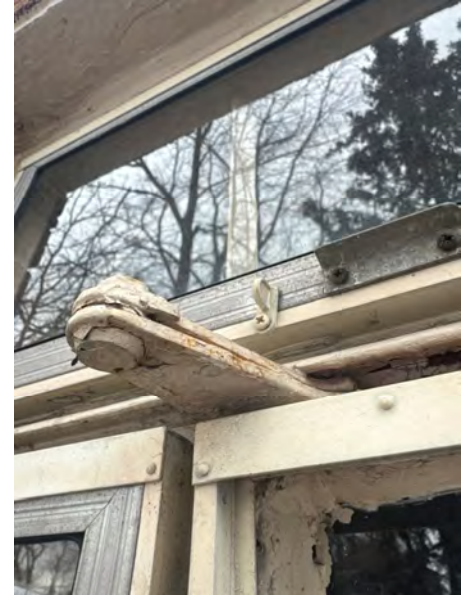
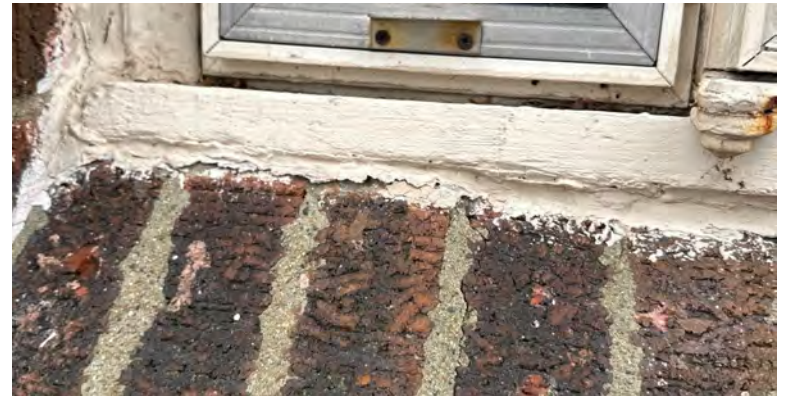
Window 8
(Continued)

8- inward angled deteriorated sill, damaged interior sill, damaged hardware, evidence of mold, exterior hinges rusted out.

- Exterior sill not grading water properly, caused water to damage interior sill
- Hardware receiver rusted out and stripped, repair of handle no longer possible
- Evidence of mold
- Exterior hinges all rusted out, only one casement opens. Does not meet egress/code. Extremely drafty.

- **Water Pooling and Structural Risk:** The bottom stud is incorrectly angled inward, allowing water to collect rather than drain away from the window. This design flaw exacerbates water retention and encourages wood rot, mold growth, and potential damage to surrounding structures, including the interior walls.
- **Necessity of Replacement:** Adjusting the stud's angle retroactively is not a feasible repair solution due to its integration into the structural frame. Full replacement of the window frame ensures proper water grading and long-term protection against water infiltration

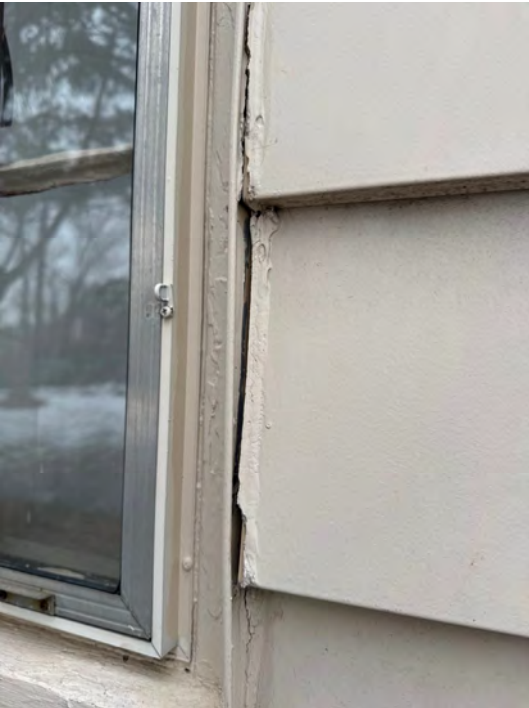
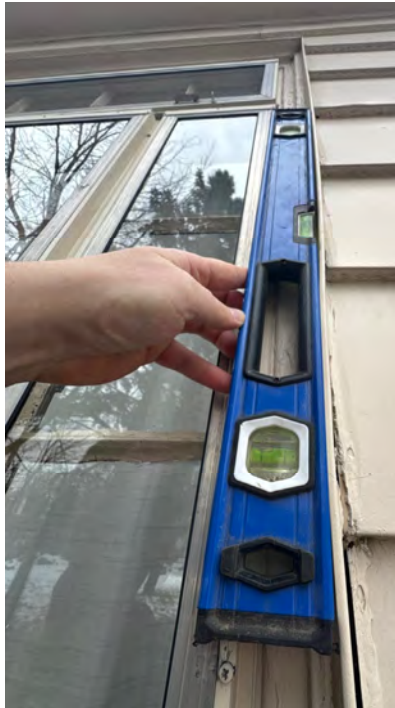
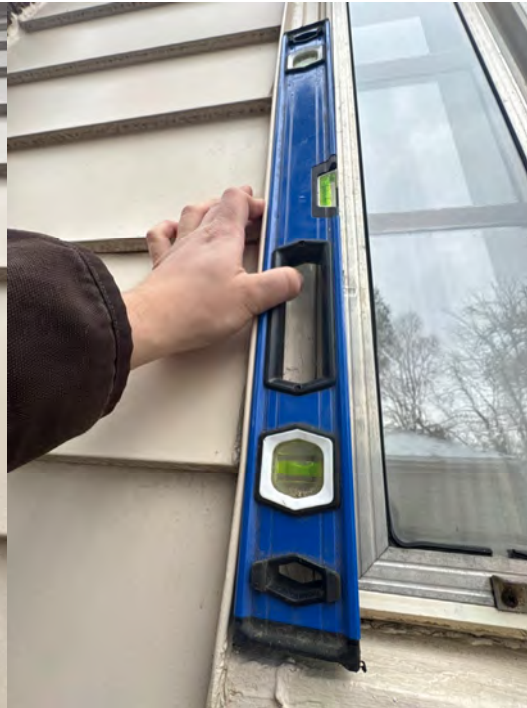
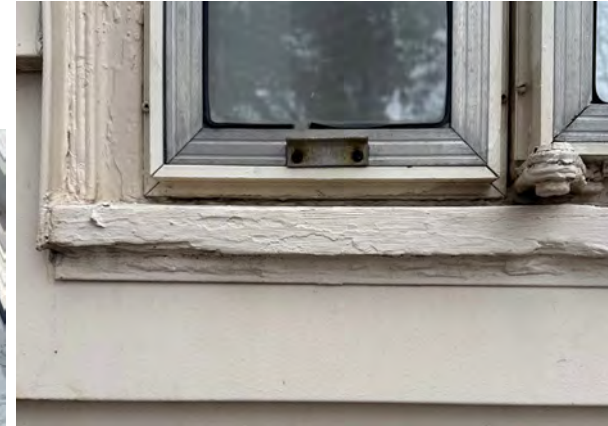
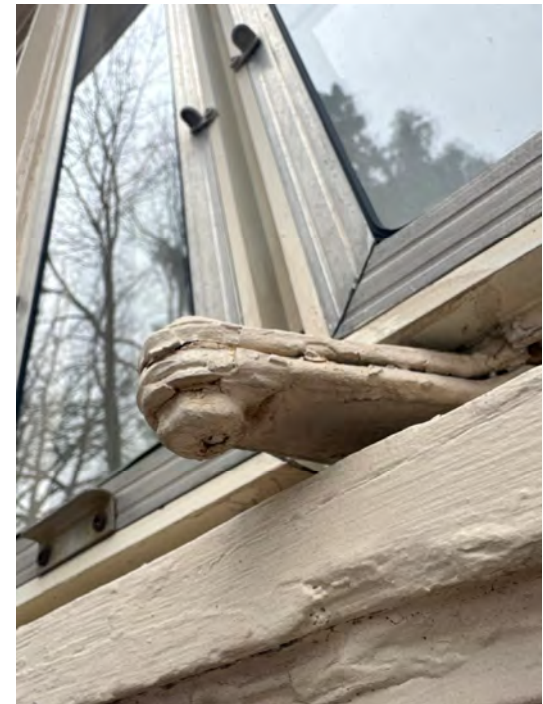
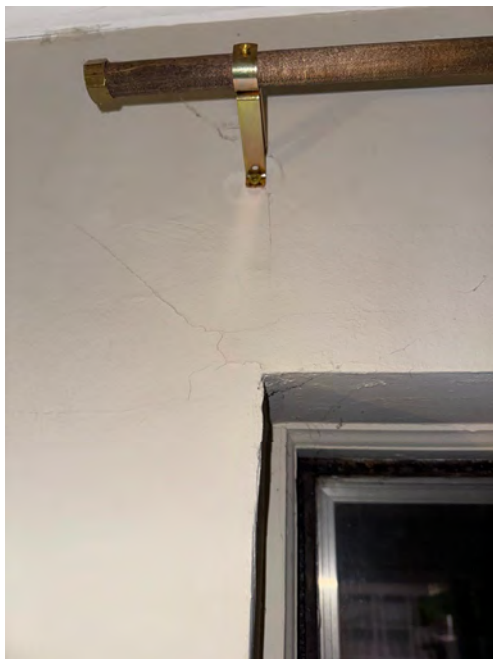
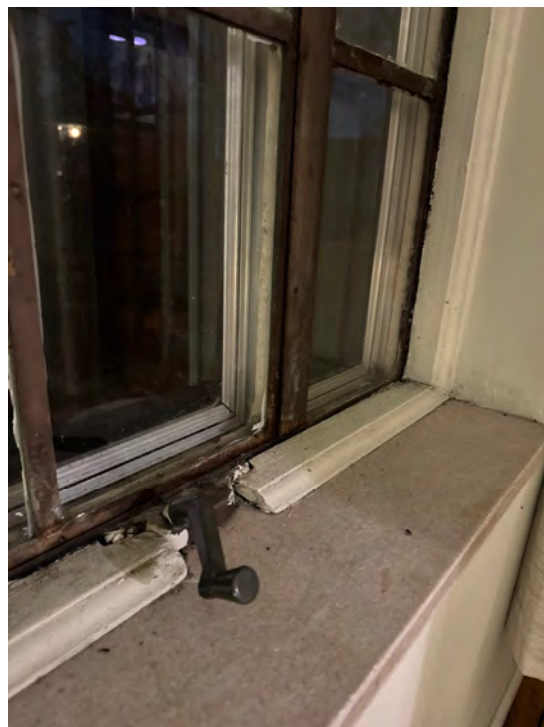
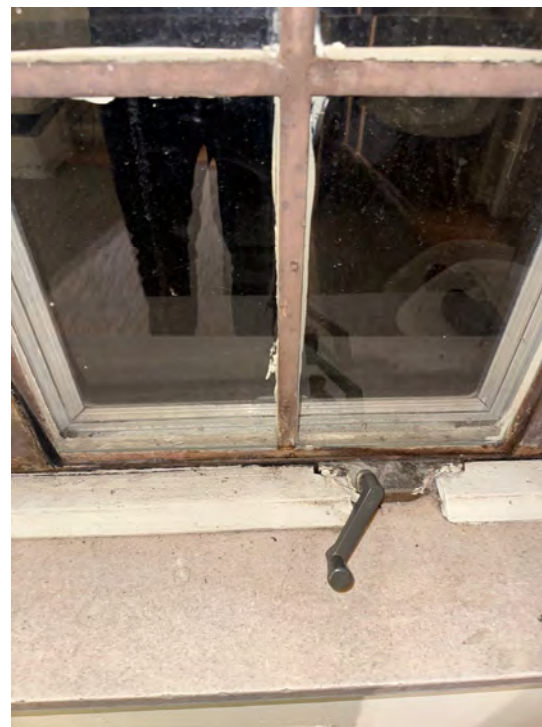
Window 9 Continued

9- evidence of mold, windows not level/flush with rest of home, necessary for proper siding replacement

- Deterioration of bottom exterior sill
- Evidence of mold
- Window not level with home, home has shifted, only remedy is replacement
- Window not flush, needs to be flush for proper siding replacement

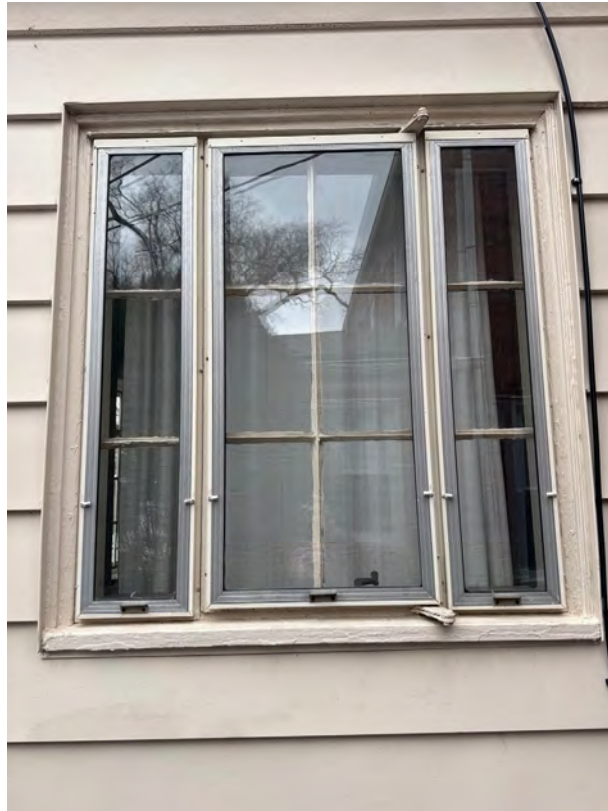
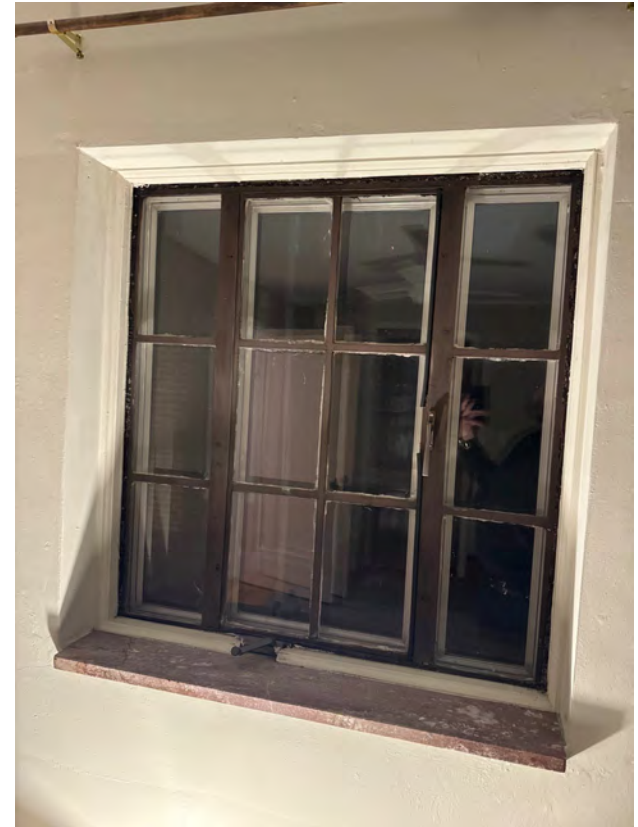
Window 10

10- substantial rust present, substantial gaps in frame, weather stripping was attempted but did not remedy to draft.

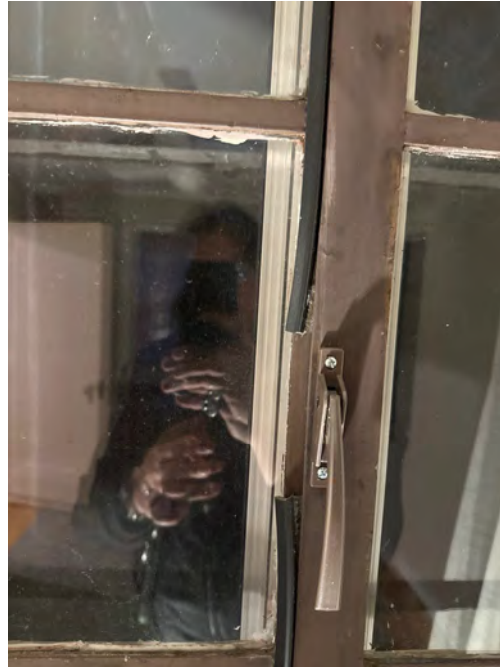
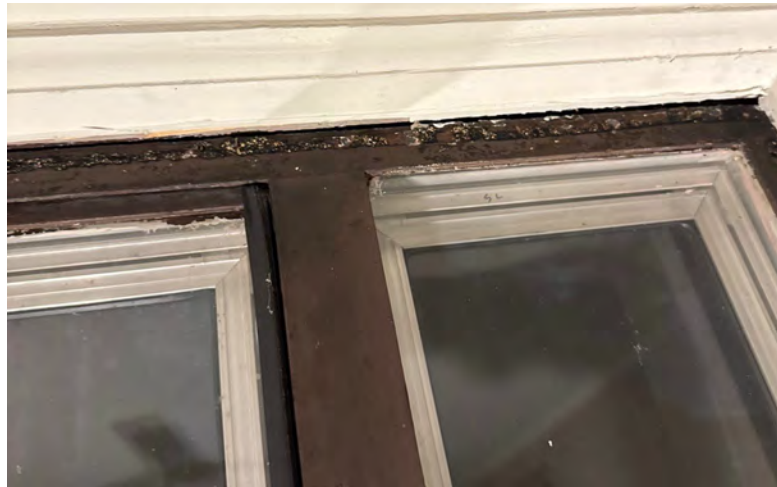
Window 10 (Continued)

- New weather stripping was attempted, did not fix the issue
