HISTORIC DISTRICT COMMISSION NOTICE OF DENIAL

Application Number: HDC2025-00014

NAME: Alexander Belilovsky		COMPANY NAME: Alexandria Home Solutions	
ADDRESS: 24293 Telegraph Road	CITY: Southfield	STATE: MI	ZIP: 48033
PROJECT ADDRESS: 4071 Leslie			
HISTORIC DISTRICT: Russell Woods-Sullivan

Replace historic steel windows and associated wood trim with new aluminum-clad wood windows

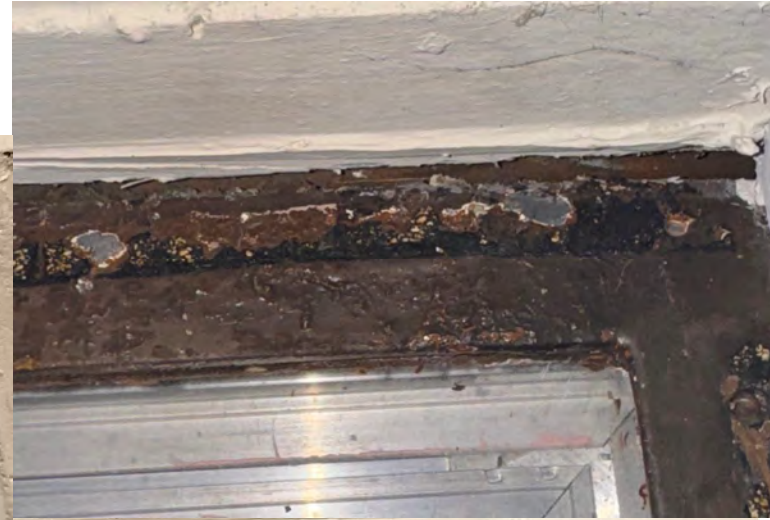
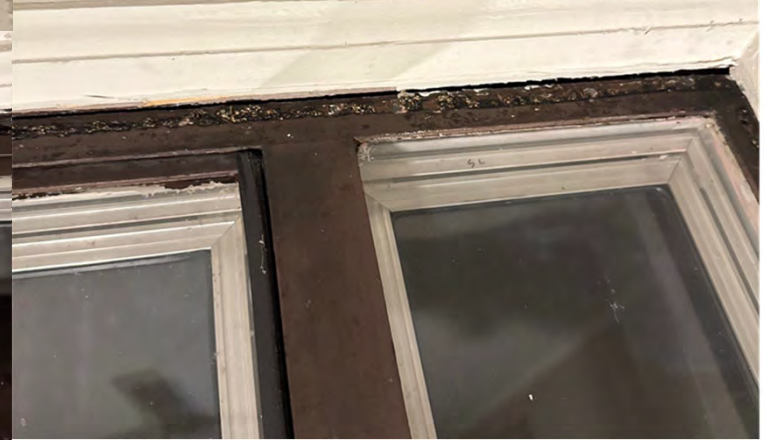
Window 10 (continued)

- Substantial gap above window; not level with home
- Gap in weather stripping
- Very rusted frame

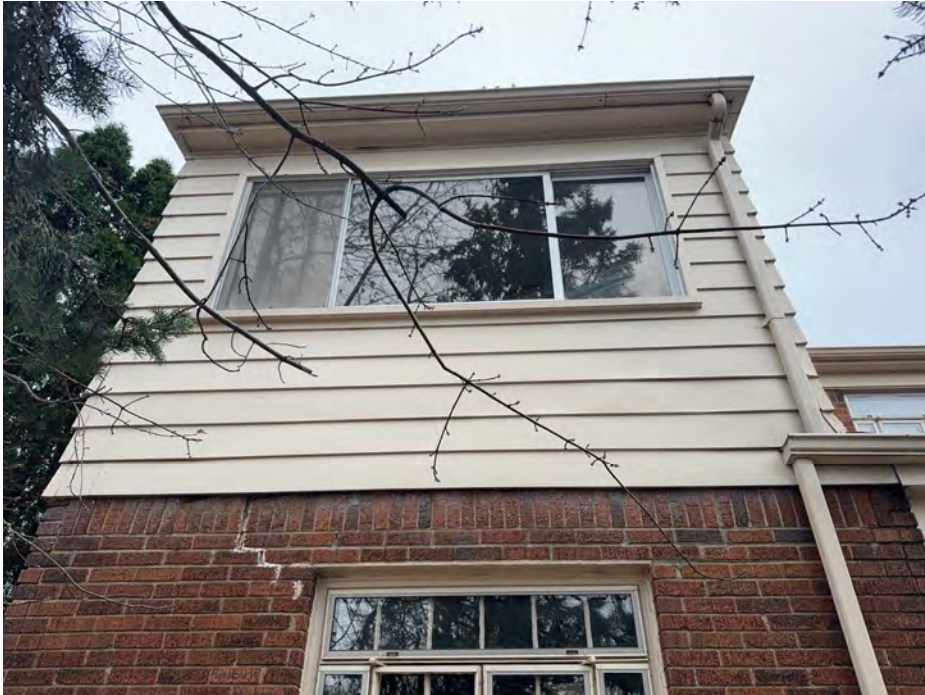
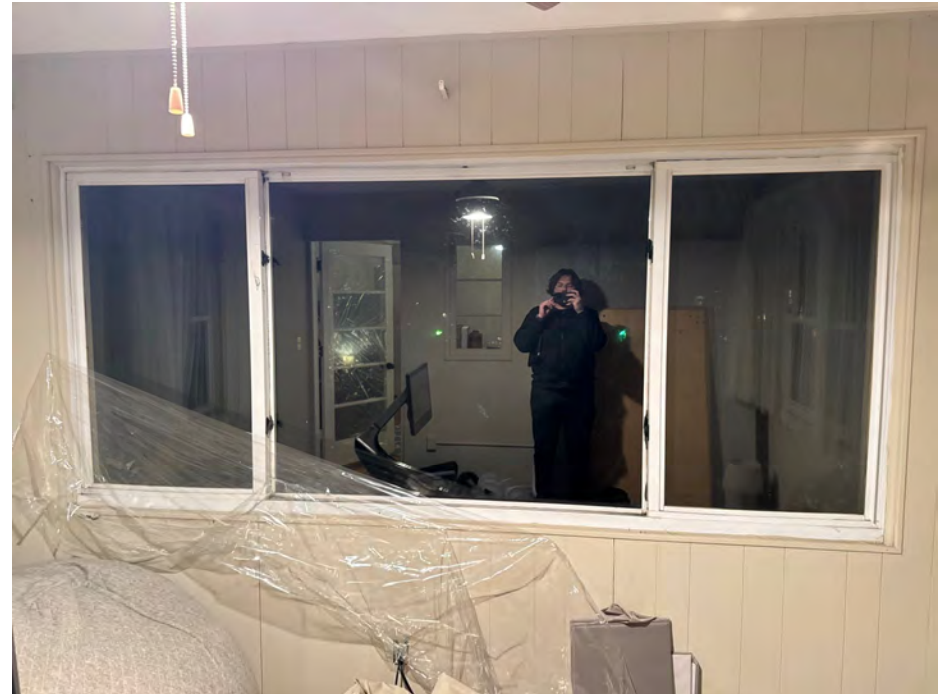
Window 20

- vinyl

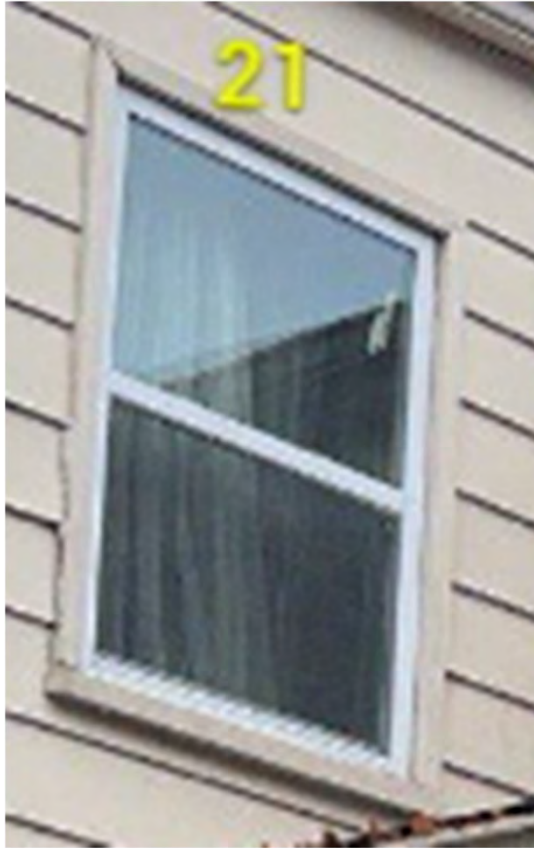
Window 21

- Vinyl; historically incorrect

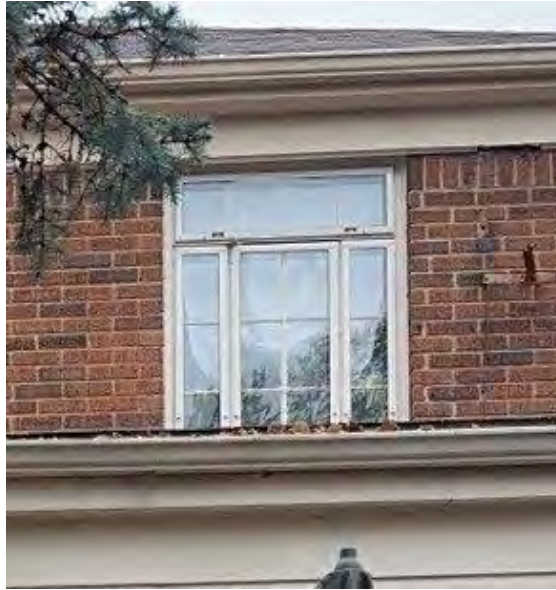
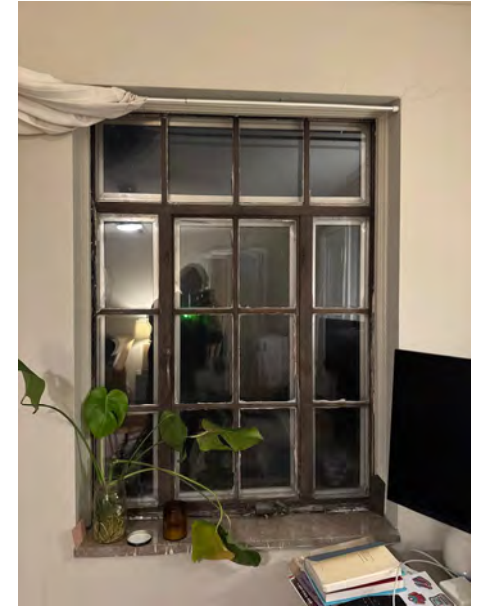
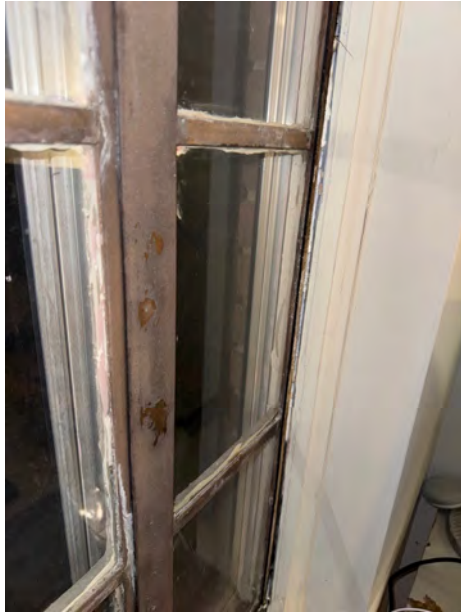
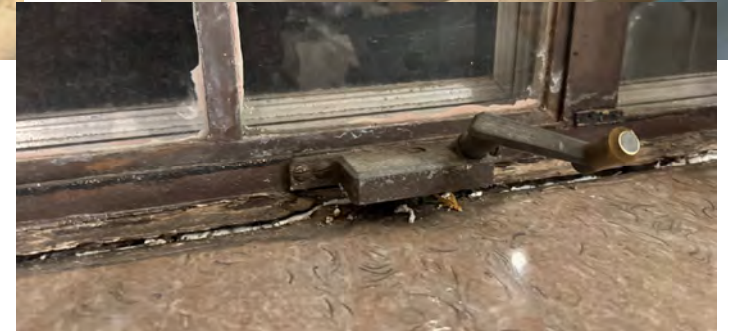
Window 22

22- evidence of water damage, substantial rust is present, broken glass

- evidence of water damage,
- substantial rust is present
- broken glass

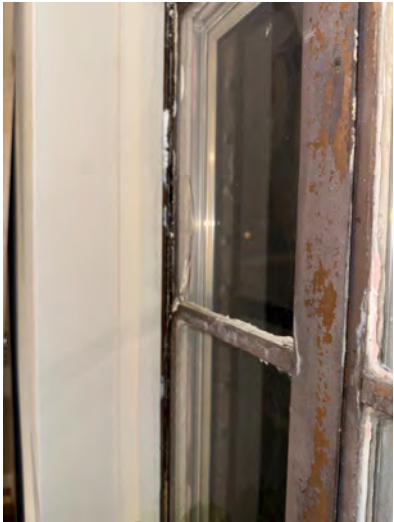
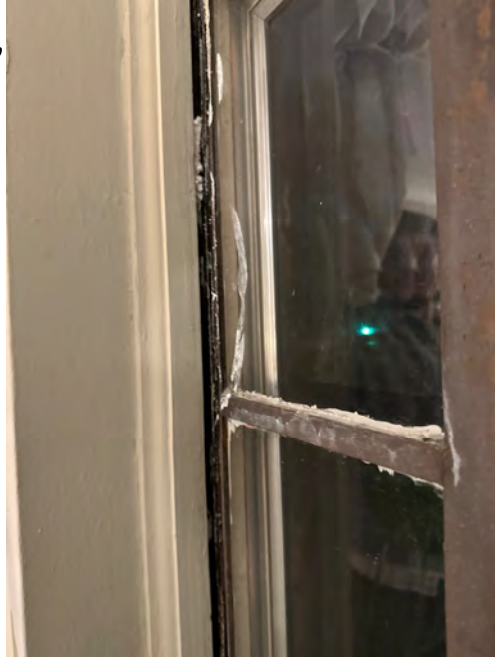
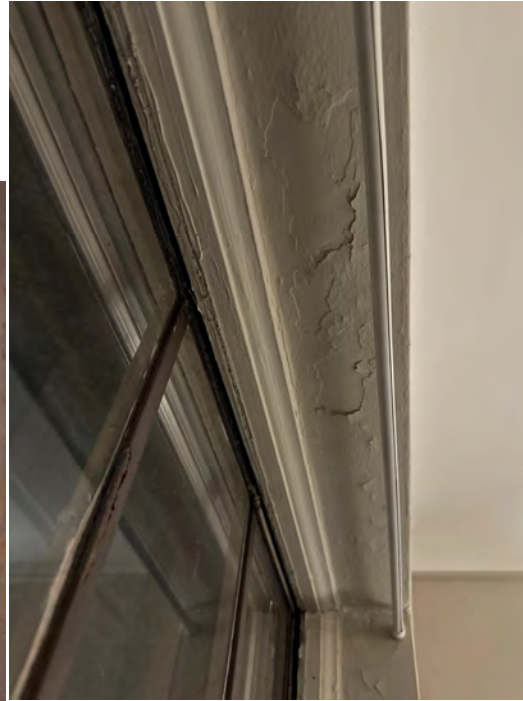
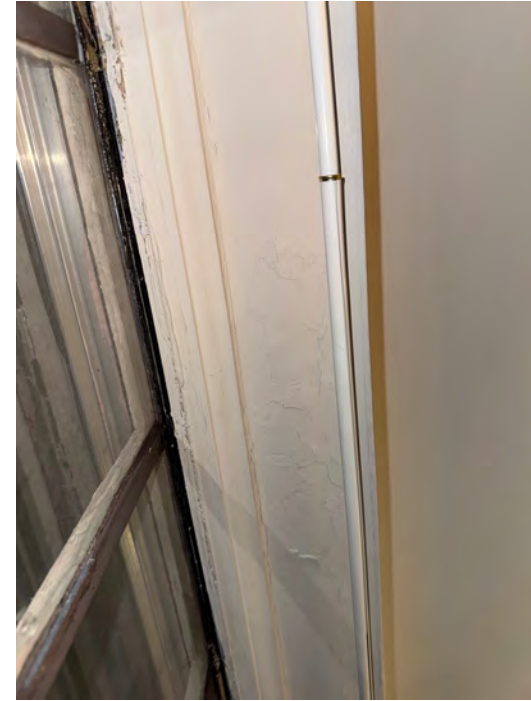
Window 22 (continued)

- Evidence of water damage present,
- Broken glass
- Substantial rust, compromising integrity of the window

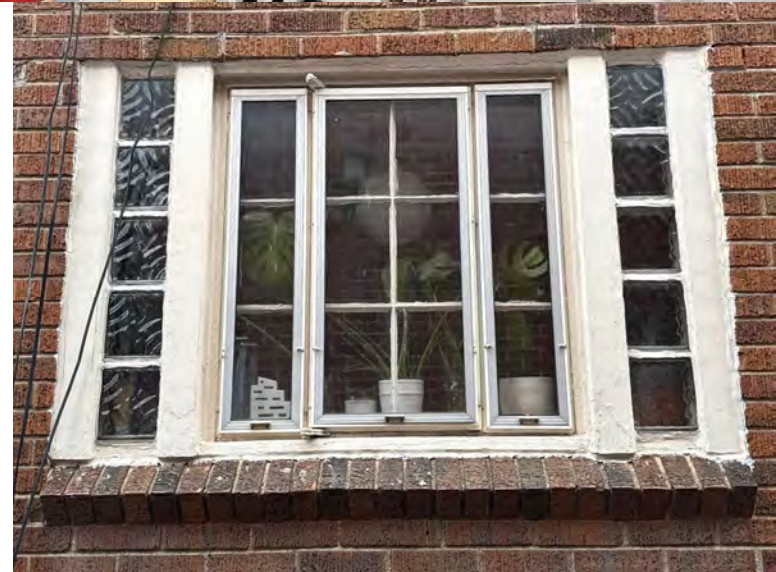
Window 11

11- cant lock, doesn't seal. Draftiest window on first floor. Glass blocks are not original to historical look of the home. Glass blocks were used as an incorrect repair.

- Glass block are not original to home, therefore not historically accurate. Requires replacement of entire opening.

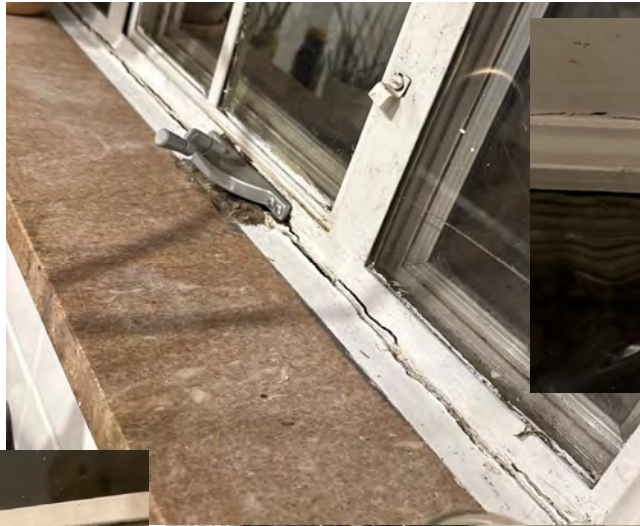
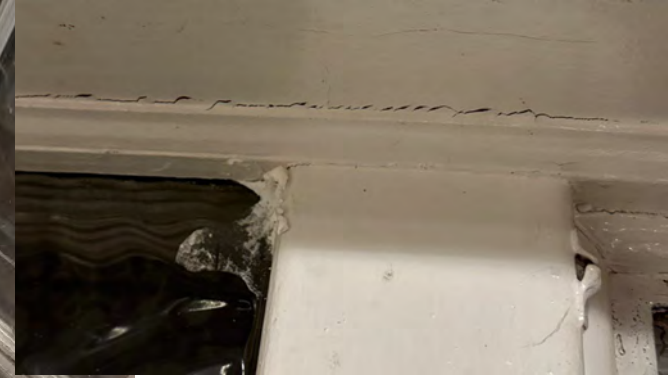
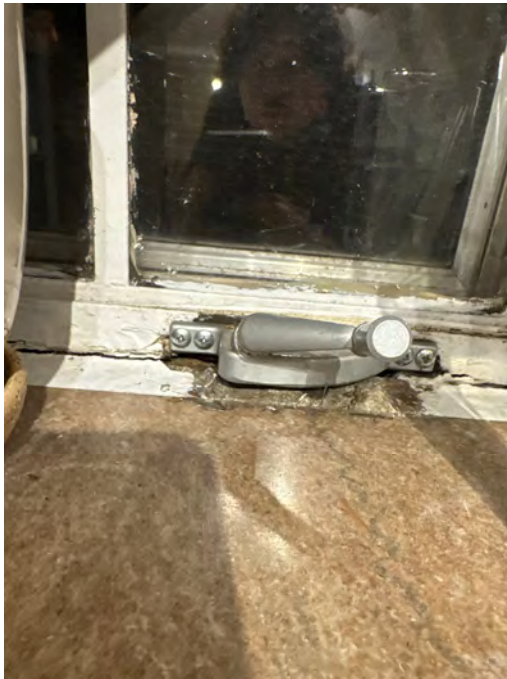
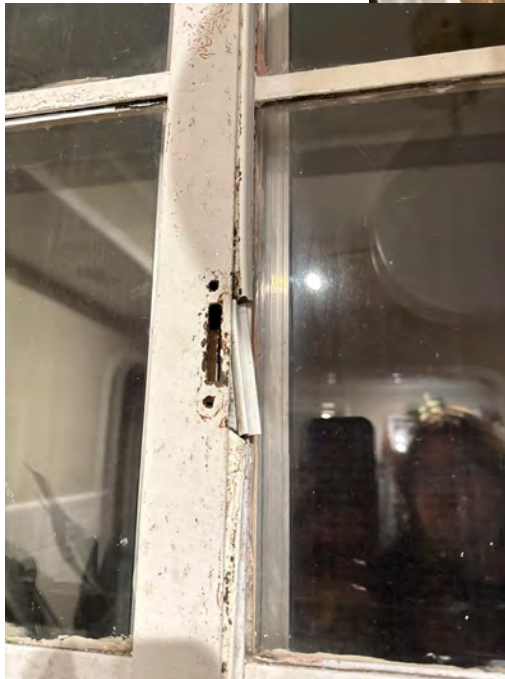
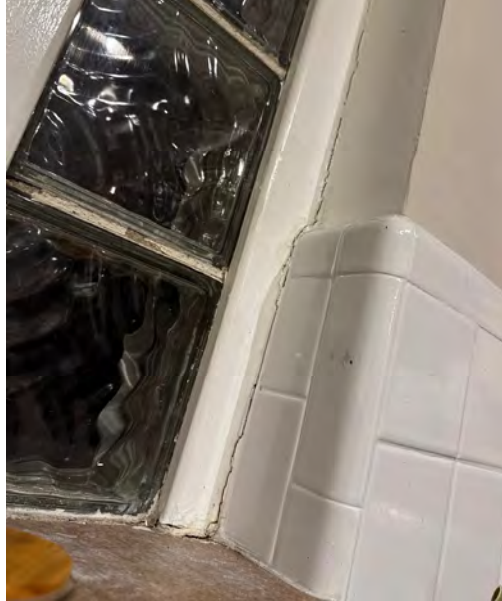
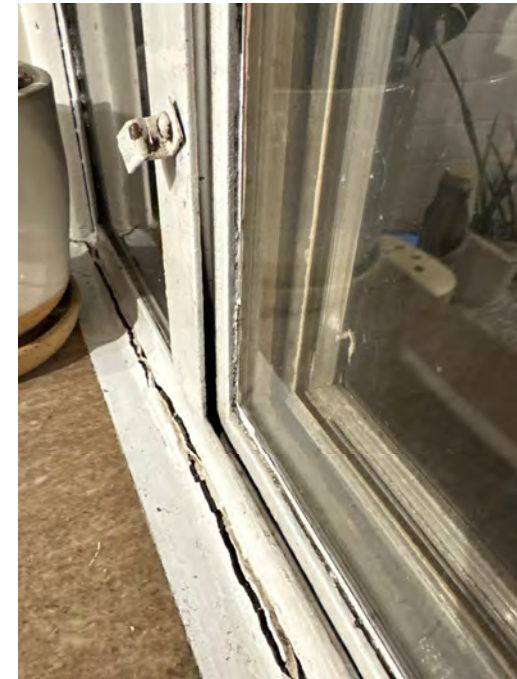
Window 11 (continued)

- Hardware was repaired but can not lock.
- Substantial gaps. Draftiest window on the floor

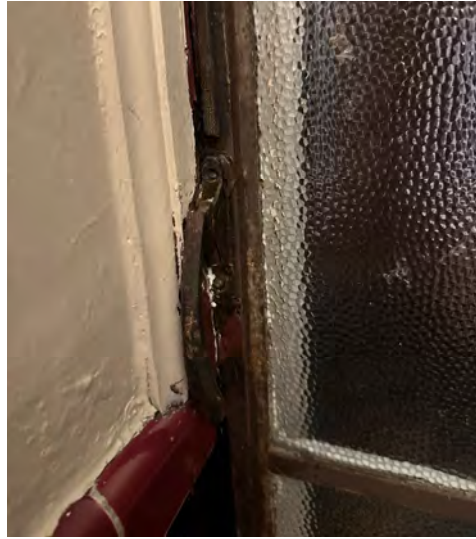
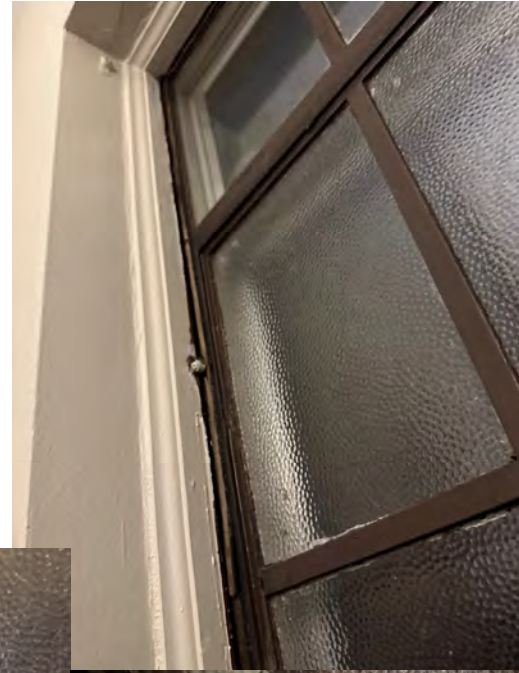
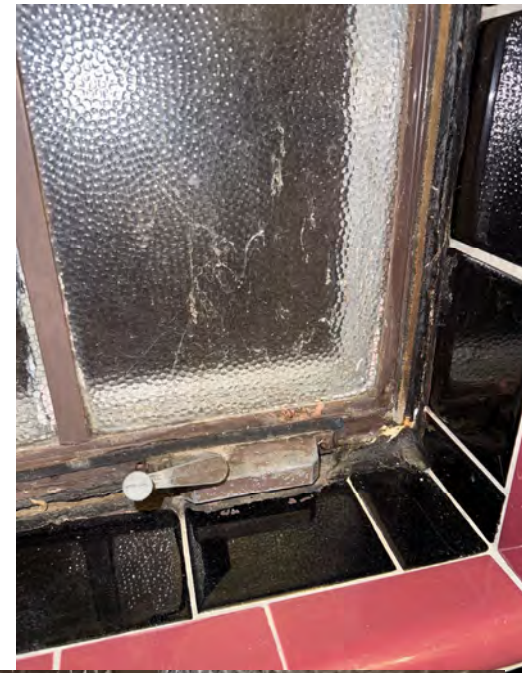
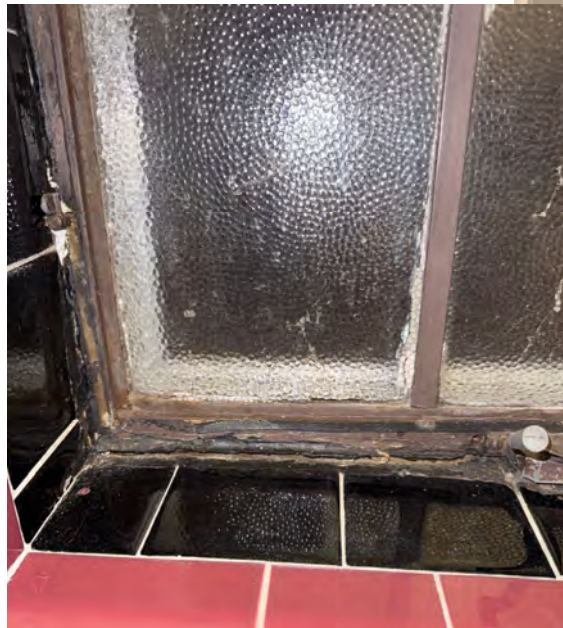
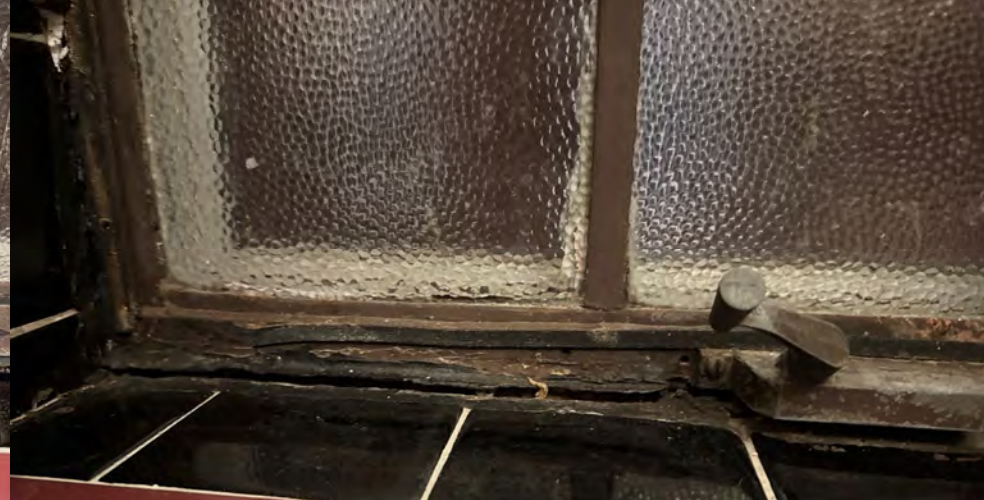
Window 12 (continued)

- Sealed shut, has never been able to be opened
- Substantial gaps, very drafty.
- Severe structural rust

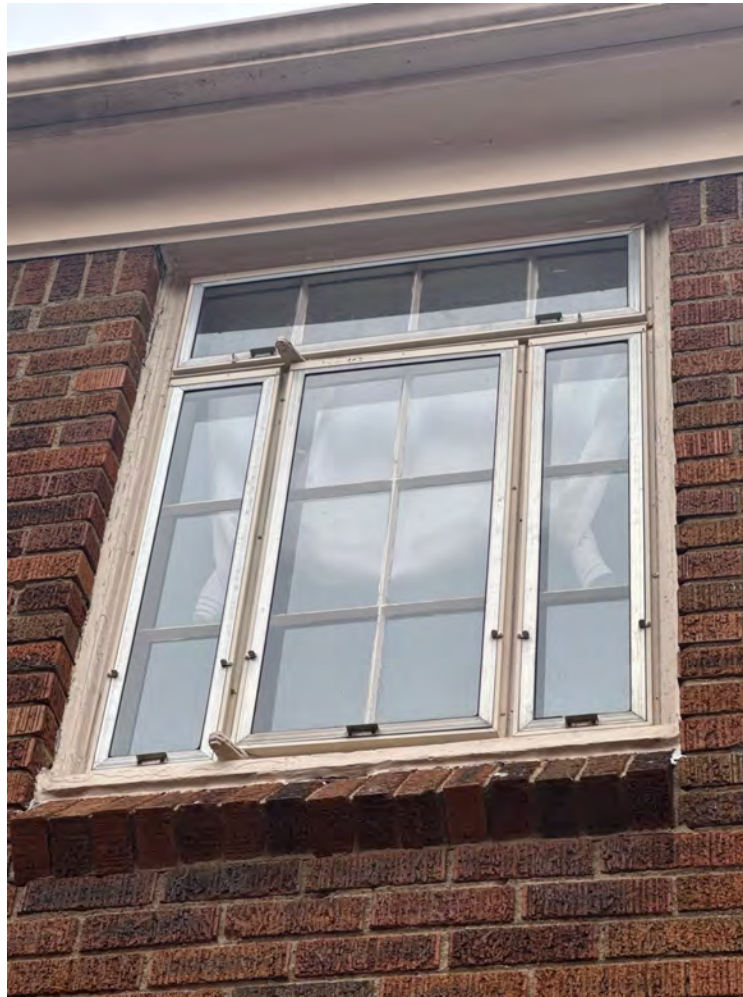
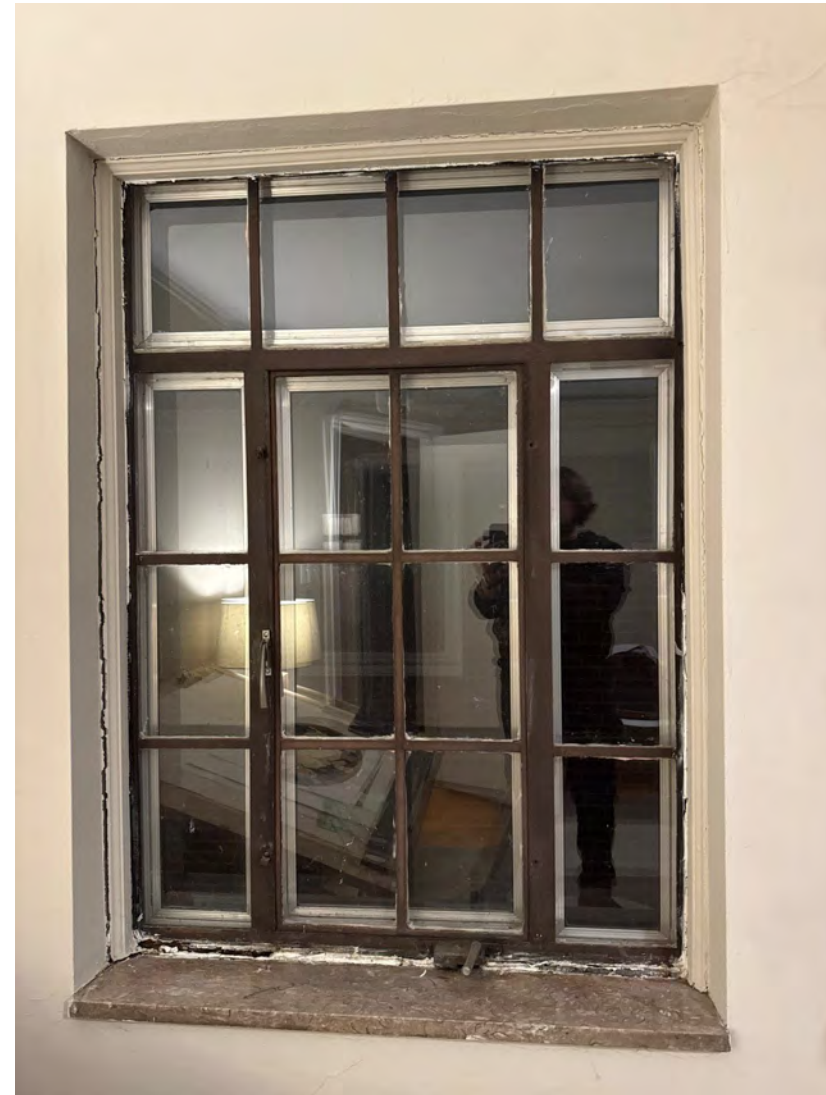
Window 23

- Substantial gaps in window frame. Not flush with home. Very drafty.

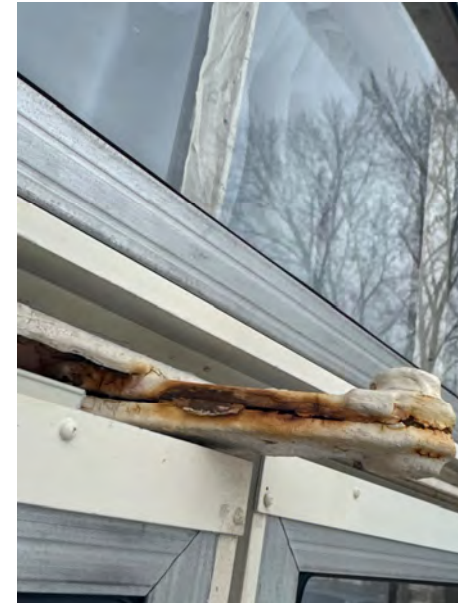
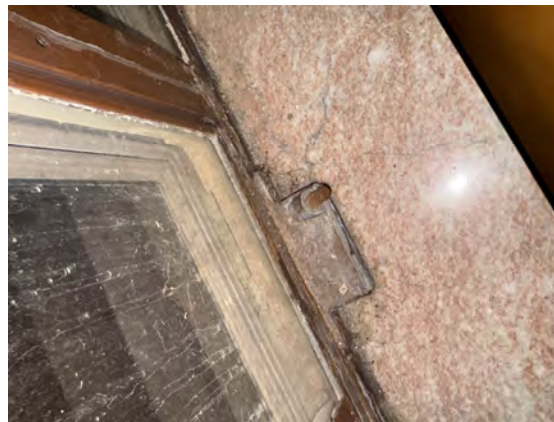
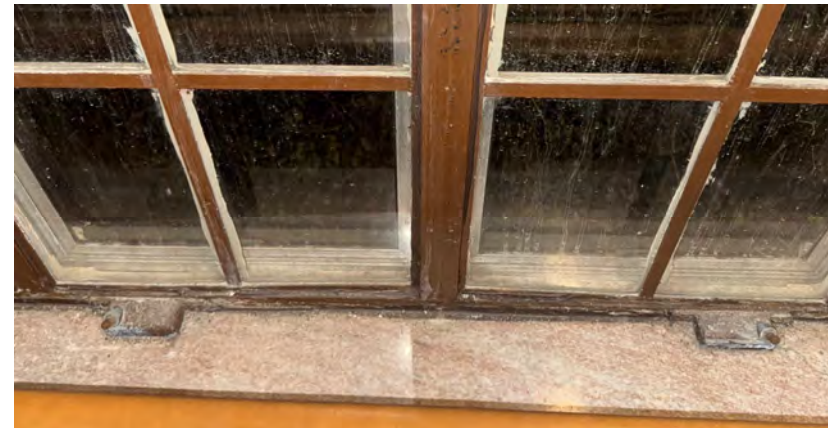
Window 1: (Continued)

1. Rusted Gear in Casement Window:

•**Functional Obsolescence:** A rusted gear in a casement window has lost its mechanical integrity, preventing smooth or reliable operation. Rust compromises the precise movement required for opening and closing, and repairs (e.g., lubrication or partial component replacement) often fail to restore full functionality due to corrosion spread across interconnected parts.

•**Safety Concerns:** A malfunctioning gear could lead to sudden failure, making the window unsafe for operation. As per guidelines, operability is essential to preserve the historic character of windows

Full Replacement Justification:

- Holistic Solution:** Full replacement with wood windows featuring aluminum cladding ensures compliance with historic guidelines while addressing durability, functionality, and weatherproofing.
- Long-Term Preservation:** The new windows will match the original design while incorporating modern materials that prevent recurrence of these issues. Proper water grading, operability, and protection against further deterioration are integral to preserving the building's structural and historical integrity

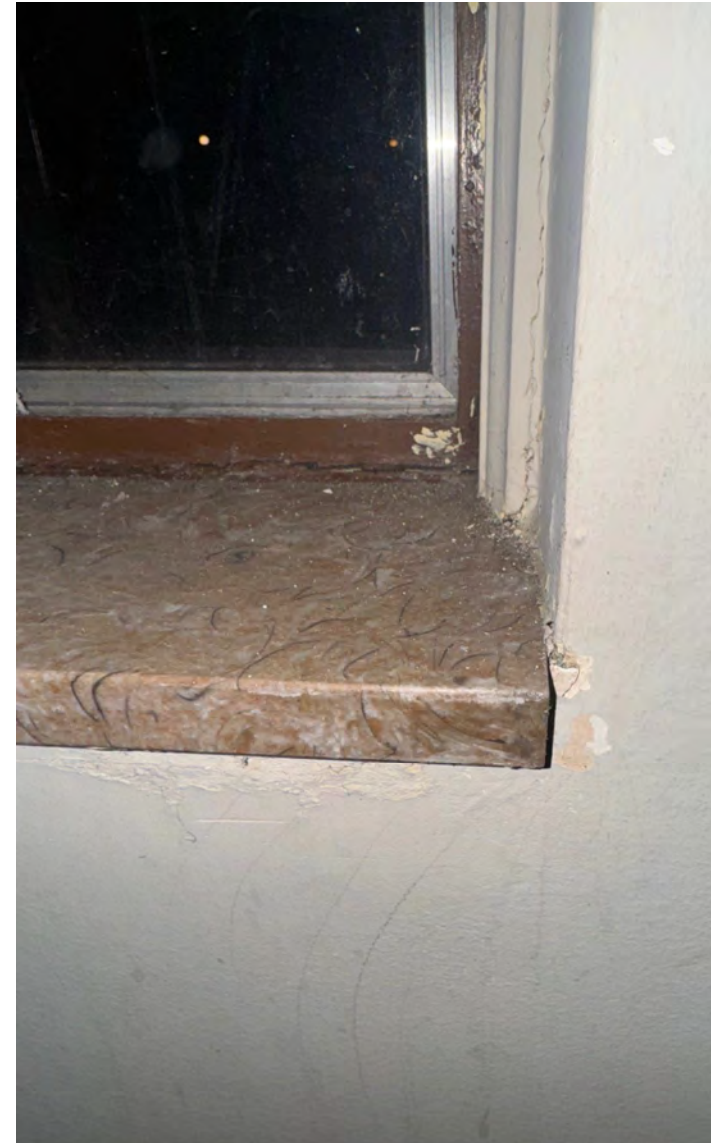
Window 3:

- Evidence of exterior wood frame rot
- Evidence of mold between storm window and original window

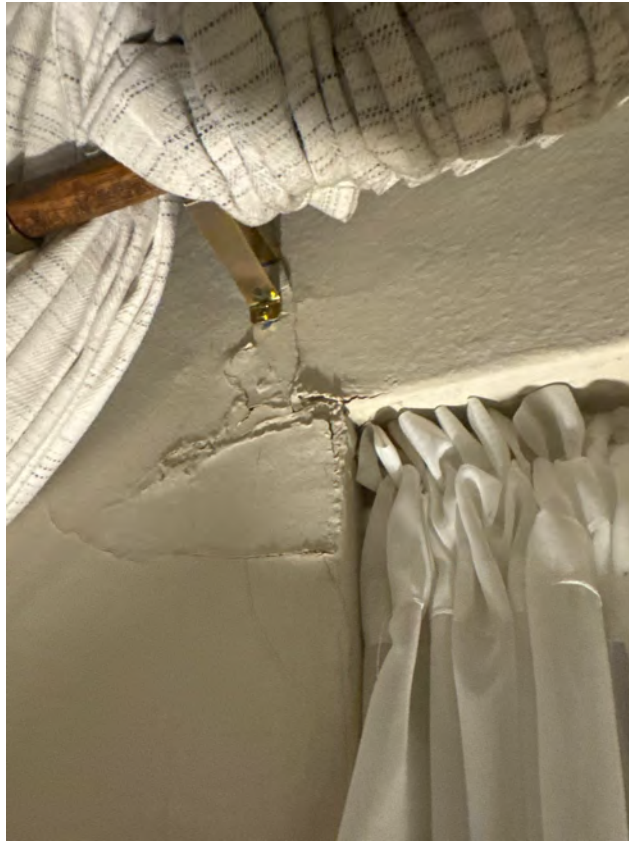
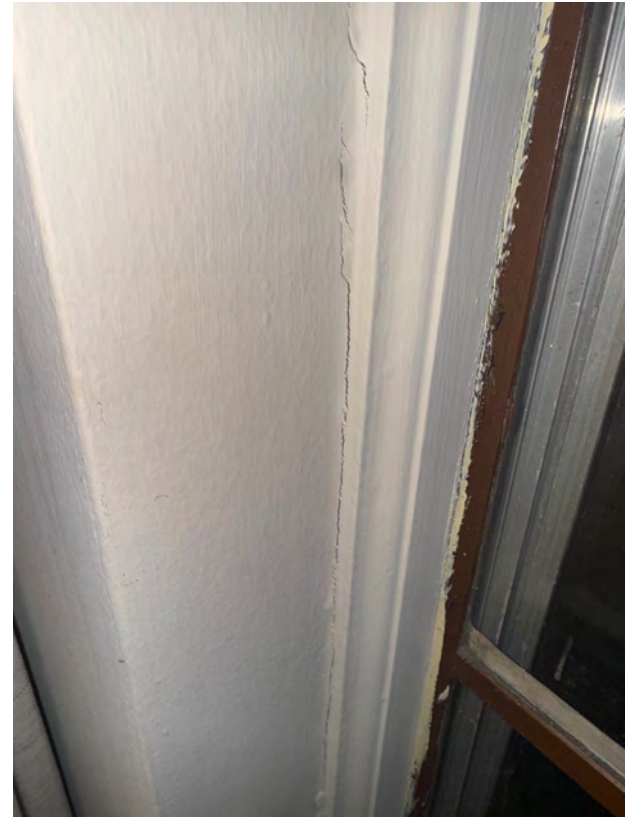
Window 3:

- **Deteriorated Wood on exterior:**
- **Loss of Structural Integrity:** Wood that has deteriorated due to moisture, mold, or rot no longer provides adequate support for the window assembly. This compromises the entire frame's stability and may pose a safety hazard.
- **Guideline Requirements:** Replacement is necessary when repair is not technically feasible or when deterioration affects the window's ability to retain its shape, support glass, and maintain weatherproofing. Aluminum-clad wrapping further ensures long-term durability by protecting against future moisture and weather-related damage

Why Mold Warrants Window Replacement Instead of Repair:

- **Compromised Integrity:** Mold indicates prolonged moisture exposure, often leading to weakened or deteriorated materials that cannot be effectively repaired, necessitating full replacement.
- **Health Hazards:** Mold poses significant health risks (e.g., respiratory issues) and can persist in porous materials, making replacement essential to fully eliminate the issue and prevent recurrence.
- **Underlying Moisture Issues:** Mold is often caused by structural defects like improper grading or seals, which require replacement to correct and ensure future moisture resistance.
- **Code and Safety Compliance:** Replacement ensures compliance with modern building codes and health standards, providing a safe, mold-free environment while preventing further damage.

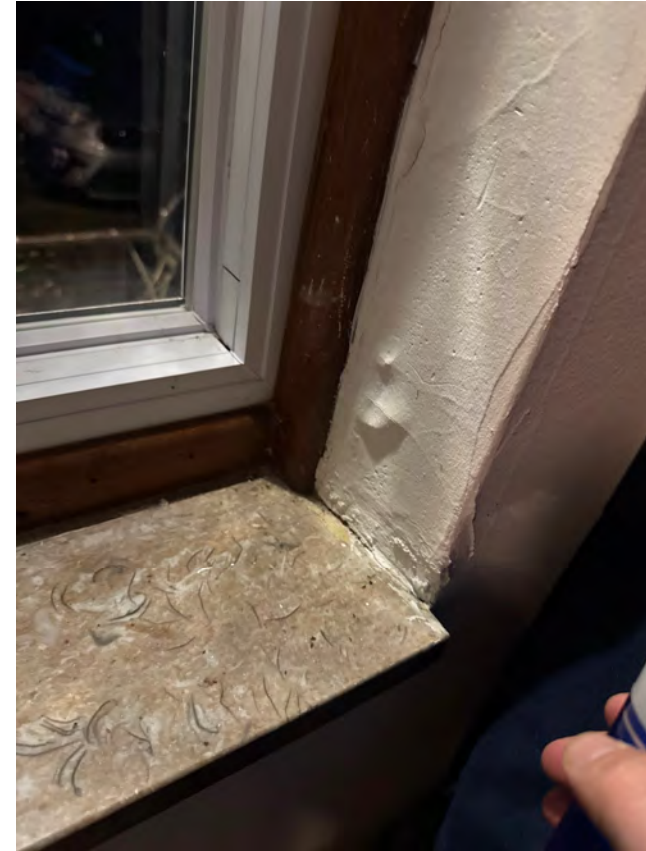
Window 14:

- Vinyl
- Marble sill will be preserved to maintain historical correctness

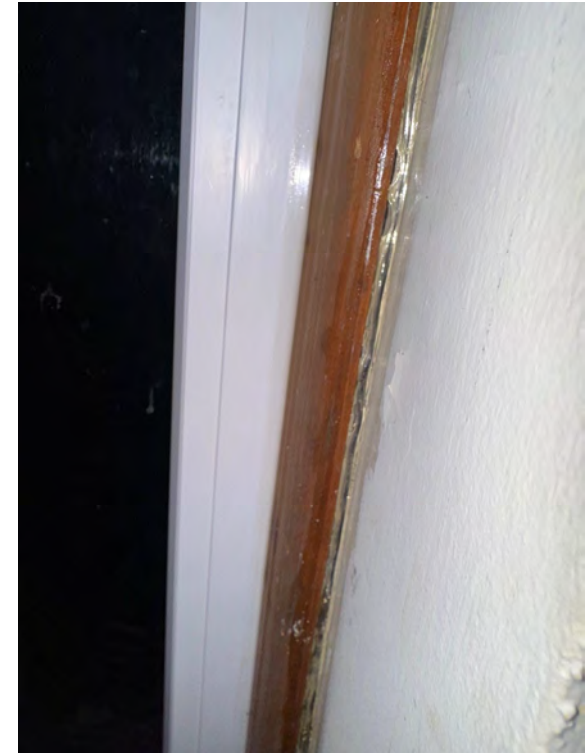
Window 16:

16- Master bedroom: substantial gaps in weather proofing, only one casement window opens due to hardware rusted shut, fails to meet egress/code

- substantial gaps in weather proofing,
- only one casement window opens due to hardware rusted shut,
- fails to meet egress/code

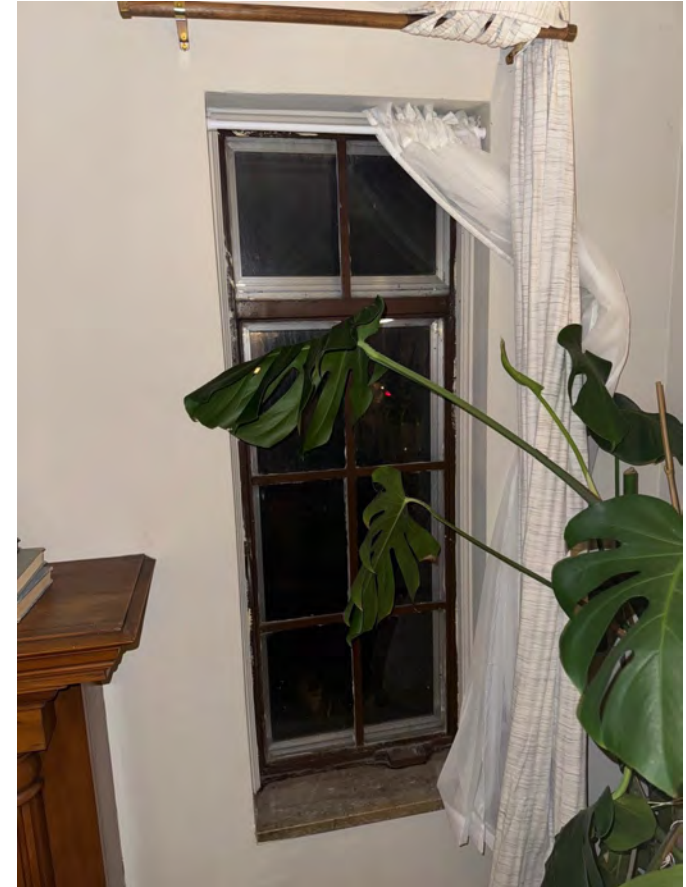
Window 4 (continued)

- Sealed shut, does not meet egress/code

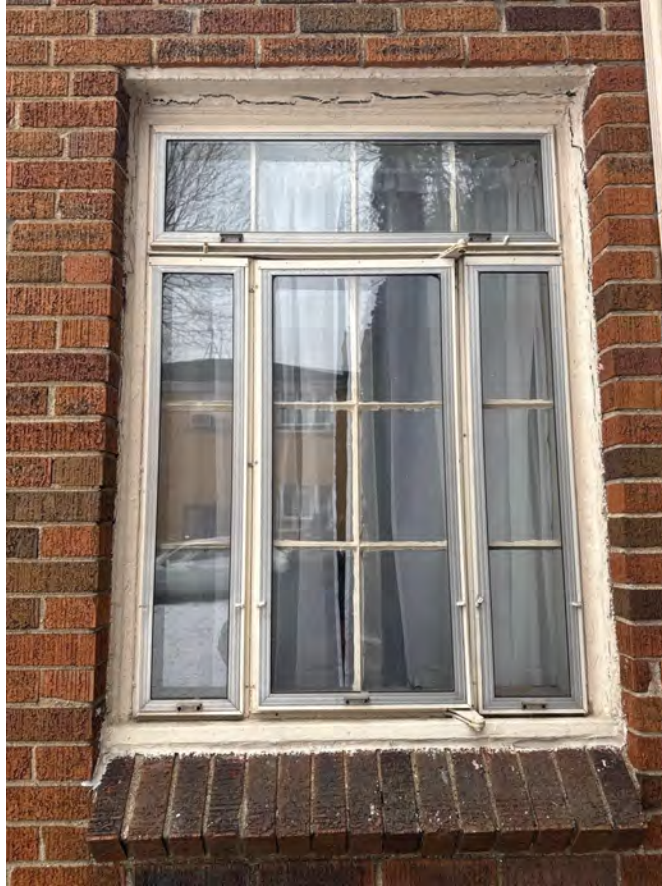
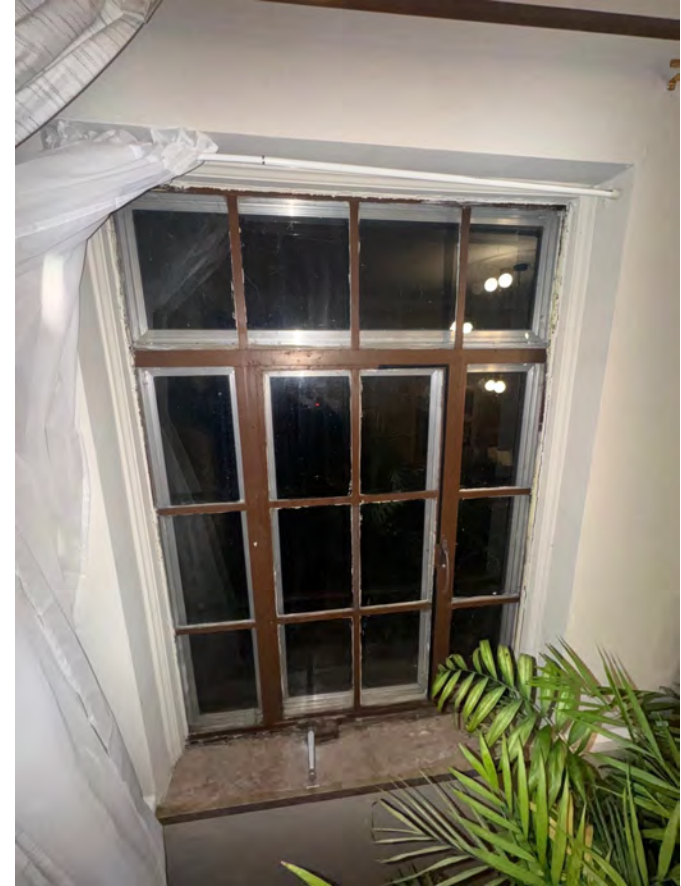
Window 7

- Handle no longer works, gears
rusted shut

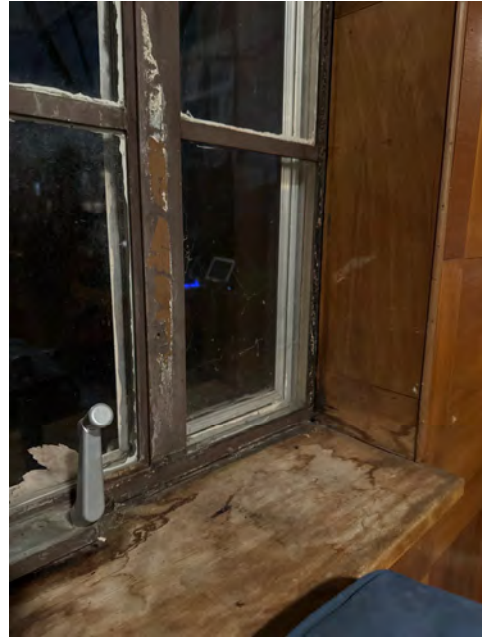
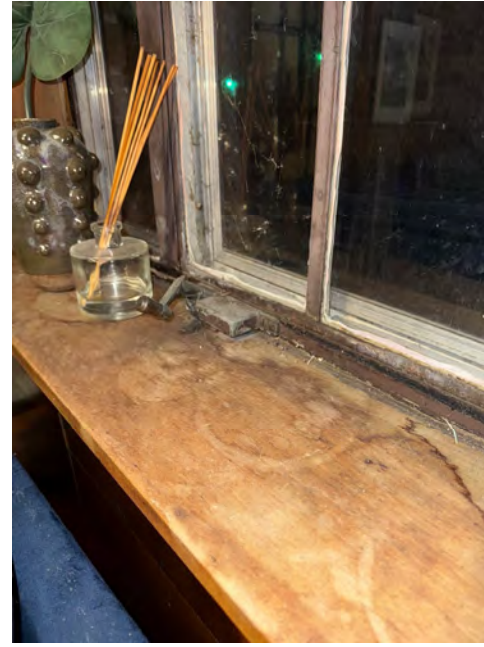
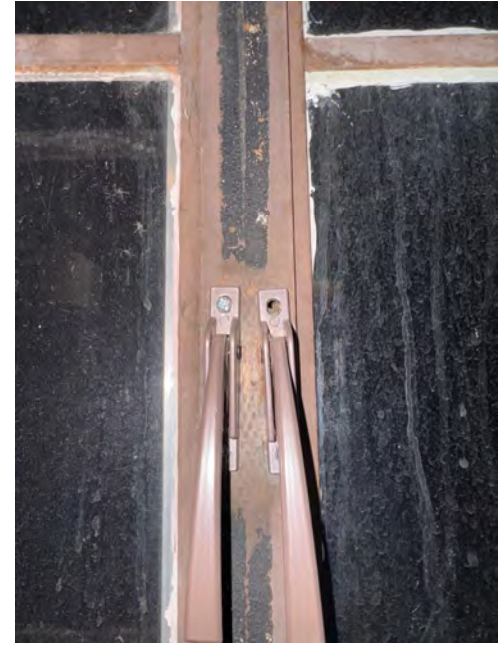
Window 8
(Continued)

8- inward angled deteriorated sill, damaged interior sill, damaged hardware, evidence of mold, exterior hinges rusted out.

- Exterior sill not grading water properly, caused water to damage interior sill
- Hardware receiver rusted out and stripped, repair of handle no longer possible
- Evidence of mold
- Exterior hinges all rusted out, only one casement opens. Does not meet egress/code. Extremely drafty.

- **Water Pooling and Structural Risk:** The bottom stud is incorrectly angled inward, allowing water to collect rather than drain away from the window. This design flaw exacerbates water retention and encourages wood rot, mold growth, and potential damage to surrounding structures, including the interior walls.
- **Necessity of Replacement:** Adjusting the stud's angle retroactively is not a feasible repair solution due to its integration into the structural frame. Full replacement of the window frame ensures proper water grading and long-term protection against water infiltration

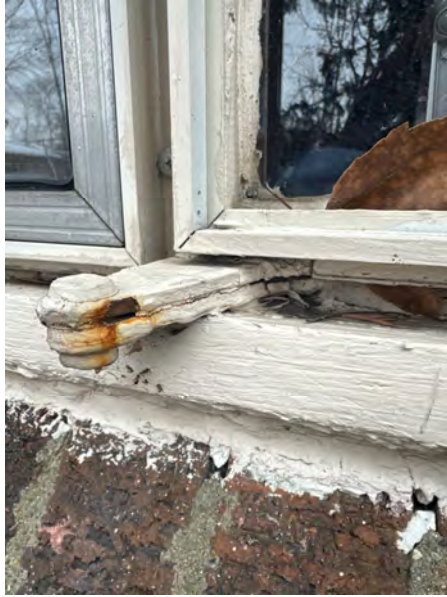
Window 9

9- evidence of mold, windows not level/flush with rest of home, necessary for proper siding replacement

- Deterioration of bottom exterior sill
- Evidence of mold
- Window not level with home, home has shifted, only remedy is replacement
- Window not flush, needs to be flush for proper siding replacement

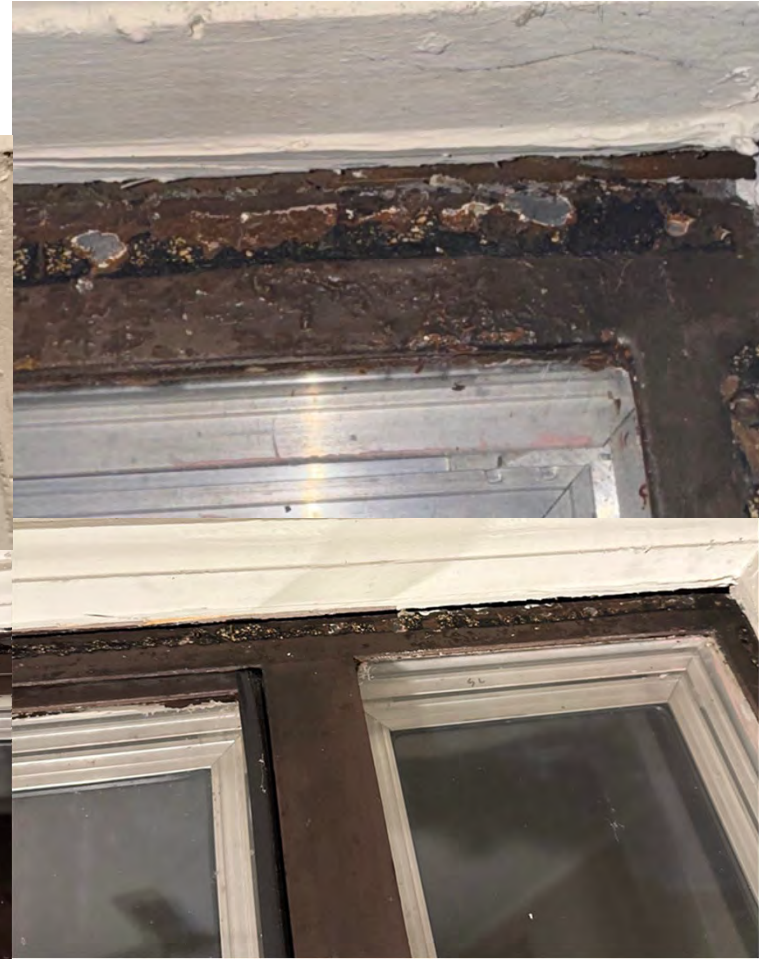
Window 20

- evidence of water damage,
- substantial rust is present
- broken glass

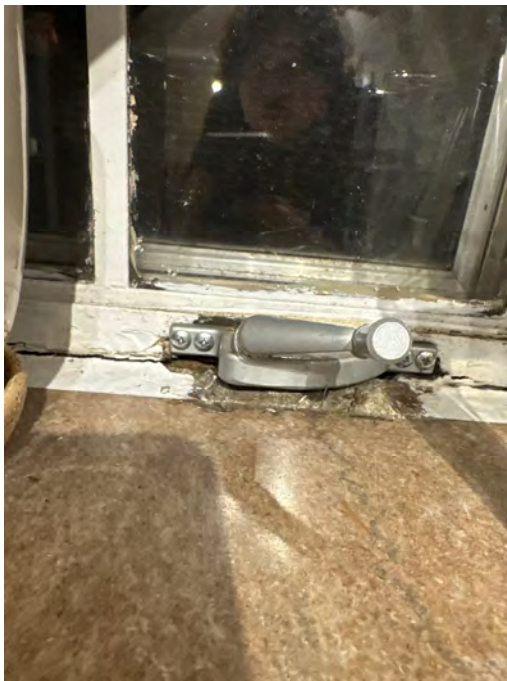
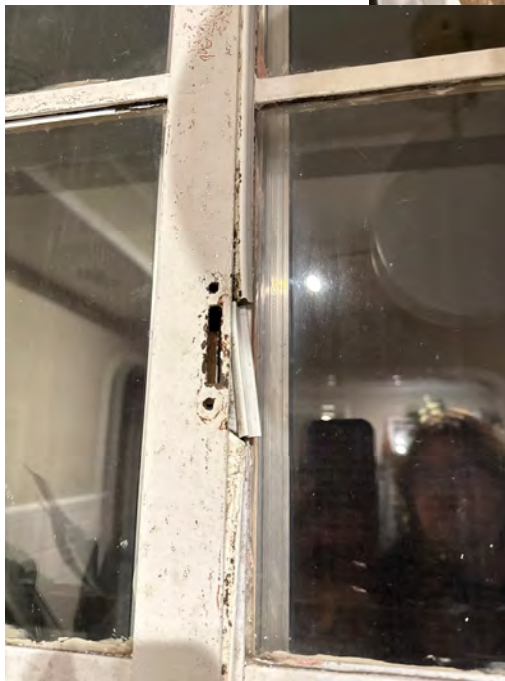
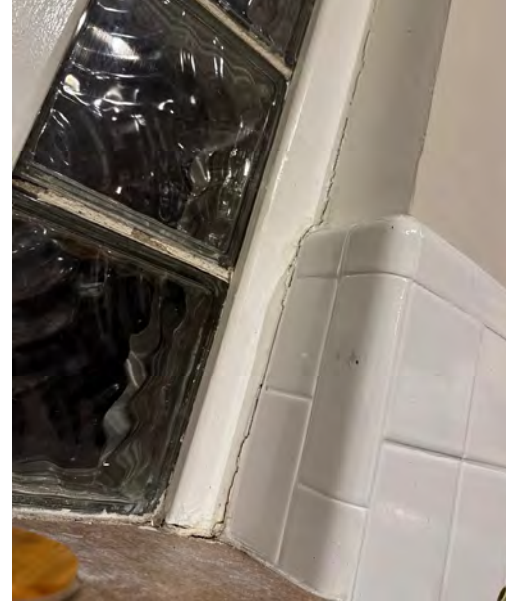
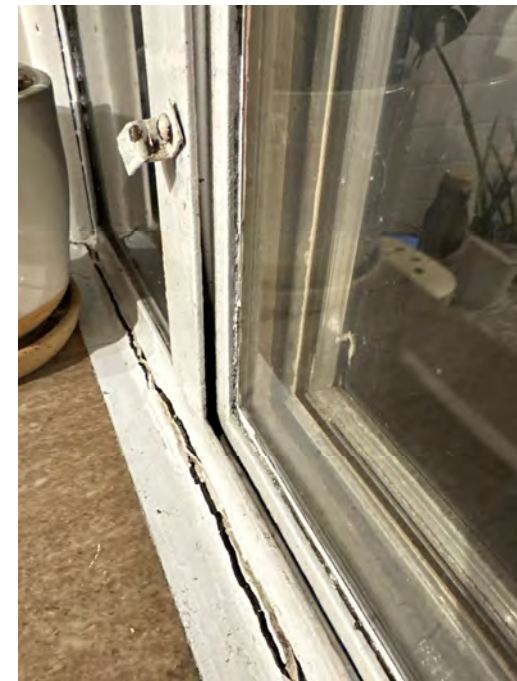
Window 11 (continued)

11- cant lock, doesn't seal. Draftiest window on first floor. Glass blocks are not original to historical look of the home. Glass blocks were used as an incorrect repair.

- Glass block are not original to home, therefore not historically accurate. Requires replacement of entire opening.

- Hardware was repaired but can not lock.
- Substantial gaps. Draftiest window on the floor

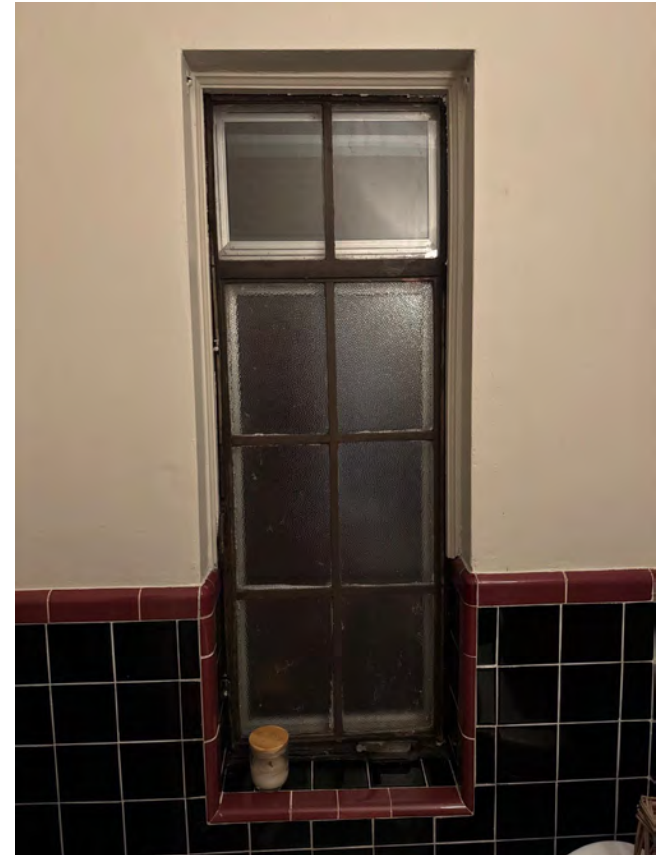
Window 12 (continued)

- Sealed shut, has never been able to be opened
- Substantial gaps, very drafty.
- Severe structural rust
