HISTORIC DISTRICT COMMISSION NOTICE OF DENIAL

Application Number: HDC2025-00014

NAME: Alexander Belilovsky		COMPANY NAME: Alexandria Home Solutions	
ADDRESS: 24293 Telegraph Road	CITY: Southfield	STATE: MI	ZIP: 48033
PROJECT ADDRESS: 4071 Leslie			
HISTORIC DISTRICT: Russell Woods-Sullivan

Replace historic steel windows and associated wood trim with new aluminum-clad wood windows

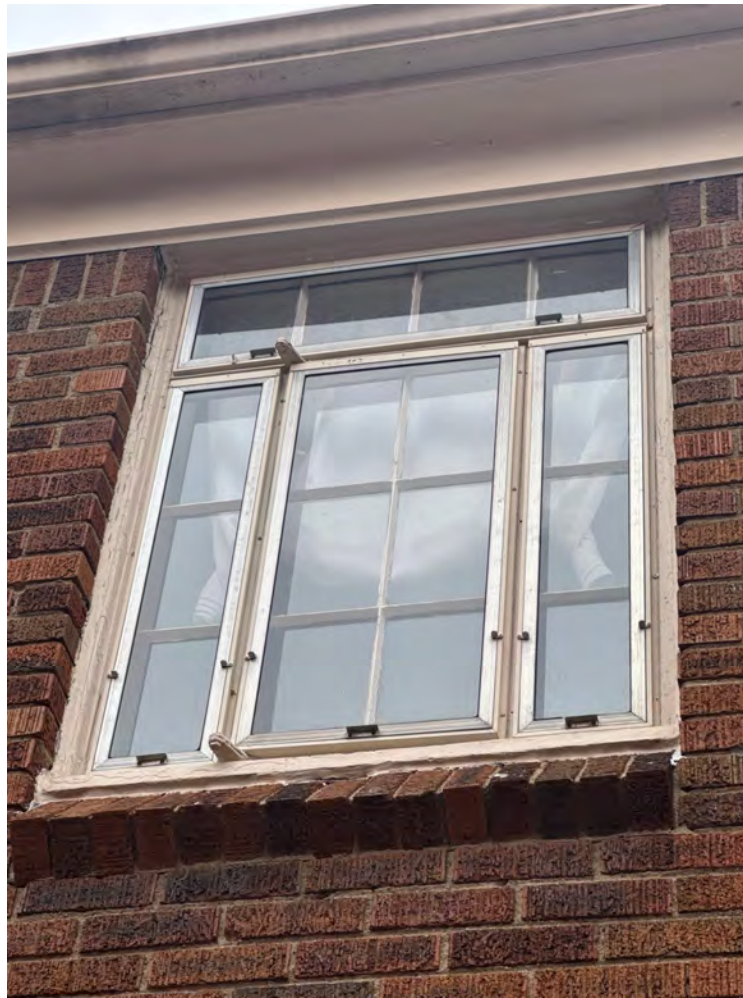
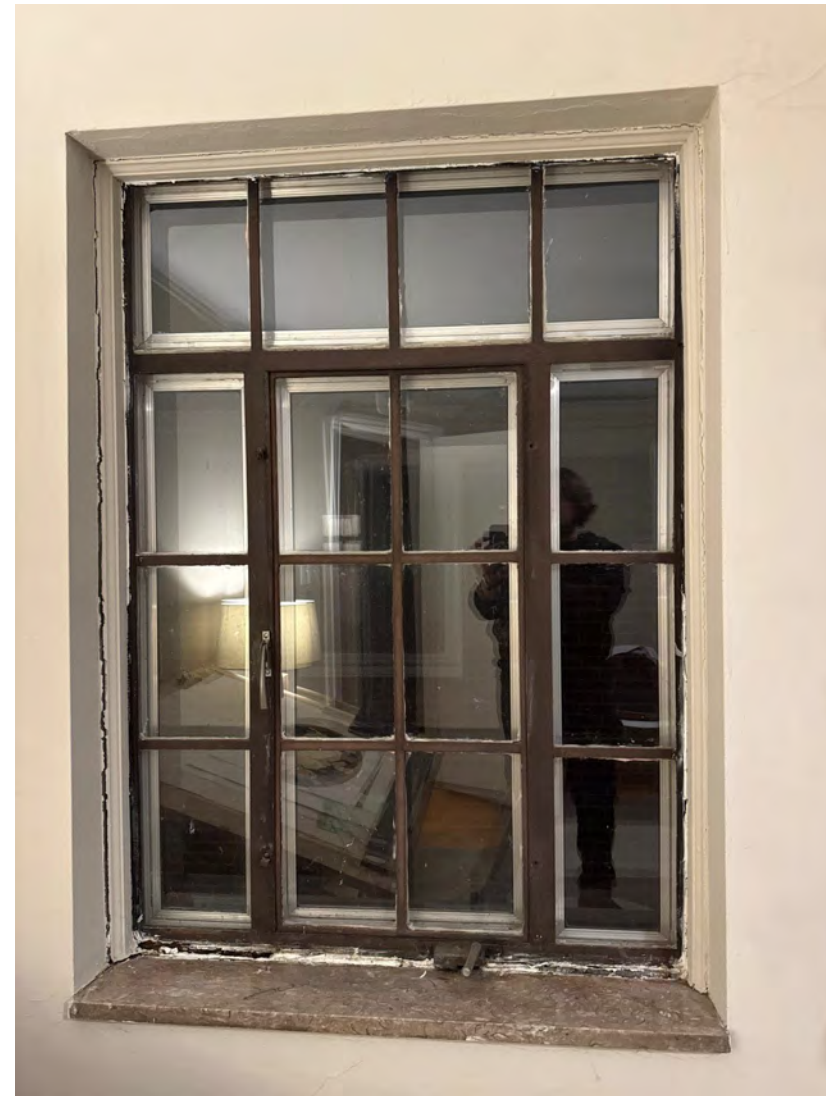
Window 23 (continued)

- Substantial gaps in window frame. Not flush with home. Very drafty.
