**STAFF REPORT: JULY 8, 2020 MEETING**

**APPLICATION NUMBER: 20-6770**

**ADDRESS: 1225 WOODWARD AKA *THE FOWLER BUILDING***

**SCOPE OF WORK: REHAB BUILDING, REPLACE WINDOWS, STOREFRONT SYSTEM**

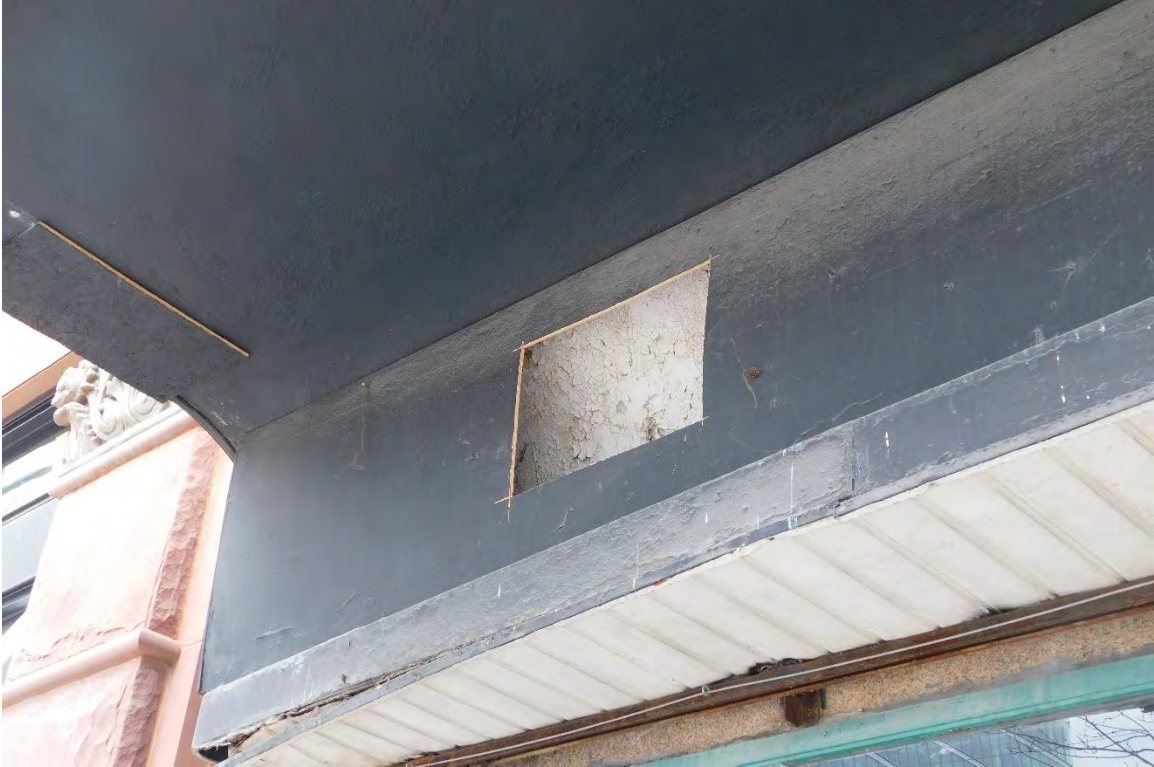
Figure #21: Exterior, Canopy, Looking up. 10/15/19

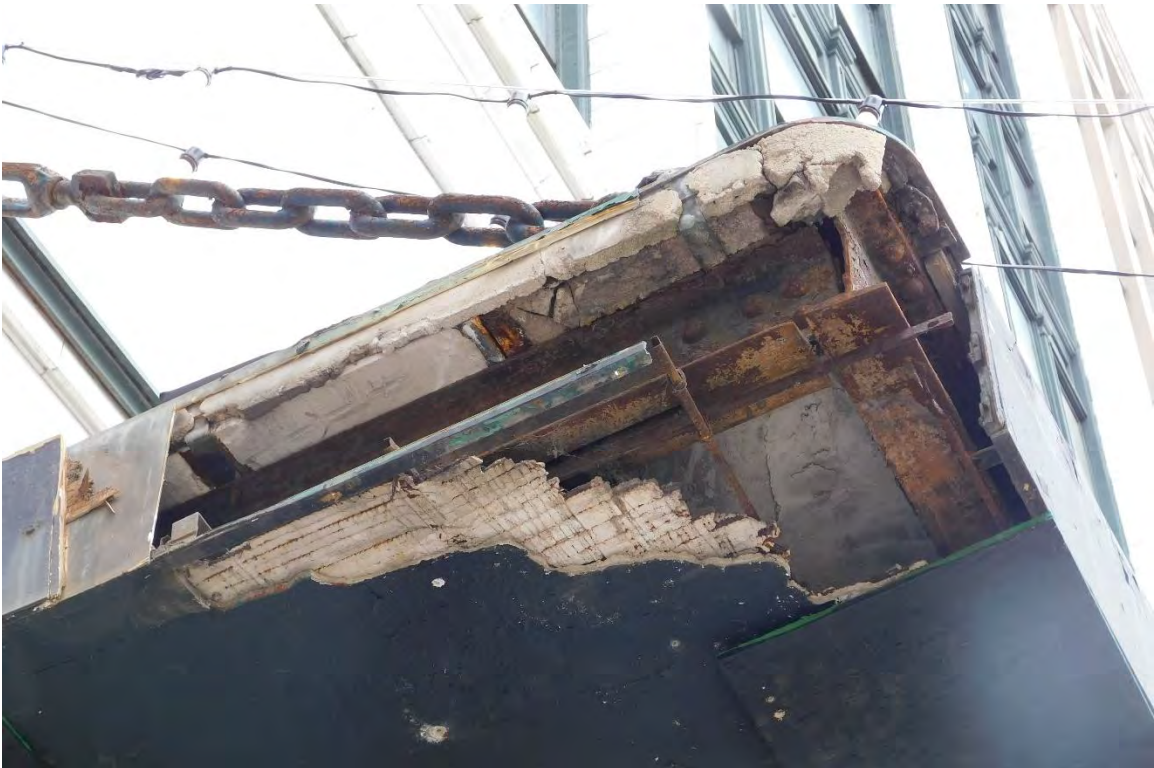
Figure #22: Exterior, Canopy, Looking Up. 10/15/19

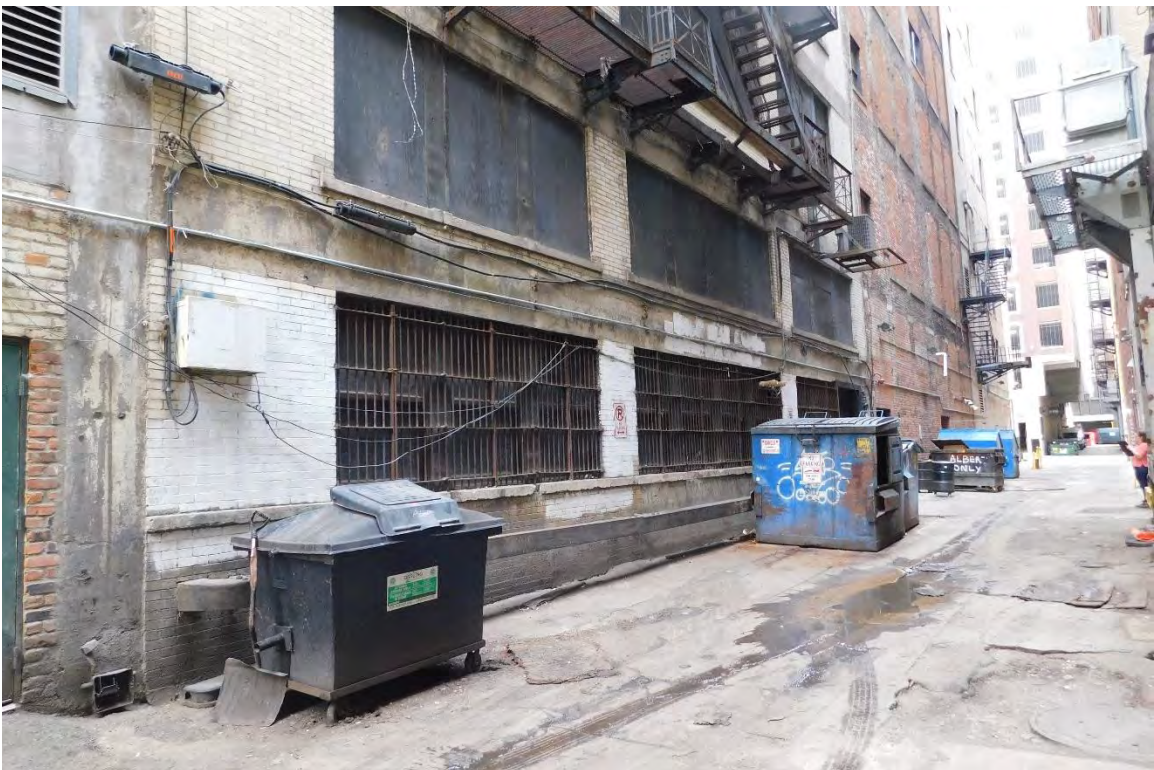
Figure #32: Exterior, Alley and West Façade, Looking Southeast. 10/15/19

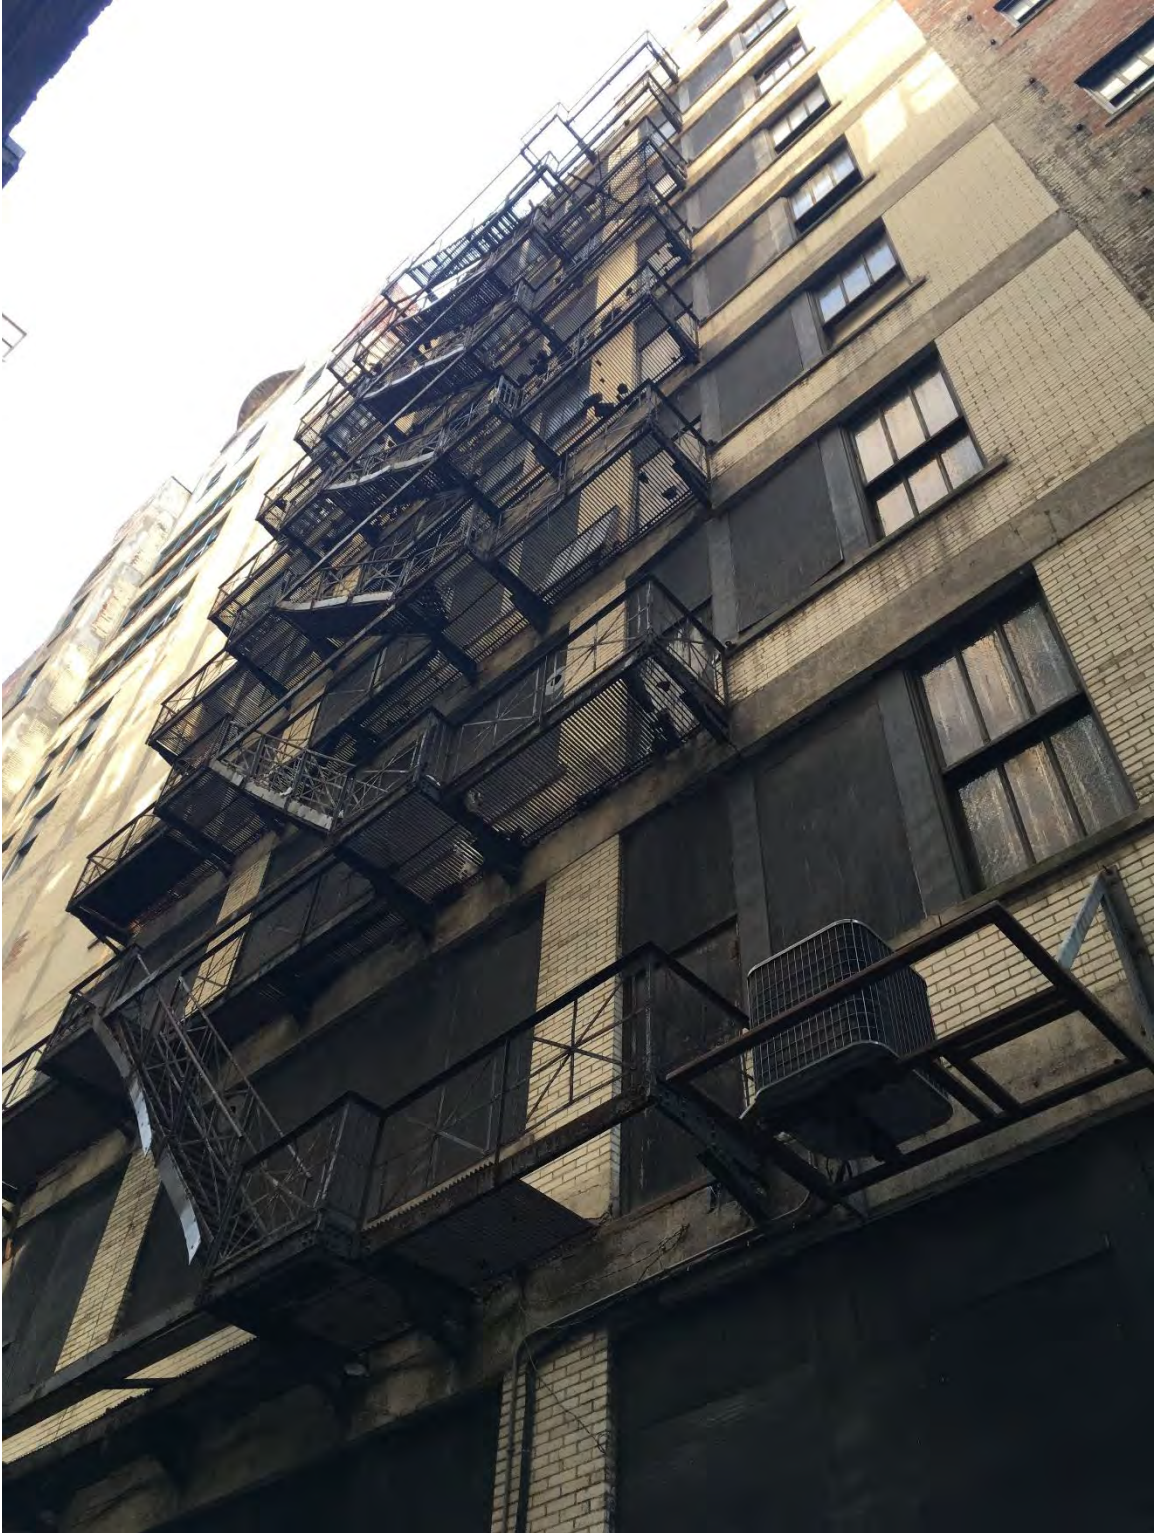
A single steel fire escape runs from the roof to the second level at the alley. The fire escape is black metal and is in poor condition with extensive corrosion, signs of rust, and damaged/missing components. The fire escape is to be removed and replaced with a new unit that will be used as a means of egress from the building. Connections to the building shall be repaired as necessary to ensure structural stability. It will be repainted black.

Figure #33: Exterior, Alley, Looking Up. 5/31/19

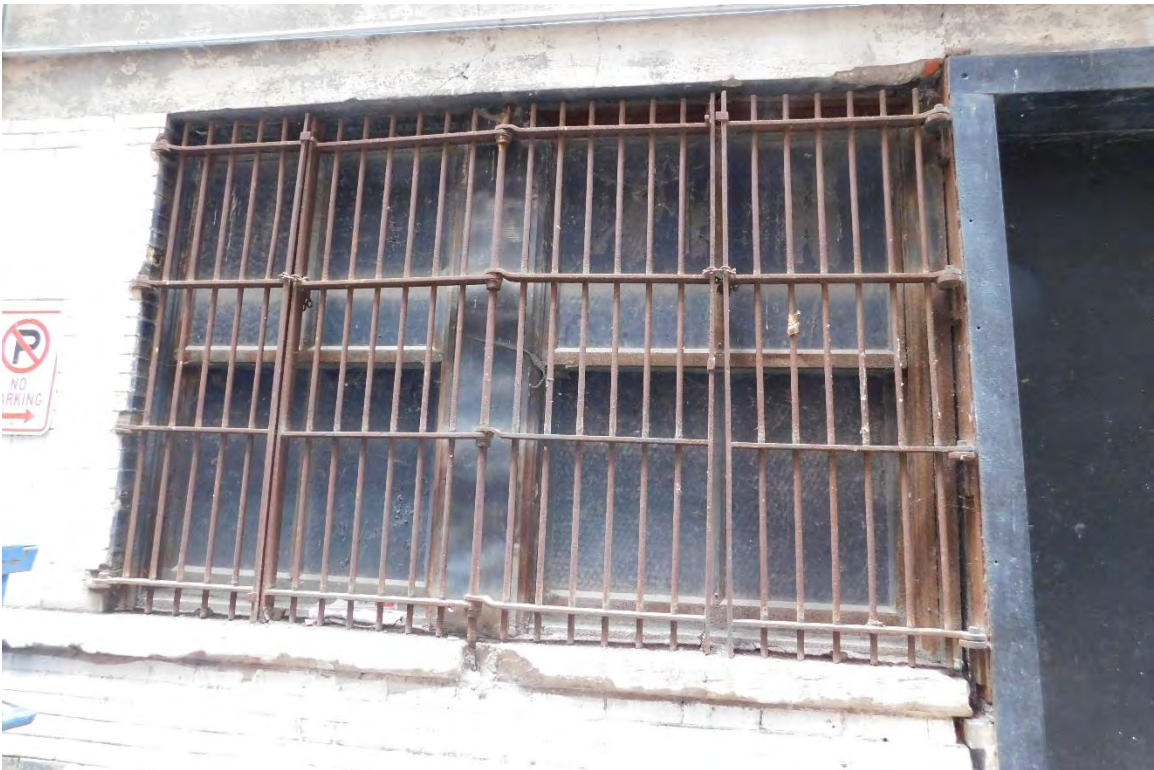
The windows on the alley façade are three-over-three double hung hollow metal, cold-rolled steel windows. These windows are in poor condition with evidence of corrosion on all exterior elements with many missing and broken

panes and joinery failure on the bottom sash rails and meeting rails. Because hollow metal windows corrode from the inside-out, and because corrosion is now visible on the exterior of these units, the structural integrity of these windows are deficient. The units on floors two through eight will be removed and replaced with thermally broken aluminum replica units. The units on the first floor will be removed and infilled with brick to allow for back of house tenant areas. The infilled brick will be inset 1" and the sills will remain to provide evidence of the historic window locations. The proposed window details are attached.

Figure #36: Exterior, Alley Façade Window, Looking East. 10/15/19

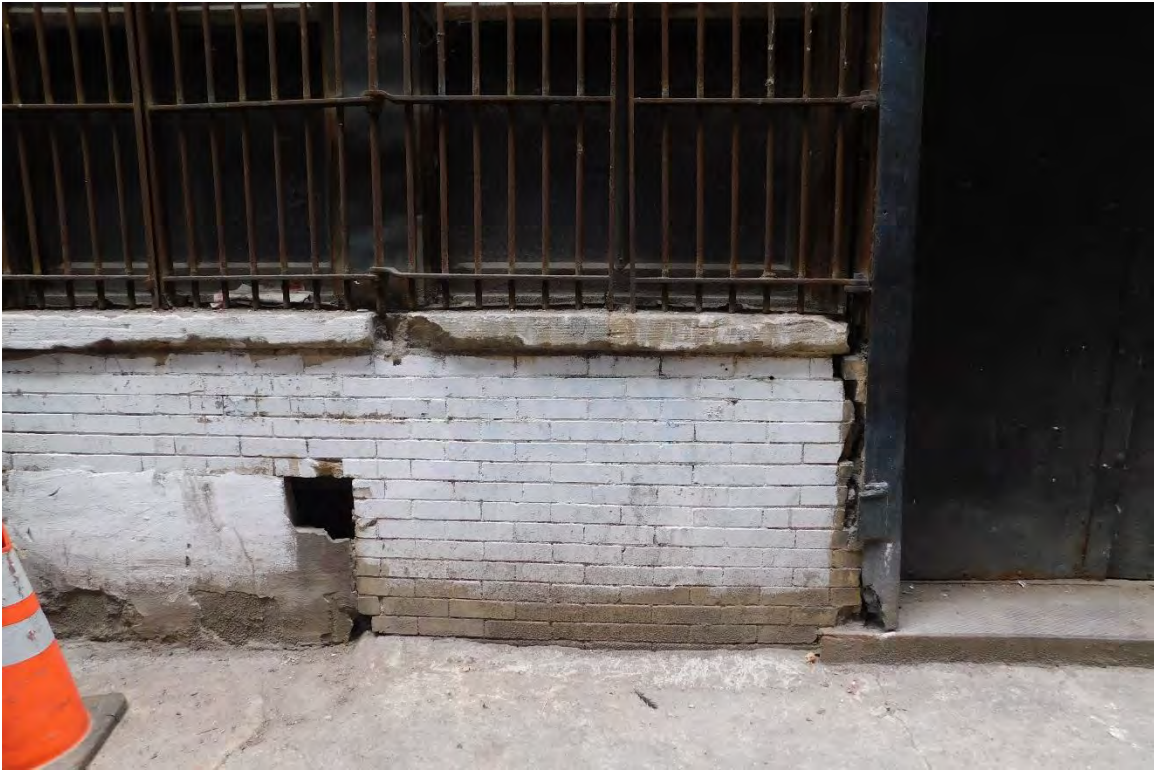
Figure #37: Exterior, Alley Façade Knee Wall, Looking Down. 10/15/19

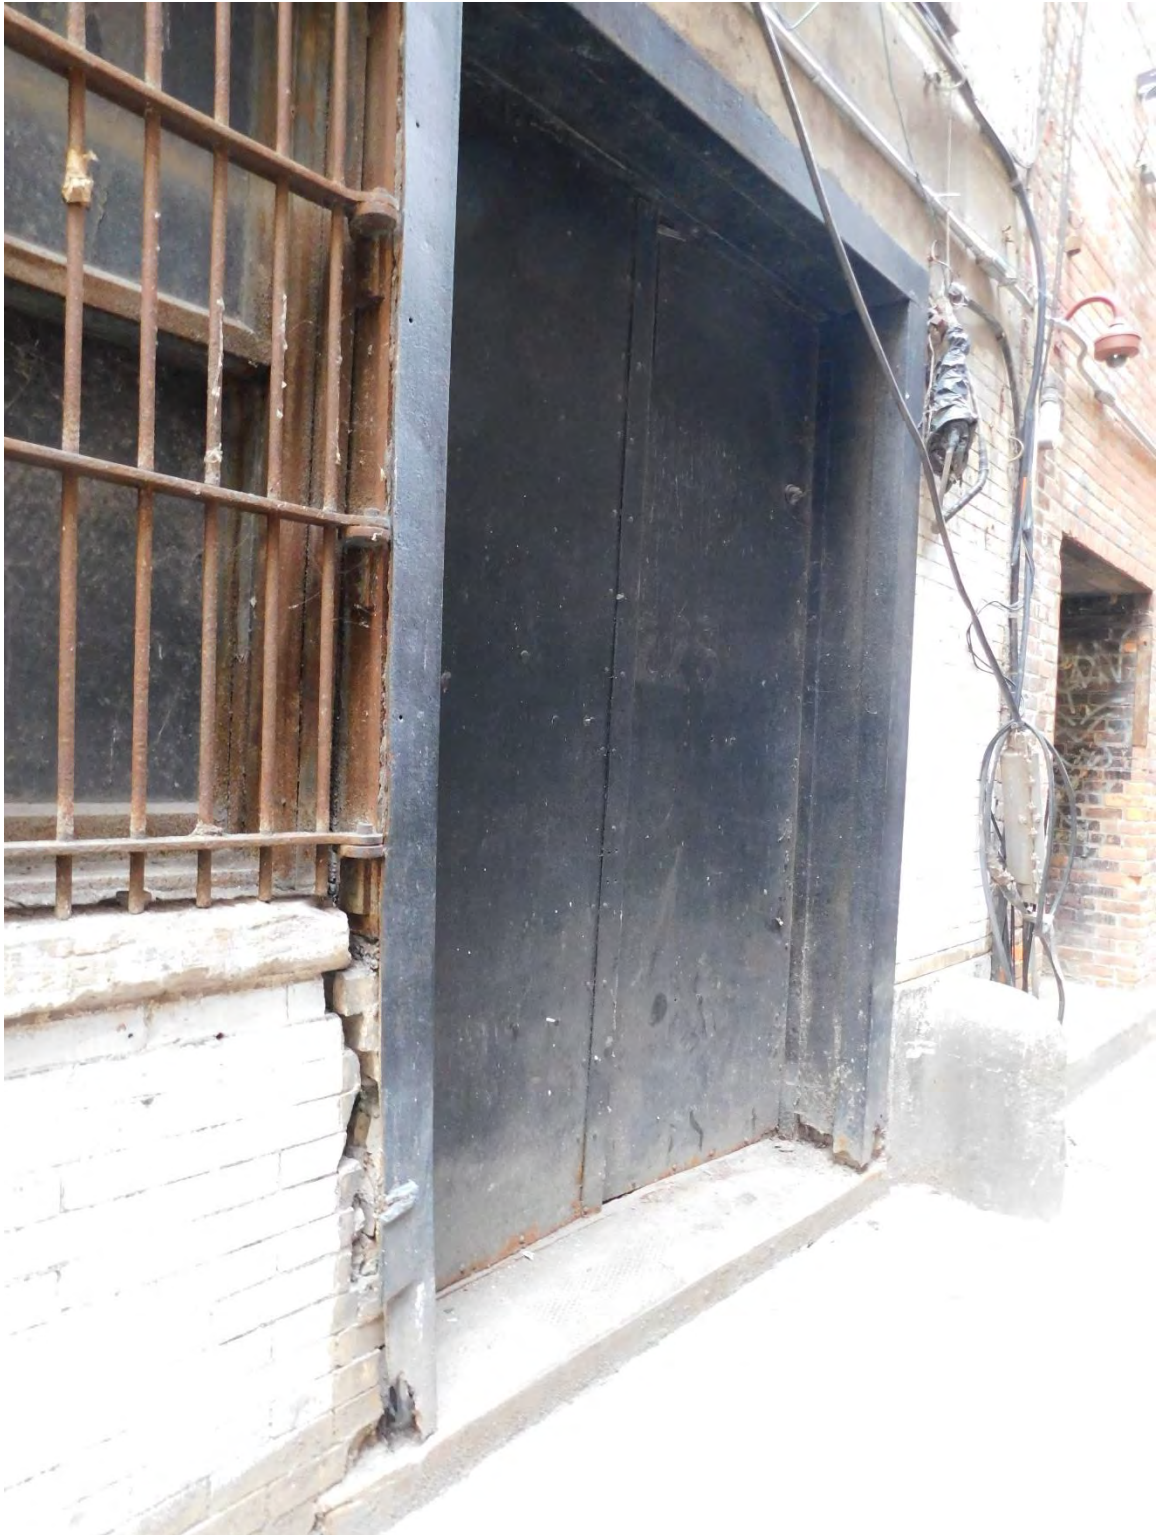
On the first floor of the alley (west façade), there is one exterior metal door in fair condition. On floors two through eight there are two exterior doors on each floor that lead out onto the fire escape. Some of these doors are modern replacements and some are original metal units. Overall, they are in poor condition. The first-floor exterior door is not historic and will be removed and replaced with a new metal double door unit. The exterior doors on floors two through eight will be removed and replaced with new metal units as well. See Storefront section for description of new main entrance doors on east façade.

Figure #39: Exterior, Alley Façade Door. 10/15/19

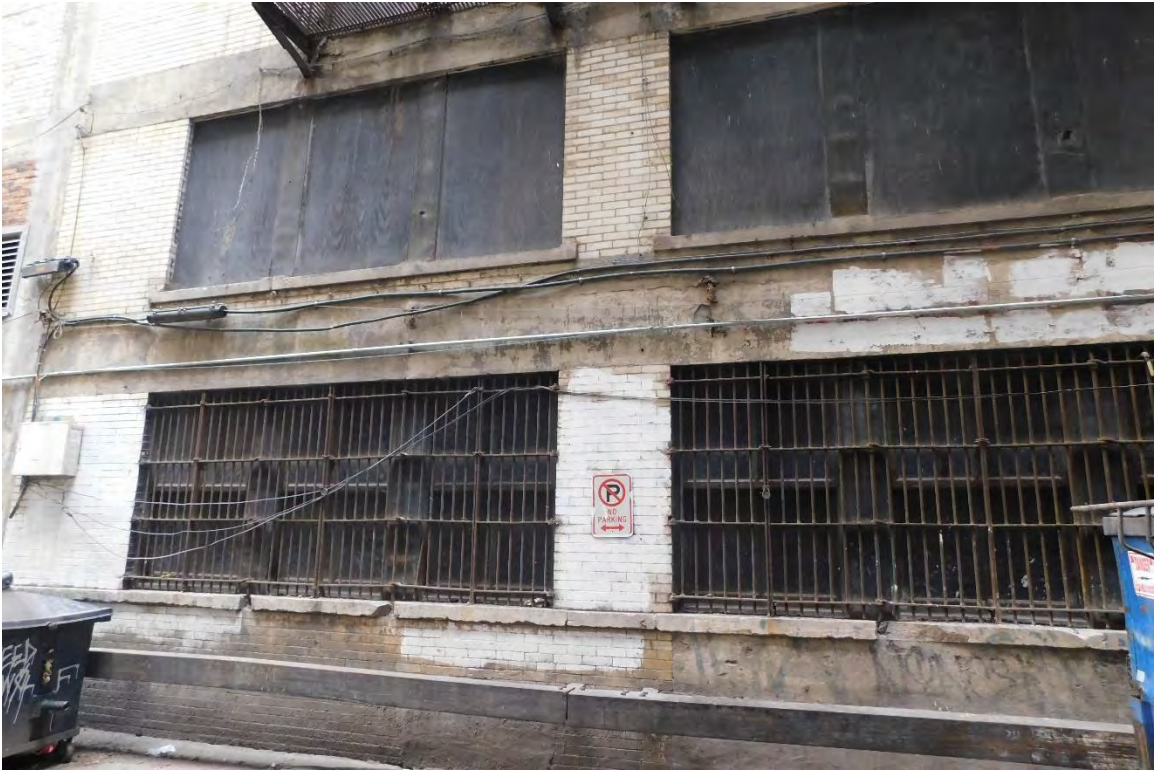
Figure #40: Exterior, Alley façade windows, Looking East. 10/15/19

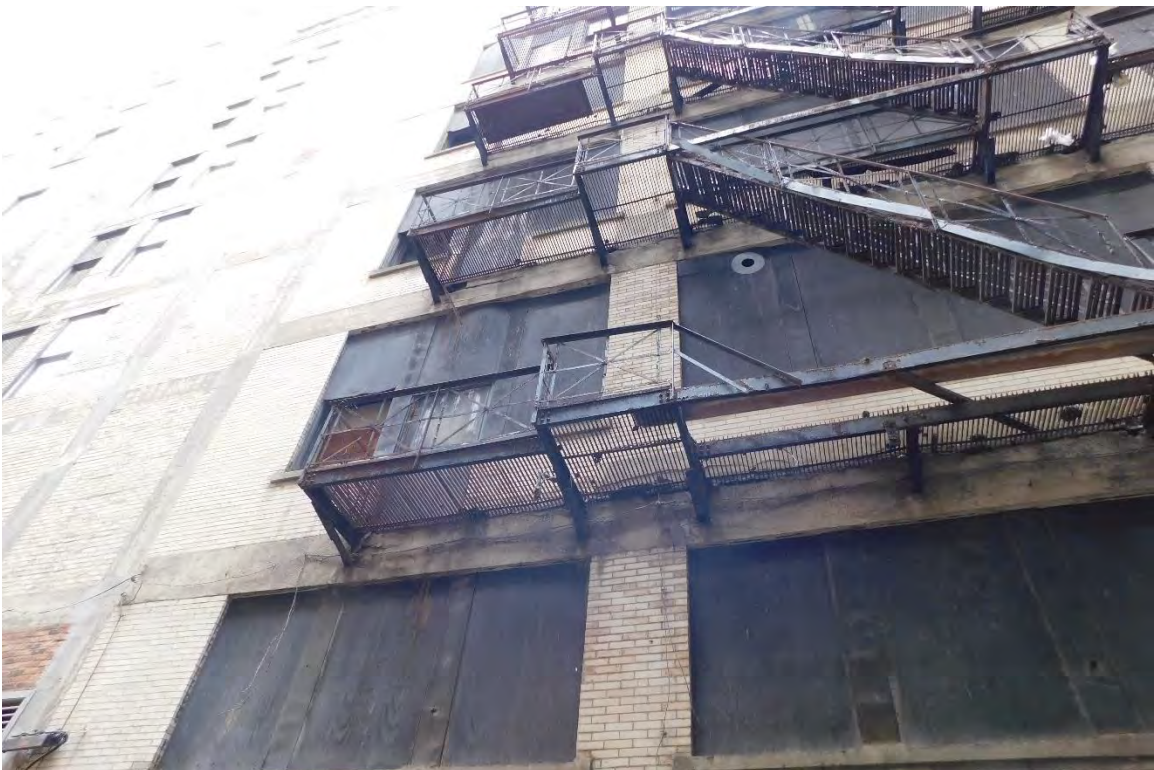
Figure #41: Exterior, Alley Façade, Looking Up. 10/15/19

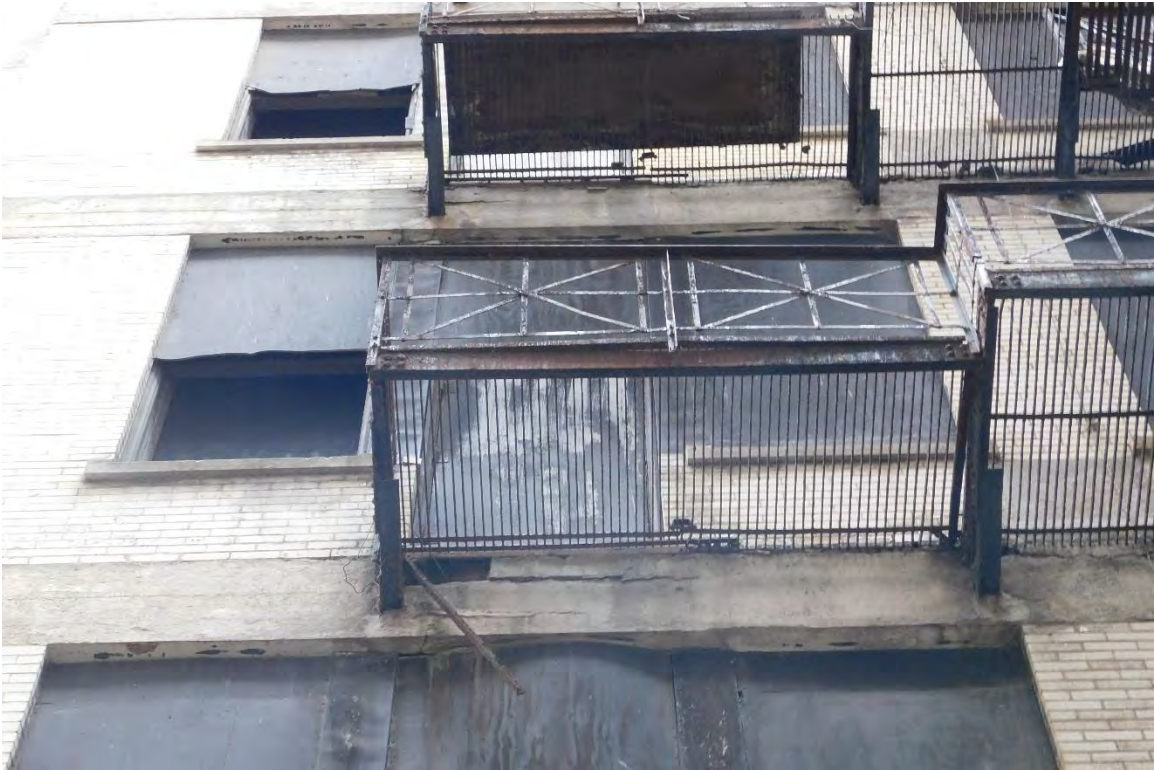
Figure #44: Exterior, Fire Escape, Looking Up. 10/15/19

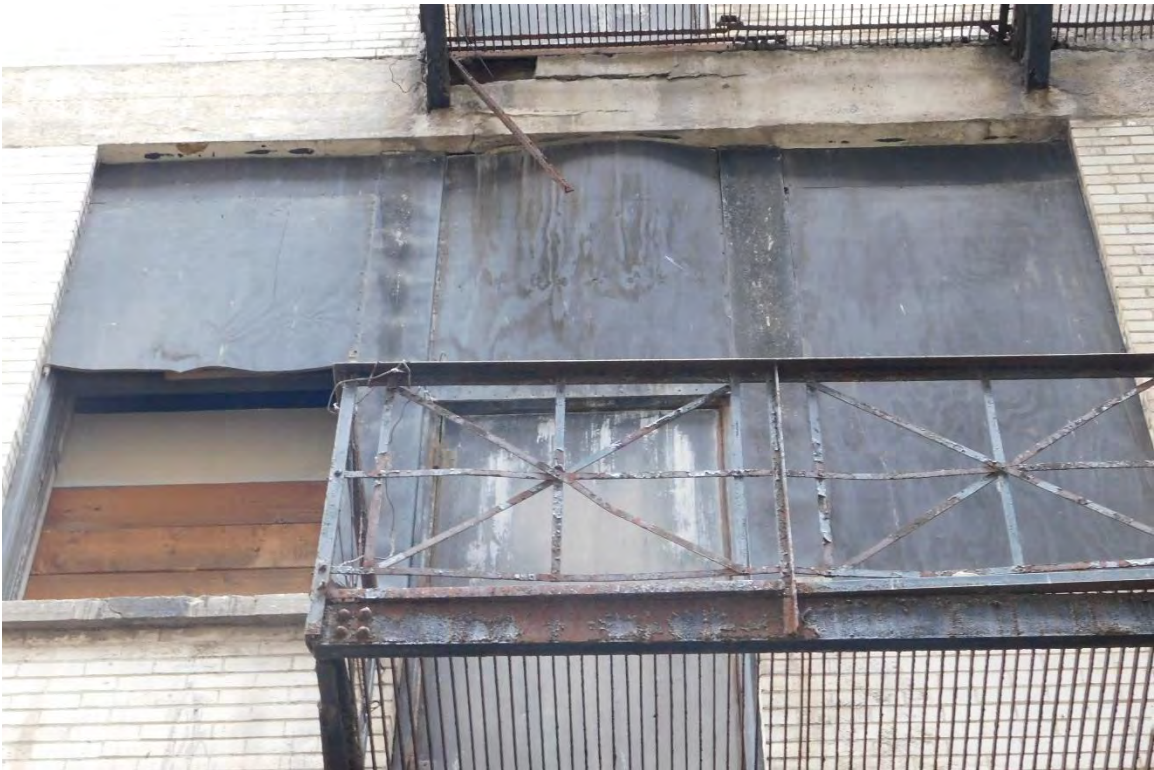
Figure #45: Exterior, Fire Escape, Looking Up. 10/15/19

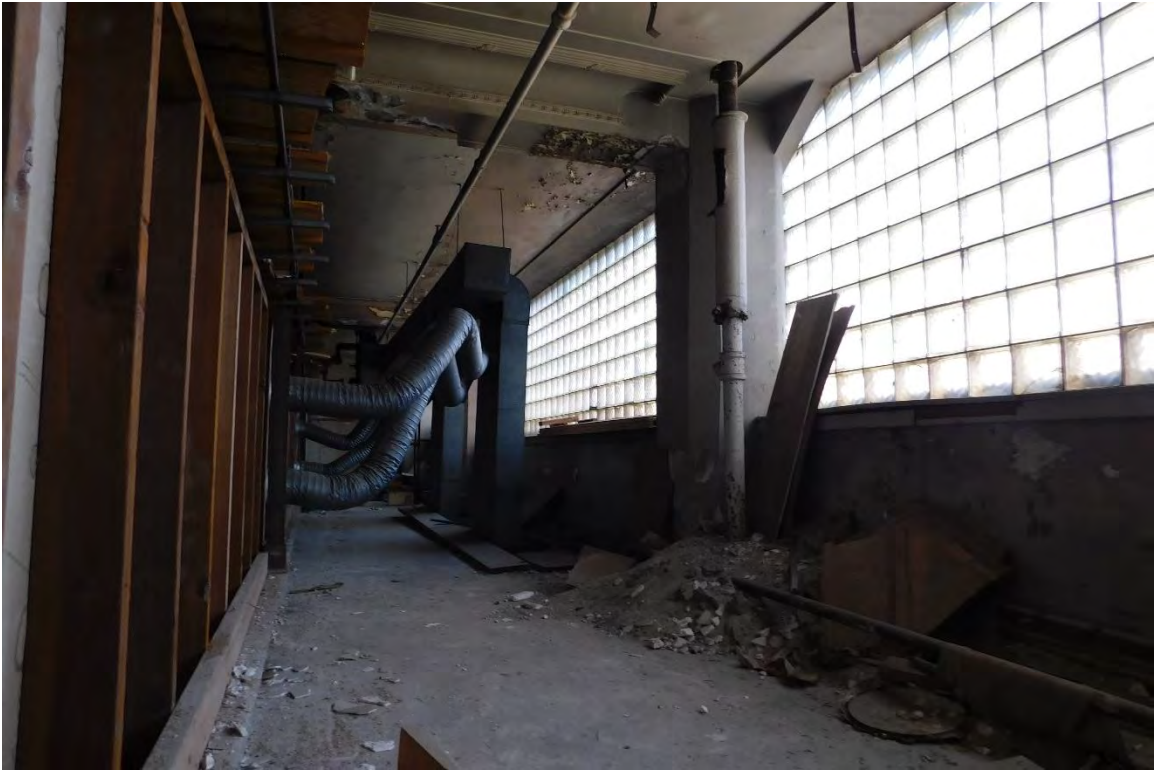
At the east façade, the mezzanine level currently features patterned glass block windows in fair condition with some units broken and cracked. The mezzanine glass block windows will be retained and repaired.

Figure #52: Interior, Mezzanine Glass Block, Looking Northeast. 10/15/19

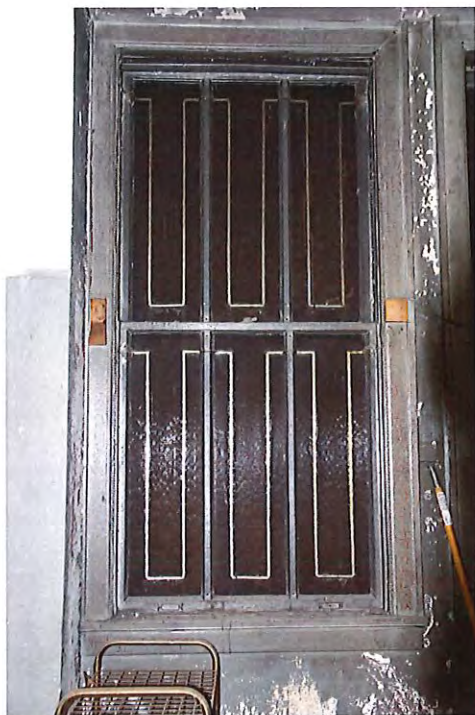
These windows are located on the West Elevation, rear façade on the alley side of the building. The windows are in poor condition with heavy corrosion and rust on all exterior components. Because of water penetration there is joinery failure at the bottom sash rail and meeting and meeting rail. These windows are notoriously difficult to restore since there is no way to arrest the corrosion in the tubular profiles. Even when the exterior surfaces are in good condition the joinery will show rust deposits soon after full restoration. Glazing compound is failed and likely contains asbestos as well as all the perimeter exterior caulking. The sash and frame components mimic wood window in the era. The bottom rail is 4", the typical side rail is 1 3/4" and top rail is 1 3/4"; meeting rail is 1 3/4". The parting bead is 1/2" x 1/2" and sash stop is 1/2" x 1 3/4". Note all window components are galvanized steel. All sashes are 2" thick and have 1/4" clear plate glass. Muntins are 1 1/2", and mullions are approximately 9" but must be checked from the exterior since the window are inoperable. The interior case work is in various states of condition, some is missing, some is damaged, and some is in good shape.

Interior of Steel  
Double Hung

**Recommendation: BlackBerry would recommend the full replacement of the cold rolled steel windows with an historic replica thermally broken aluminum single hung window. The entire existing metal frames and sash would be removed and replaced. The following budget price does not include the metal door and transoms. We would need direction as to the design, hardware, and code compliance issues. Windows will require lead paint and ACM abatement.**
