**STAFF REPORT:** 08-12-2020 MEETING

**APPLICATION NUMBER:** 20-6760

**ADDRESS:** 1980 EDISON

**HISTORIC DISTRICT:** BOSTON-EDISON

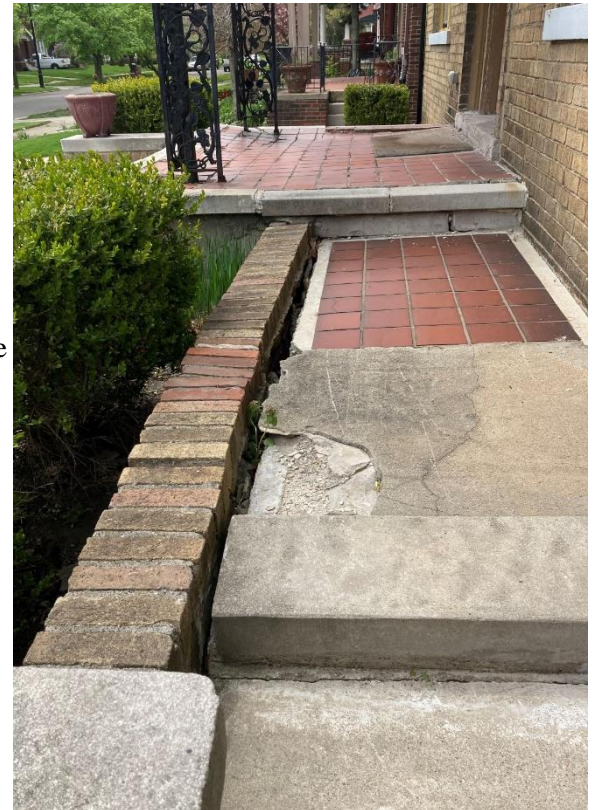
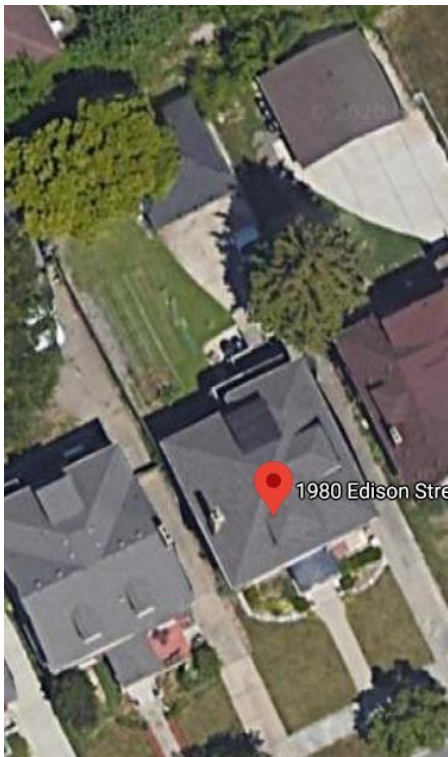
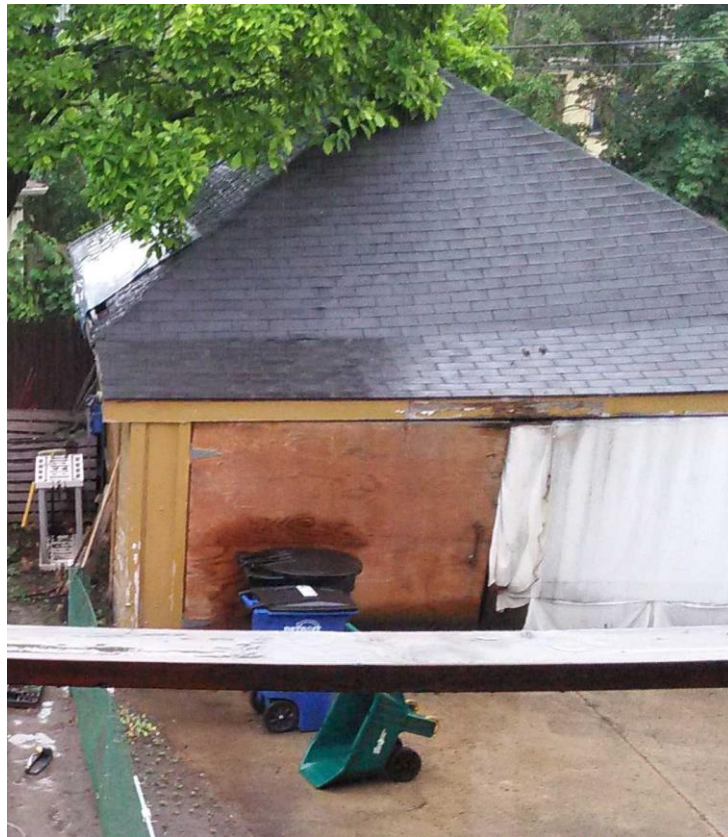
The centrally located front porch stairs retain the masonry wing walls with stone caps. An extension to the east, connecting the front entrance to the driveway, is a common feature within this neighborhood, and is faced with matching brick. Both platforms feature square clay tiles with a concrete border.

- The photographs submitted by the applicant of the current condition of the porch front entry and stairs show sinking platforms, the separation of the support walls from the platforms, and insensitive platform repairs (pouring of concrete where tiles had once been installed).

- Should new face brick be needed, it shall match the historic brick in dimension, color, composition, pattern and profile. A historic mortar mix, matching that of the existing mortar, shall also be used. The existing stone caps, shall be reused, or new stone caps will be specified (no concrete caps).
- The existing front door shall be retained or, if the applicant can substantiate the existing door and surround are beyond repair, all components will be replaced in-kind. The paint color for the front door will be submitted for staff review.
