**STAFF REPORT:** 08-12-2020 MEETING

**APPLICATION NUMBER:** 20-6791

**ADDRESS:** 869 LONGFELLOW

**SCOPE:** REPLACE 10 WOOD 1/1 DOUBLE-HUNG WINDOWS WITH PELLA ARCHITECT SERIES 1/1 DOUBLE-HUNG WINDOWS

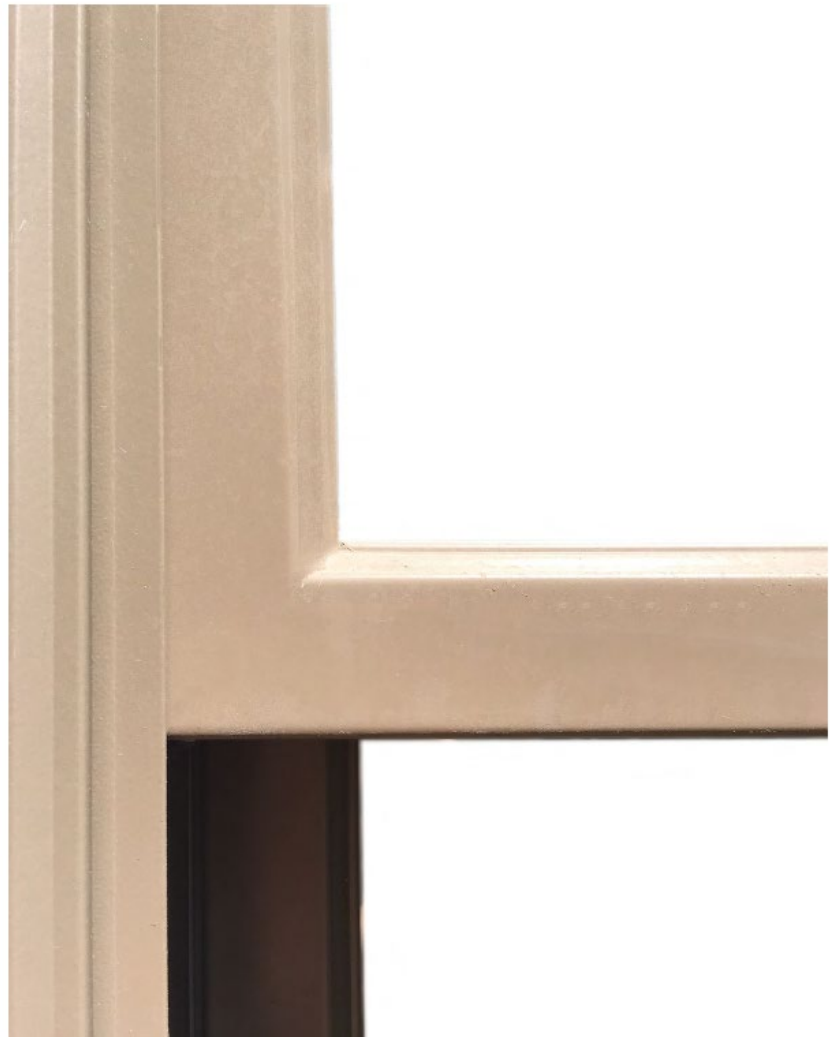
Proposed Exterior Corner Profile  
(color to match current trim and historic palette B:8, Grayish Brown)
