STAFF REPORT 12-9-2020 REGULAR MEETING

APPLICATION NUMBER: 20-6968

ADDRESS: 691 W. ALEXANDRINE STREET

SCOPE: REHABILITATE EXISTING BUILDING; ERECT NEW BUILDING

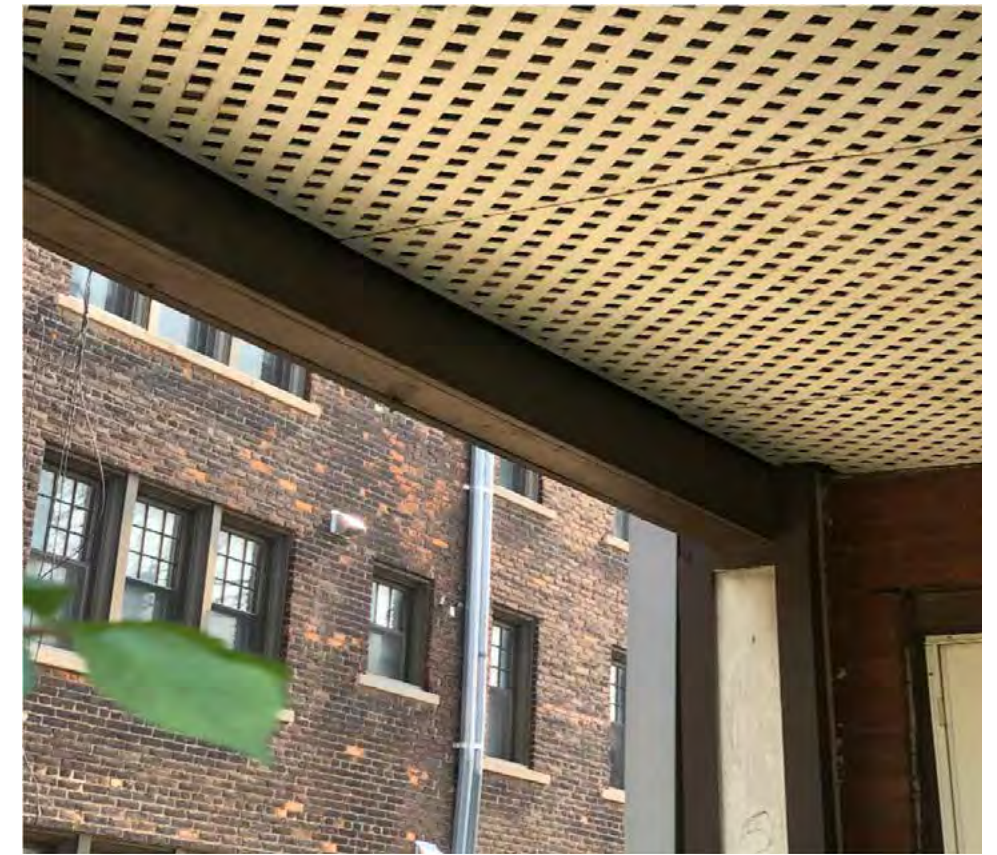
- UPPER PORCH HAS SOME ROT IN THE SUPPORTS
- THE FLOORING HAS A LOT OF ROT (WOULD NOT RECOMMEND ANYONE VENTURE ONTO THE PORCH)
- THE CEILING OF THE LOWER DECK HAS BEEN REPLACED WITH VINYL LATTICE.

IT IS OUR OPINION THAT THE WOOD ON THE PORCH HAS SEVER ROT AND IS IN DISARRAY. THE UPPER PORCH IS DANGEROUS AND SHOULD NOT BE USE. THE WOOD ON THE PORCH NEEDS TO BE DISASSEMBLED WHILE SUPPORTING THE ROOF. THE PORCH TO BE REBUILT USING NEW WOOD AND SUPPORT COLUMNS. TRIM BOARD TO BE INSTALLED TO MATCH EXISTING AND PAINTED TO REDUCE THE CHANCE OF ROT.

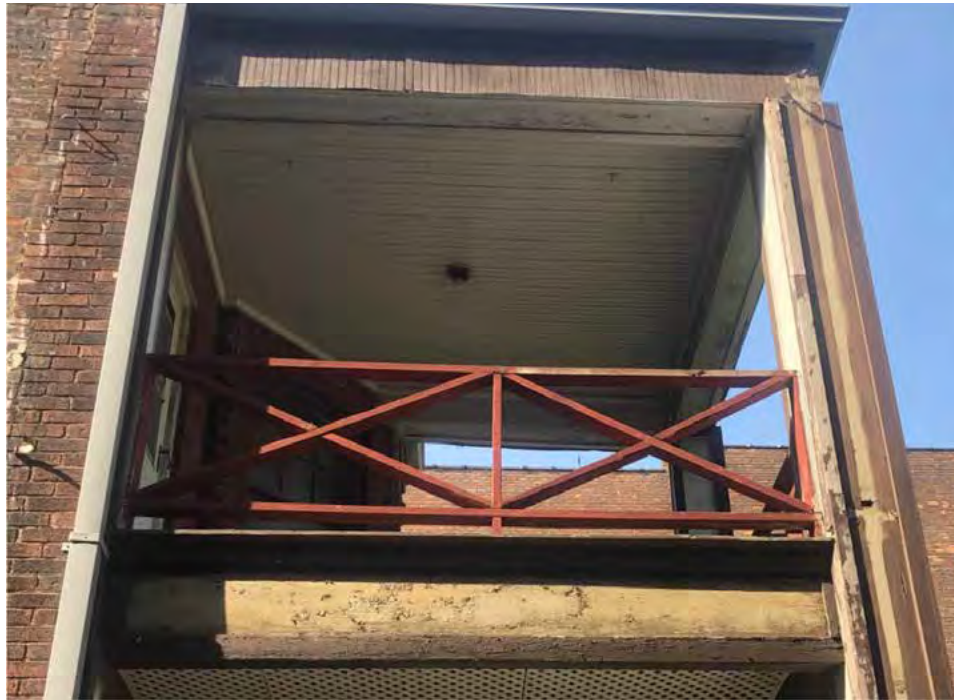
- UPPER PORCH CEILING IS BEADBOARD AND IN GOOD CONDITION. WOULD SUGGEST REMOVING AND REINSTALL ON REBUILT PORCH.

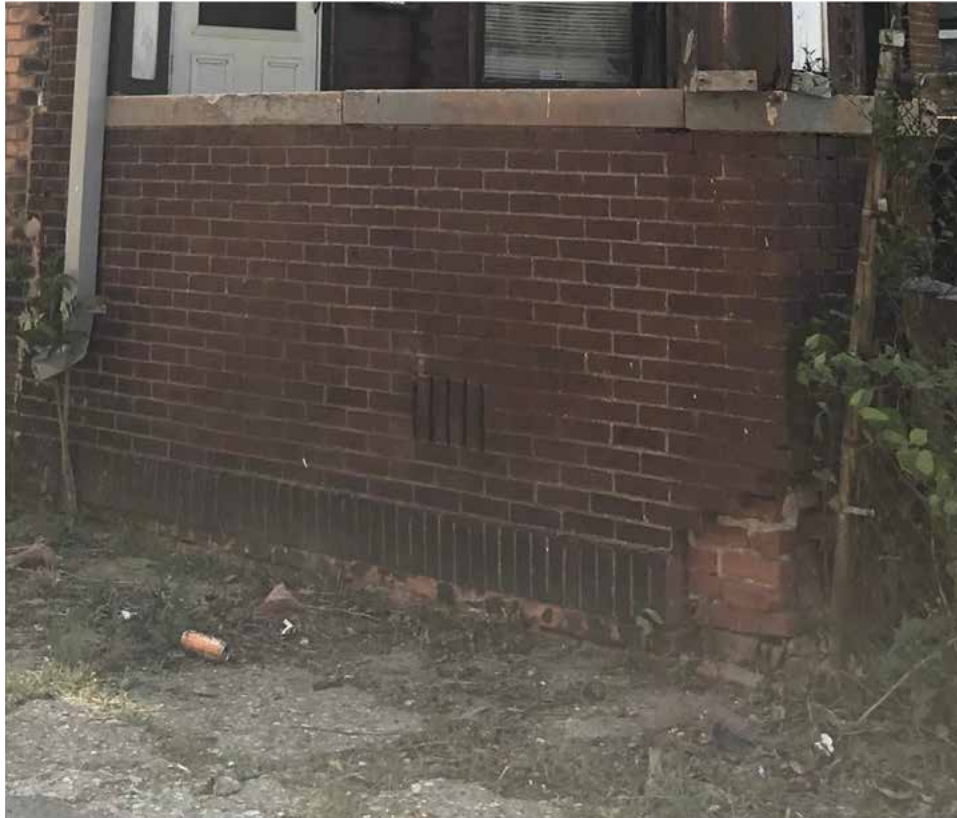
- WALL IS 4 LAYERS OF BRICKS
- THERE ARE SEVERE CRACKS IN THE PORCH WALL
- THE GAPS IN THE BRICK HAVE BEEN IMPROPERLY FILLED AND LOOK BAD.
- BRICKS ARE LOOSE AND FALLING OUT
- WALL IS FALLING APART AND IS UNSAFE. WILL NEED TO BE TORN DOWN AND REBUILT TO BE CORRECTED.
- SOME BRICKS HAVE BEEN REPLACED WITH NON-MATCHING BRICKS.
- WALL SUPPORTS THE UPPER PORCH AND IS LEANING OUT AND COULD COLLAPSE CAUSING THE UPPER PORCH TO COLLAPSE ALSO.
- BRICKS ON CORNER ARE MISSING.
- THE REST OF THE PORCH WALLS IS IN GOOD CONDITION. BRICKS NEED TO BE CLEANED.

IT IS OUR OPINION THAT THE PORCHES ARE IN SERVER DISARRAY. THE PORCHES ARE DANGEROUS AND NEEDS TO BE DISASSEMBLED, AND THE BRICK BE CLEANED OF OLD MORTAR, THE LIMESTONE STEPS, AND CAPS TO BE REMOVED AND CLEANED. THE PORCH TO HAVE A CONCRETE FOOTING AND THE PORCH TO BE REBUILT USING THE EXISTING BRICK AND LIMESTONE STEPS AND CAPS.

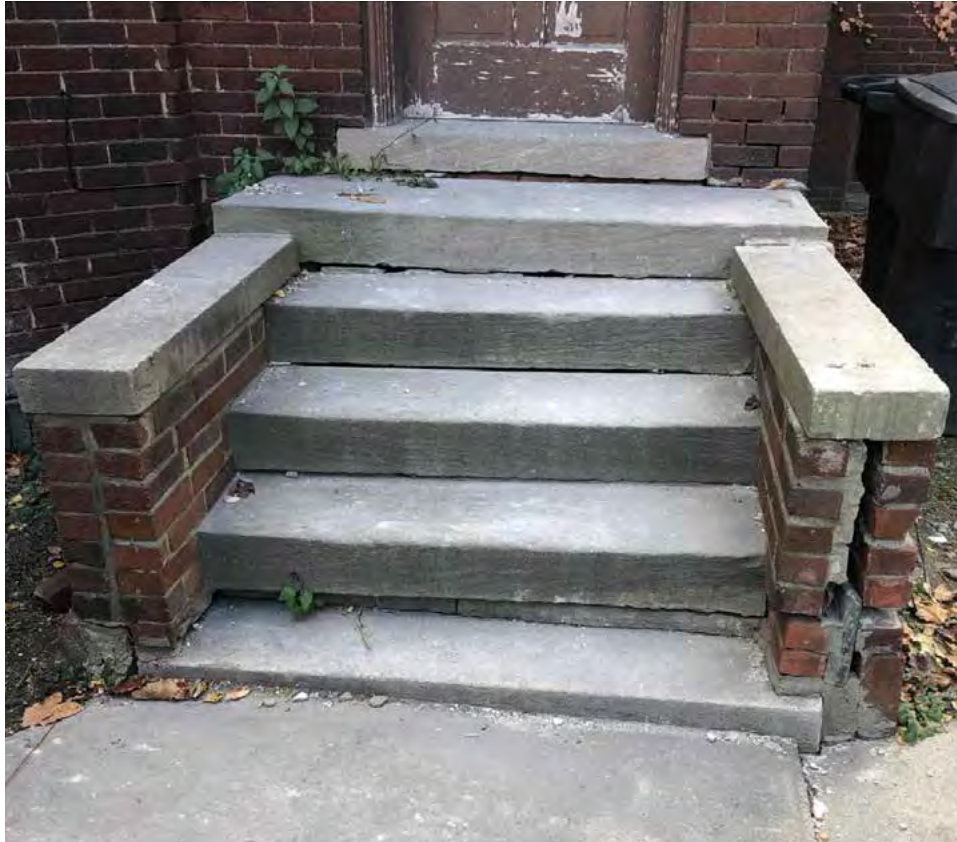
- STEPS HAVE PULLED AWAY FROM THE PORCH AND WAS IMPROPERLY FILLED
- STEP WALL HAS PULLED AWAY FROM ITSELF AND WAS IMPROPERLY FILLED
- STEPS ARE NOT TO CODE OR ADA COMPLIANCE.
- THERE ARE GAPS BETWEEN THE STEPS AND HAVE BEEN FILLED

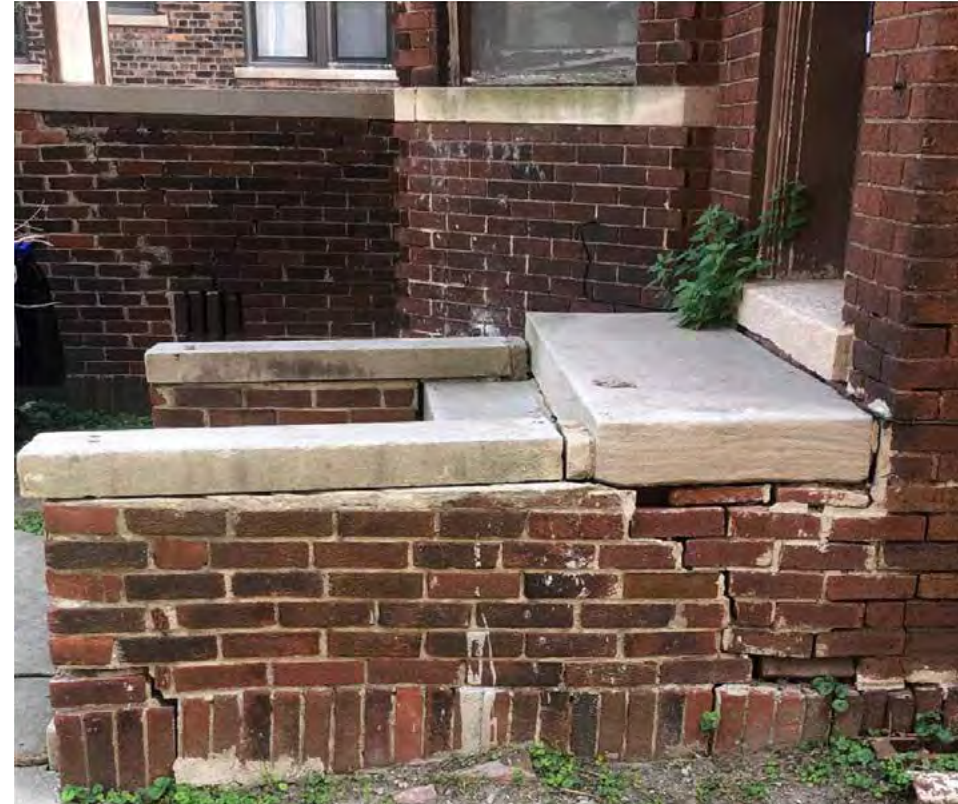
- THE GAPS IN THE BRICK HAVE BEEN IMPROPERLY FILLED AND LOOK BAD.
- BRICKS ARE LOOSE AND FALLING OUT
- THERE ARE SEVERE CRACKS IN THE PORCH WALL
- WALL IS FALLING APART AND IS UNSAFE. WILL NEED TO BE TORN DOWN AND REBUILT TO BE CORRECTED.
- SOME BRICKS HAVE BEEN REPLACED WITH NON-MATCHING BRICKS

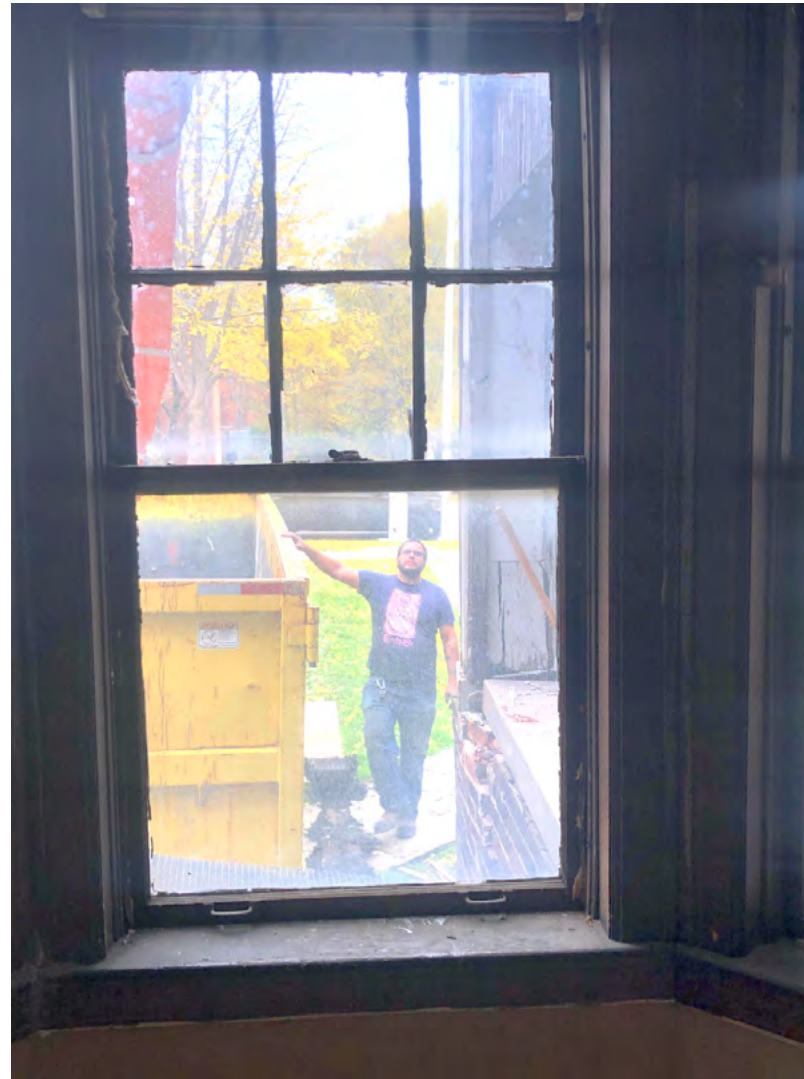
Window F-2

- Window opens but the lead counterweights are missing
- Interior sill is rotten
- One stop is missing, and the other stop is missing all but one of the screws
- Window needs to be re-putted
- Weather stripping missing
- Jamb on right side has rot

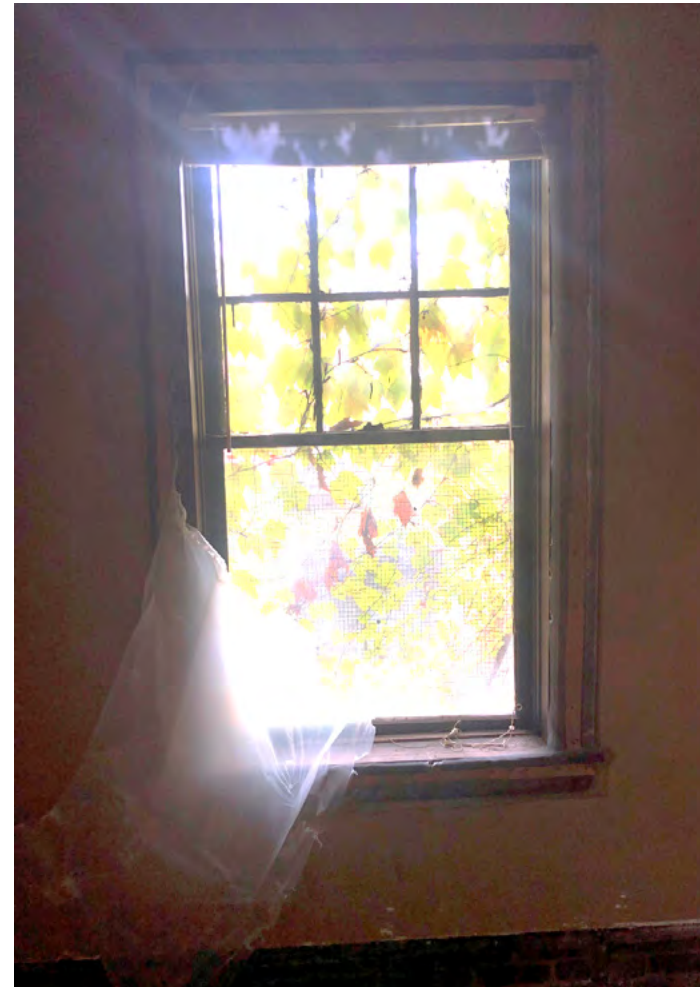
Window F-4

- Window will not open
- Missing Handles
- Both of the lead weights are missing
- Upper Sash has extensive rot on bottom
- Window interior sill had some replacement
- Exterior brickmold extensive rot on bottom
- Exterior sill has extensive rot
- Weather stripping missing
- Window needs to be re-putted
- Window will not lock

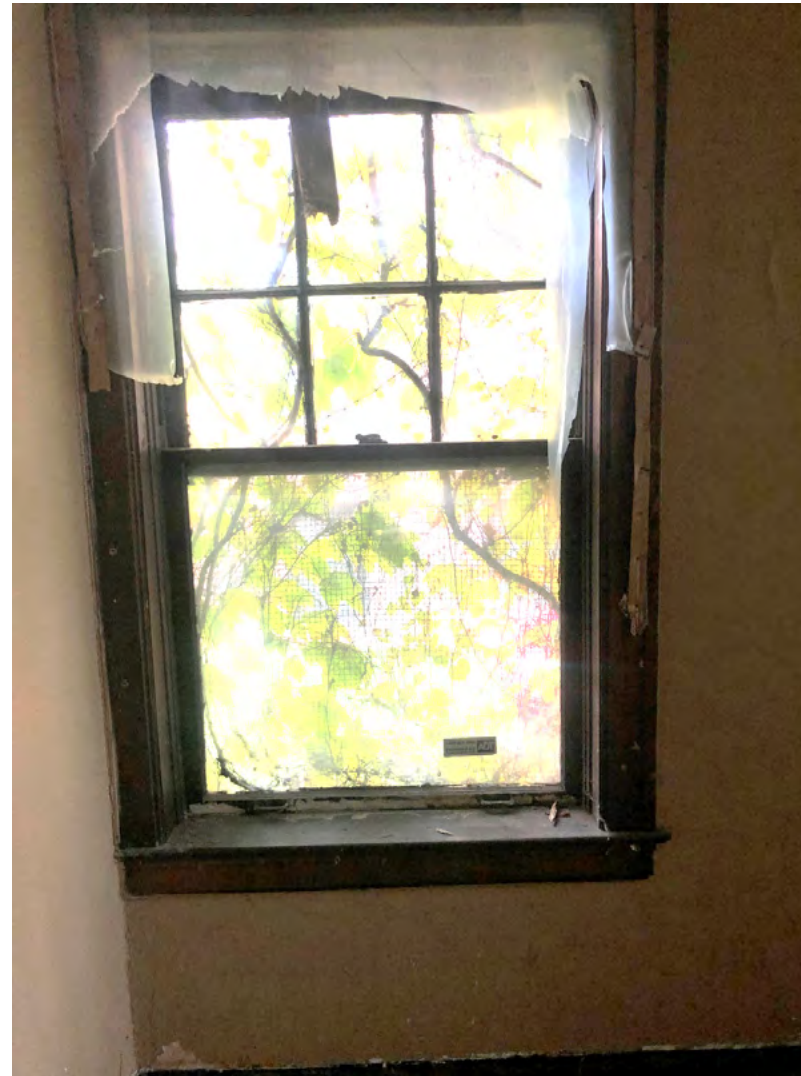
Window F-5

- Upper sash has fallen and will not move. Old newspaper has been stuffed in gap
- Window needs to be re-putted
- Both lead weights are missing
- Interior sill is rotten
- Bottom sash has extensive rot
- Stops have rot
- Exterior left brickmold has extensive rot
- Exterior sill has extensive rot

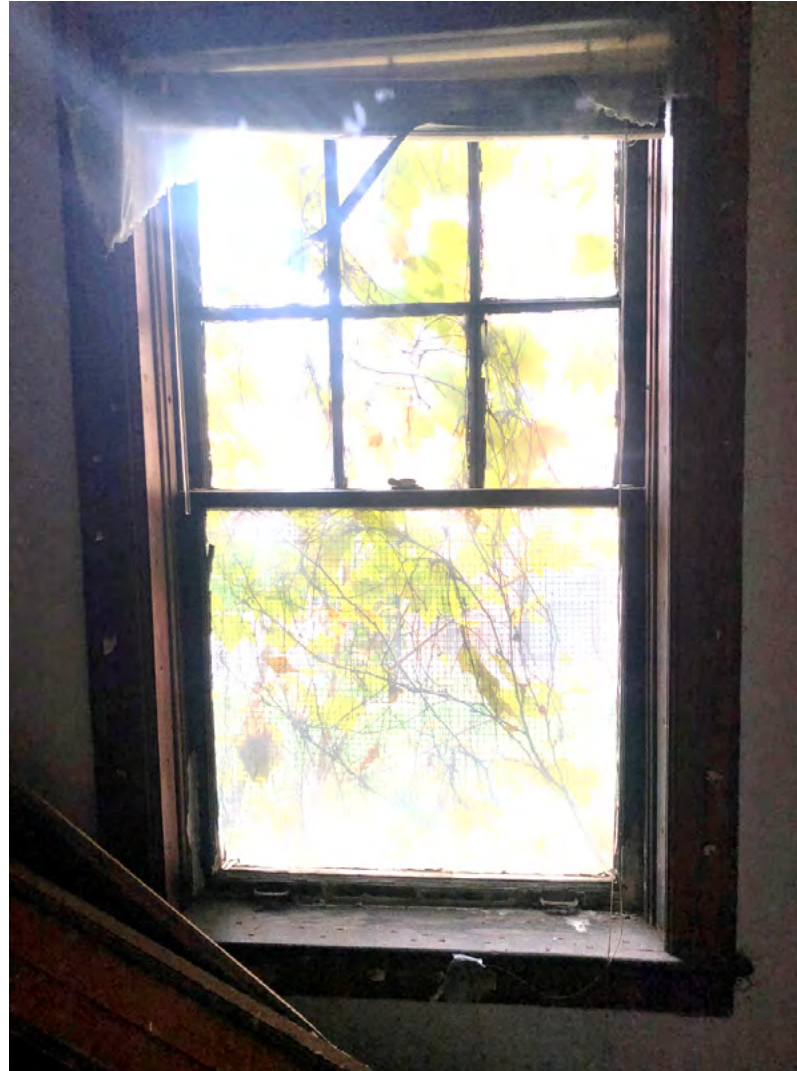
Window F-6

- Window will not open
- Bottom sash has extensive rot
- Window needs to be re-putted
- Both lead weights are missing
- Interior sill is rotten and broken
- Exterior sill has extensive rot, and the sash is pushed out
- Stops are missing
- Weather stripping missing

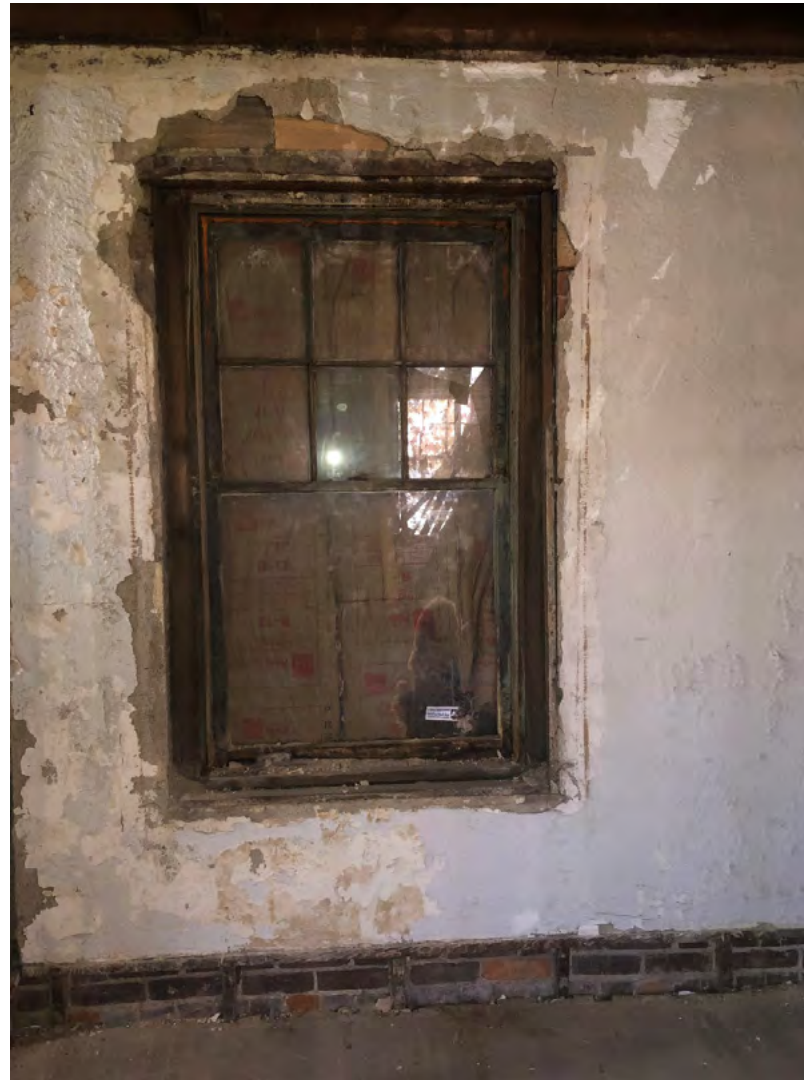
Window F-7

- Internal sill is missing
- Window was boarded up on the outside and sealers was use around the sashes
- Stops are broken on both sides
- Sever rot on what is left of the jambs
- Stops are missing
- Upper Sash glass is broken
- Lead weights are missing
- Trim is missing

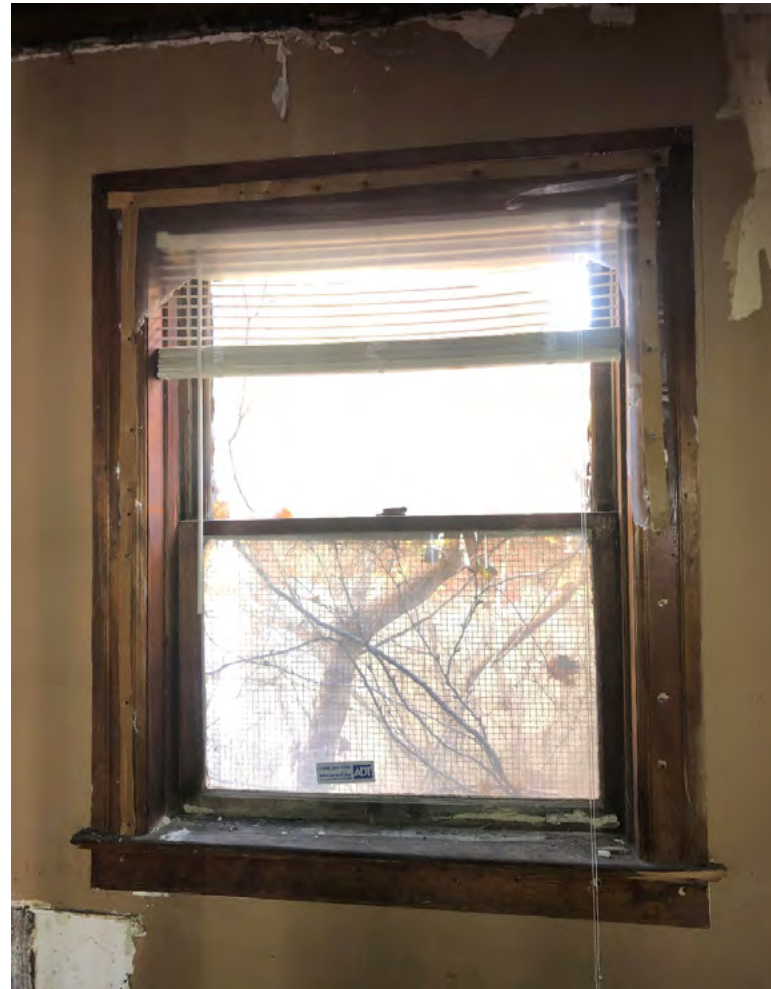
Window F-9

- Both sashes' have severe rot
- Missing both handles
- Window needs to be re-putted
- Both lead weights are missing
- Window will not open
- Weather stripping missing
- Jamb on right side has water damage
- Brick molding on both sides have severe rot
- Exterior sill has extensive rot
- Stops have been replaced and do not match

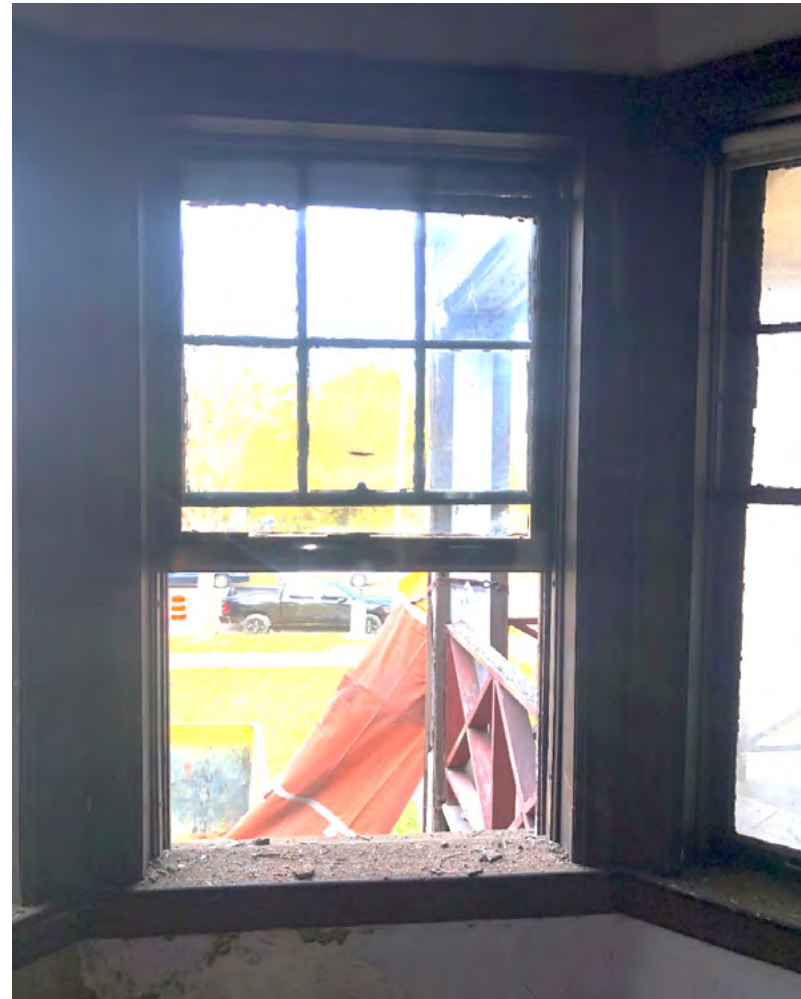
Window S-2

- Window will open
- Lead weights are in place, but cords need replacing
- Bottom sash has some rot
- Stopes are missing screws
- Sashes will not line up or lock
- Weather stripping missing
- Window needs to be re-putted
- Interior sill is rotten and loose
- Brick molding on right side have some rot

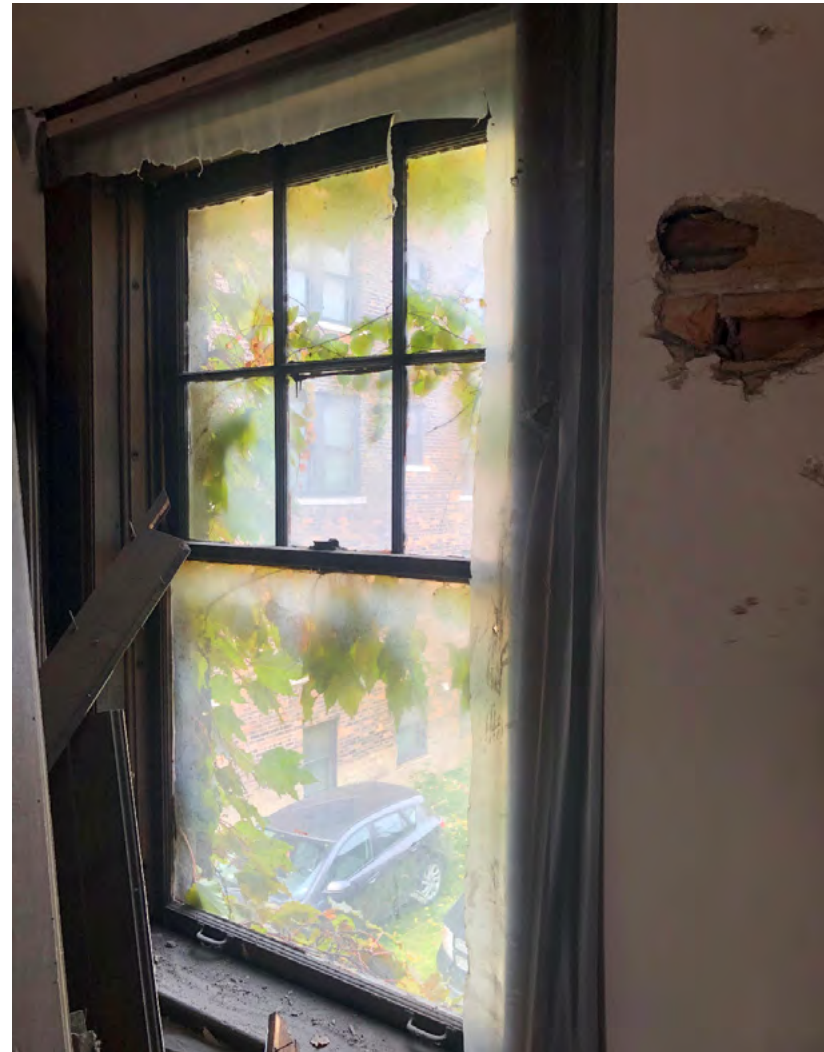
Window S-6

- Glass is broken in upper sash
- Window will not open
- Missing both weights
- Exterior sill has extensive rot
- Window needs to be re-putted
- Missing screws in stops
- Weather stripping missing
- Top sash has rot on right side
- Vines are growing thru window

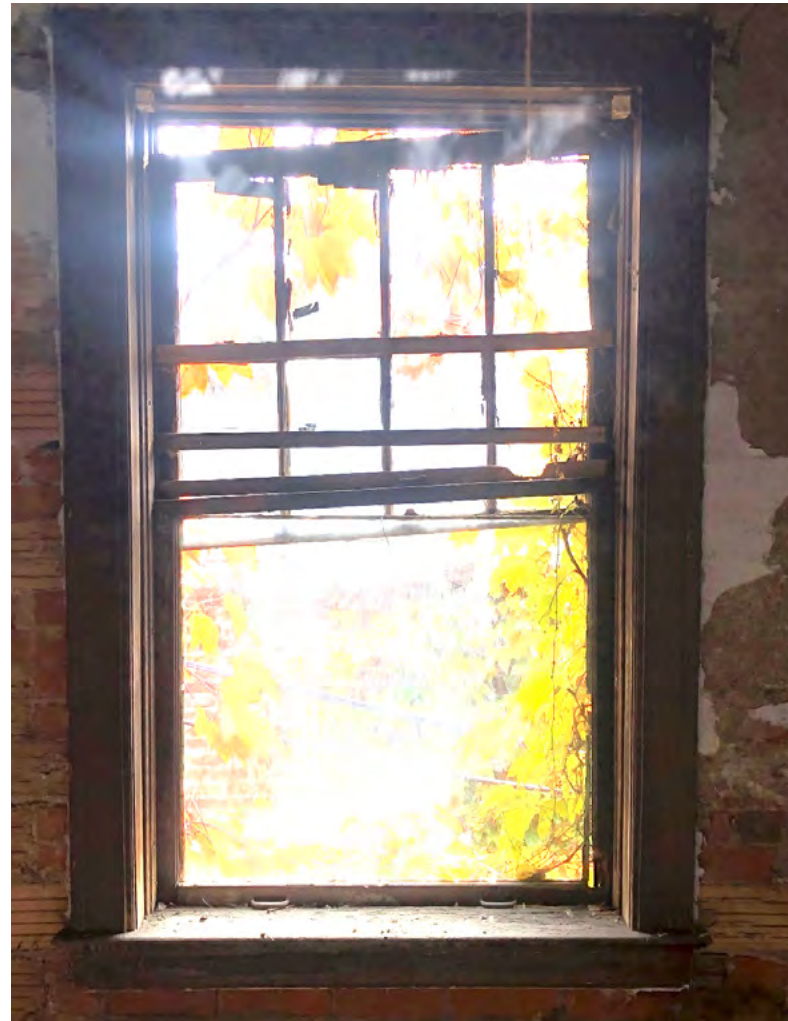
Window S-10

- Upper and lower sashes have massive rot
- Both sashes are falling apart
- Missing glass in upper sash
- Interior sill has massive rot
- Exterior sill has massive rot
- Weather stripping missing
- Stops & Jambs have massive rot and are falling apart
- Trim around window has water damage
- Lead weights are in place, but cords need replacing
- This window is beyond repair and needs to be replaced

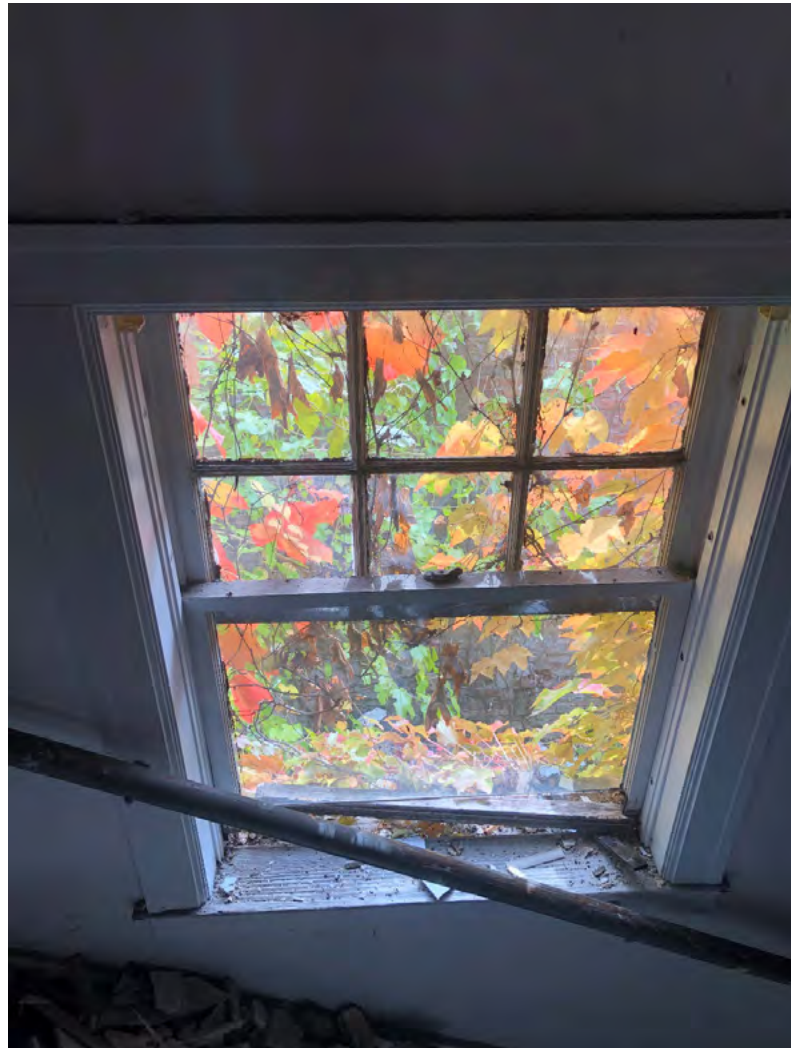
Window S-12

- Window will not open
- Window is three over one
- Bottom sash has extensive rot and is broken
- Glass in upper sash is broken on right side
- Interior sill has massive rot
- Weather stripping missing
- Window needs to be re-putted
- Exterior sill has massive rot
- Lead weights are missing

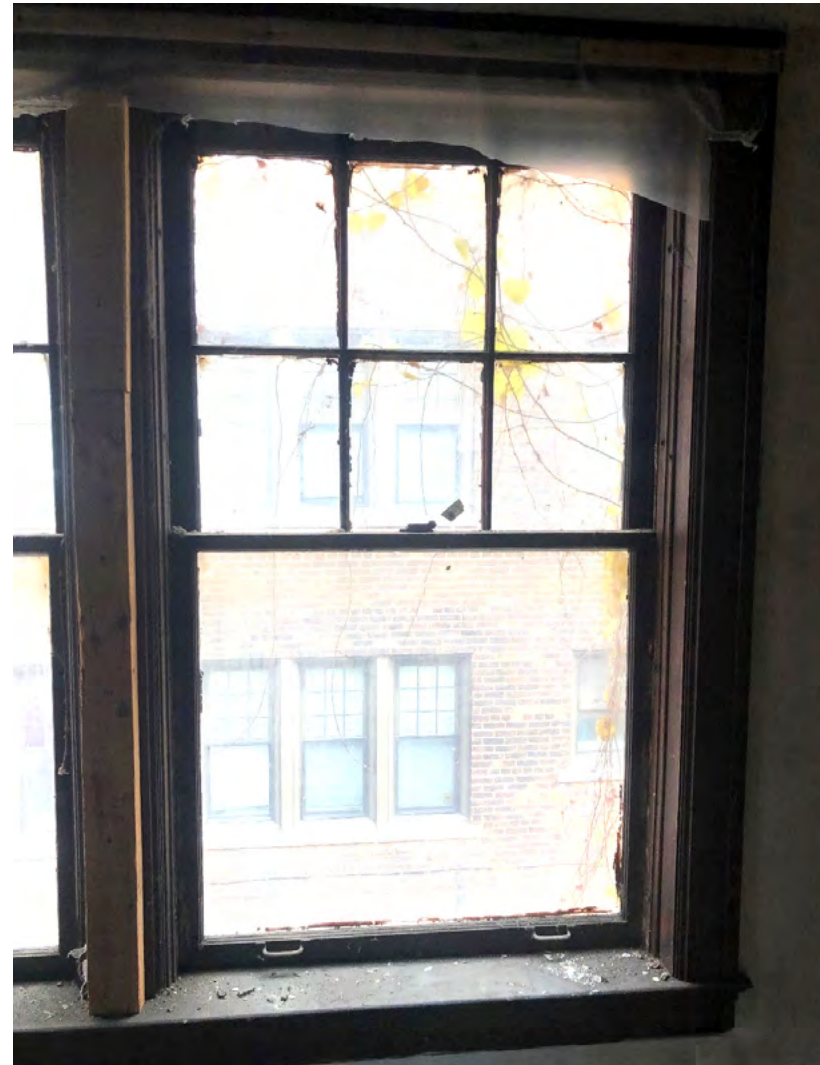
Window S-15

- Window will not open
- Lead weights are in place, but cords need replacing
- Bottom sash has extensive rot
- Weather stripping missing
- Window is boarded up on the outside
- Window will not lock
- Brick molding has extensive rot
- Glass in upper sash is broken
- Upper sash has extensive rot

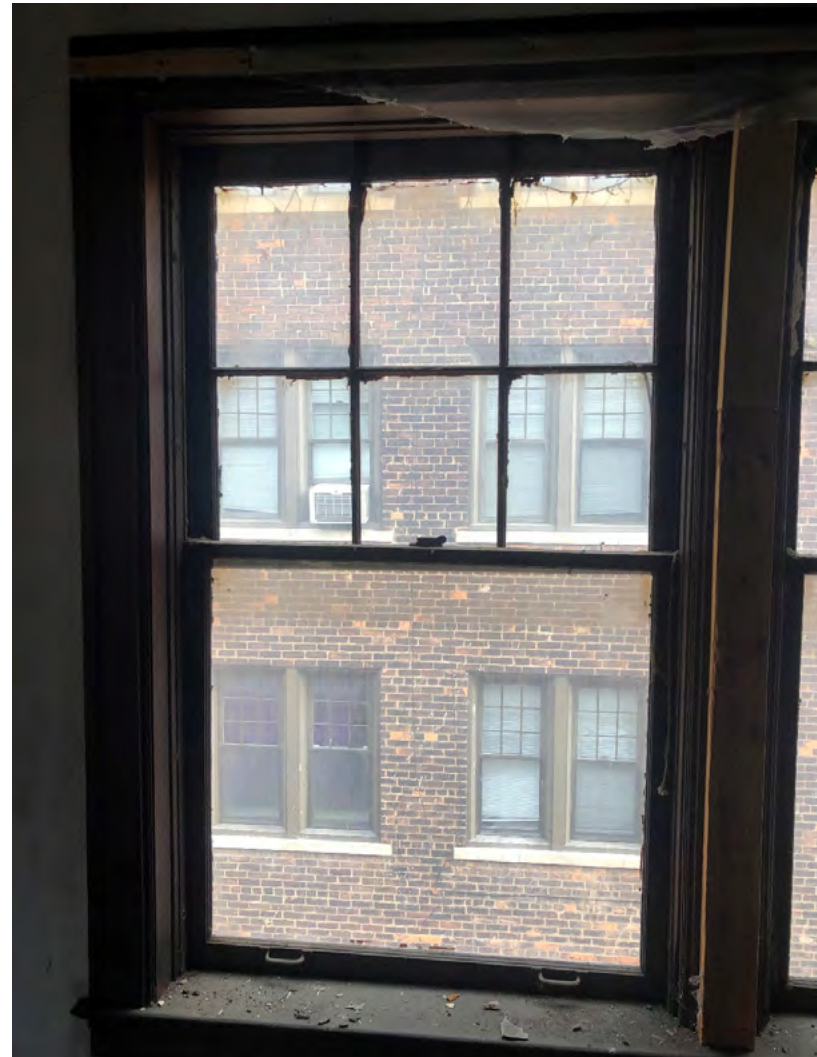
Window S-16

- Window will not open
- Lead weights are in place, but cords need replacing
- Bottom sash has extensive rot
- Weather stripping missing
- Window is boarded up on the outside
- Window will not lock
- Brick molding has extensive rot
- Trim below window has water damage
- Window will not lock

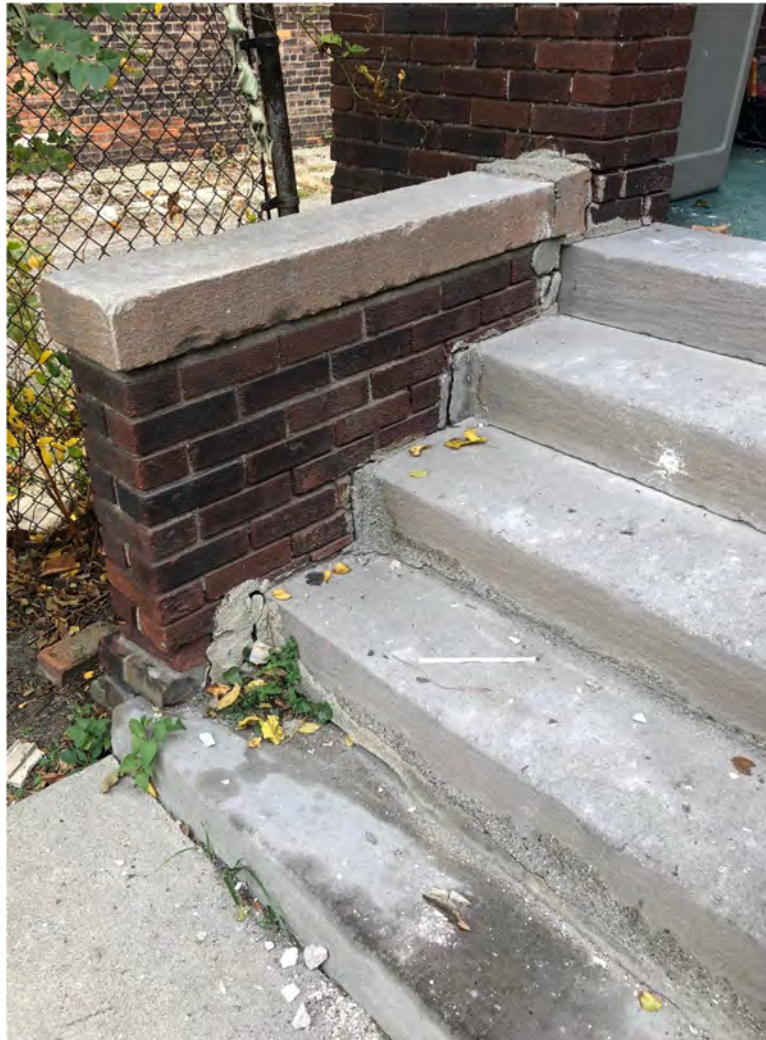
STEP and STEP WALLS

- Steps have pulled away from the porch and was improperly filled
- Wall has pulled away from the porch and was improperly filled
- Steps are not to code or ADA compliance.
- There are gaps between the steps and have been filled

It is our opinion that the porches are in server disarray. The porches are dangerous and needs to be disassembled, and the brick be cleaned of old mortar, the limestone steps, and caps to be removed and cleaned. The porch to have a concrete footing and the porch to be rebuilt using the existing brick and limestone steps and caps.

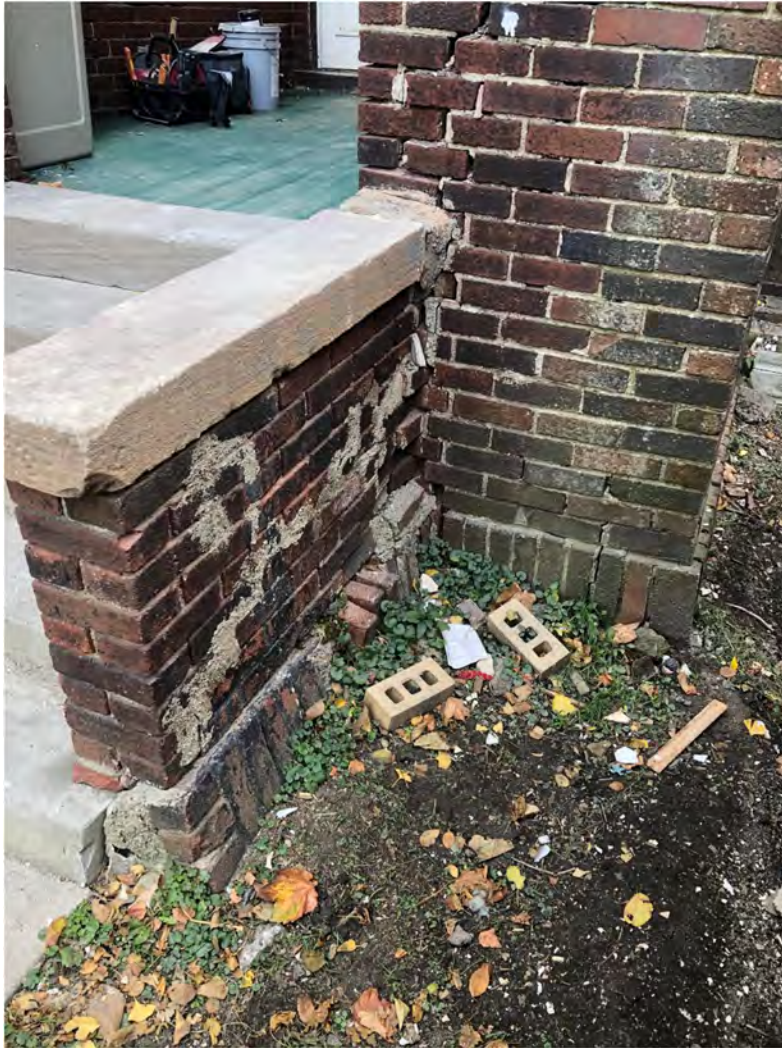
- Wall is 2 layers of brick
- Wall has pulled away from the porch and was improperly filled
- Wall is falling apart. Will need to be torn down and rebuilt to make right.
- The gaps in the brick have been improperly filled and look bad.
- Bricks are loose and falling out

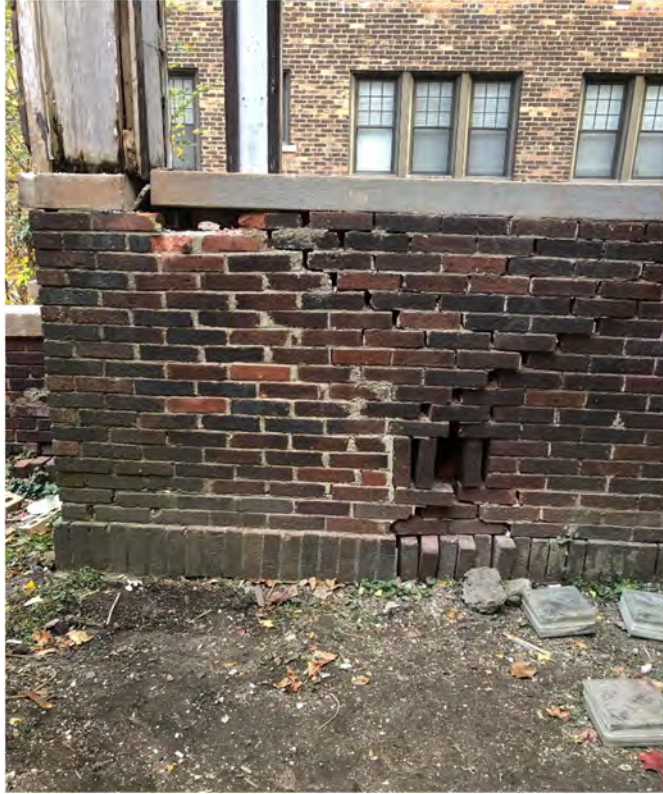
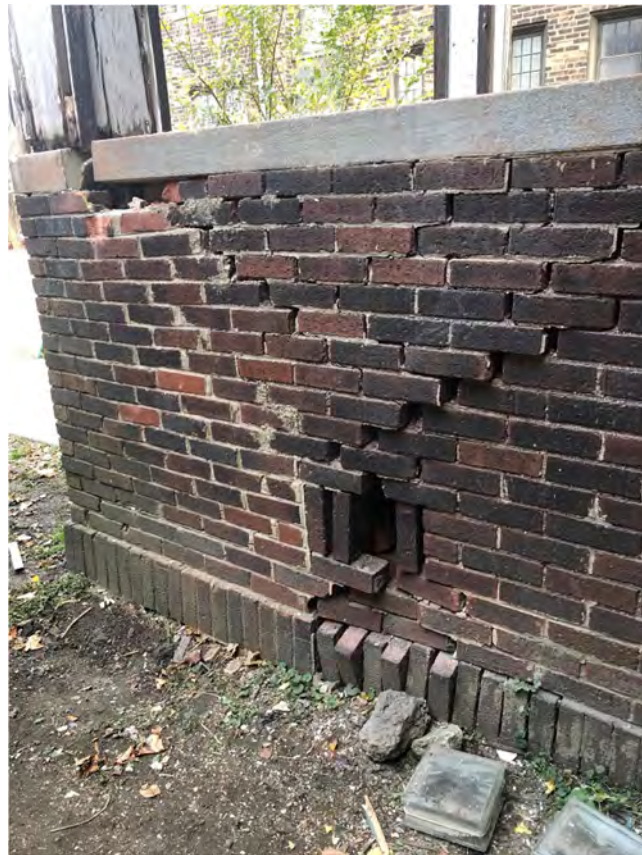
- Wall is 4 layers of bricks
- There are severe cracks in the porch wall
- The gaps in the brick have been improperly filled and look bad.
- Bricks are loose and falling out
- Wall is falling apart and is unsafe. Will need to be torn down and rebuilt to be corrected.
- Some bricks have been replaced with non-matching bricks.
- Wall supports the upper porch and is leaning out and could collapse causing the upper porch to collapse also.

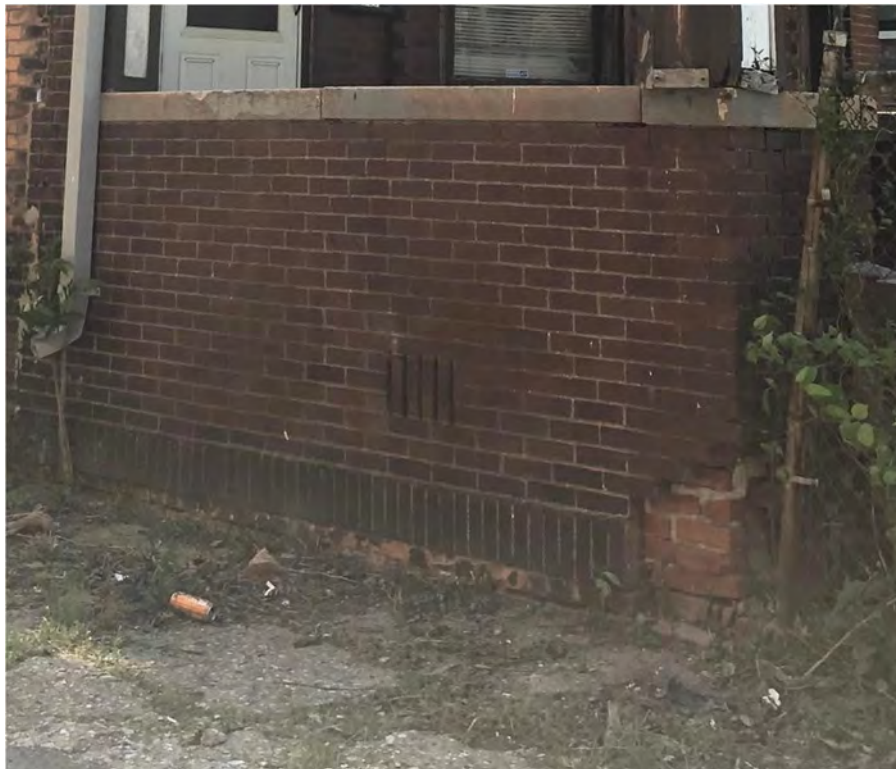
- Bricks on corner are missing.
- The rest of the porch walls is in good condition. Bricks need to be cleaned.

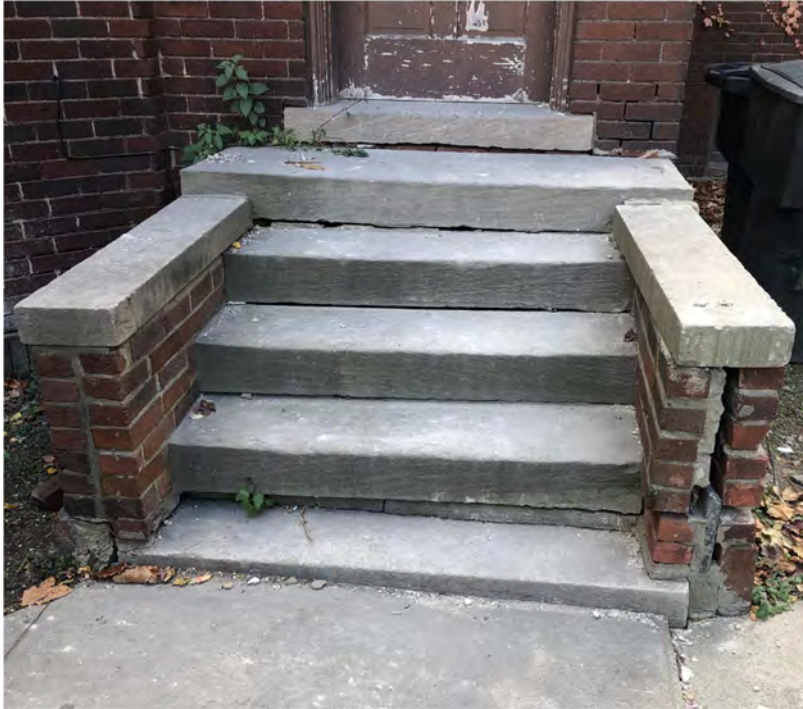
SECOND PORCH

- Steps have pulled away from the porch and was improperly filled
- Step Wall has pulled away from itself and was improperly filled
- Steps are not to code or ADA compliance.
- There are gaps between the steps and have been filled

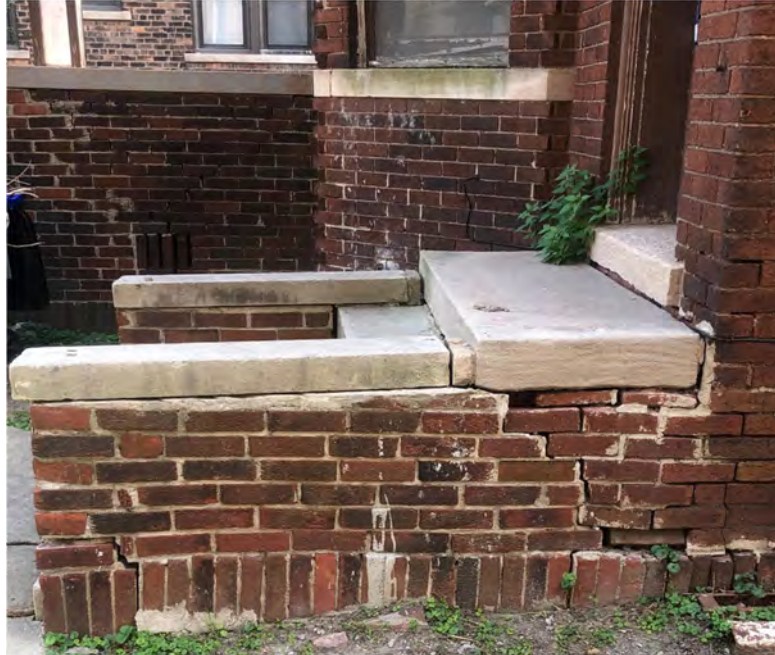
- The gaps in the brick have been improperly filled and look bad.
- Bricks are loose and falling out
- There are severe cracks in the porch wall
- Wall is falling apart and is unsafe. Will need to be torn down and rebuilt to be corrected.
- Some bricks have been replaced with non-matching bricks

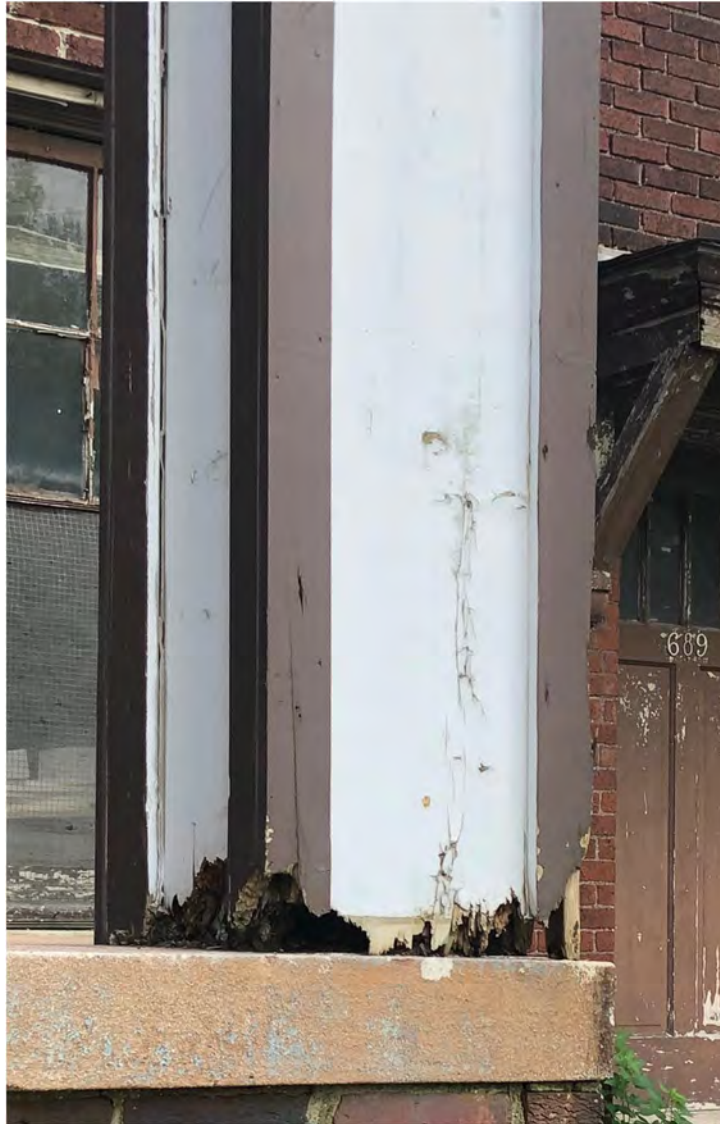
PORCH COLUMNS

- Columns have severe rot and decay
- Trim boards are missing

It is our opinion that the wood on the porch has sever rot and is in disarray. The upper porch is dangerous and should not be use. The wood on the porch needs to be disassembled while supporting the roof. The porch to be rebuilt using new wood and support columns. Trim board to be installed to match existing and painted to reduce the chance of rot.

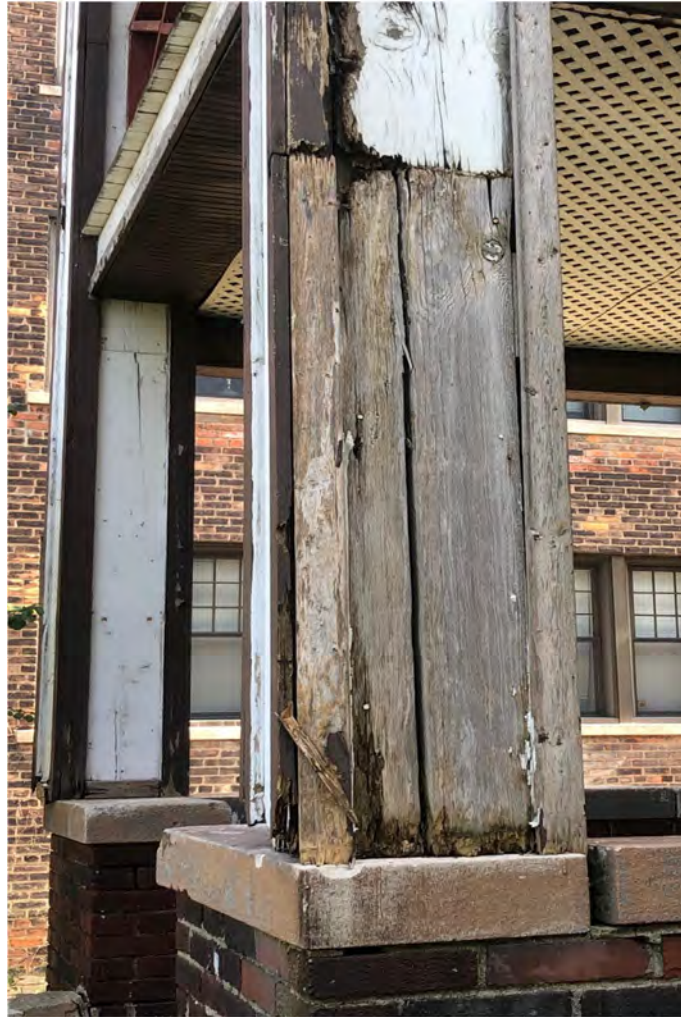
- Boards have been replaced
- Columns have severe rot and decay
- Support for the upper porch is in risk

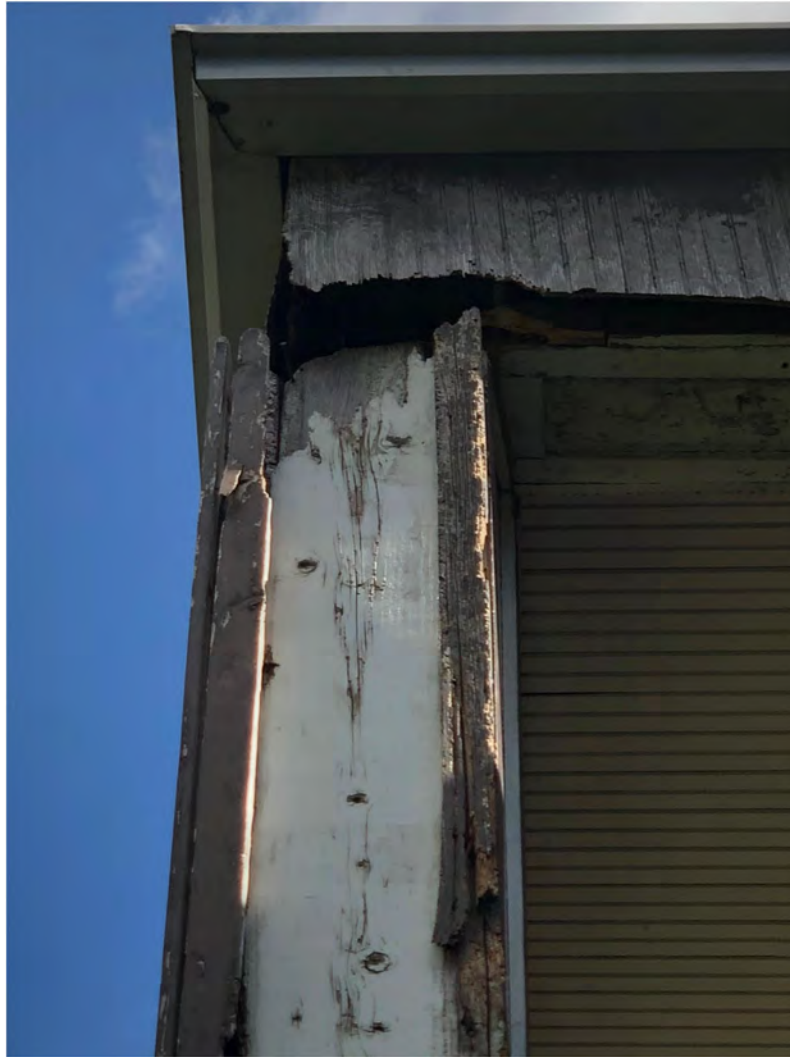
- Boards have been replaced
- Trim boards are missing
- Columns have severe rot and decay could collapse causing the upper porch to collapse.
- Fascia boards have rotted away
