STAFF REPORT 12-9-2020 REGULAR MEETING

APPLICATION NUMBER: 20-6968

ADDRESS: 691 W. ALEXANDRINE STREET

SCOPE: REHABILITATE EXISTING BUILDING; ERECT NEW BUILDING

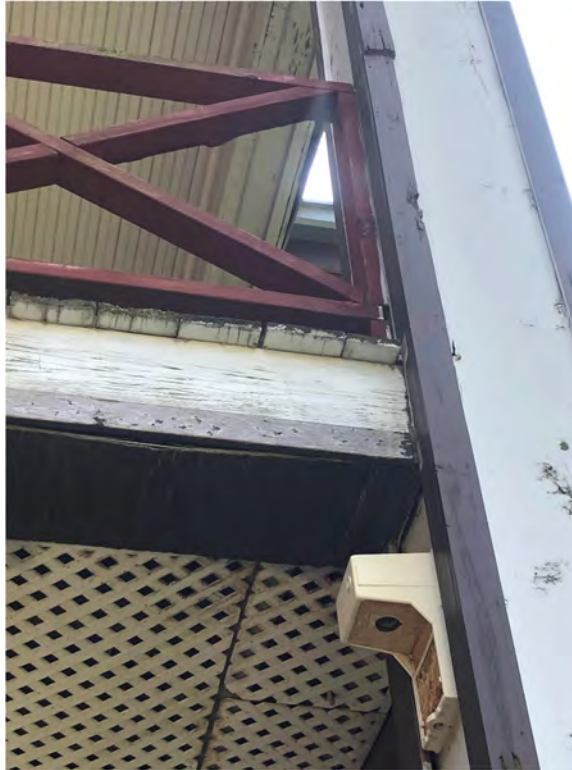
UPPER PORCH

- Upper porch has some rot in the supports
- The flooring has a lot of rot (would not recommend anyone venture onto the porch)
- The ceiling of the lower deck has been replaced with viny lattice.

It is our opinion that the wood on the porch has sever rot and is in disarray. The upper porch is dangerous and should not be use. The wood on the porch needs to be disassembled while supporting the roof. The porch to be rebuilt using new wood and support columns. Trim board to be installed to match existing and painted to reduce the chance of rot.

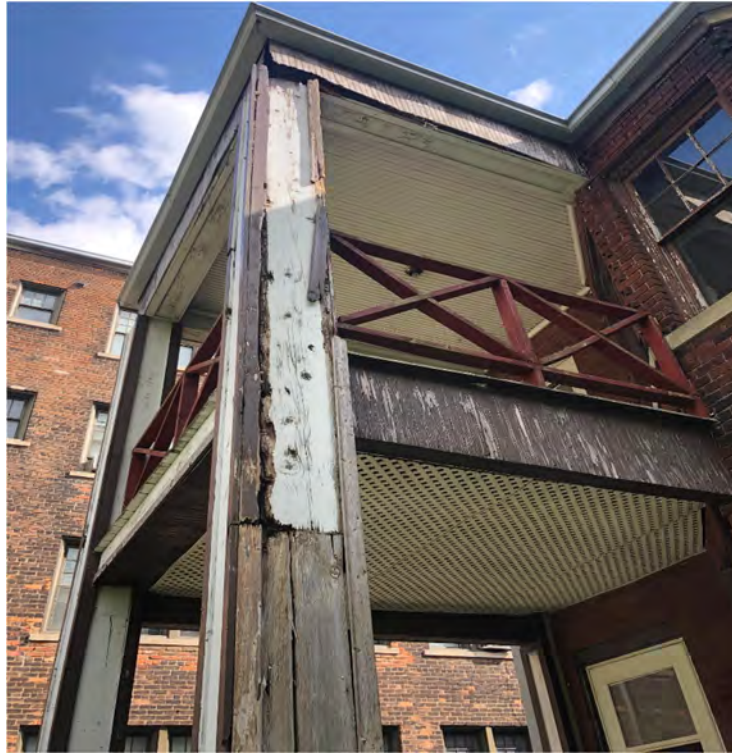
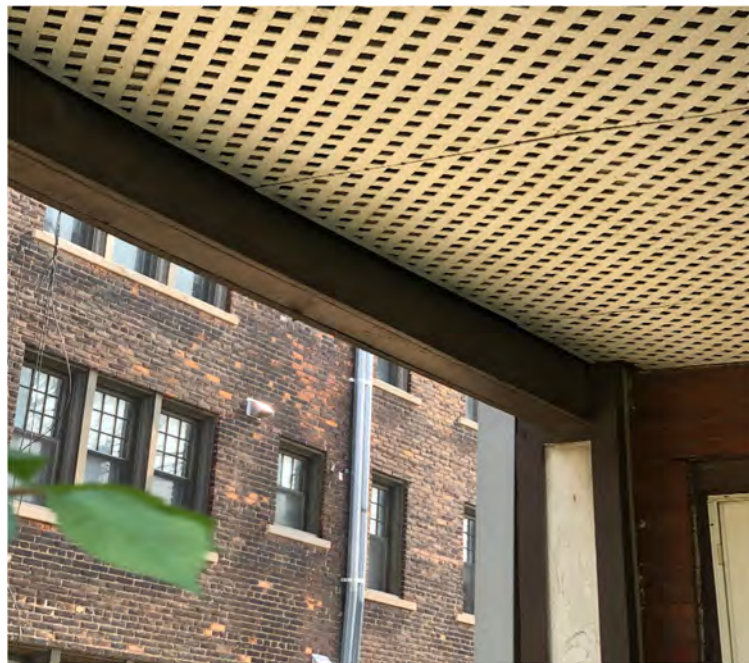
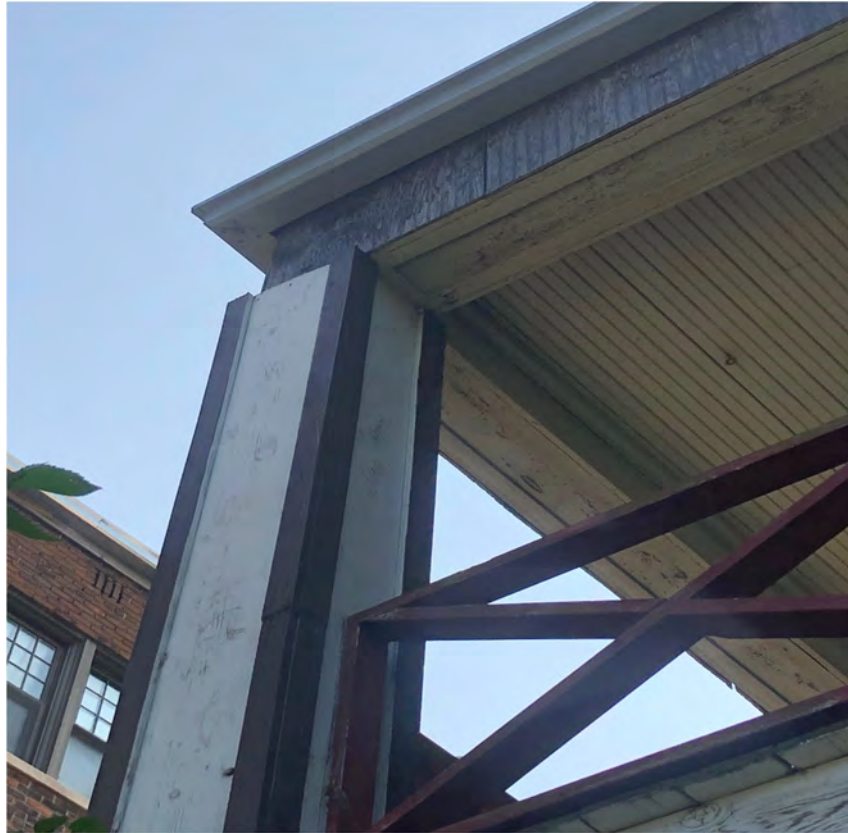
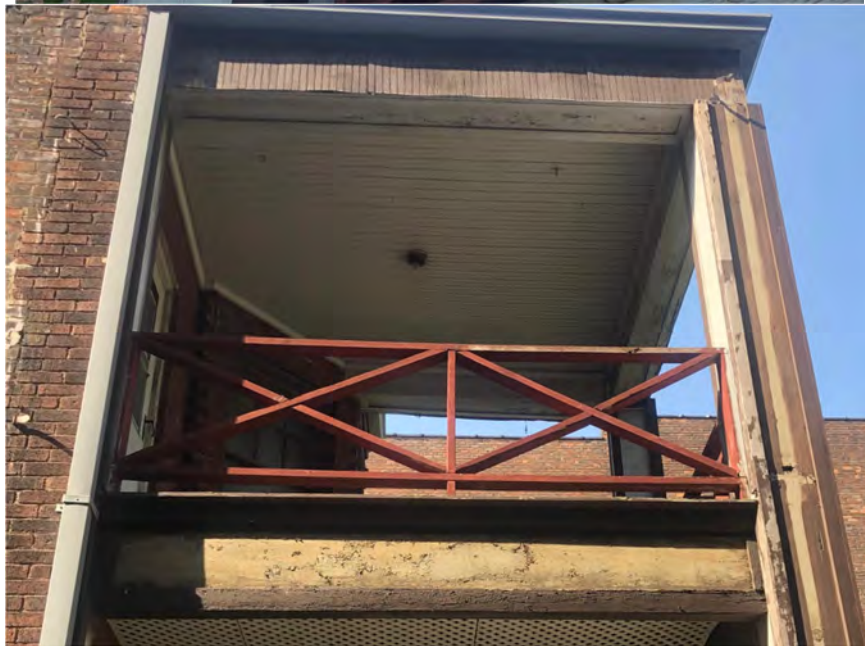
- Column has shifted from support on the upper roof.
- Railing has rot.
- Railing does not meet code.
